JUNE 14, 2006 - Lessons Learned - Case Studies in Engineering Failures

Speaker: [Eric Green, P.E.](#) Principal with [Walter P. Moore](#), Structural Diagnostics Group, Tel. 713-630-7306

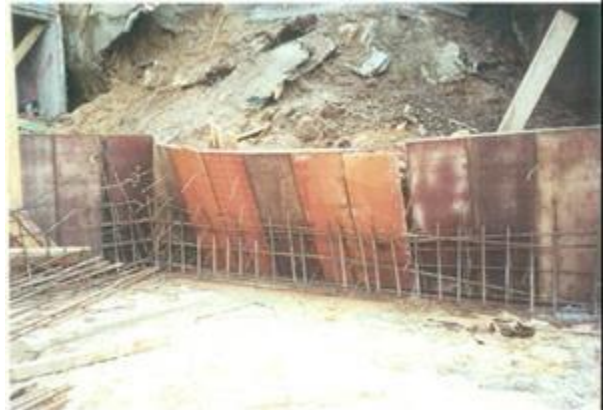
Soil-Nailed Walls - Mr. Green discussed a project with a soil-nailed retaining wall (see photo), used to temporarily retain soil during construction, which failed 30 days after its construction. In performing his forensic evaluation, Mr. Green found the wall only had a safety factor of 0.56 and therefore should have failed even sooner. He found the geotechnical engineer's investigation was deficient, the structural engineer used the wrong software and made bad design assumptions, and the wall was not constructed per the drawings. Mr. Green said two accepted programs one should use when designing soil-nailed retaining walls are GOLDNAIL and SNAILZ.
