MARCH 2008 MEETING

Underground Vault Failure Investigation and Repair

Speaker: [Eric Green, P.E.](#), Green Engineering Consulting

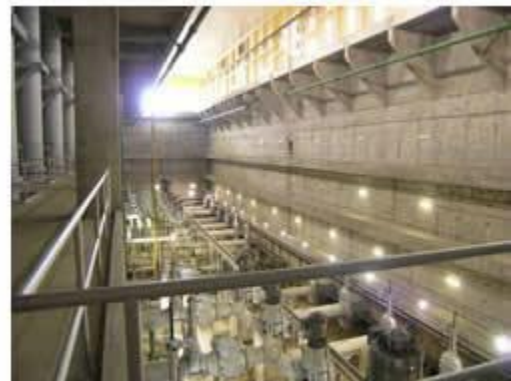
The project Mr. Green discussed was the failure of a 230' x 360' underground pump vault designed to hold raw sewage on its way to a sewage treatment plant. It was opined that the failure resulted from external hydrostatic loads, that resulted in a large crack in the 5-foot thick mat slab that formed the base of the pump vault. The presentation discussed the design, failure, the failure analysis, and the repair to this failure. The failure occurred during commissioning, i.e., before construction was complete.

The design calculations assumed a hydrostatic head of 195 pcf at 90 ft., well in excess of the 82 pcf needed if the water table were to occur at grade level, which it nearly did. However gross errors were found in the structural design calculations, which were opined to have been the cause of numerous undersigned structural elements. The structural design calculations were believed to be limited to only seven pages of hand calculations. No errors were found in the geotechnical design or the construction.

Once the vault became accessible, it was determined that the main leak initiated in the mat of the vault, and numerous fractures and cracks occurred in the mat and surrounding upper structure. Also vertical offsets were observed in the mat, especially adjacent to a drain trench, that paralleled one of the outer walls, where the mat thickness necked down from 5 ft. to 3.5 ft.

Next Mr. Green discussed the different alternatives of repair to restore the structural integrity of the vault and the repair option that was implemented. Fortunately, the leak (from the outside inward) kept the vault from popping out of the ground as it only had a 0.5 safety factor against uplift when empty. After dewatering was implemented, this allowed a repair that included adding dozens of precast concrete compression struts at several levels of the 90-foot high walls, added 3 to 4 ft. of concrete thickness to the existing perimeter walls that were as thick as 8 ft. at the base, and reinforcing the mat with over a hundred rock anchors on a 25 ft. grid to resist future hydrostatic heave.
