# Case Study #1

**Poor Geotechnical Engineering + Poor  
Structural Engineering + Poor  
Construction**

Location: McKinney, Texas

Size/Use: 60,000 SF – Office Building

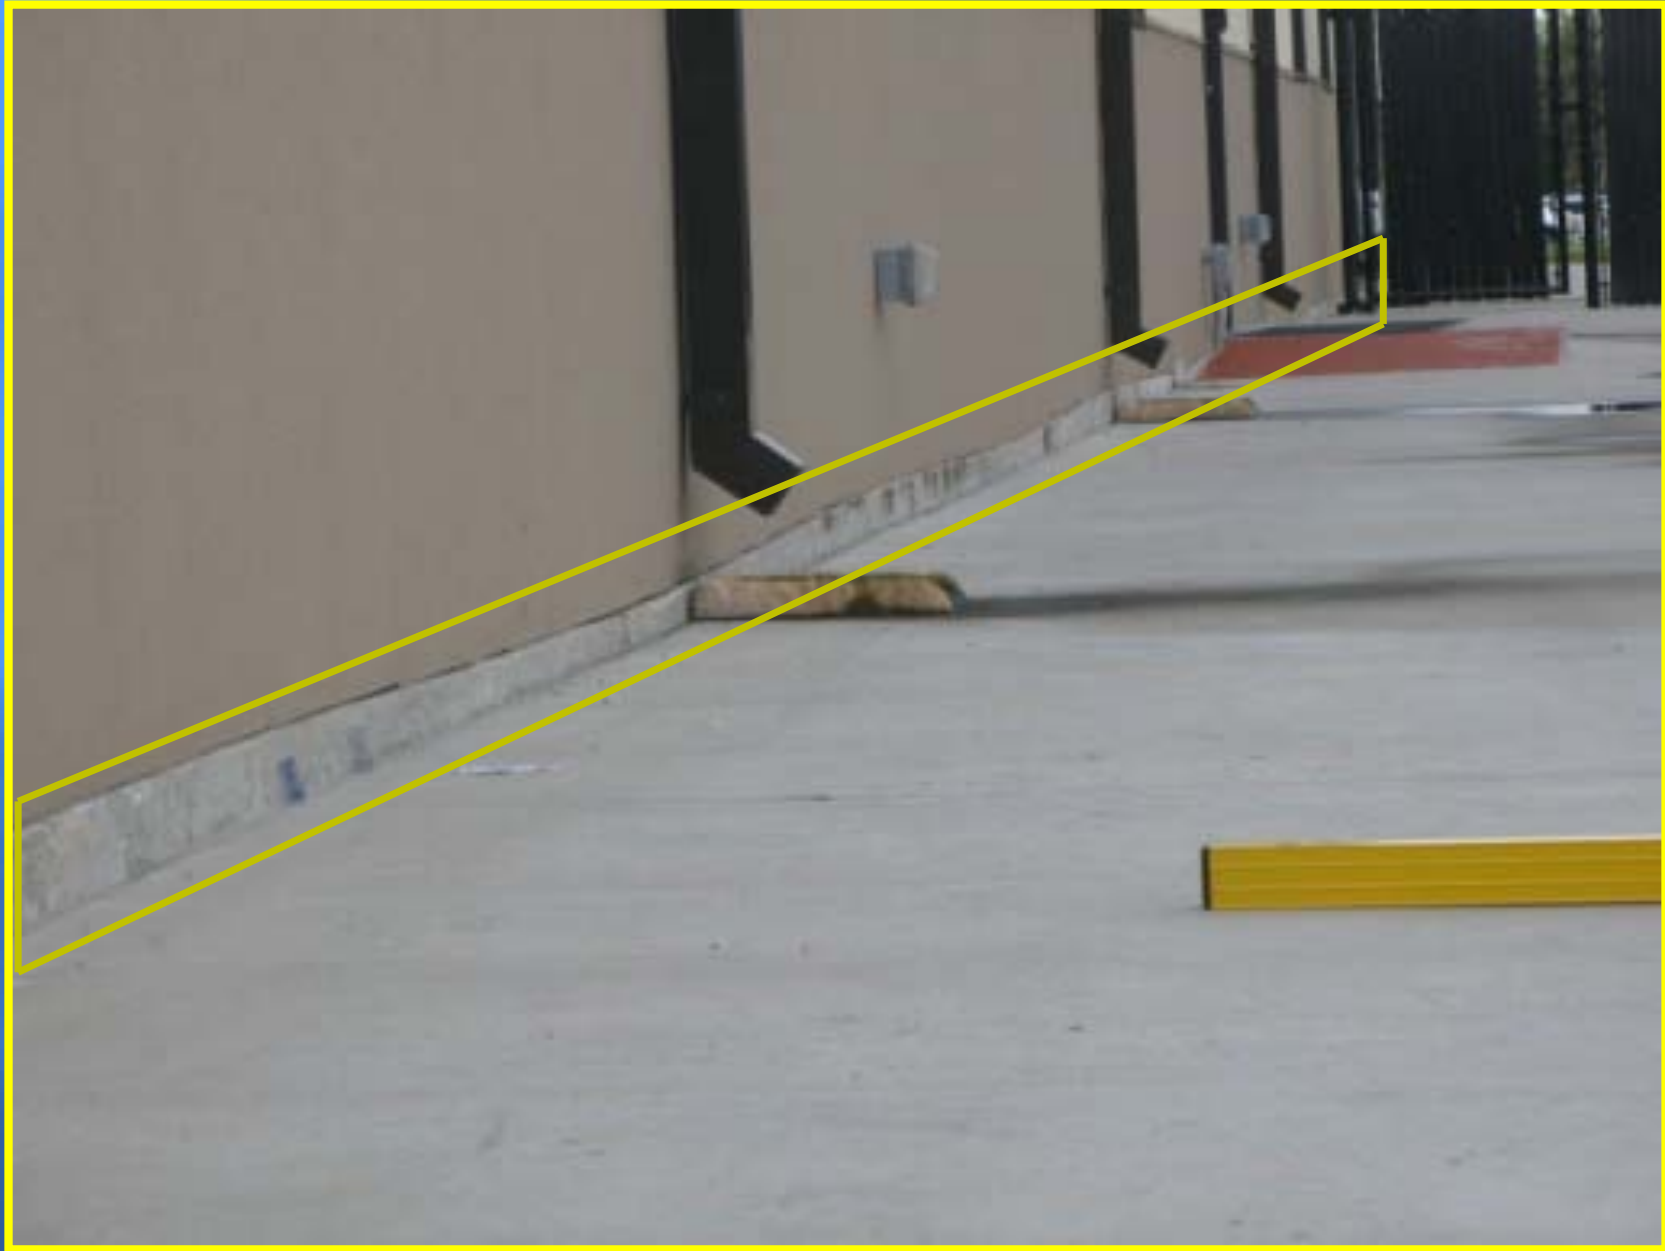
# Uneven Floors

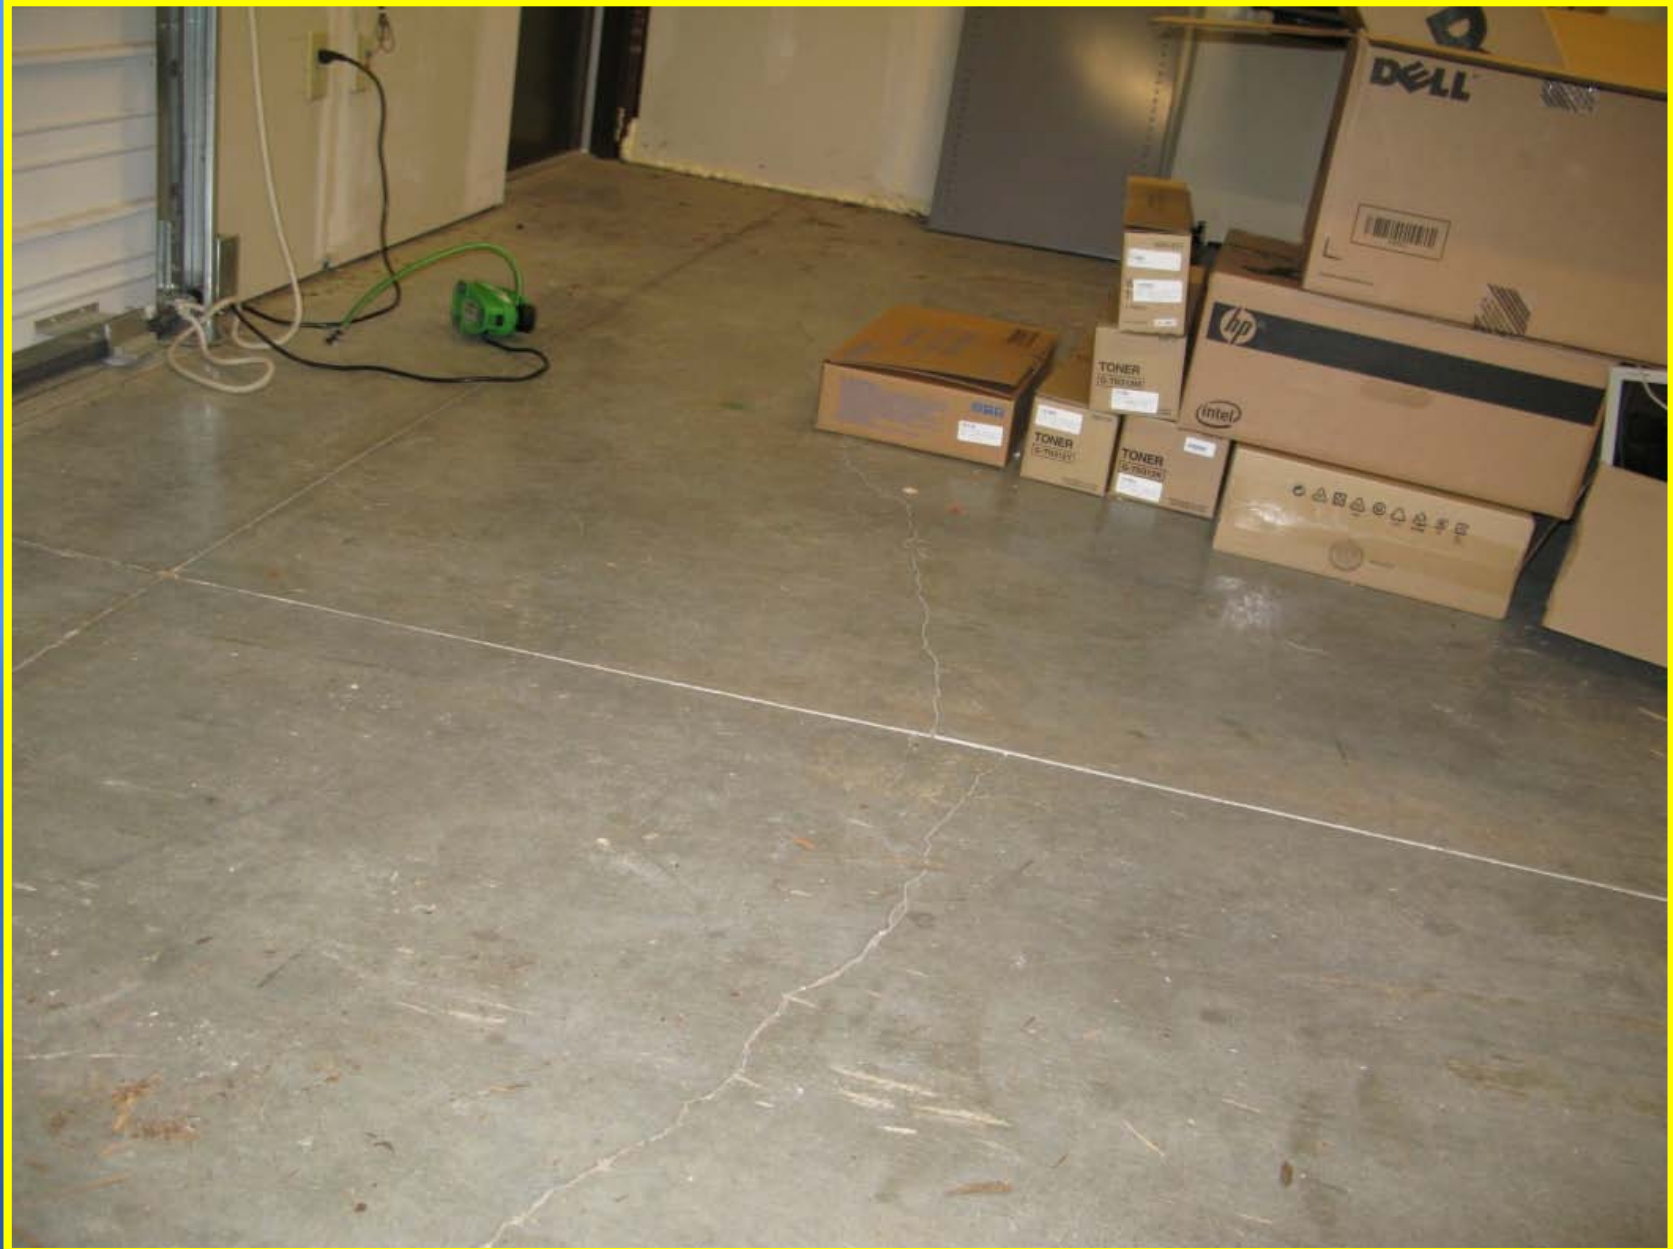
# Foundation Fractures

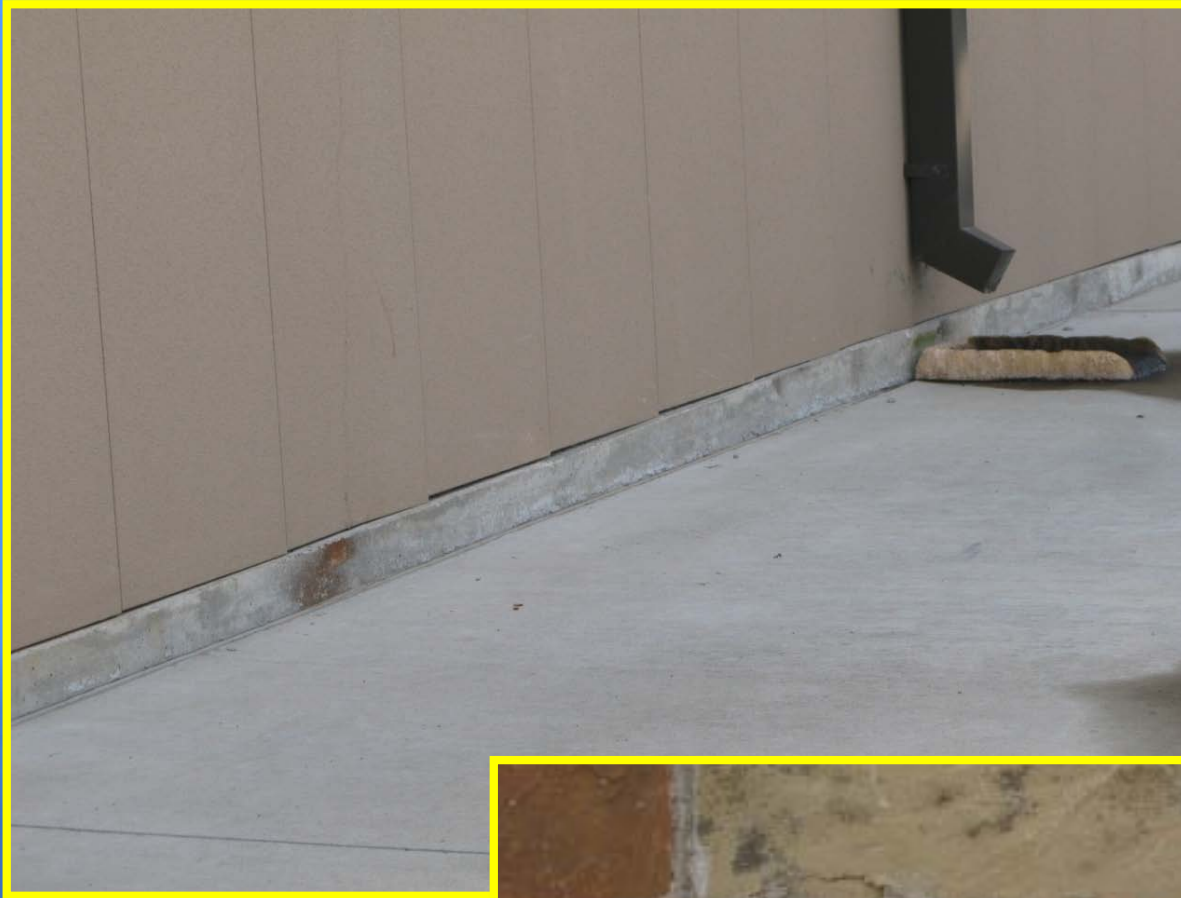
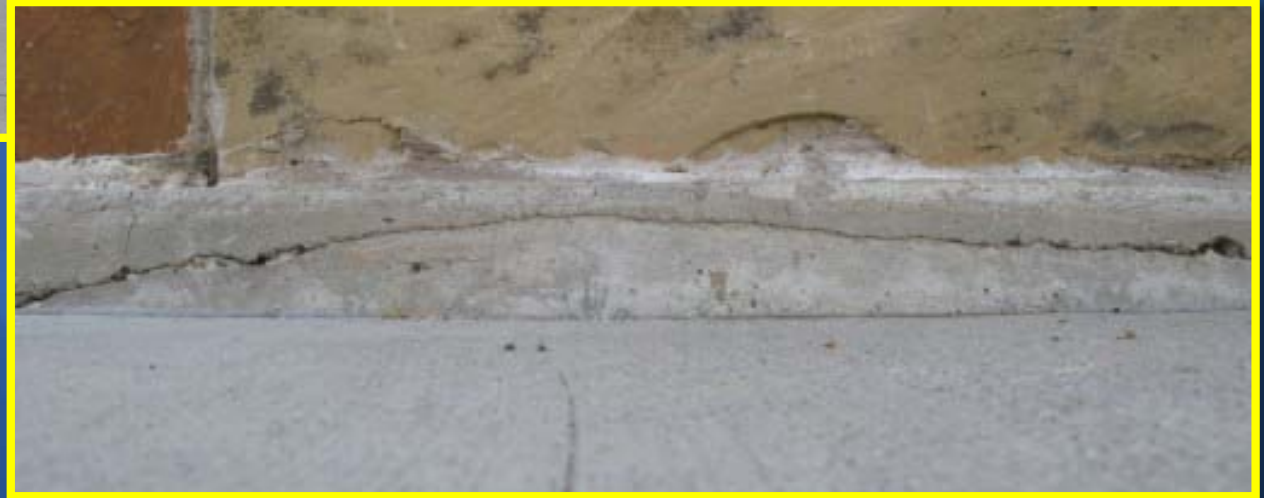
# Foundation Fractures

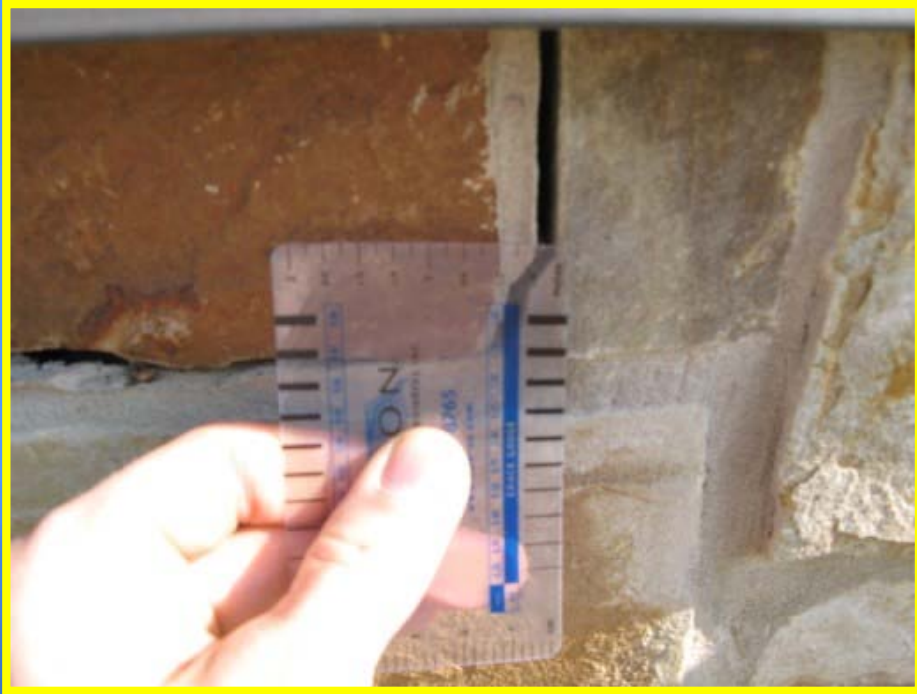
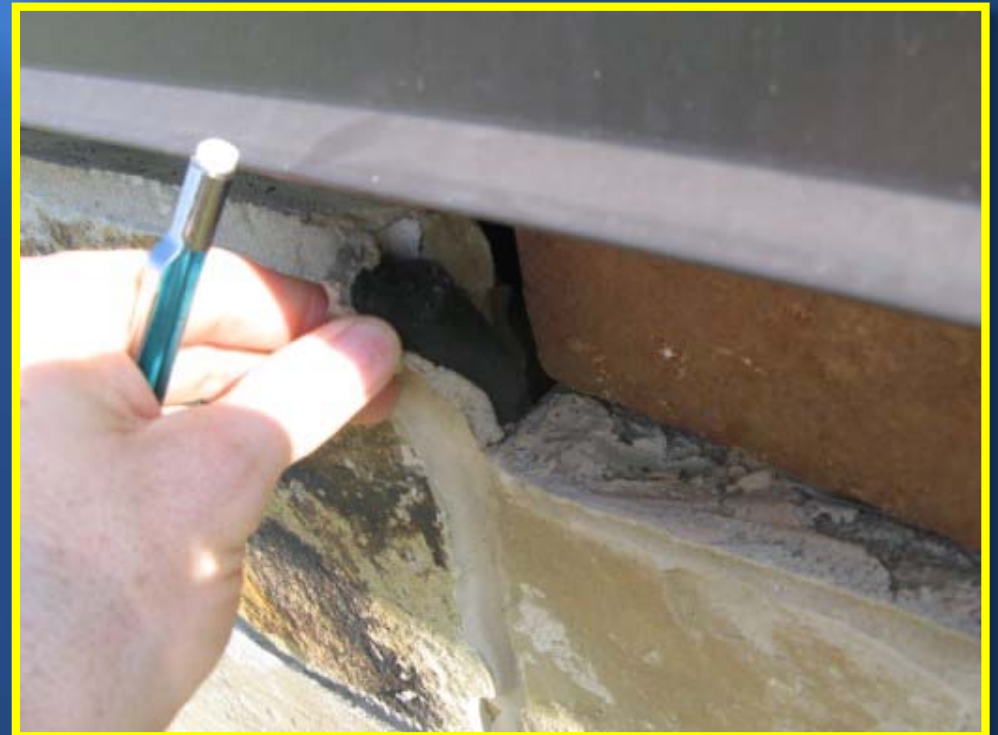
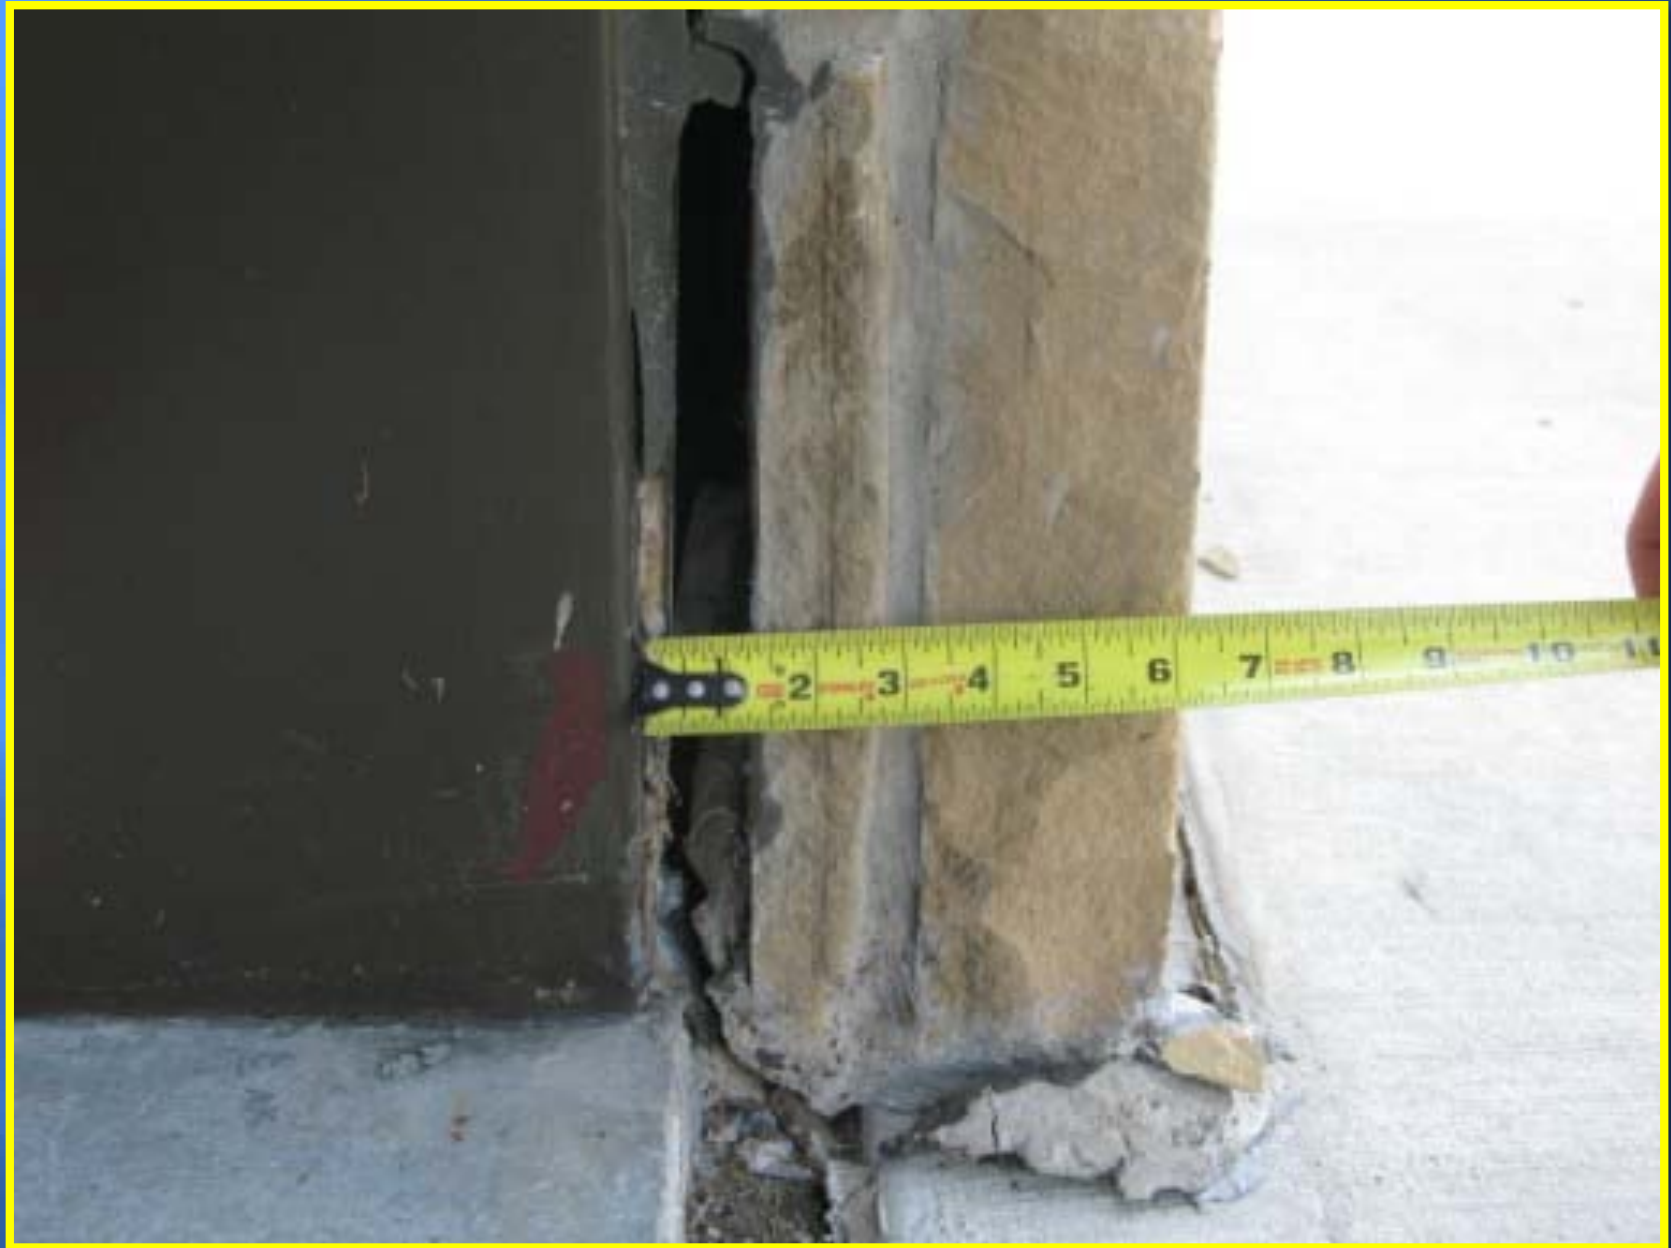
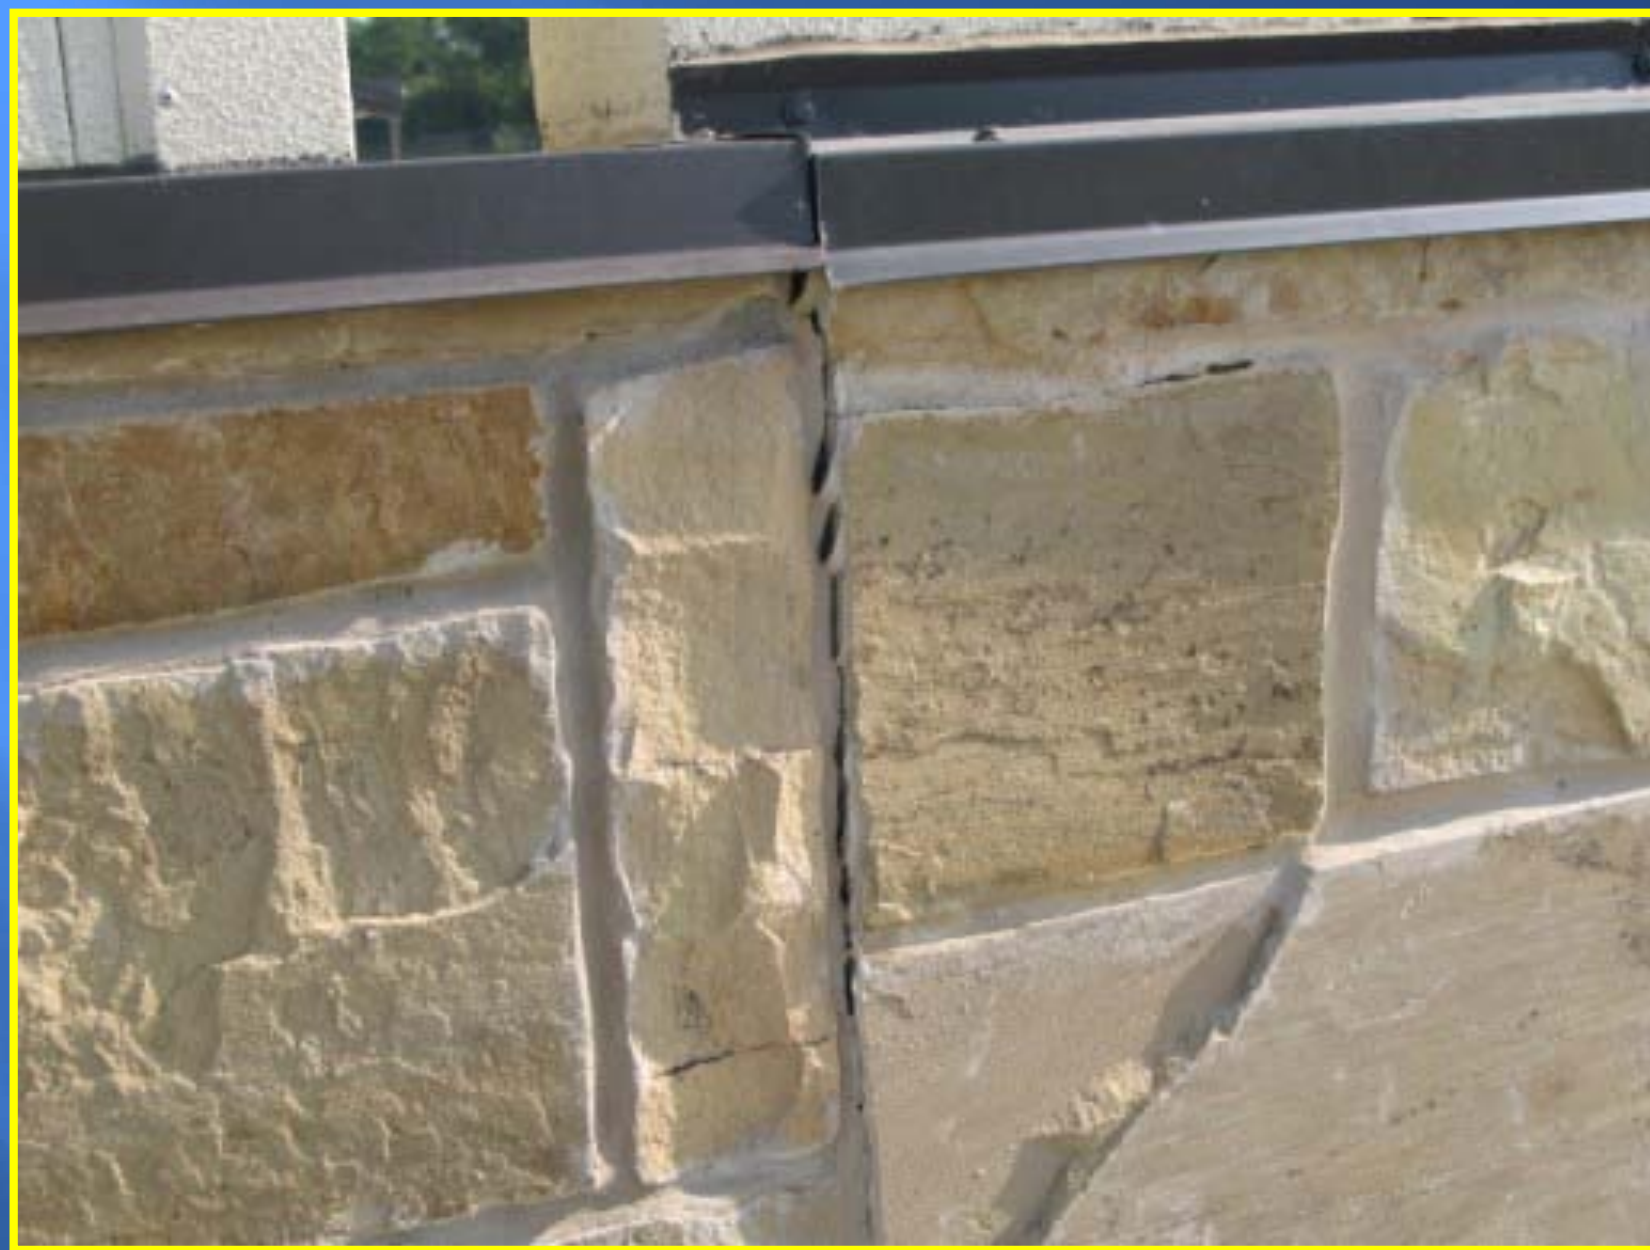
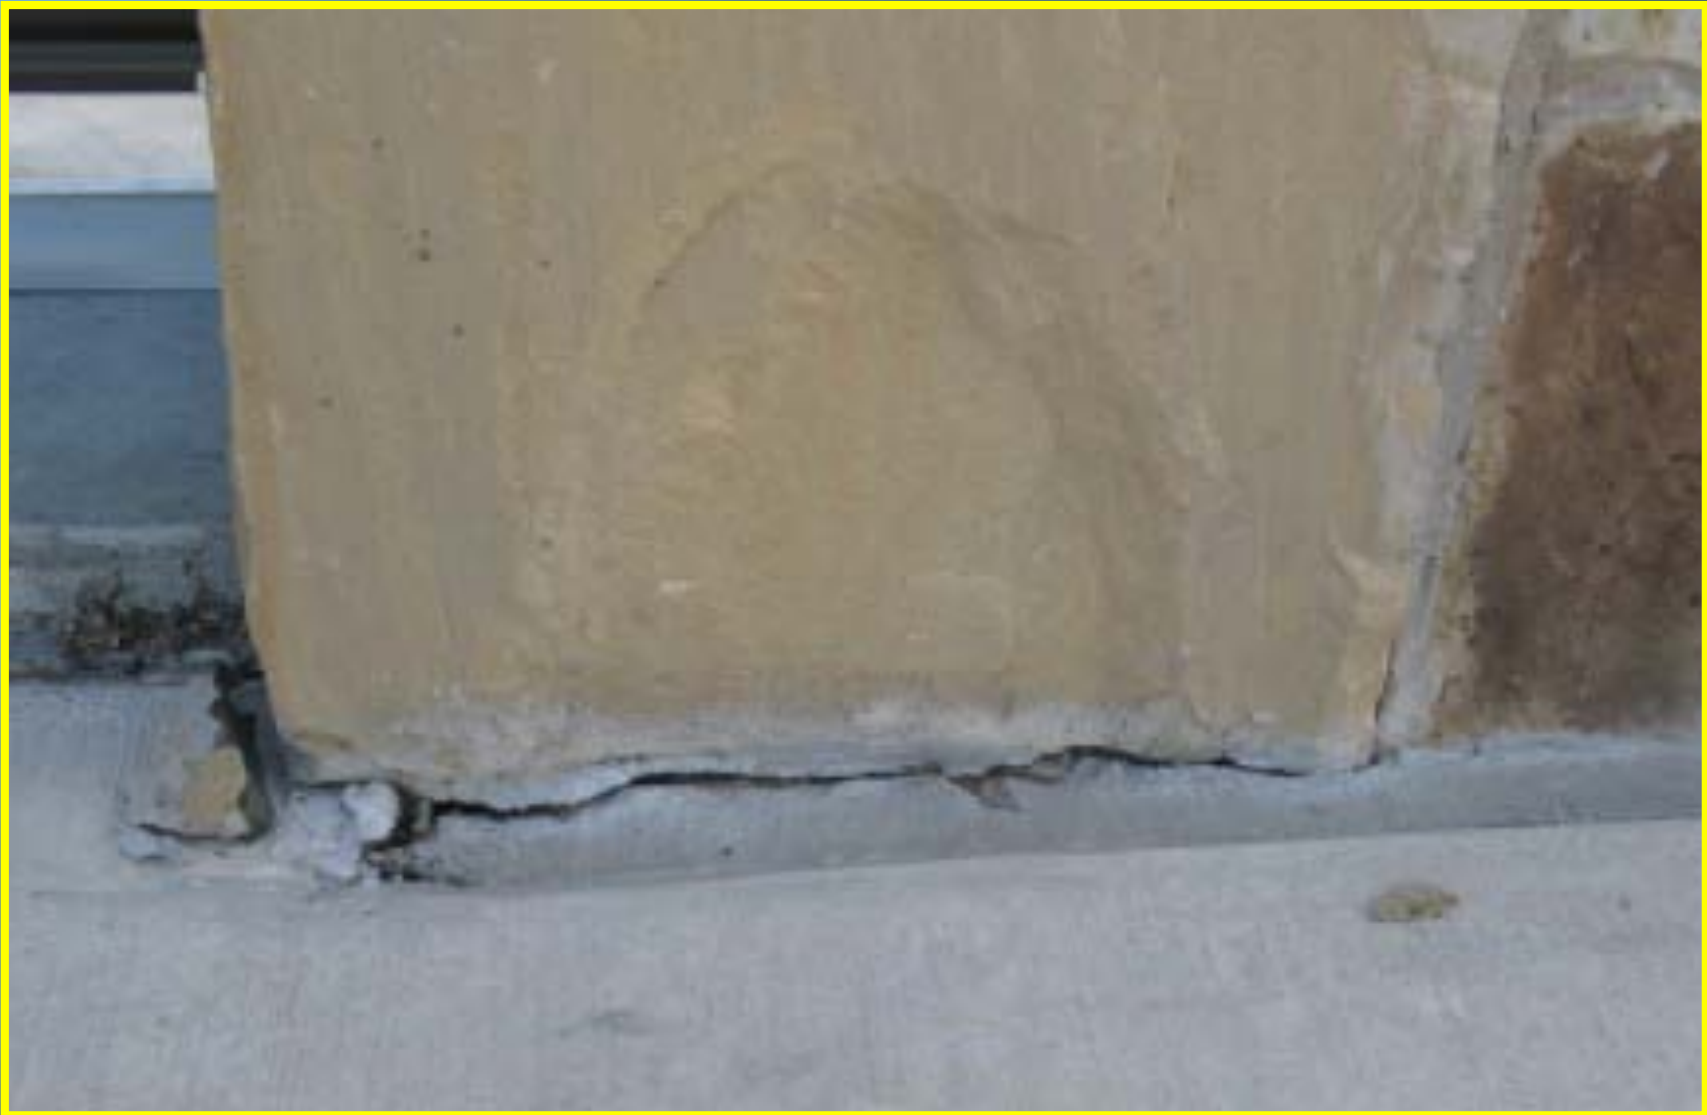
# Exterior Veneer Distress

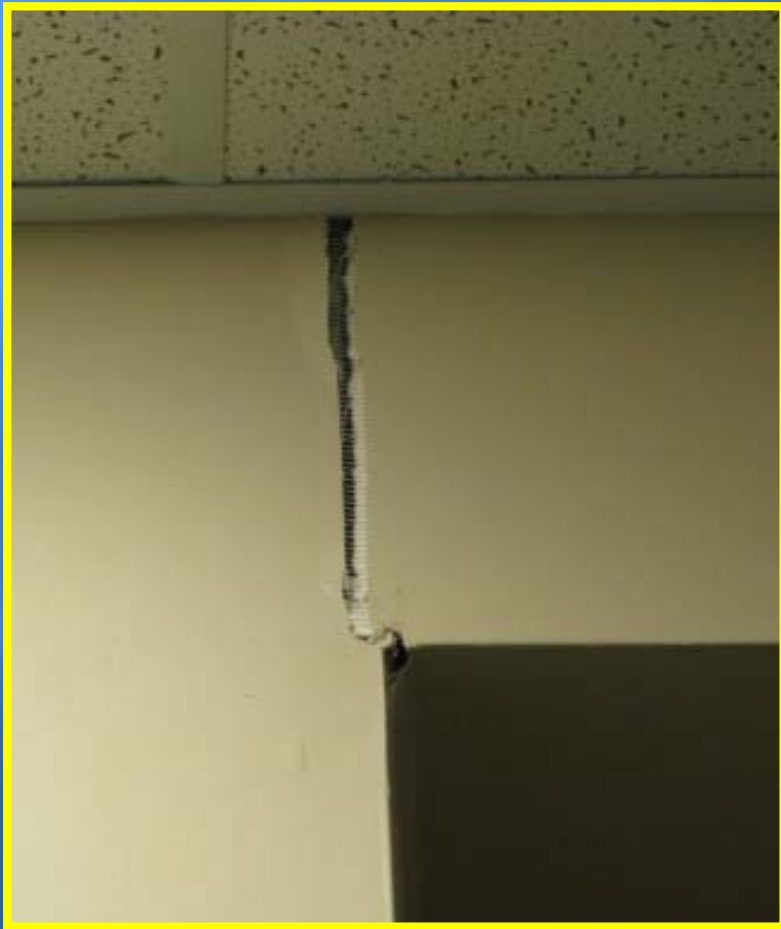
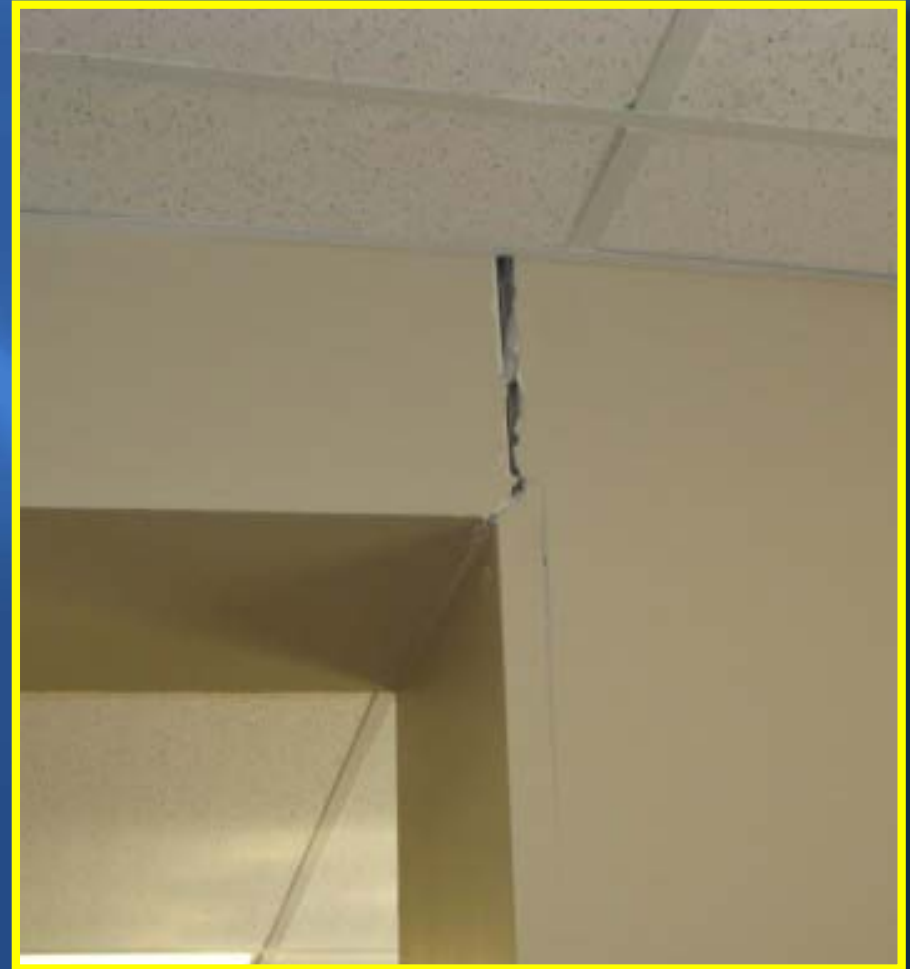
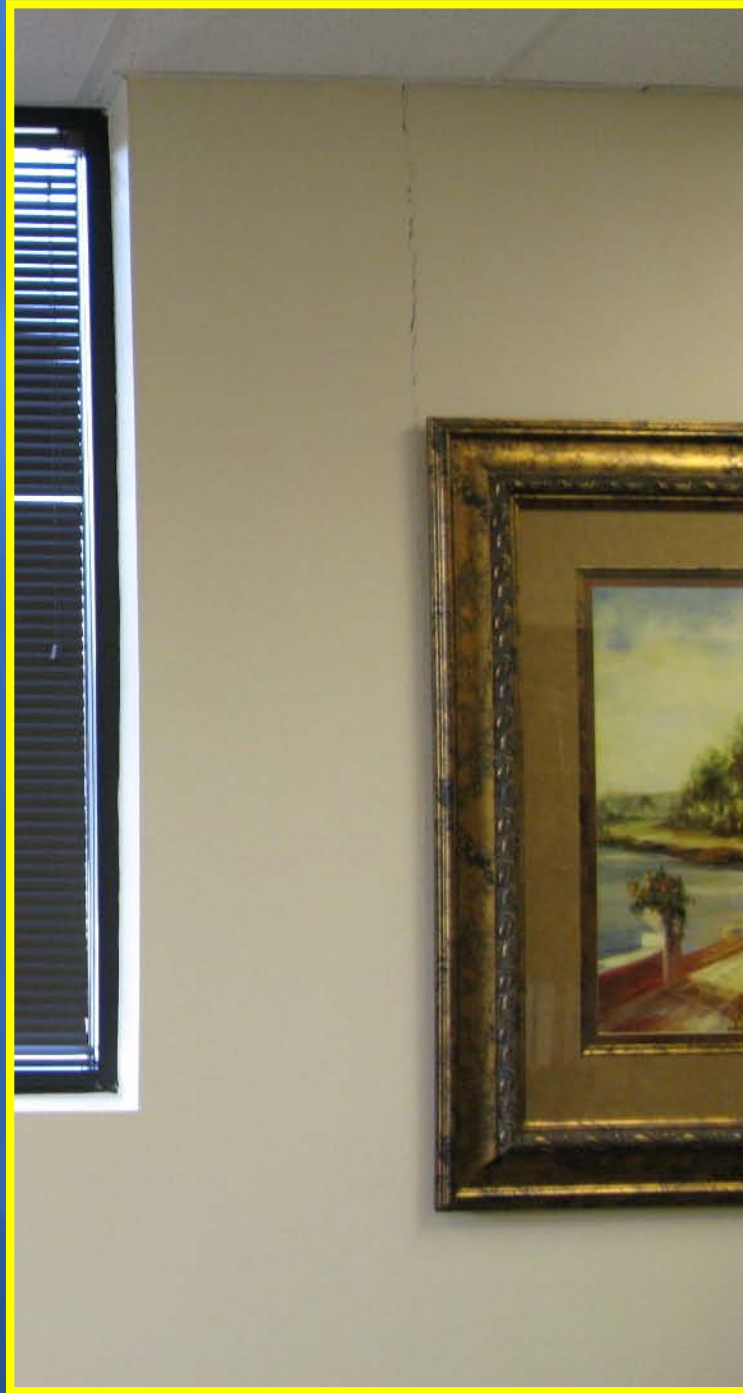
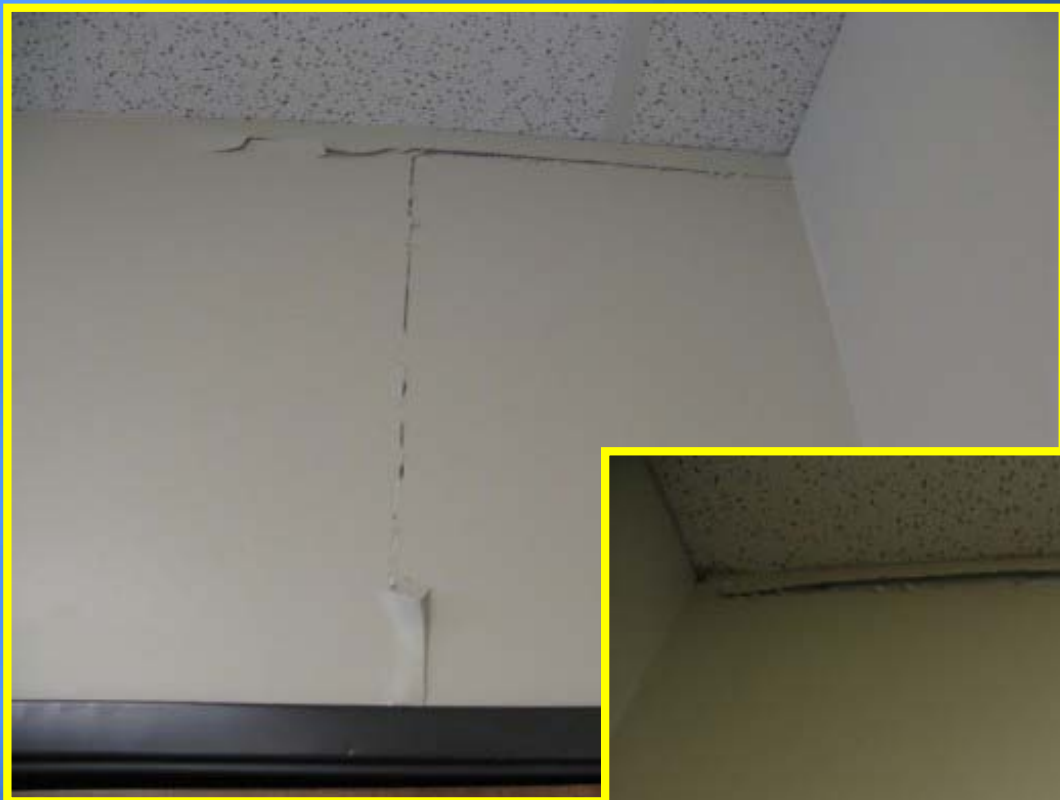
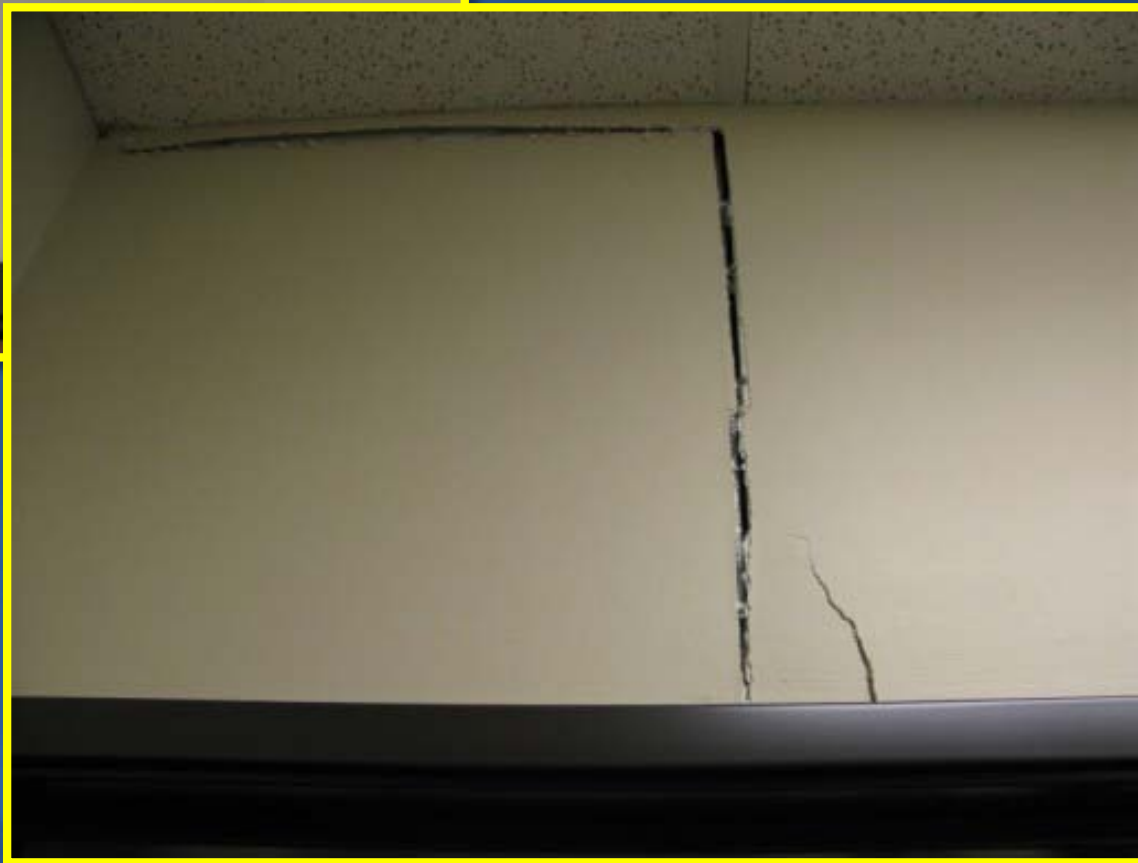
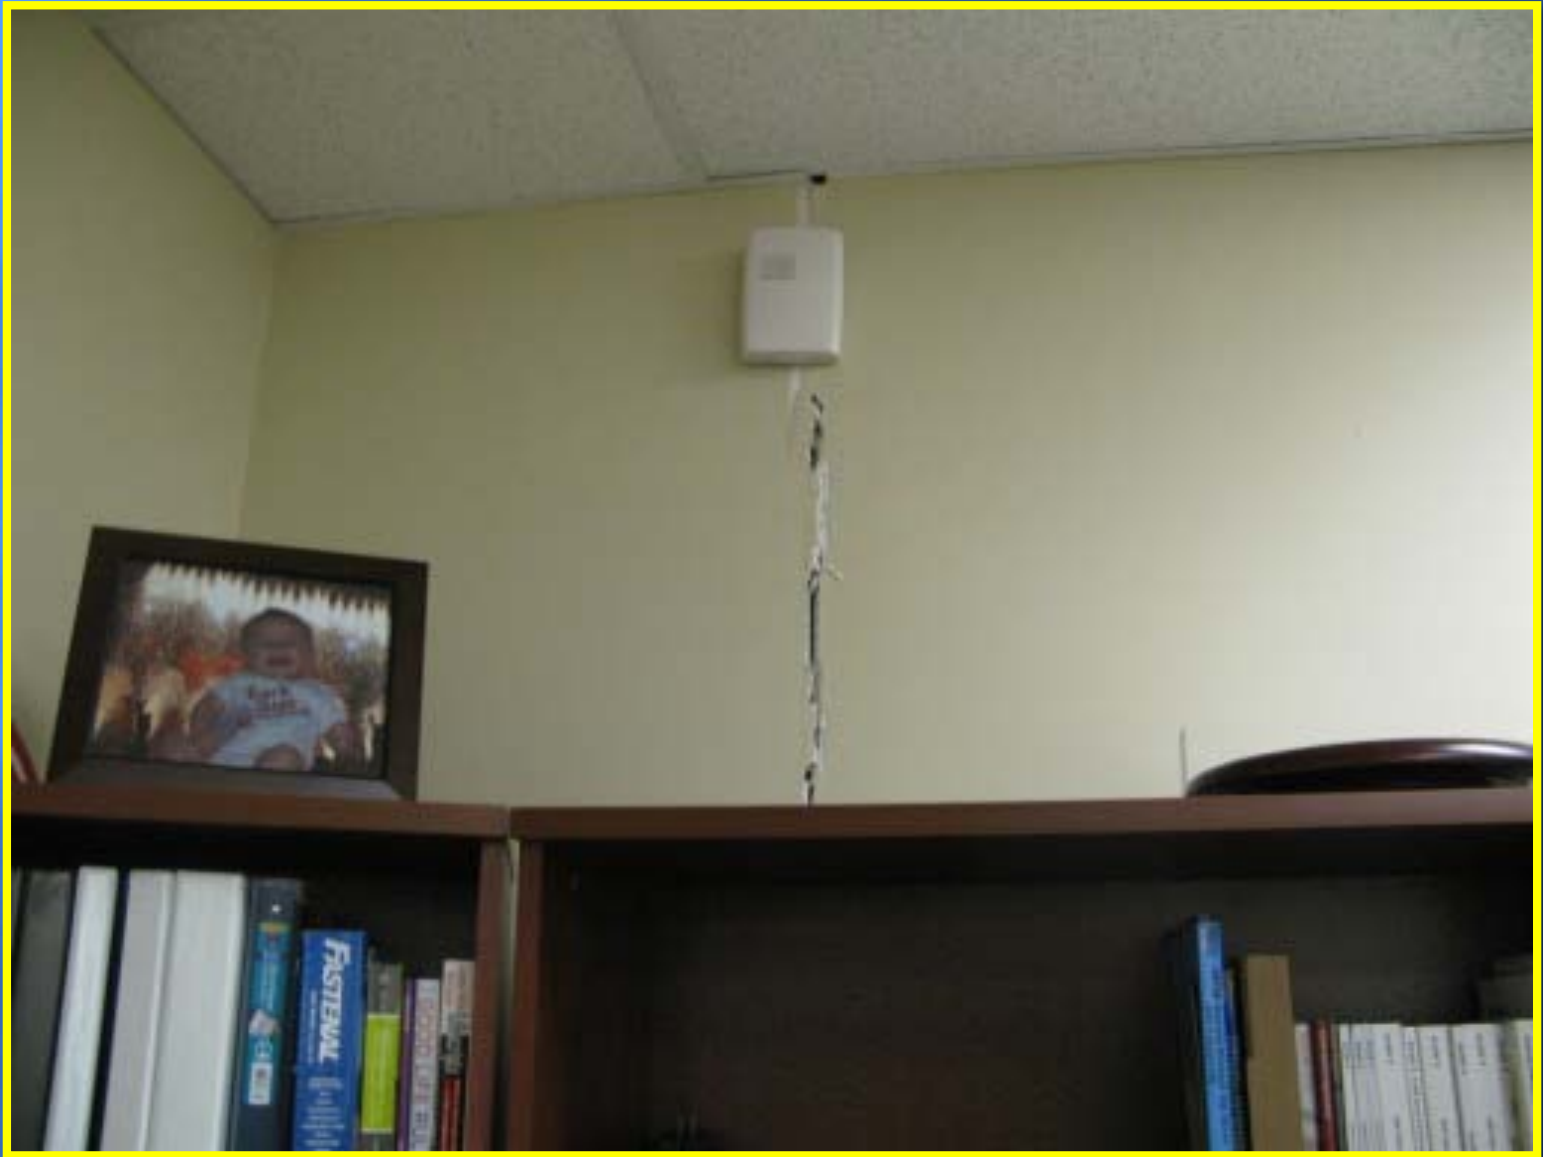
# Interior Veneer/Finish Distress

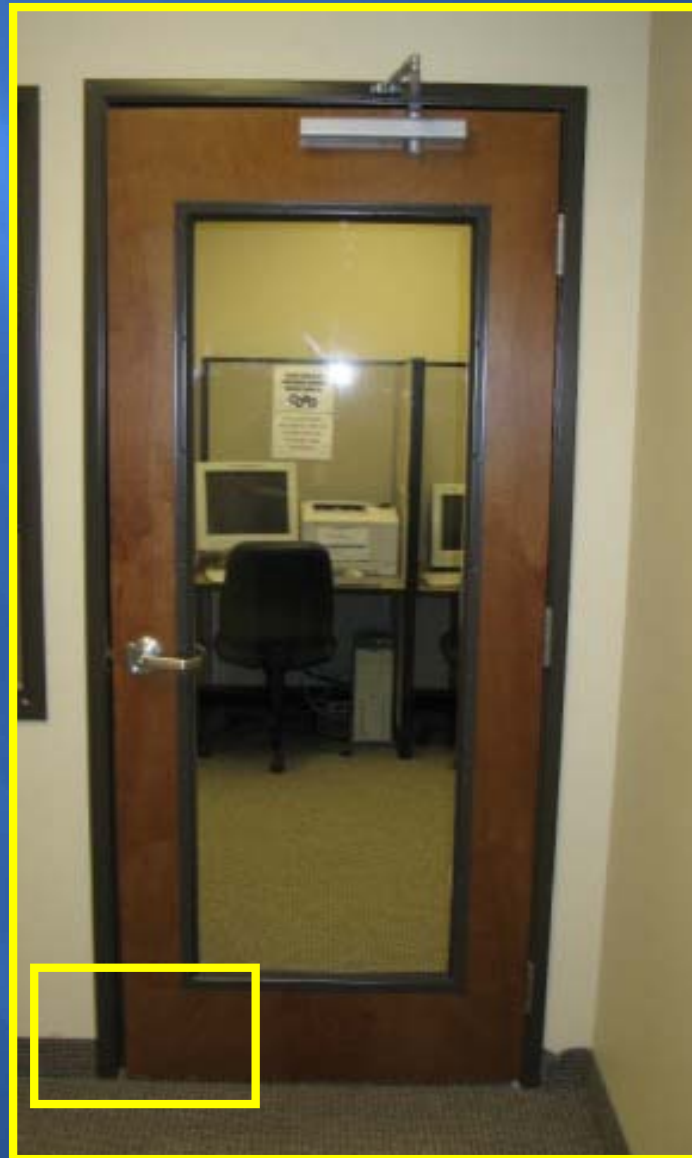
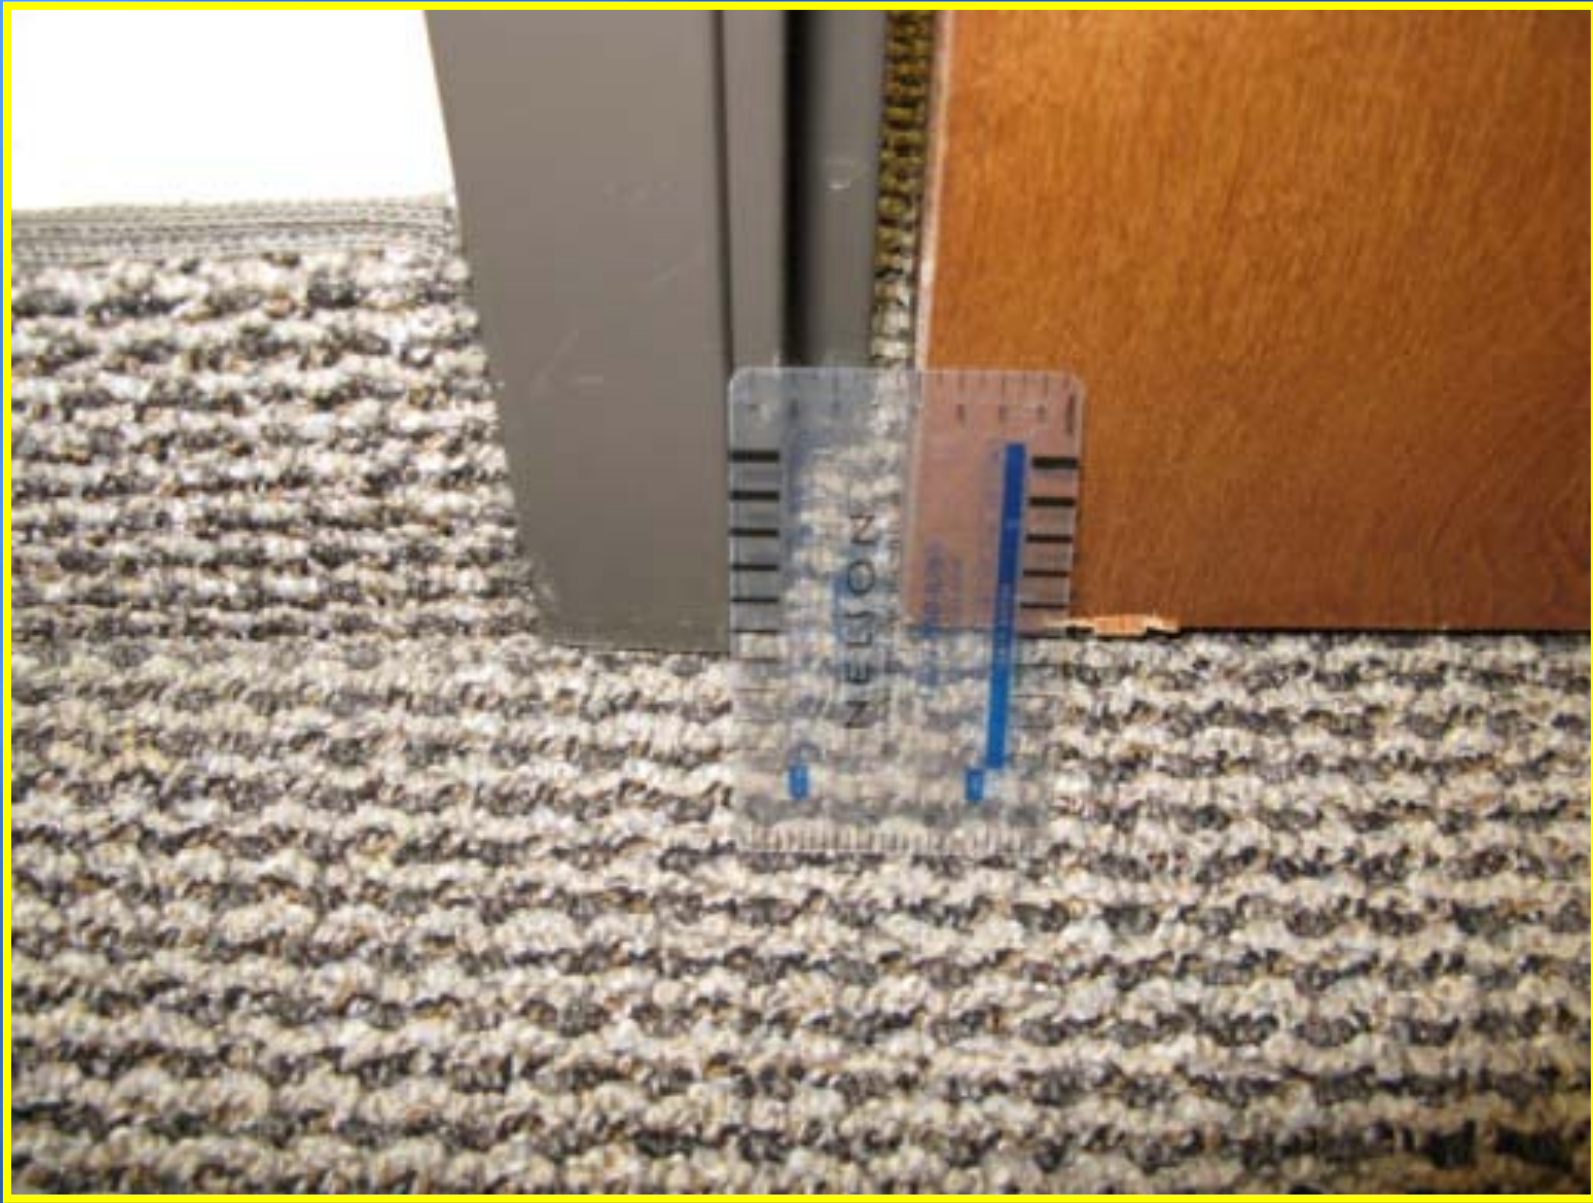
# Inoperable Doors
