# Case Study #1

**Poor Geotechnical Engineering + Poor  
Structural Engineering + Poor  
Construction**

Location: McKinney, Texas

Size/Use: 60,000 SF – Office Building

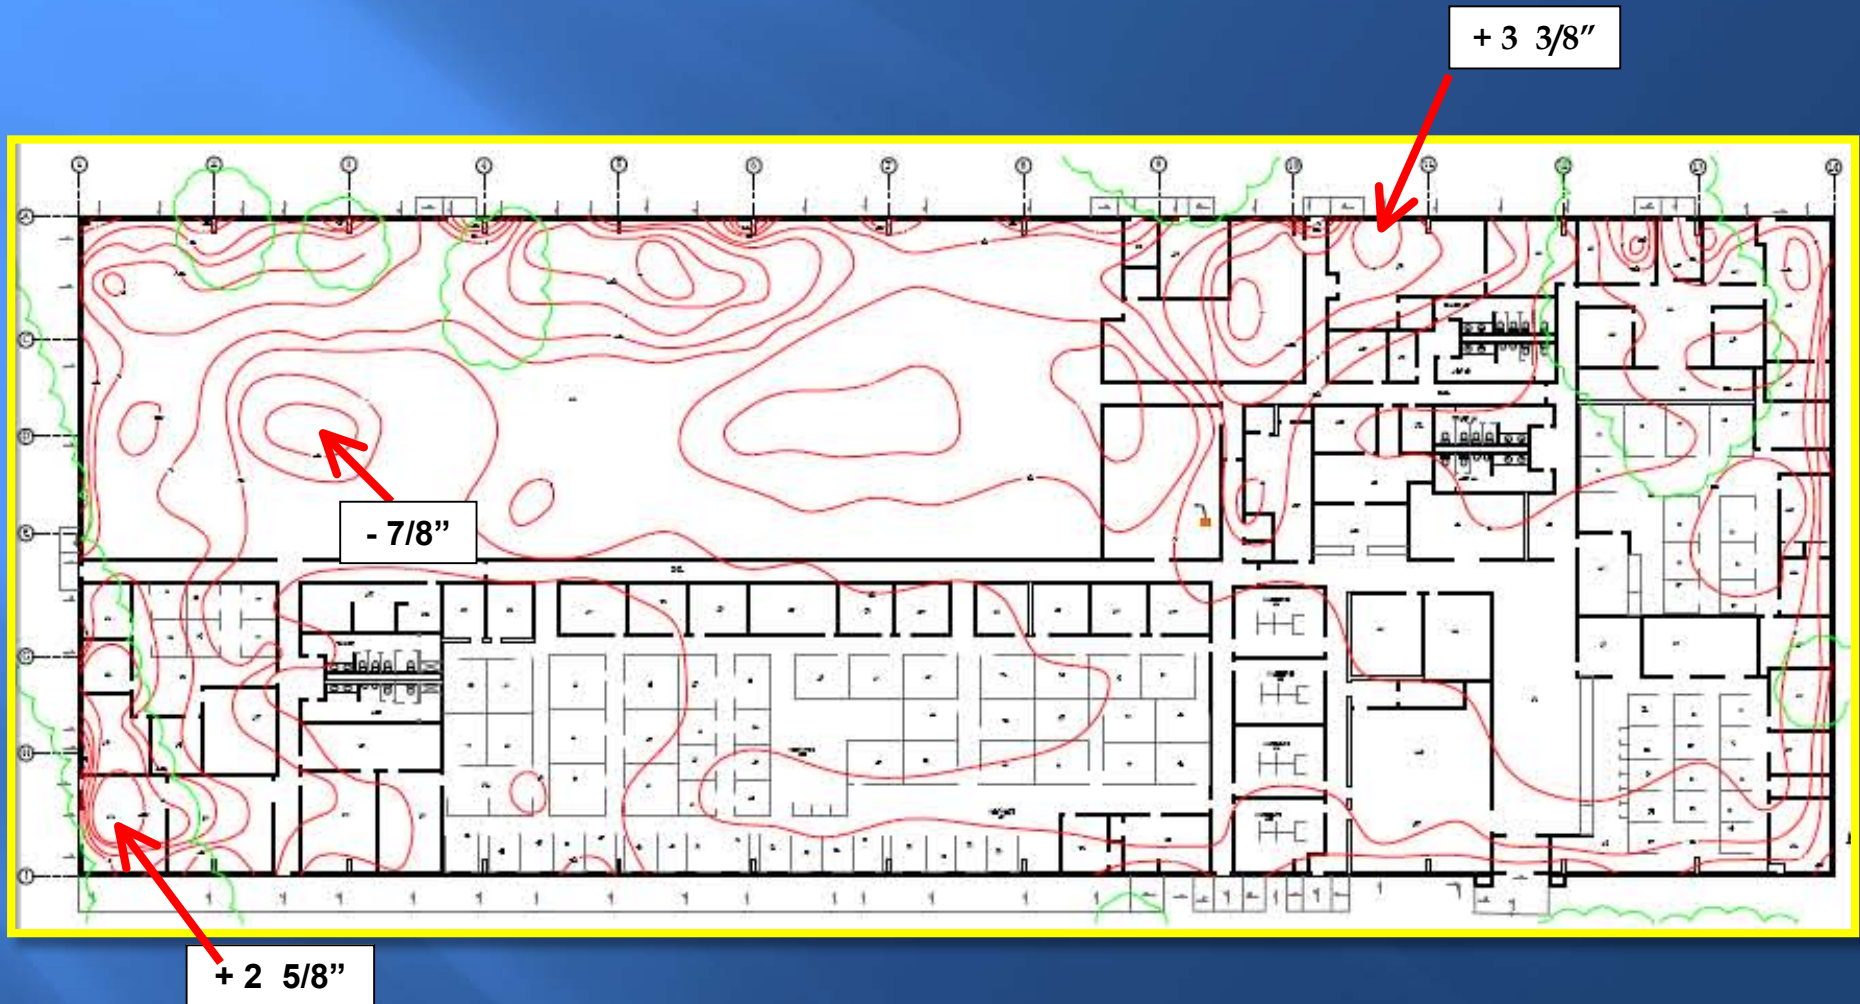
# Relative Elevation Survey (2-D)

Total Out-of-Levelness =  $4 \frac{1}{4}''$

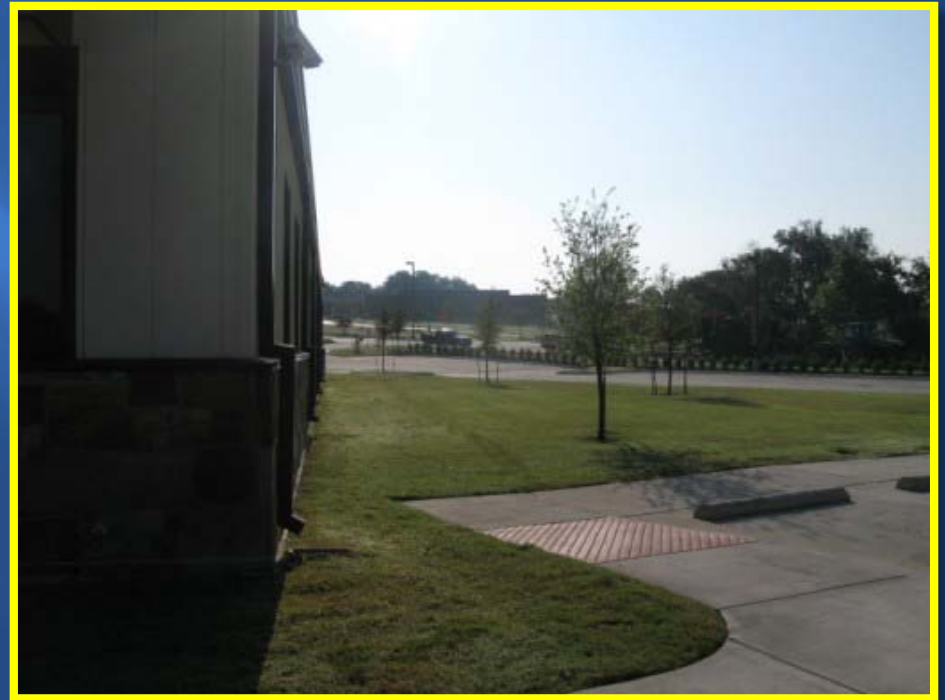
- ❑ Grade sloped **toward** building
- ❑ Ineffective rain guttering system along the perimeter
