Foundation Performance Association

Imad F Abdullah AIA

June 14, 2017

A. Case Study 1: Structural Roof Collapse of 100,000 sq ft former “Kmart” due to Hurricane Ike, Analysis of parameters that contributed to collapse, Aftermath Structural Repair Options Considered, Remedies implemented

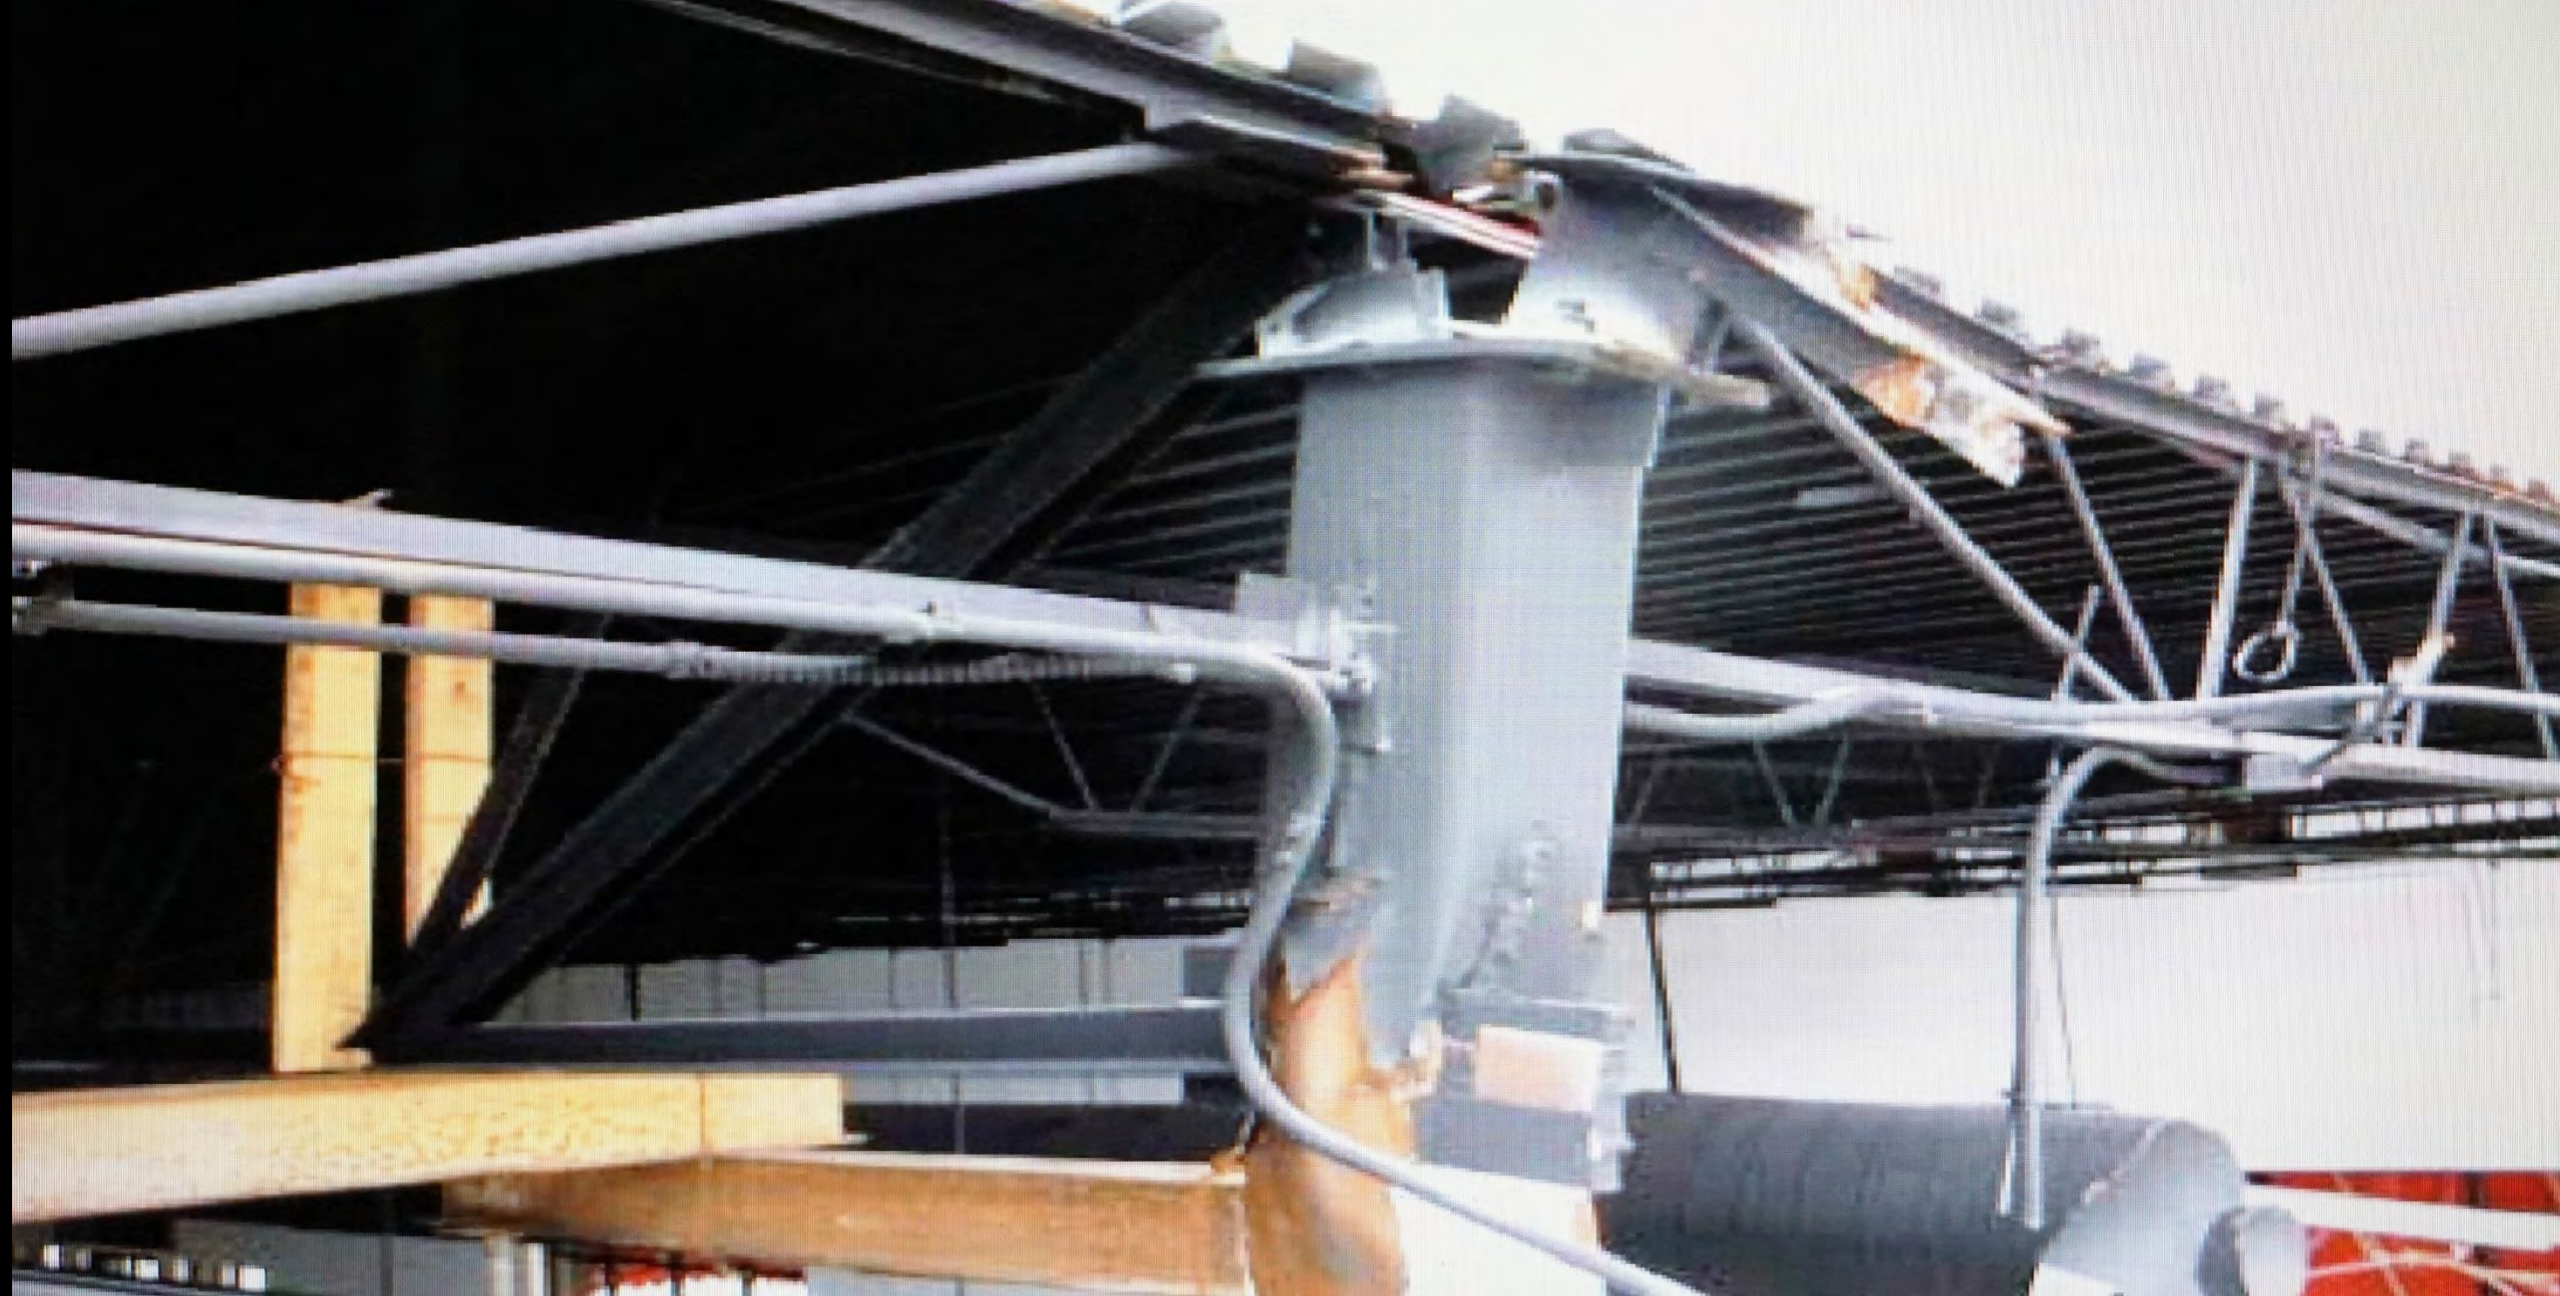
- REASONS FOR COLLAPSE
- VERY LARGE BUILDING
- SLOPE FRONT TO REAR OR SIDE WOULD ADD 2 TO 3' OF HEIGHT
- BUILDING SLOPED FROM MIDDLE TO FRONT AND TO REAR
- ALL ROOF DRAINS ARE INTERNAL
- ROOF DRAINS OF 5" MAY HAVE BEEN SIZED RIGHT BUT DID NOT ACCOUNT FOR PLASTIC BAGS AND DEBRIS
- NO SCUPPERS

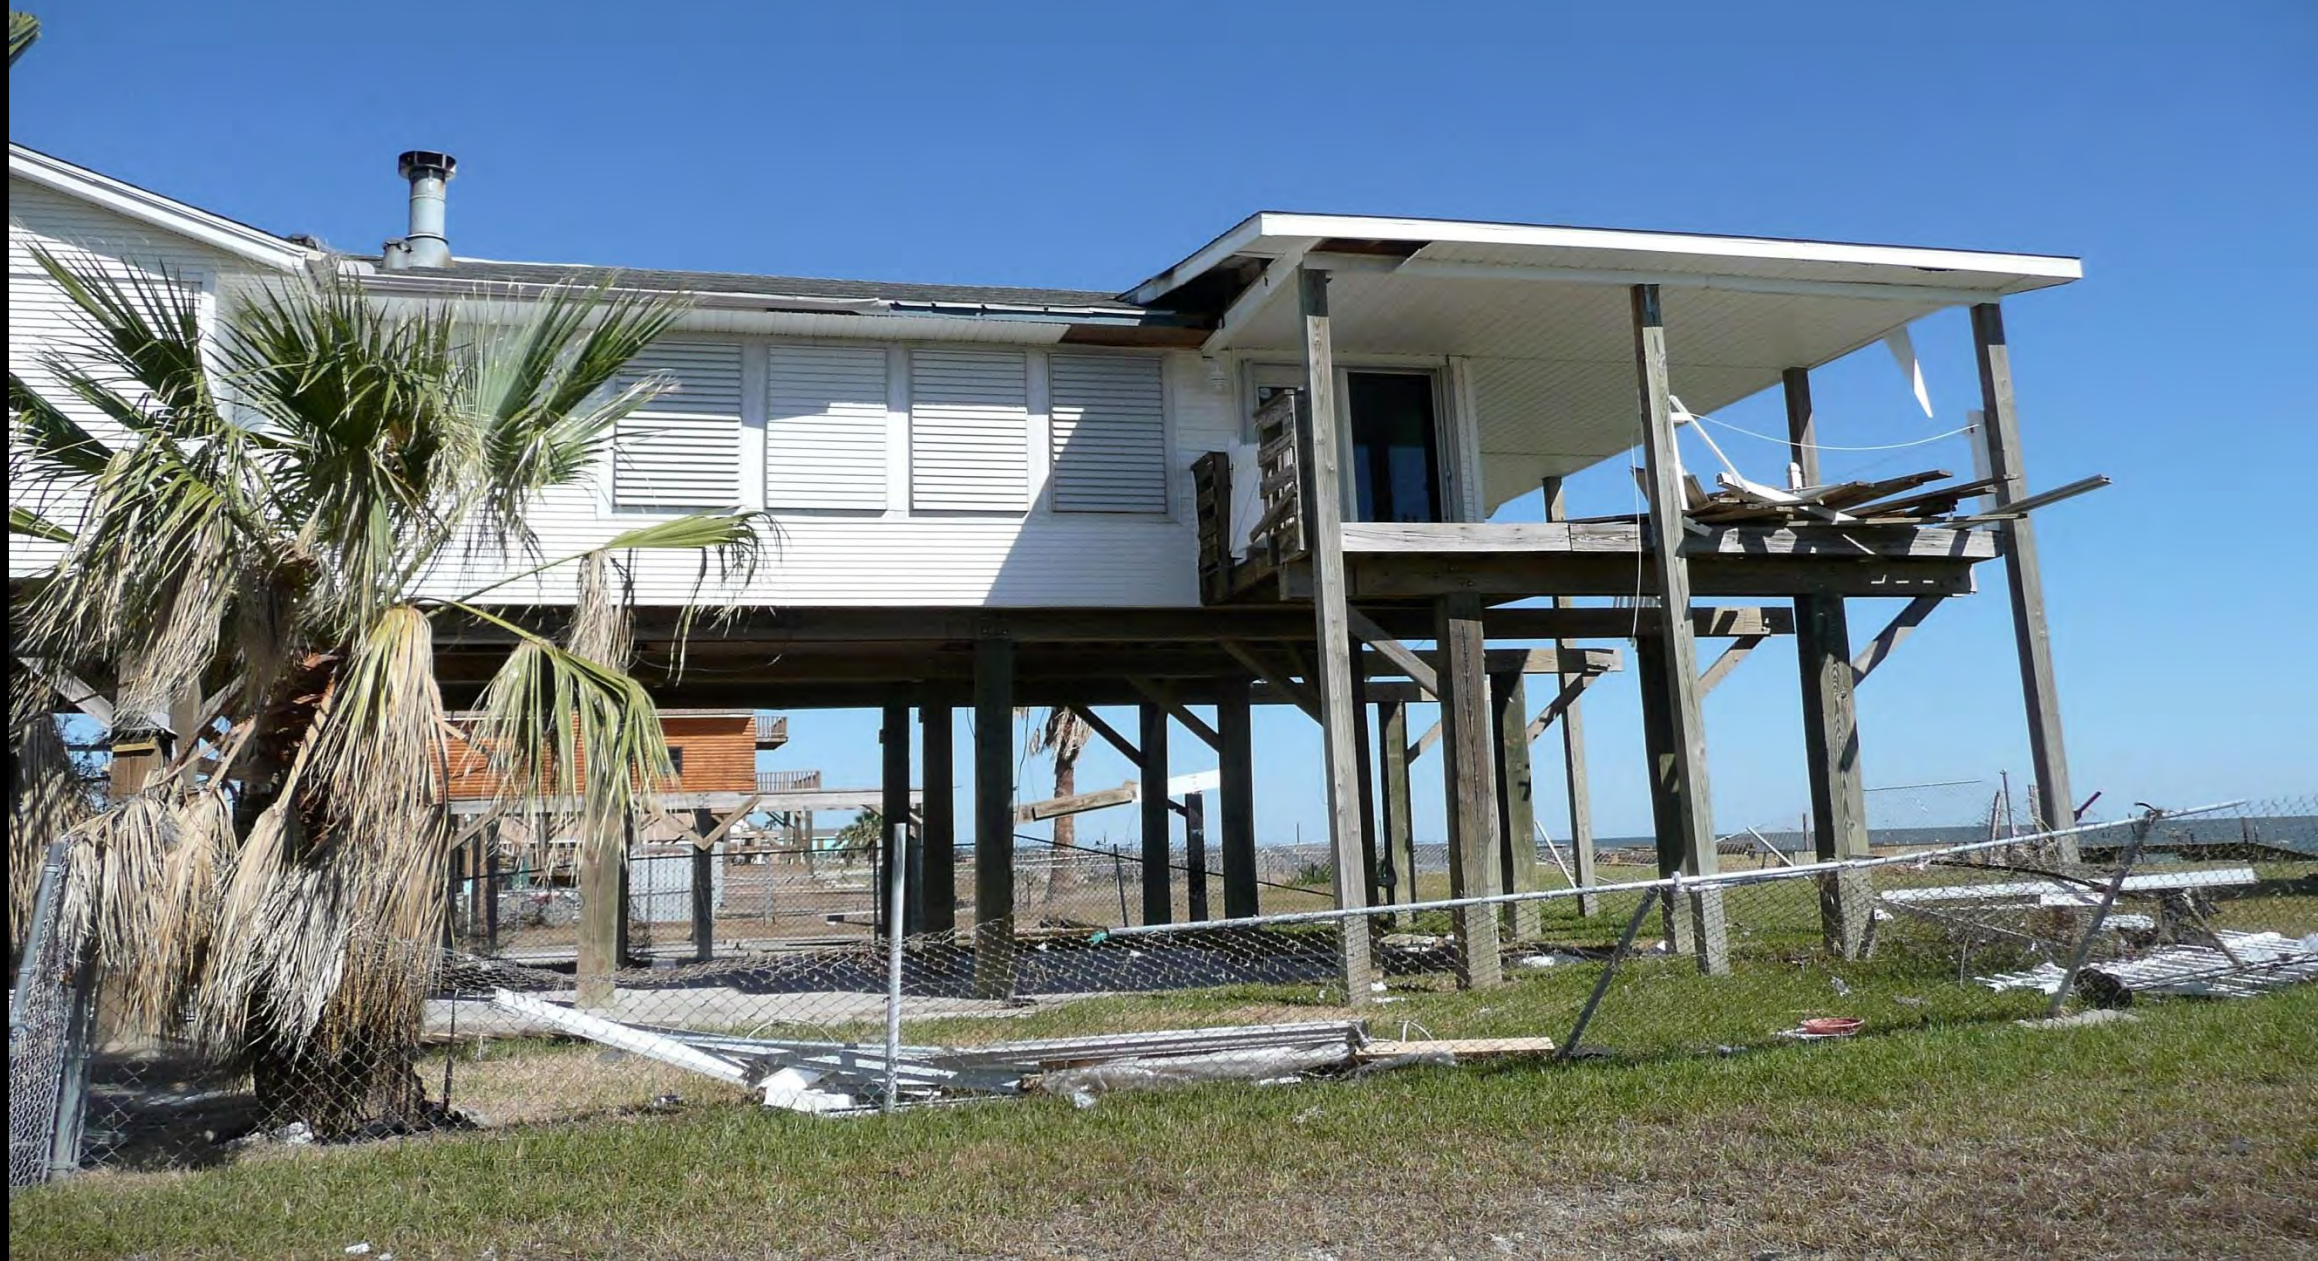
ISSUES OF CONCERN

STRUCTURAL INTEGRITY OF COLUMNS WITH TORQUE
CRACKS, FUTURE LIABILITY AS A SELLER

DID PLYWOOD FLOORING DECK LOSE MOMENT VALUE
SINCE IT WAS NOT MARINE PLYWOOD?

WHAT HAPPENS TO SOIL UNDER SLAB WHEN SO MUCH
WATER COMES IN, DOES IT PULVERIZE?

WOOD COLUMNS WERE SIZE 10X10 WHEREAS ONLY 6X6
AT BALCONY

WERE 6X6 UNDERSIZED SINCE IKE TORE UP BALCONY
AND THE WHOLE FRONT ON THE LAKE?

ELEVATION WAS 15' AT FLOOR LEVEL AND
13' TO BOTTOM OF LOWEST STRUCTURAL MEMBER

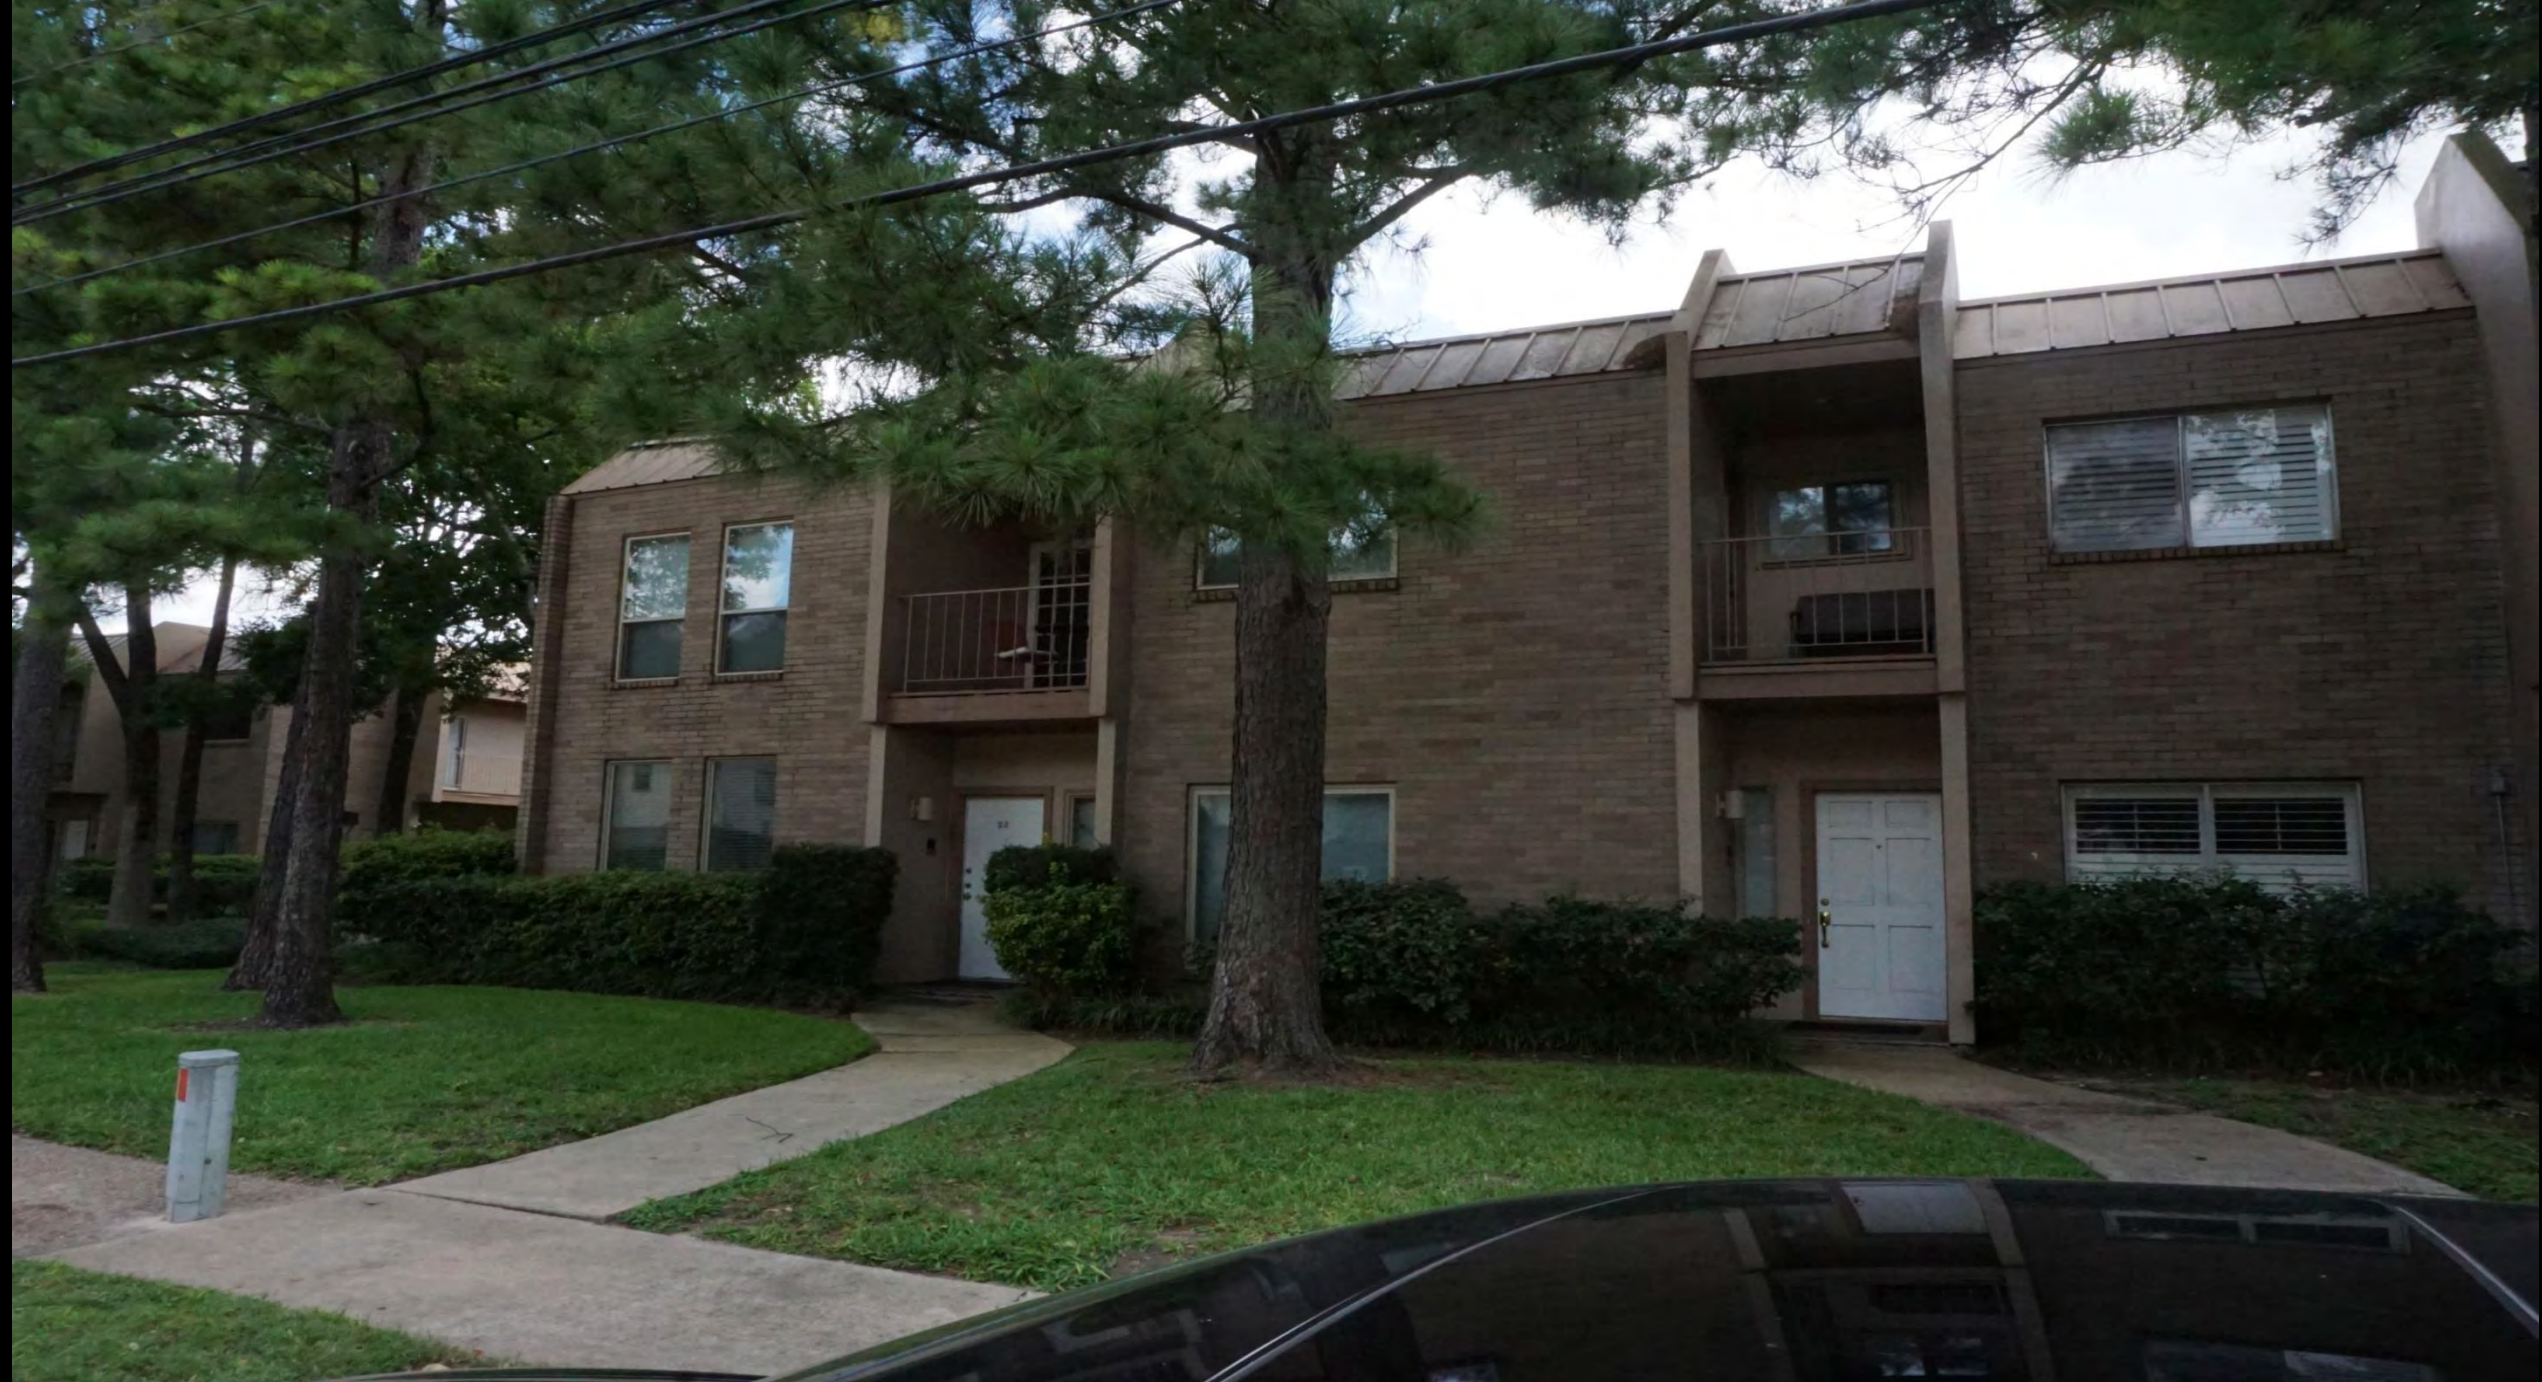
Augusta Square, 1300 Augusta Drive

- Post Tension Slab
- First Cable from slab edge went through 8" concrete element creating vertical brick column
- When tension pressure was applied on cable, the 8" ledge exploded
- Expensive remediation

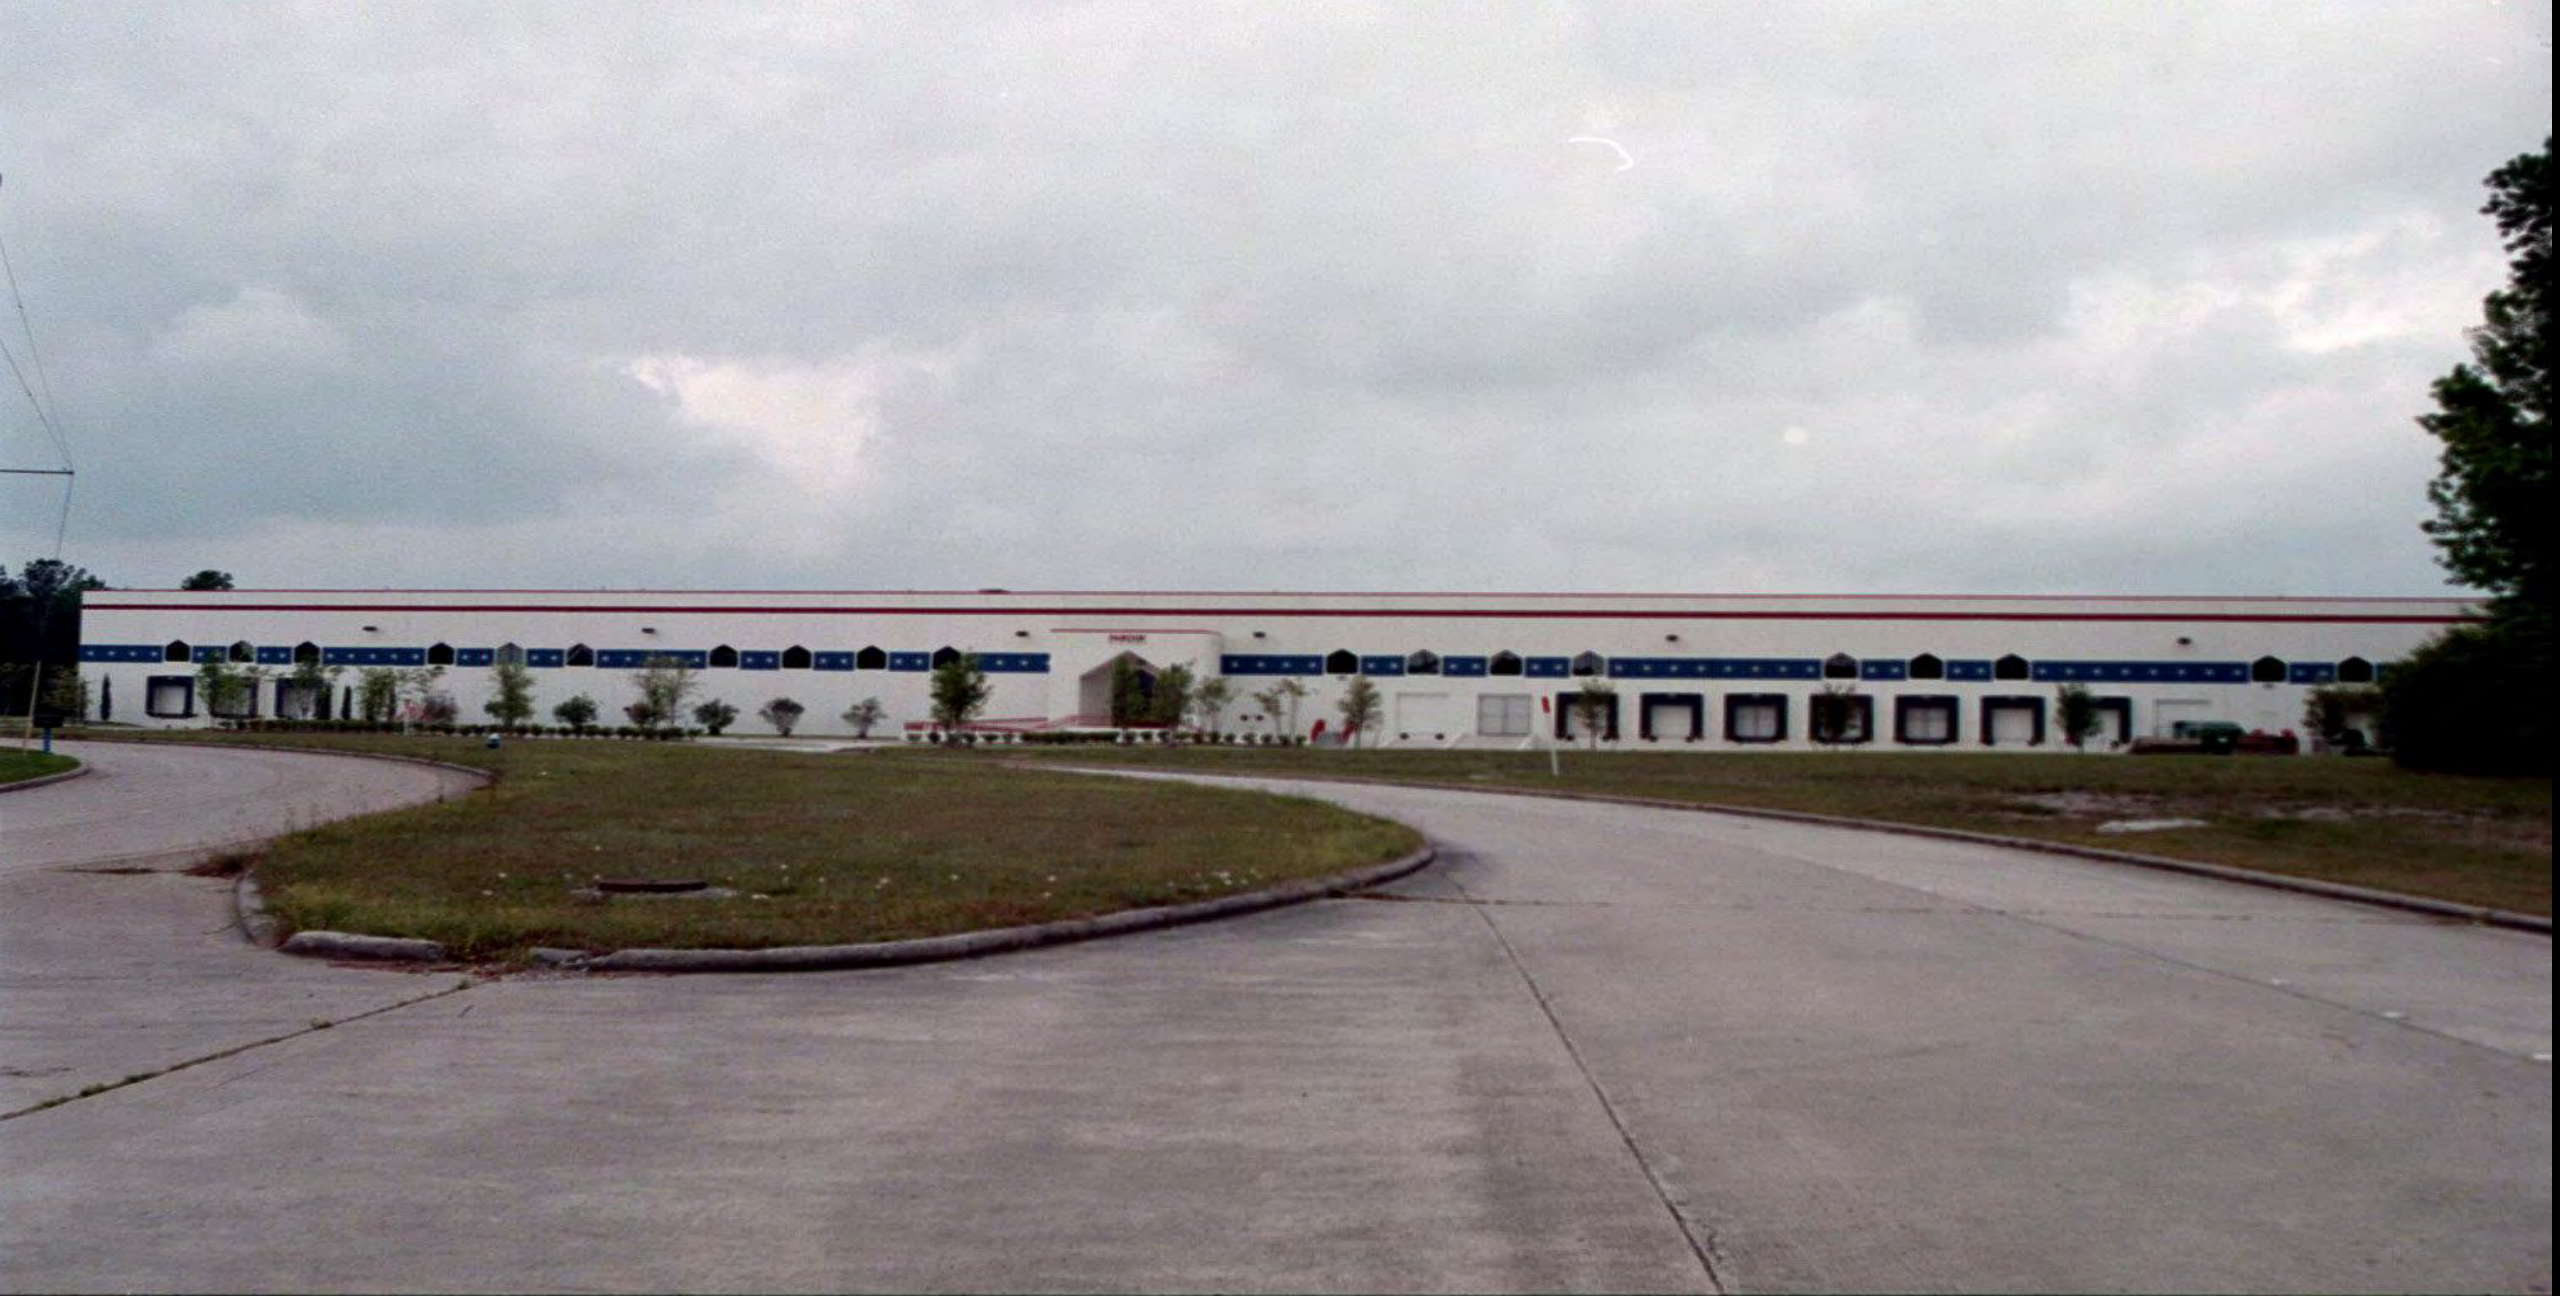
- Wheel marks of forklifts when the tilt up was lying flat on foundation. Watch-out how they move equipment in field, it's very expensive to remove and repaint Happens when you don't have enough access on sides or rear
- What happens during construction can haunt you later

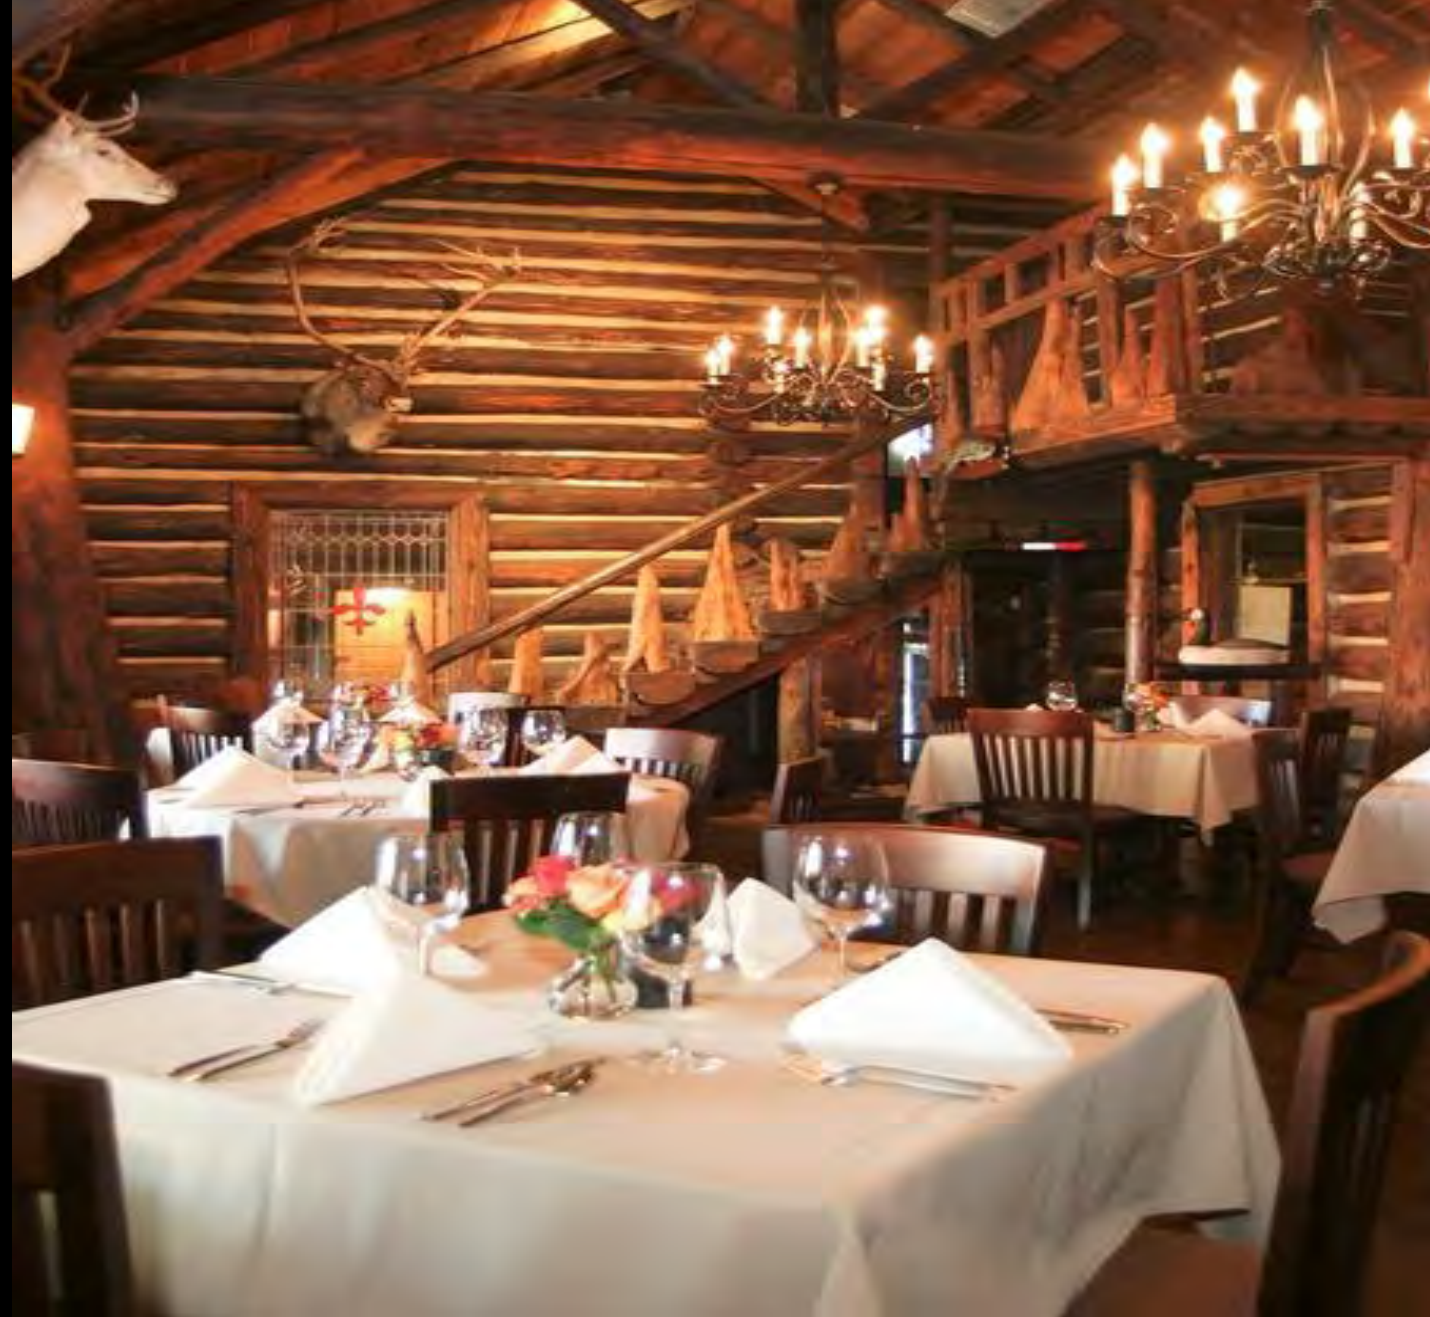
THE NIGHT WE RECEIVED THE BUILDING
PERMIT FROM THE CITY, A FIRE BROKE
OUT, MOST LIKELY BY A DISGRUNTLED
EMPLOYEE

WE ALL MET ON SITE LOOKING AT THE
CHARRED LOGS. PARTS OF THE ROOF ALSO
BURNED

LOGS BEING SO THICK ARE NOT GOING TO
BURN BEYOND THE THIN LAYER OF BLACK
SURFACE CARBON SINCE OXYGEN DOES
NOT REACH THE REST OF THE LOG

ARCHITECT ASKED OWNER TO SANDBLAST
LOGS TO REMOVE CARBON LAYER AND SEE
WHAT'S BEHIND

THIS WAS DONE, THE BUILDING WAS
INTACT STRUCTURALLY

WE RESUBMITTED AND REBUILT ROOF AND
IT IS HERE TODAY

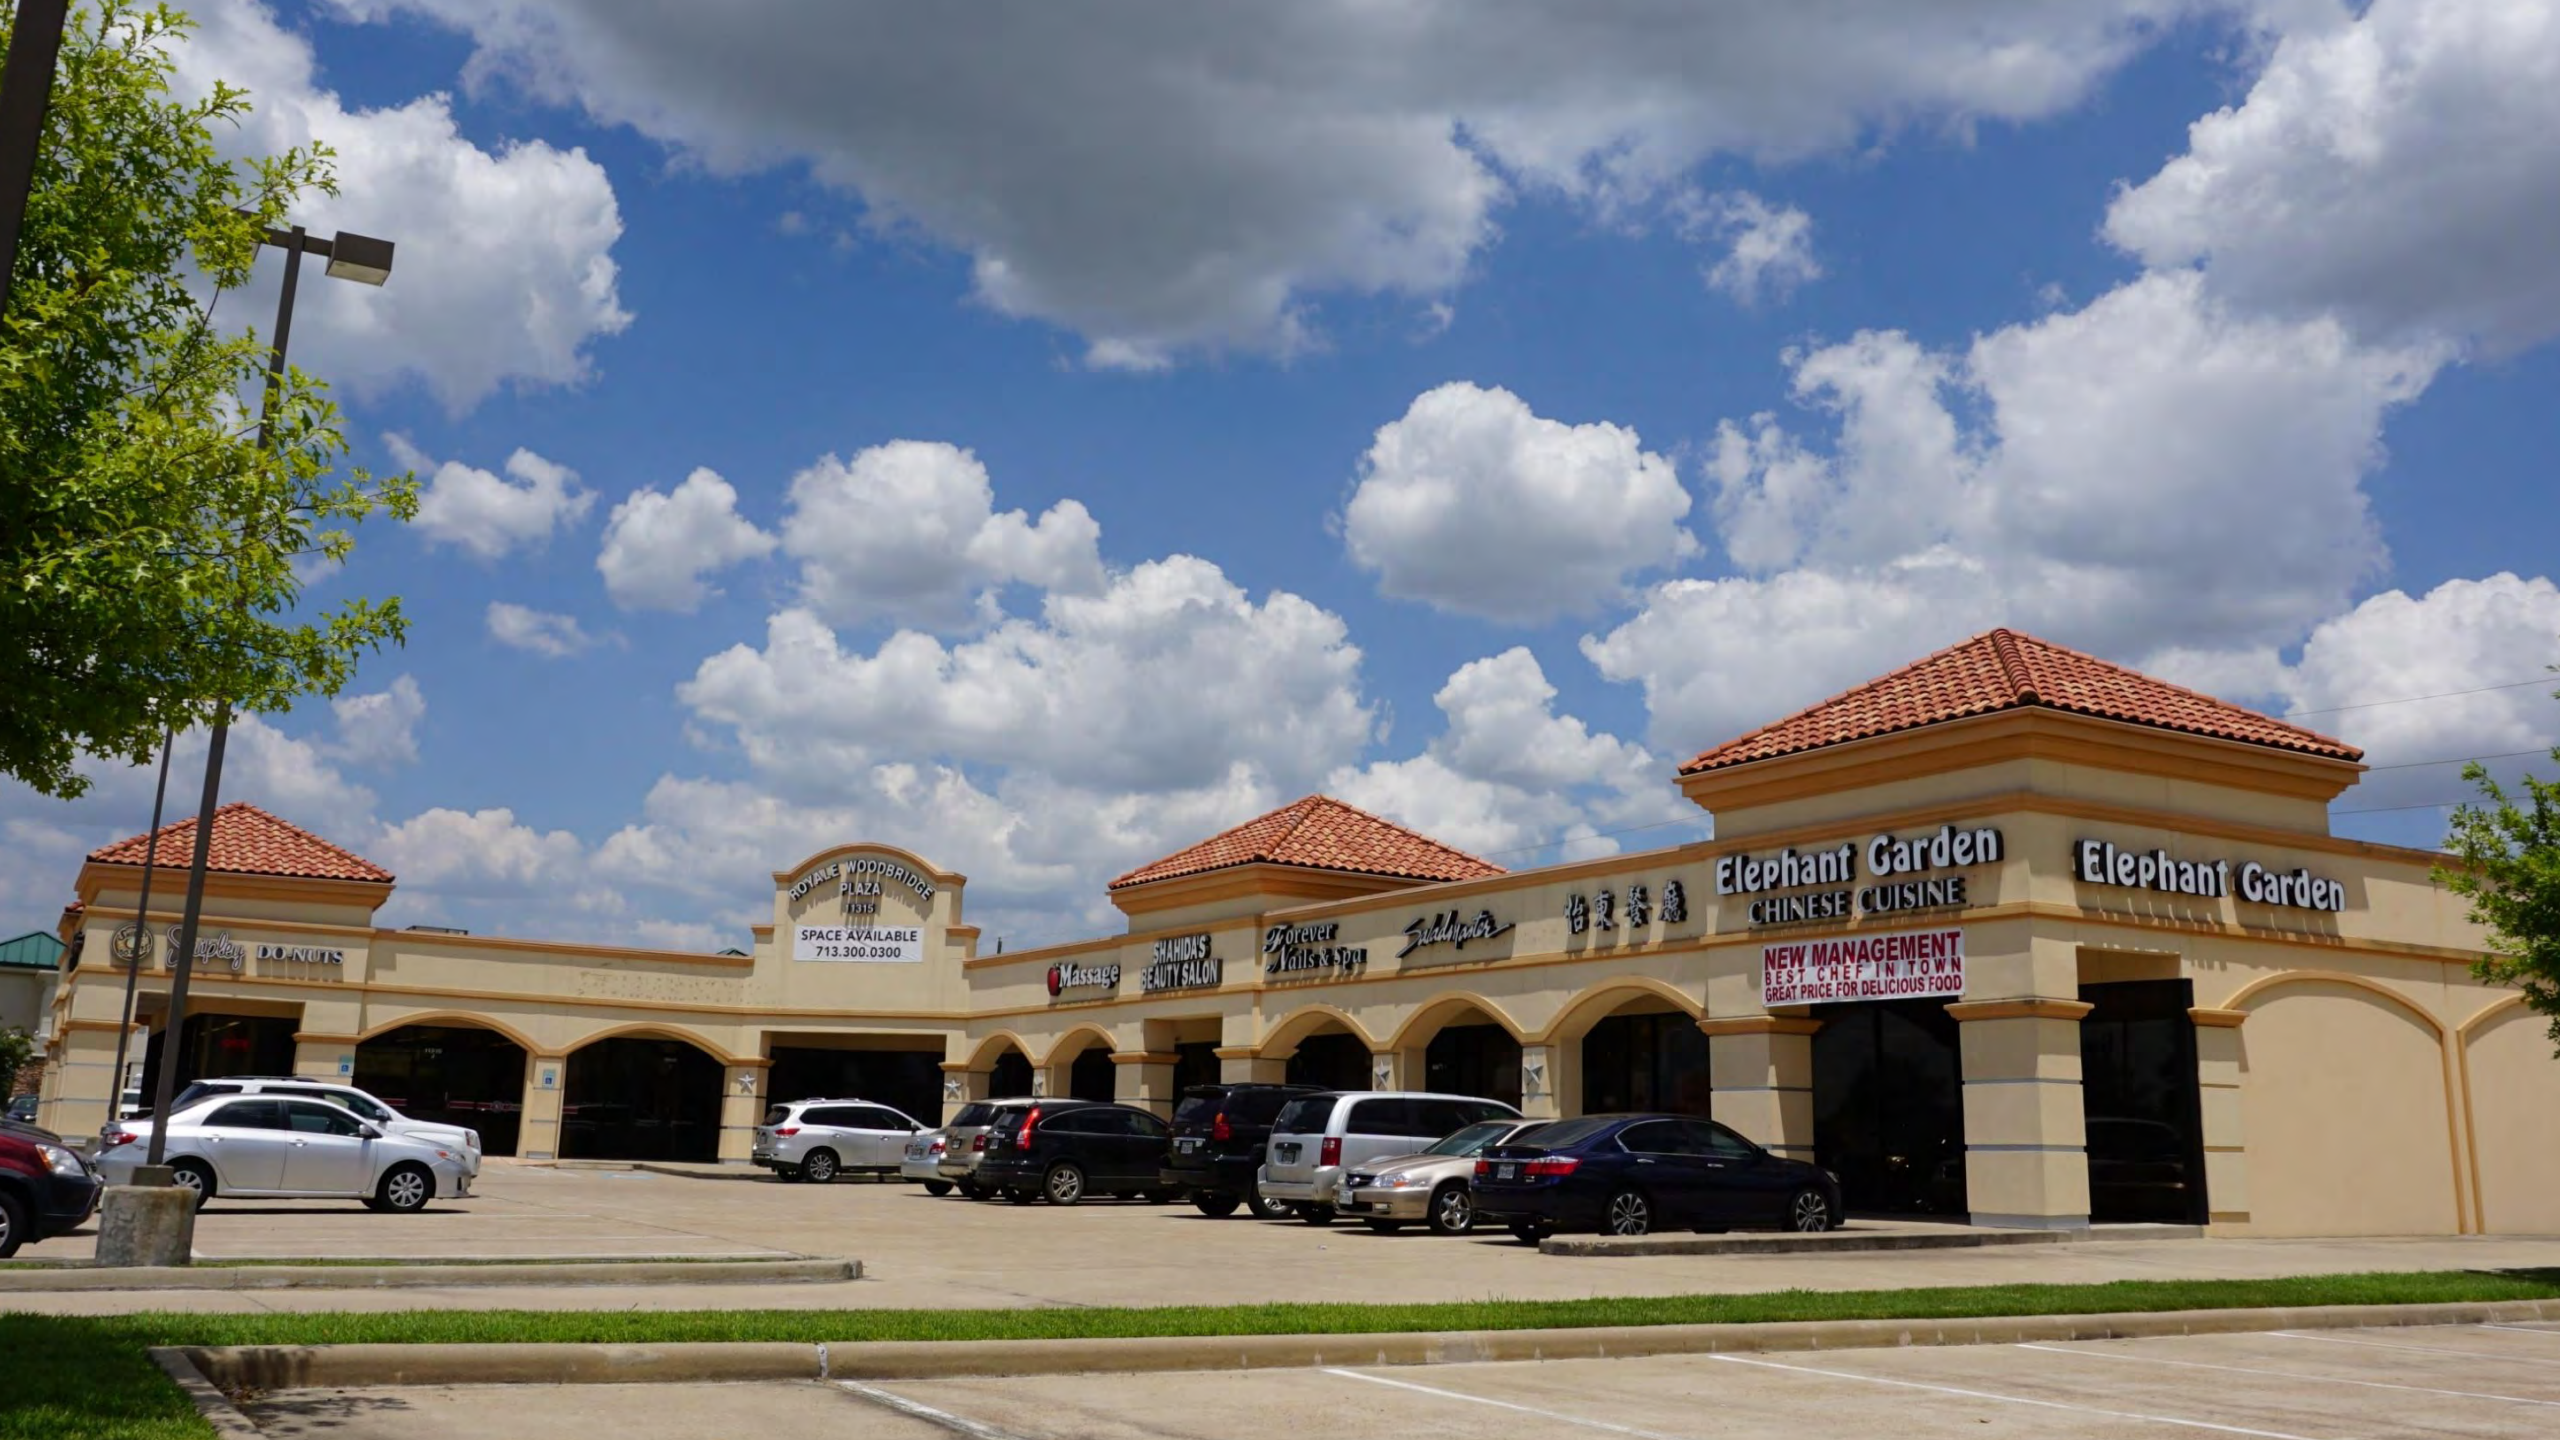
W. AIRPORT AND HWY 6 SHOPPING CENTER
17,000 SF

BETWEEN DESIGN CHANGES AND SHOP DRAWINGS

STEEL FRAME FOR ONE PYRAMID WAS WRONG
DIMENSIONS,
ALREADY DELIVERED TO SITE

- FASTEST AND EASIEST WAS TO REDESIGN ELEVATION AND REBALANCE IT ACCORDING TO STEEL DIMENSIONS
- INFORMED OWNER WHO IS AN MEP OIL COMPANY ENGINEER, WAS OVERSEAS AT THE TIME, AFTER MUCH DISCUSSION AGREED TO PAY FOR CHANGE TIME
- TOWARDS END OF PROJECT OWNER REFUSED TO PAY AND WAS STALLING
