WALKER
RESTORATION CONSULTANTS

**ASR and DEF in Concrete Structures
“It’s not as Bad as it Seems”**

**Al Bustamante, P.E.
September 13, 2017**

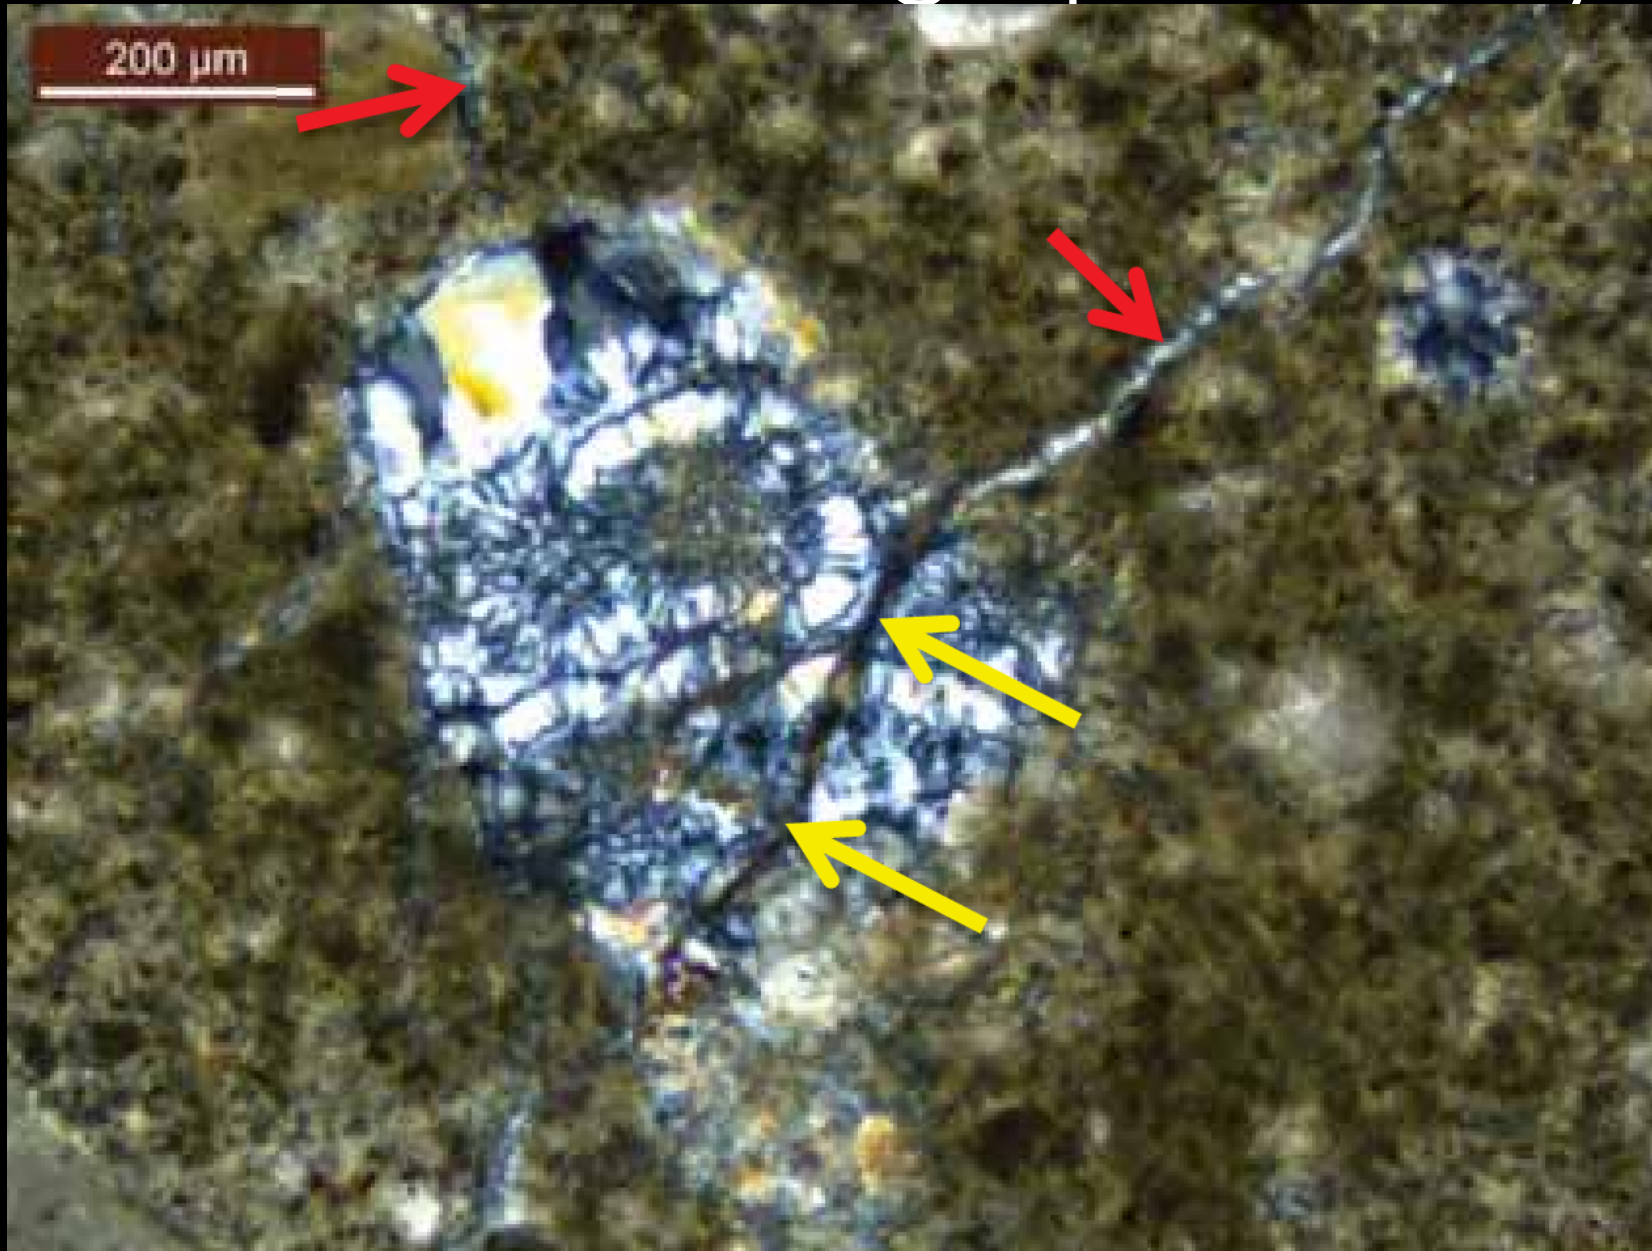
ASTM C-856

Sample Type	Precast concrete column.
Dimensions	Core diameter = 94 mm (3.7 inches); Core length = 200 mm (7.9 inches); partial column depth.
General condition	A surface perpendicular crack extends to a depth of 110 mm (4.3 inches).
Surfaces	Exposed surface exhibits a major crack and a minor crack. The minor crack intercepts the major one. Bottom surface is an irregular, fracture surface that passes both around and through aggregate particles.
Consolidation	Well consolidated
Embedded Items	None observed.
Macro-Cracks	The major crack is approximately 2.5-mm (0.10 inch) in width at exposed surface and tapers off at the depth of 110 mm (4.3 inches). The other crack is 0.4 mm (0.02 inch) wide at exposed surface, tapers off at a depth of 40 mm (1.6 inches). The cracks extend both around and through aggregate particles.
Distribution	Uniform distribution of aggregates, paste and air voids.
Aggregate Gradation and Top Size	Fairly well graded to an observed top size of 12 mm (0.5 inch).

Aggregate Types	Coarse (CA) Crushed carbonate rocks and/or gravel including mainly limestone, dolomitic limestone, dolomite and minor to trace amounts of chert, cherty dolomite and possibly opaline material.
	Fine (FA) Similar to the coarse aggregate in lithology.
Aggregate Condition	Many aggregate particles, both coarse and fine, exhibit microcracks and less frequently meso-scale cracks that often extend into or from surrounding paste. Both coarse and fine aggregates are angular to subrounded and mainly equant to bladed.
Paste-Aggregate Bond	Moderately tight to moderately weak.
Interfacial Zone	Frequently lined with ettringite; occurrence of such features increases with increasing depth.
Paste Color, Hardness, Luster	Light gray, moderately hard, and dull to subvitreous.
Paste Constituents	Residual portland cement estimated at 4 to 6 percent, finely ground; Abundant ground carbonate rocks, estimated greater than 10 percent was observed. Portlandite was not estimated due to interference of the carbonates fines.

Water-cementitious materials ratio (w/cm)	Estimated at moderate 0.50 +/- 0.02.
Carbonation Depth	1 mm (0.04 inch) from the existing exposed surface.
Air-Void System	Air content estimated at 1 to 2 percent. Concrete is not air-entrained.
Secondary Deposits	Ettringite frequently lines around aggregate particles, microcracks and voids; Alkali silica reaction (ASR) gel was observed in a few voids and microcracks in a few aggregate particles and the microcracks extending into surrounding paste.
Meso-scale and micro-scale crack	Abundant microcracks were observed in the paste and aggregate. Many of the microcracks intercept aggregate particles. Microcracks are frequently filled with ettringite, ASR gel or both.
Comments:	
<ul style="list-style-type: none"> The exposed surface of concrete exhibits a thin layer of coating material. Major crack partially filled with a small amount of sealant-like material.
