## NOVEMBER 2010 MEETING

#### What Caused it to Fail?

### PRESENTATION SUMMARY

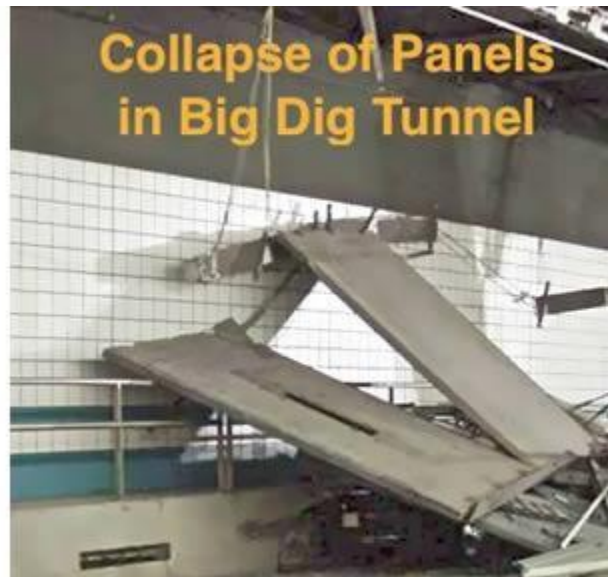
Dr. Fowler describes the failure of epoxy embedded anchor bolts that held the ceiling panels in place and the *comedy or errors* that ultimately resulted in a panel falling and killing a passenger in a car being driven through the tunnel while the driver escaped with minor injuries. This failure is shown in the photo, with the crushed care barely visible below the fallen panels.

Dr. Fowler then presented the mechanics of the failure and some of the main causes that contributed it. Briefly, there were cost issues that drove the process leading to a multitude of errors including rejecting a better anchor - undercut wedge anchors instead of epoxy anchors that would have provided much better performance. This was later required by the governor after the panel failure.

Other issues discussed were the set time for the epoxy, standard set versus fast set as a function of the creep characteristics of the epoxy, fast set has higher creep but was still used. Some bolts were found to have very little covering of the epoxy. Also the holes had dust which reduced bond strength.

NTSB determined that probable cause of failure was the use of an epoxy anchor with poor creep resistance and was not capable of sustaining long-term loads.
