Project Site with Riviera I, Riviera II, West Beach Grand post-Hurricane Ike

Mark E Haas Engineering, LLC, with extensive experience in coastal and offshore engineering projects, was retained by the condominium HOA's to reassess their buildings.

To show that condominiums are "SAFE":

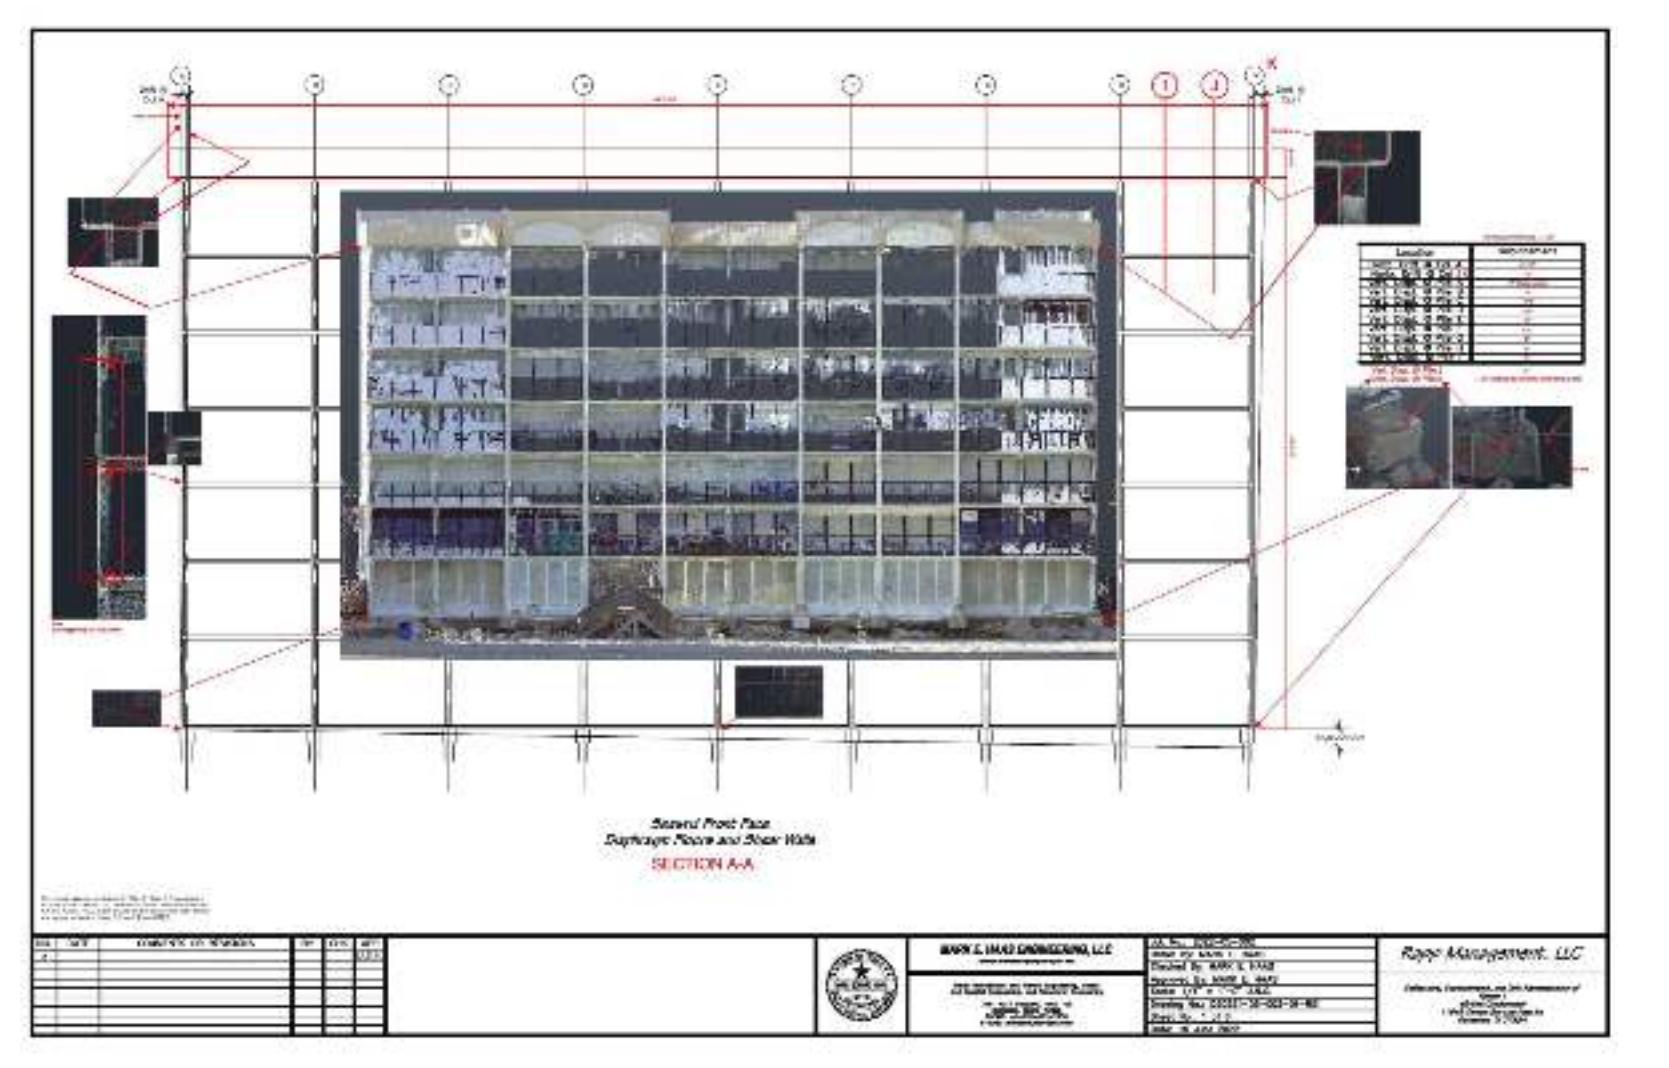
Riviera II - Plotting of Deflections

- Deflections were noted by hand and transferred to an AutoCAD template of the condominium elevation views
- Deflections were compared against applicable construction and operability tolerances per ASCE, ACI, and IBC Codes

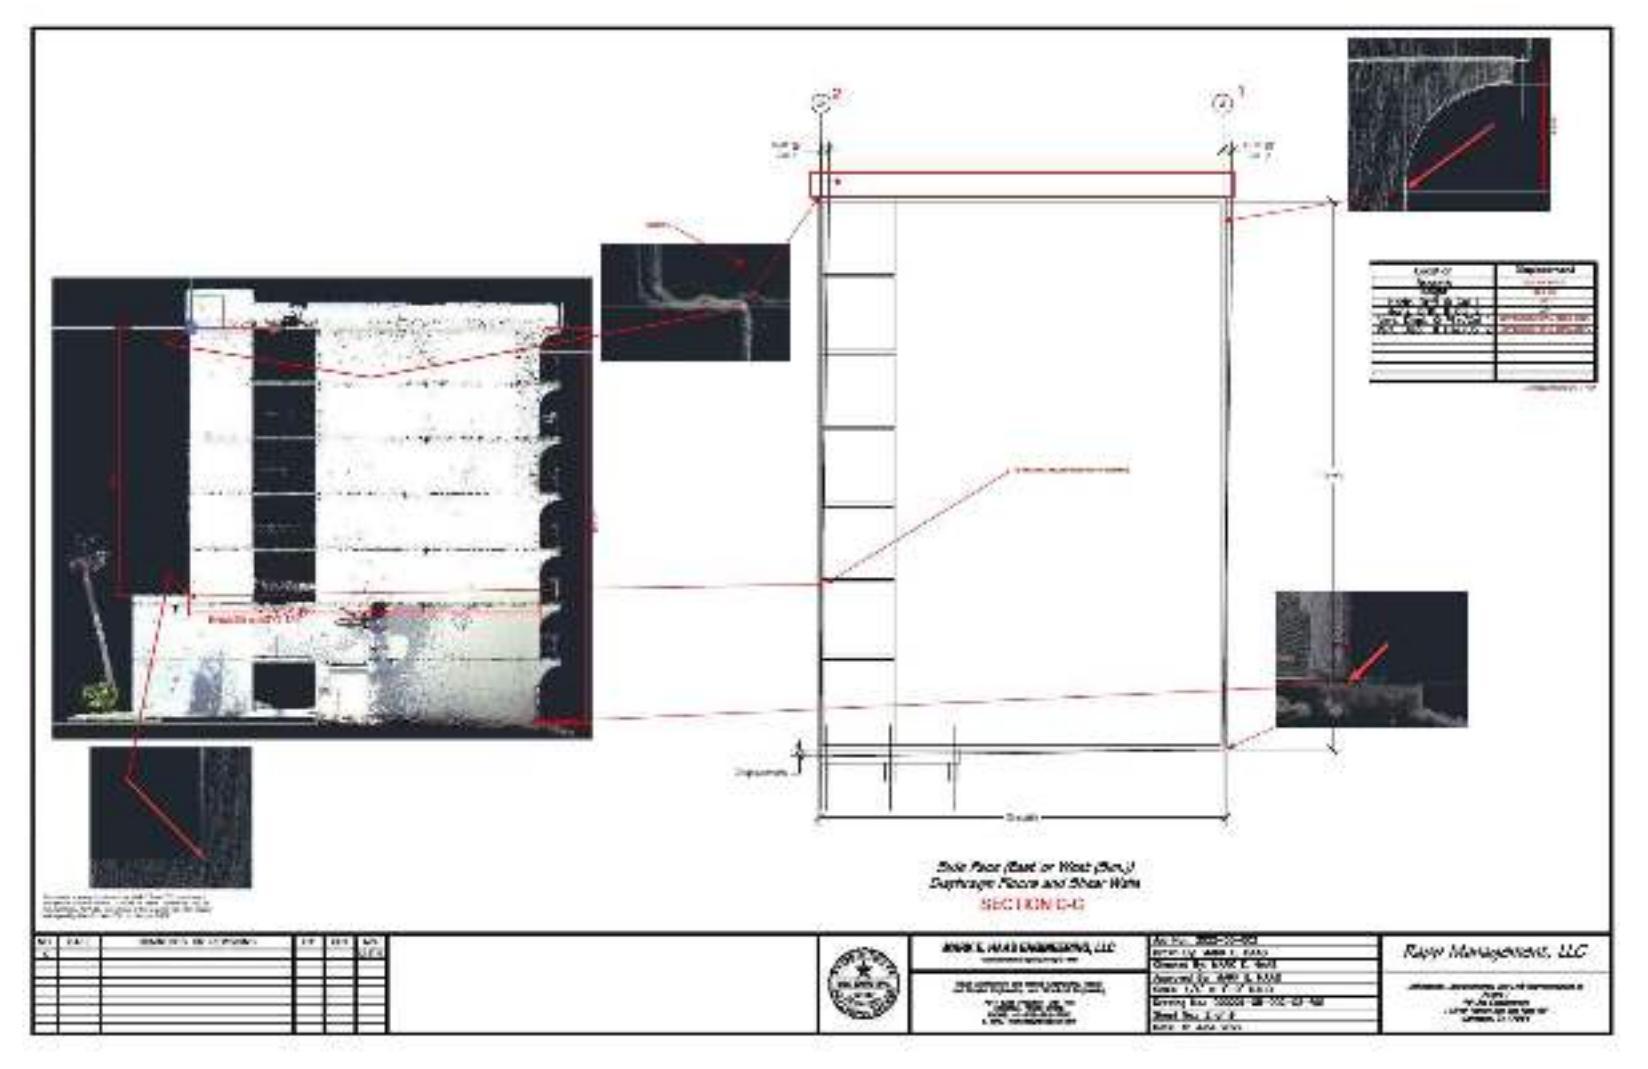
Riviera II - Plotting of Deflections

- All deflections were well within tolerances and guidelines per the applicable tolerances per ASCE, ACI, and IBC Codes
- As deflections and displacements were small and within tolerances, no distinguishable pattern emerged
- Could not distinguish between construction, operability, settling, or soil subsidence

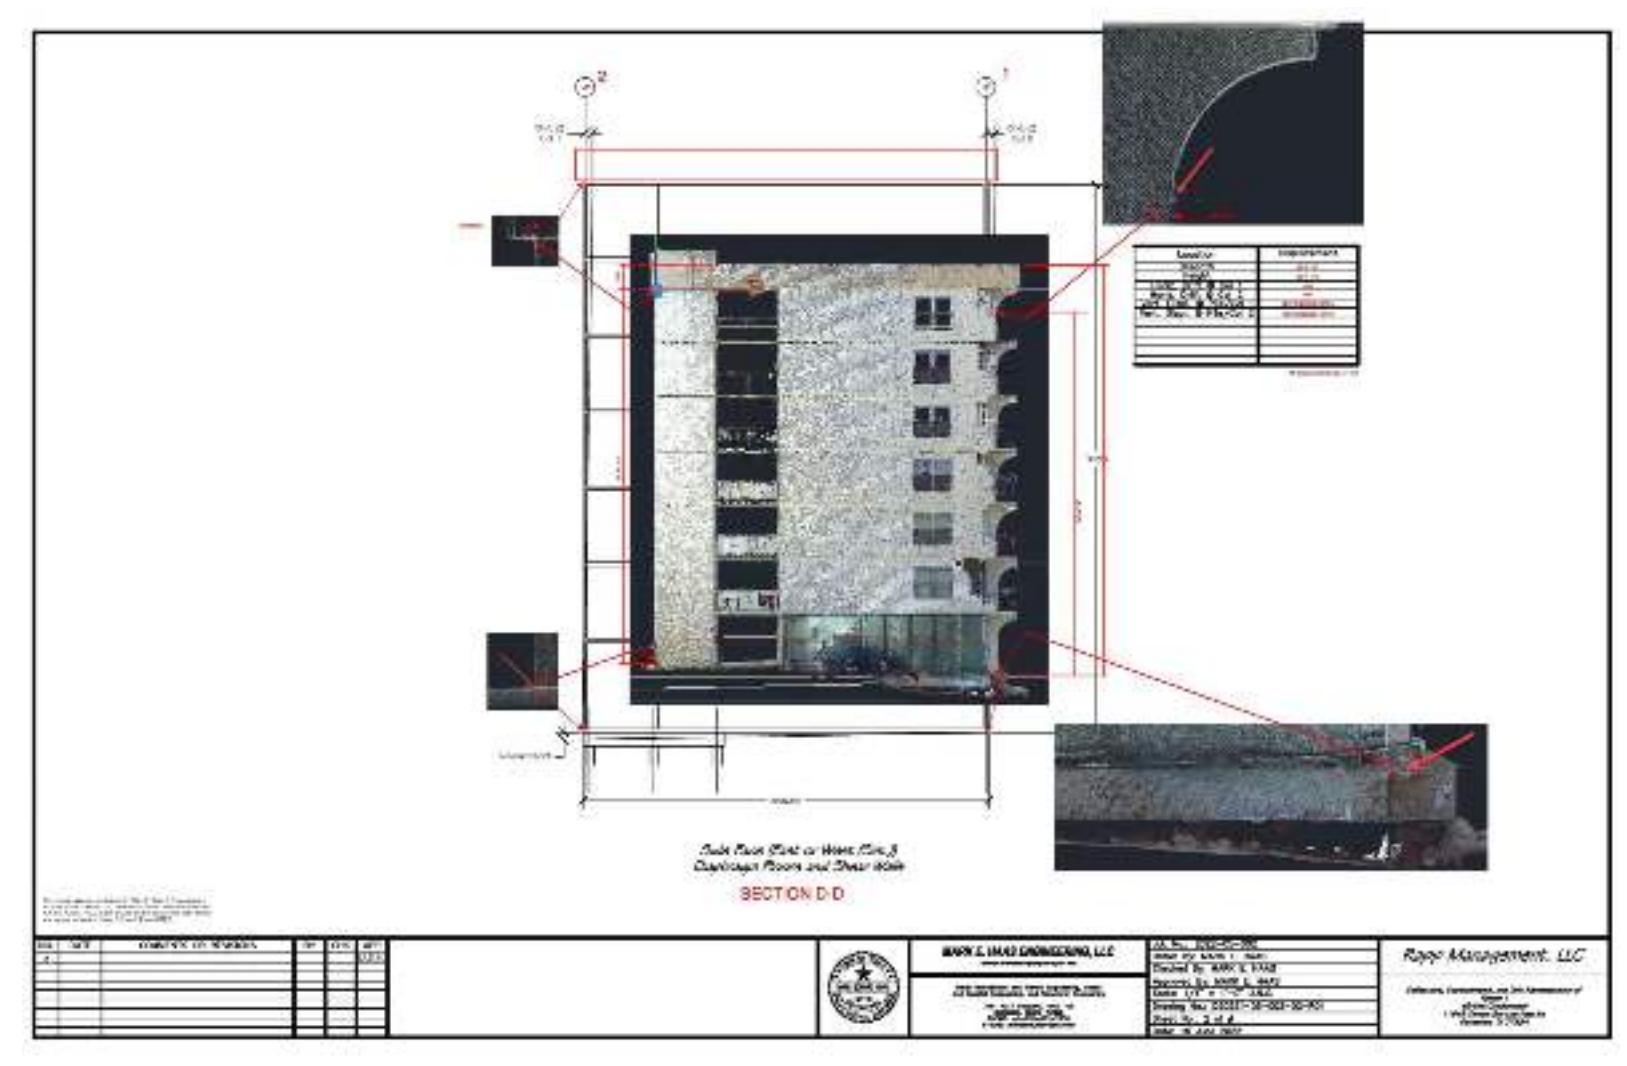
Riviera II - Plotting of Deflections

- All deflections were well within tolerances and guidelines per the applicable tolerances per ASCE, ACI, and IBC Codes
- As deflections and displacements were small and within tolerances, no distinguishable pattern emerged
- Could not distinguish between construction, operability, settling, or soil subsidence

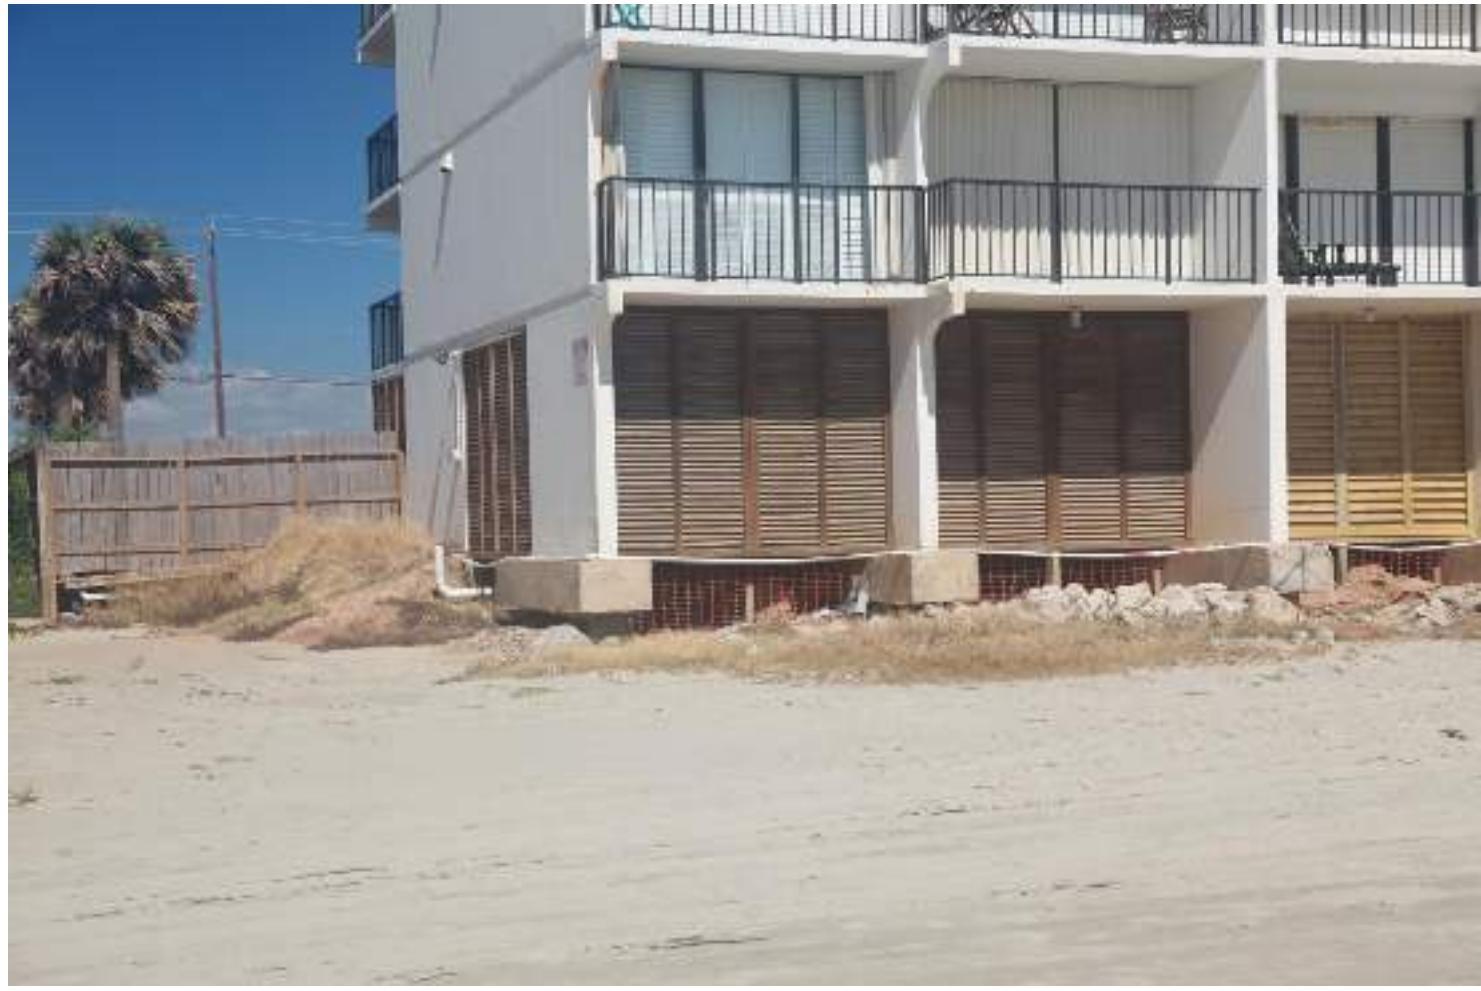
Shallow Foundation Washed Away to Expose Deep-Piled Foundation Riviera I Shown (Typical at the Three Condominiums)

- As the deflections and displacements were small, the City of Galveston, granted a reprieve against condemnation.
- State of Texas GLO concurred with the reprieve, pending a detailed engineering analysis of each condominium.
- To protect the exposed deep-piled foundations against further weathering or damage, a twostep program was initiated.

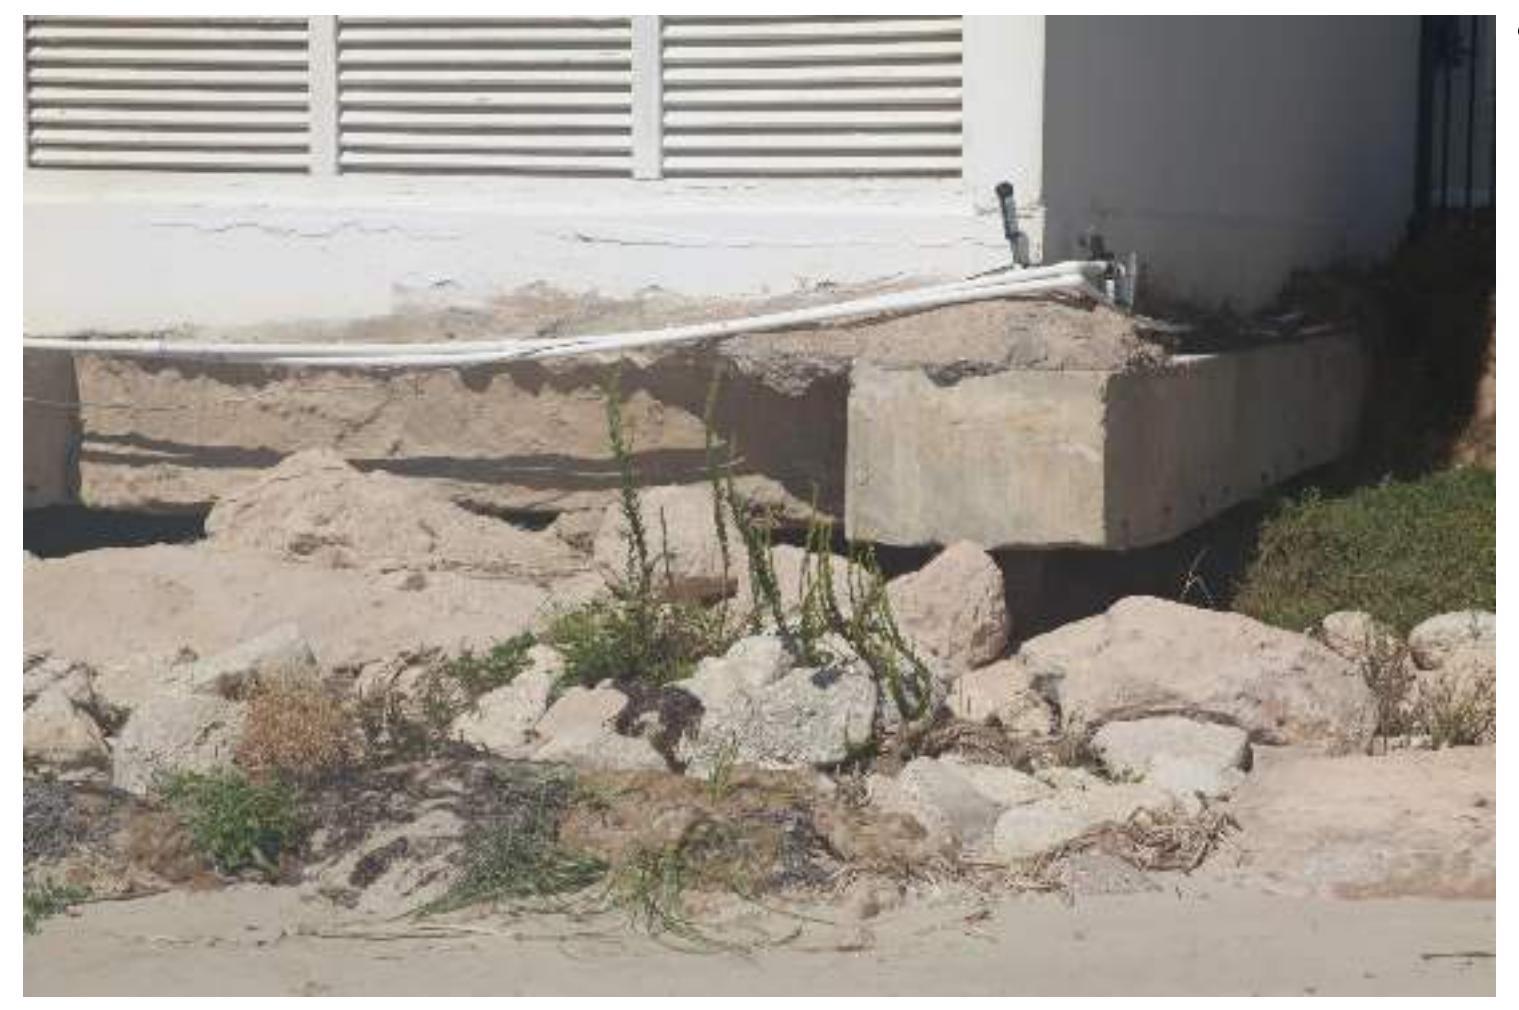
Shallow Foundation Washed Away to Expose Deep-Piled Foundation Riviera II Shown (Typical at the Three Condominiums) The Condominium HOA's and the HOA of the Sands of Kahala commissioned Mark E Haas Engineering to design a bulkhead to front the properties.

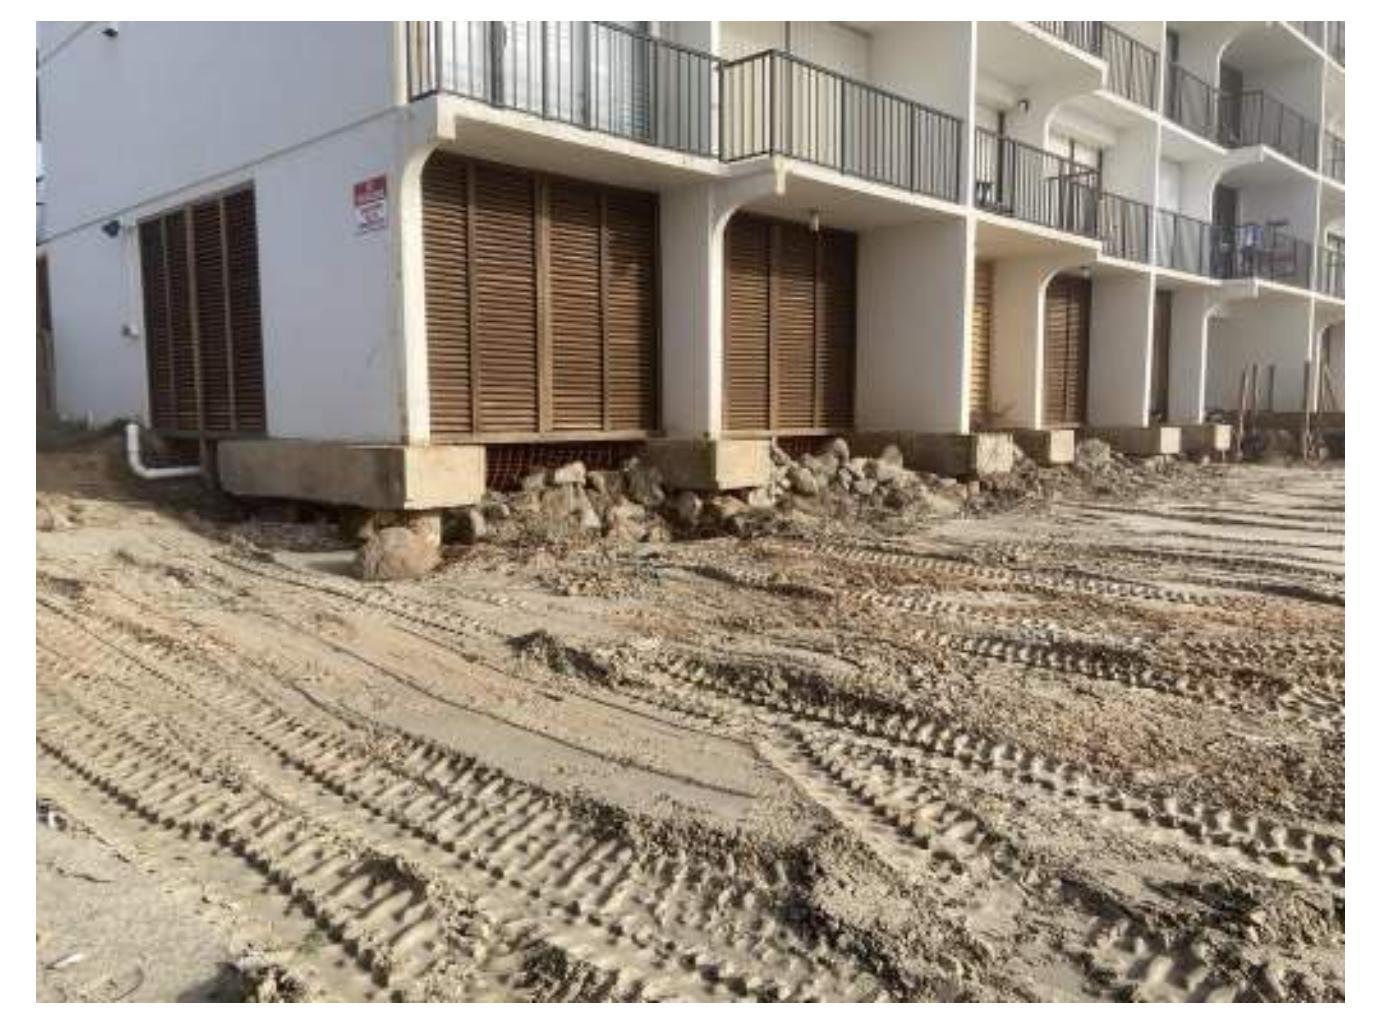
Prepping Areas for the Backfill of Cement-Stabilized Sand Riviera I Shown (Typical at the Three Condominiums)

The areas were cleared of debris from Hurricanes Ike, Harvey, Laura, and Delta. Other debris had accumulated from 2020 winter storms.

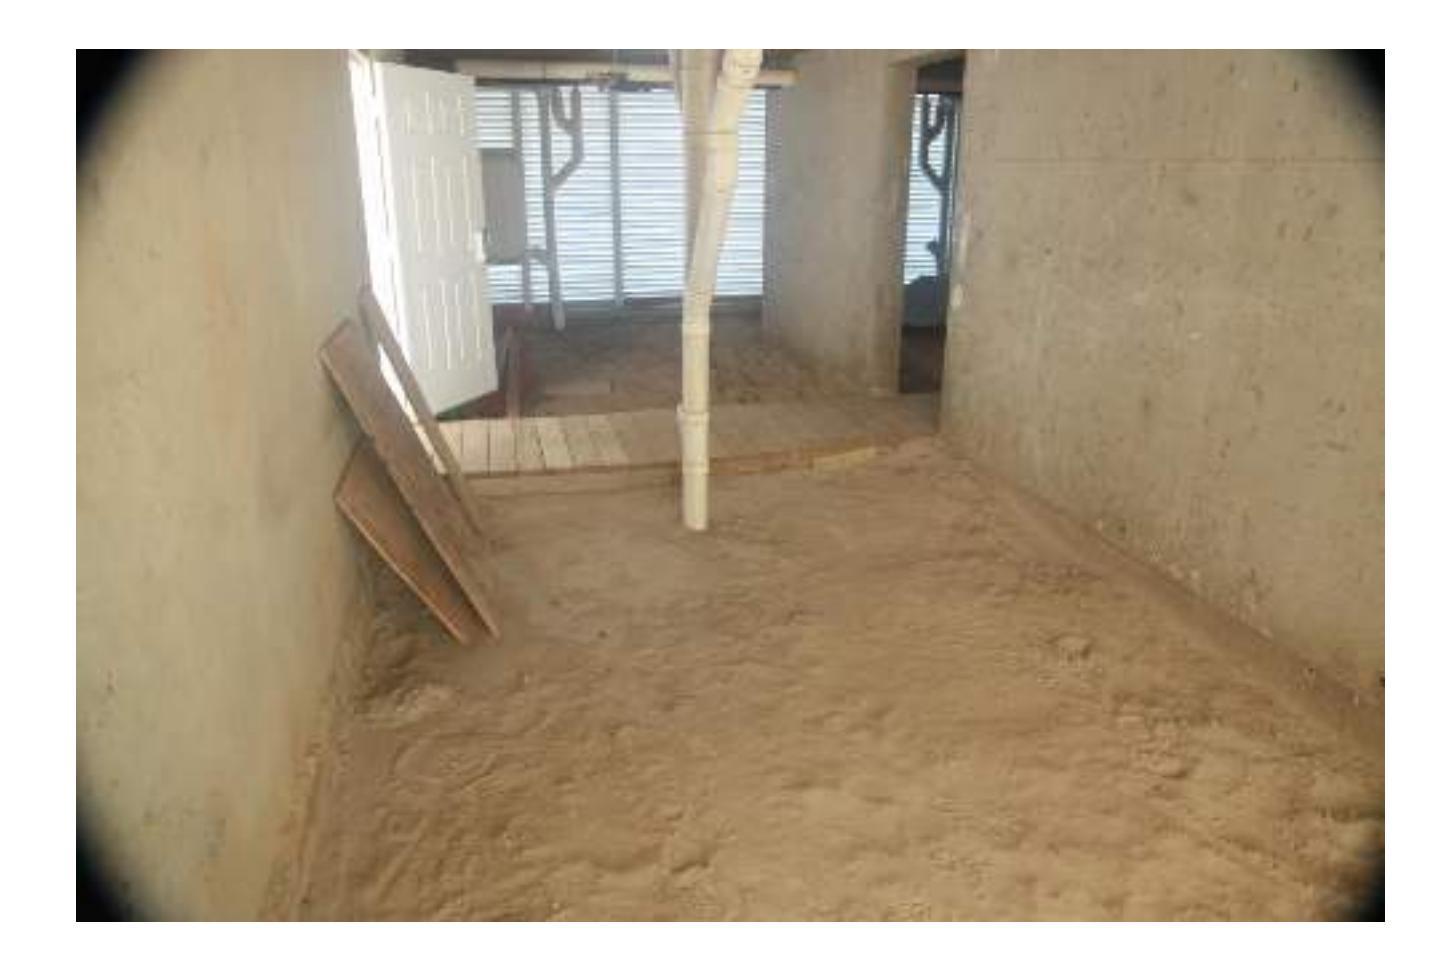
Backfill with Cement-Stabilized Sand from Inside Riviera II. (Typical at the Three Condominiums)

- The areas were cleared of debris from Hurricanes Ike, Harvey, Laura, and Delta. Other debris had accumulated from 2020 winter storms.
- After the areas were cleared of debris and detritus, then the shallow foundation was backfilled with Cement-Stabilized Sand, frequently, with wheelbarrow loads dumped inside the storage areas.

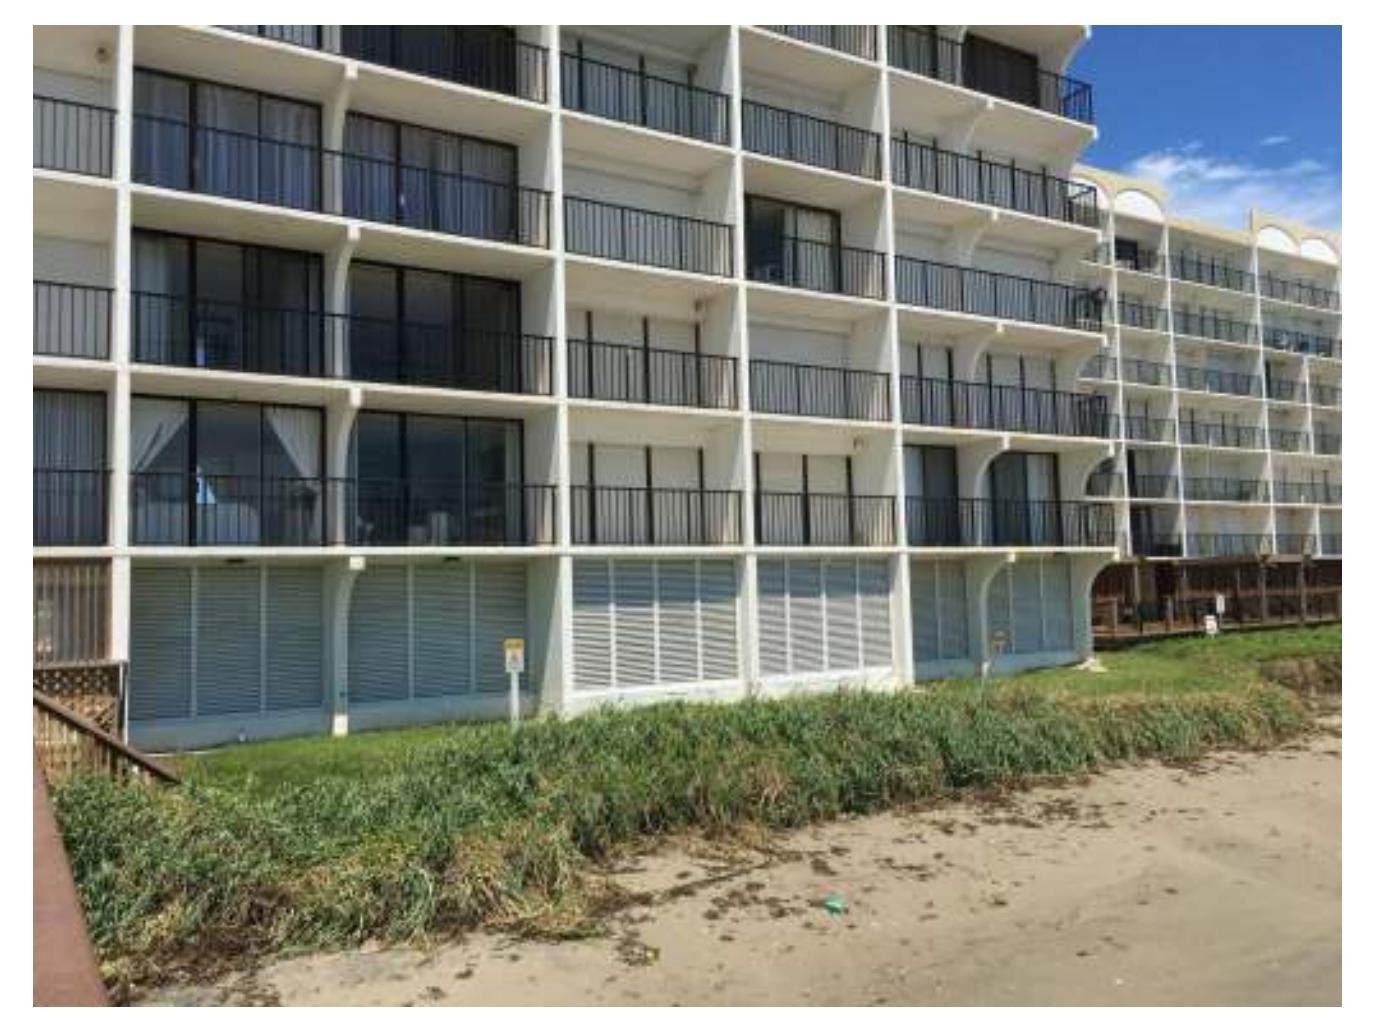
Dune grasses have taken hold at the rebuilt dunes fronting the condominiums. Riviera I shown in foreground (Typical at the Three Condominiums)

Native grasses are returning to the dunes that front the condominiums and the rebuilt shallow foundation of Cement-Stabilized Sand.

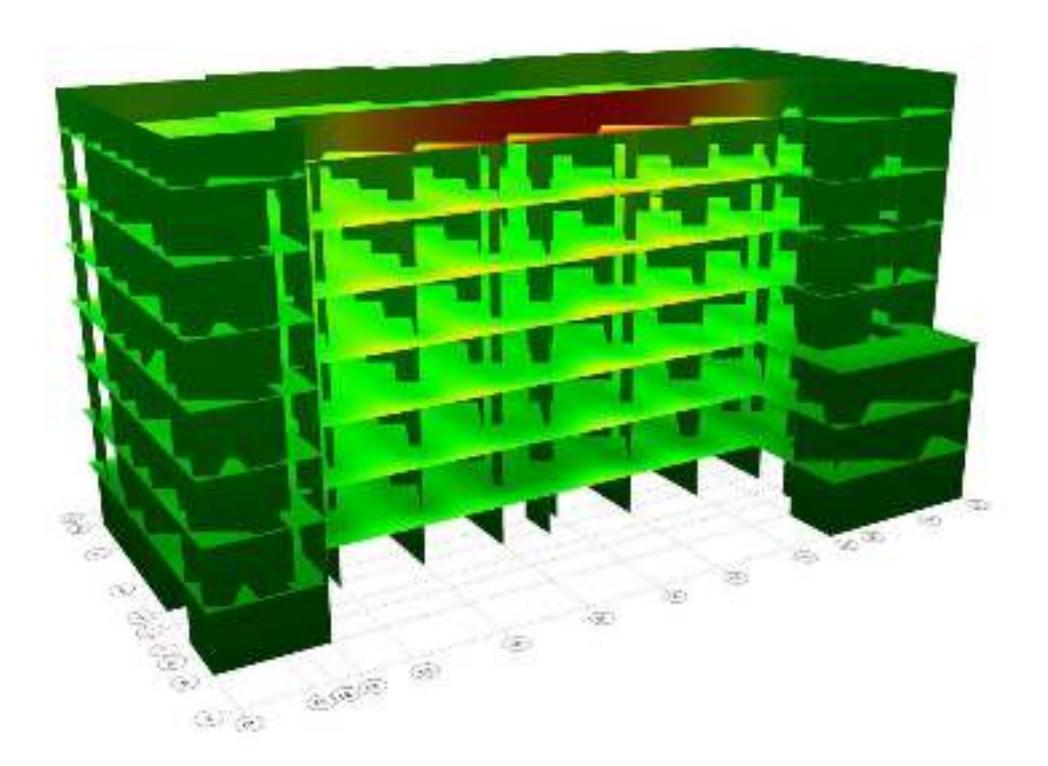
View of Riviera II from its Building NE Corner

- Deflections due to Dead Loads only.
- Maximum deflections due DL less than ¼", well within Code.

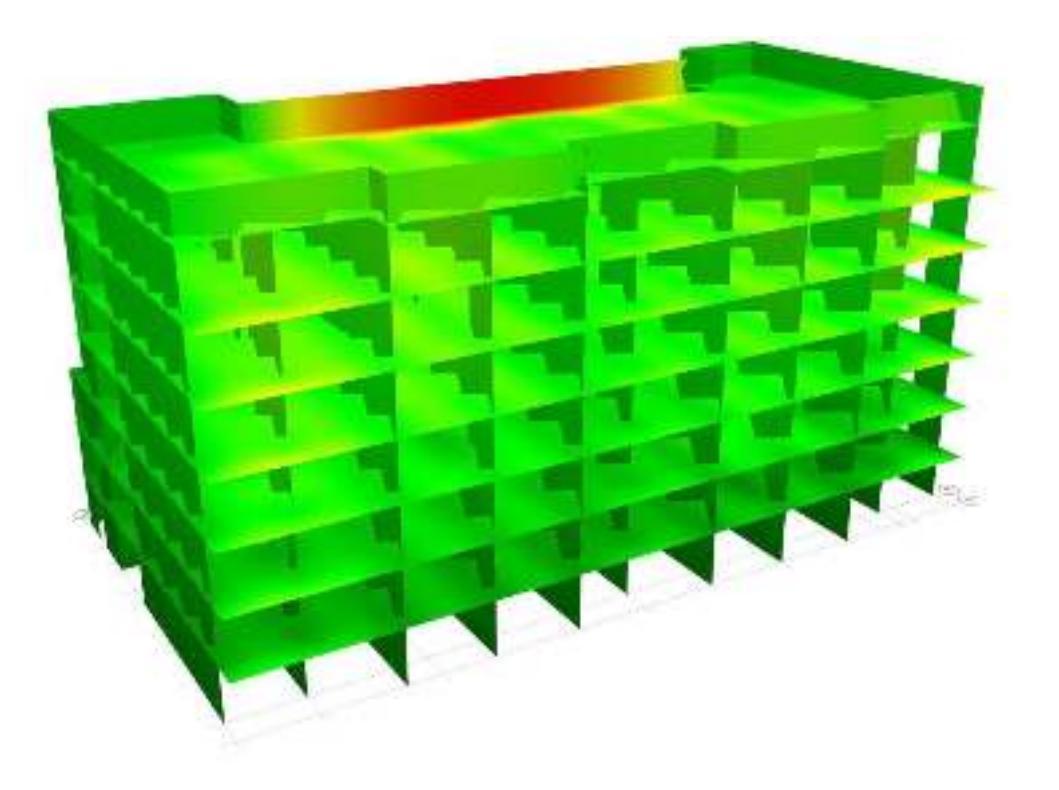
View of Riviera II from its Building SW Corner

- Deflections due to Dead Loads only.
- Maximum deflections due DL less than ¼", well within Code.

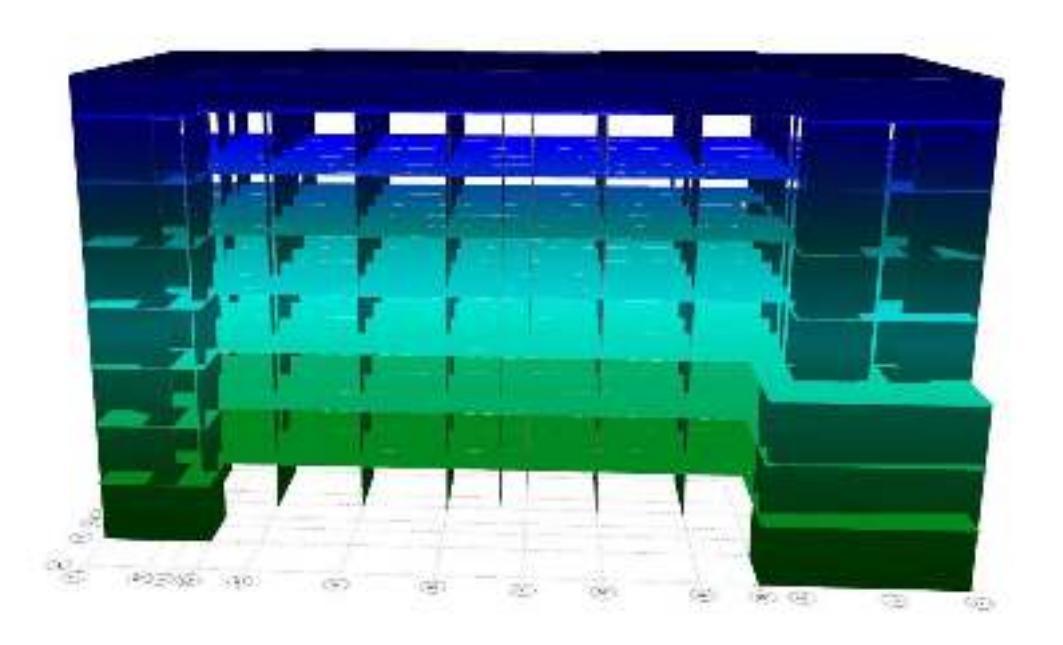
View of Riviera II from its Building North Face

- Deflections due to 150-MPH winds only.
- Wind loads were applied per ASCE/SEI 7-16, including ±e, eccentricities.
- Maximum deflections due Wind Loads less than 3/8", well within Code.

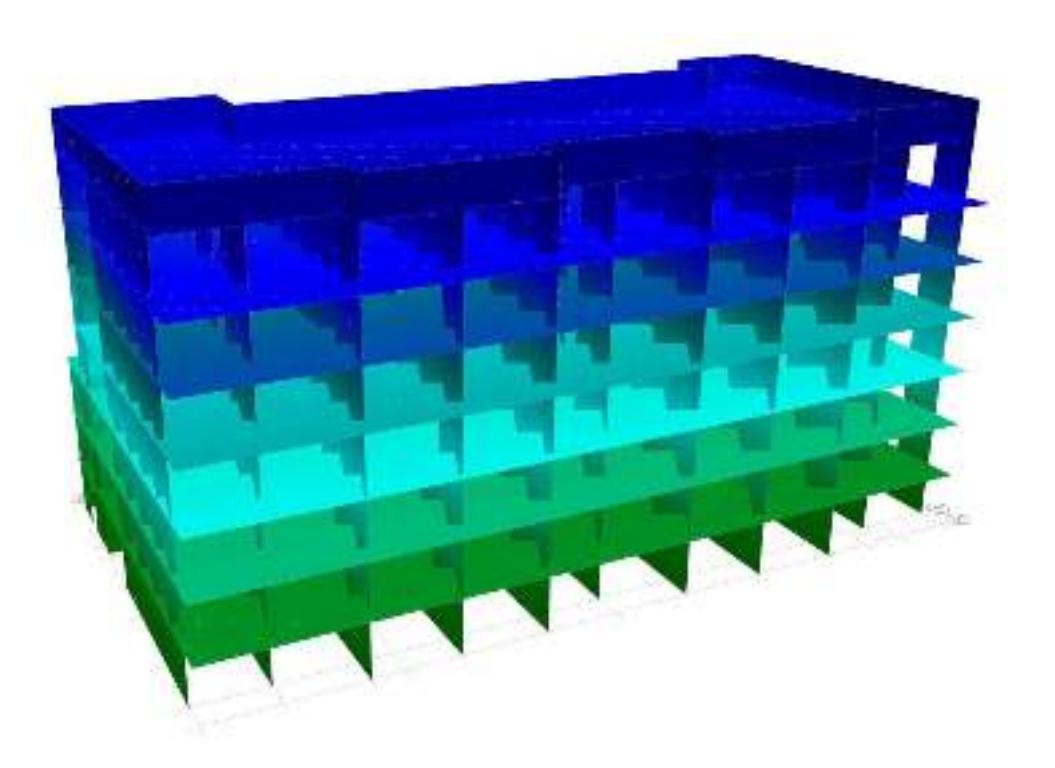
View of Riviera II from its Building SW Corner

- Deflections due to 150-MPH winds only.
- Wind loads were applied per ASCE/SEI 7-16, including ±e, eccentricities.
- Maximum deflections due Wind Loads less than 3/8", well within Code.

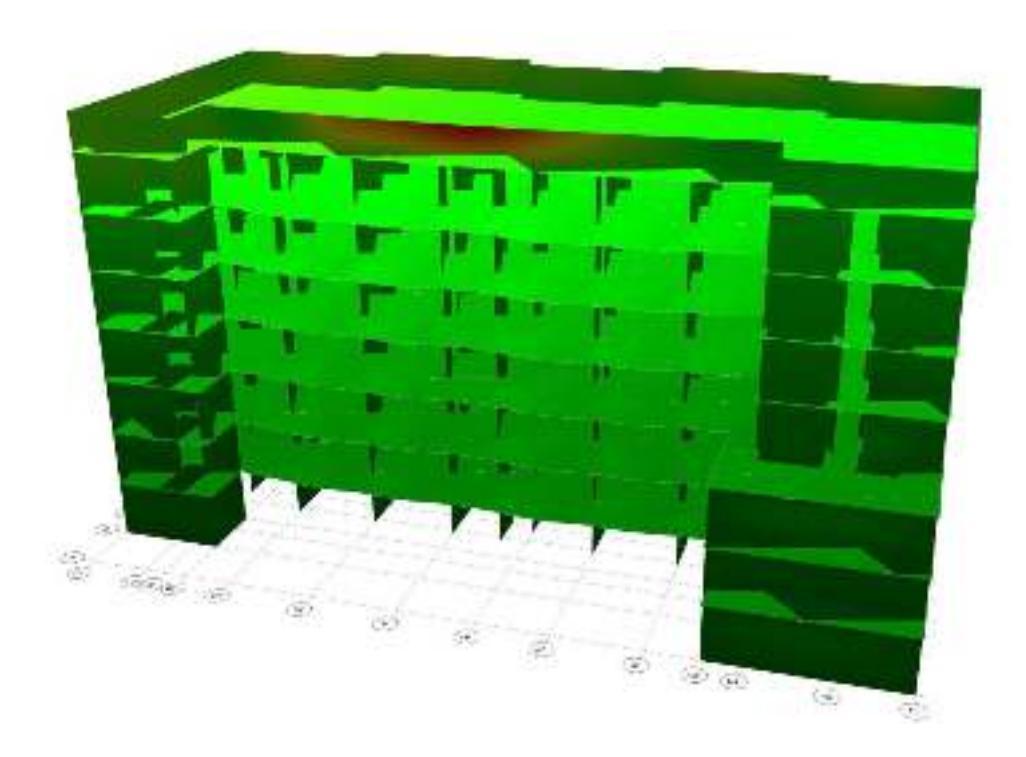
View of Riviera II from its Building NW Corner

- Deflections due to 150-MPH winds only.
- Wind loads were applied per ASCE/SEI 7-16, including ±e, eccentricities.
- Maximum deflections due Wind Loads less than 3/8", well within Code.

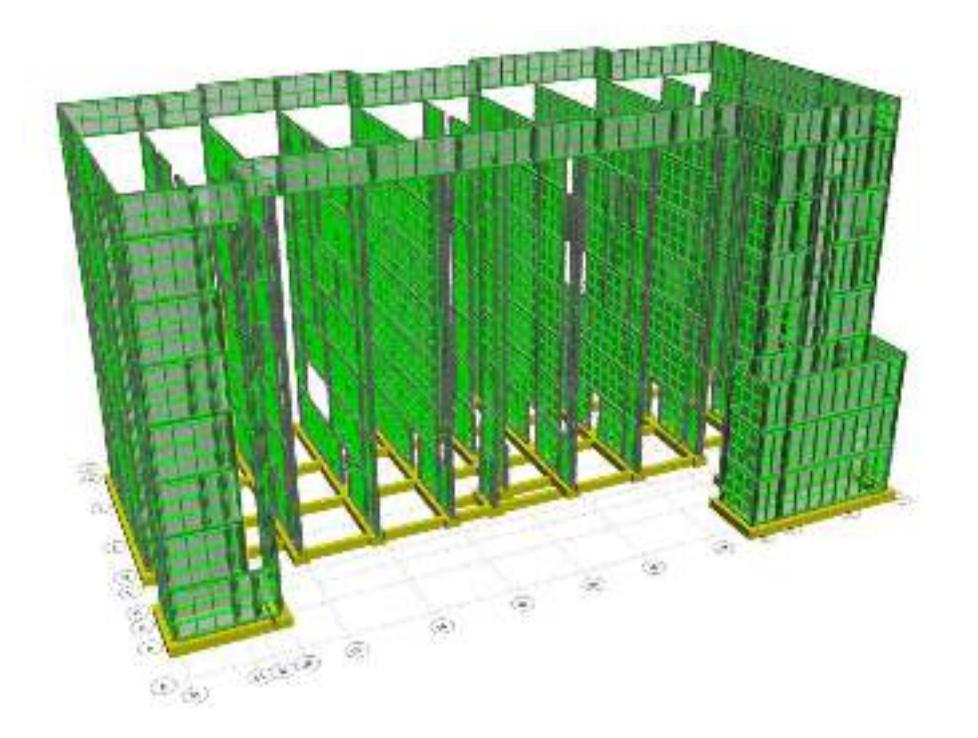
View of Riviera II from its Building NE Corner

- Code Check of the various sections across the walls.
- Riviera II was well-designed, well-built.
- All sections were passed for geometric considerations and Unity Checks at the concrete sections for forces and moments.

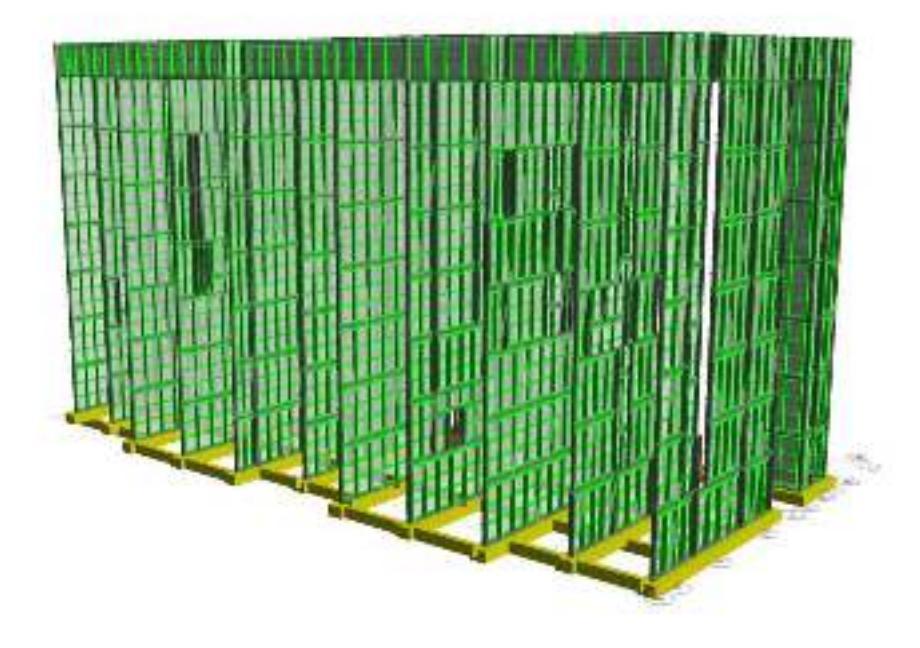
View of Riviera II from its Building SE Corner

- Code Check of the various sections across the walls.
- Riviera II was well-designed, well-built.
- All sections were passed for geometric considerations and Unity Checks at the concrete sections for forces and moments.

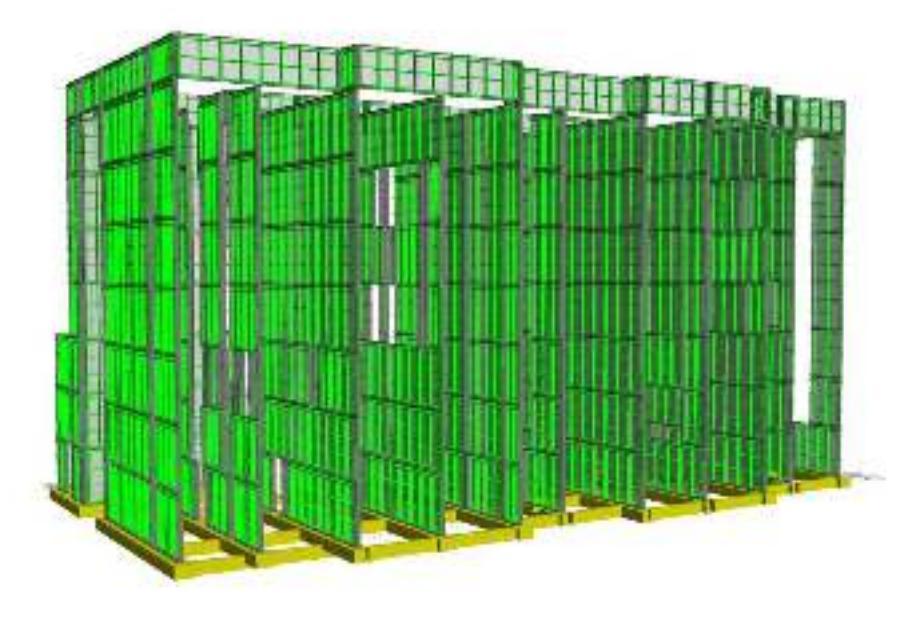
View of Riviera II from its Building SE Corner

- Code Check of the various sections across the walls.
- Riviera II was well-designed, well-built.
- All sections were passed for geometric considerations and Unity Checks at the concrete sections for forces and moments.

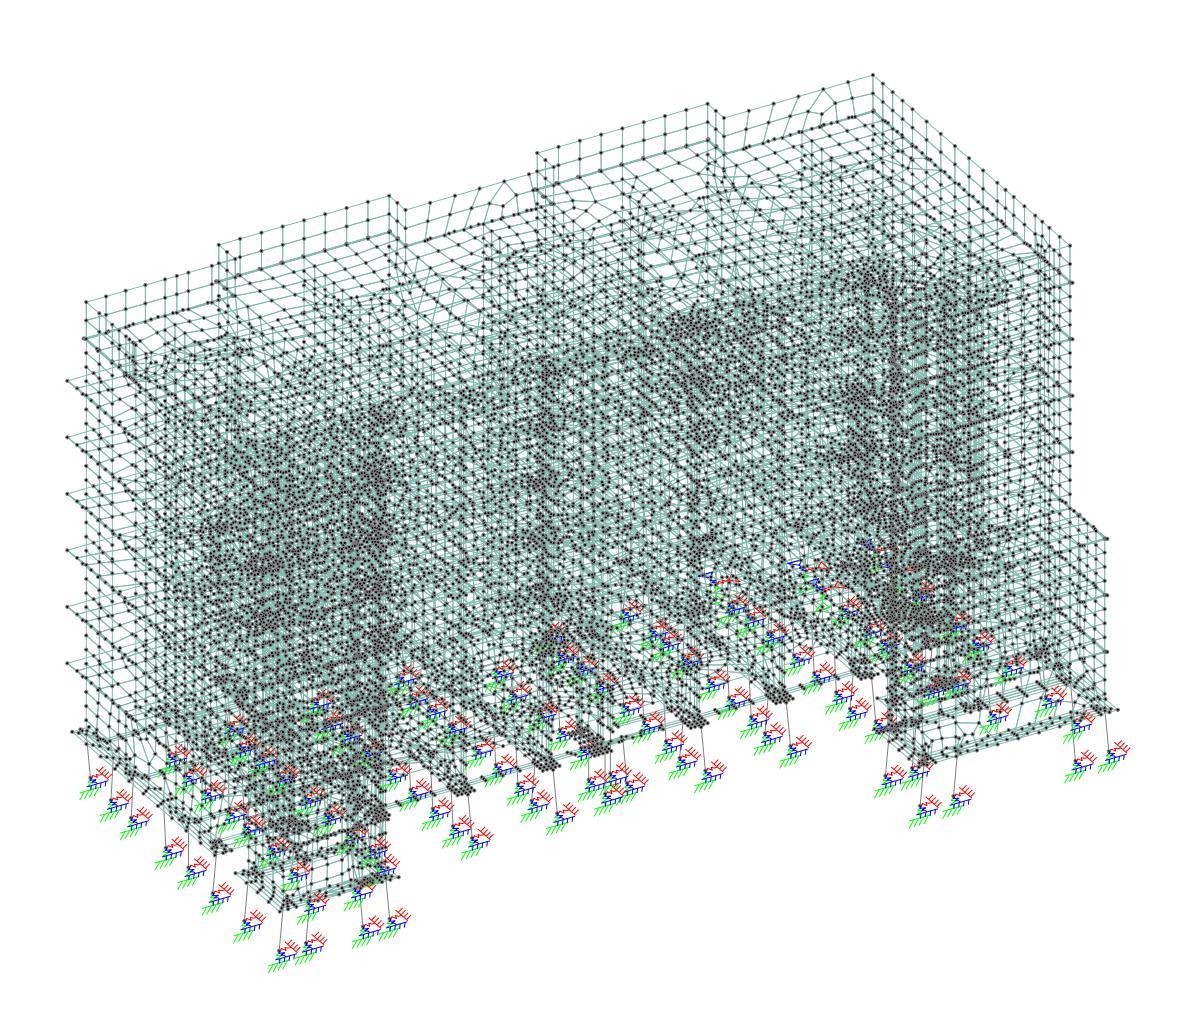
STAAD.Pro Model of Riviera II from its Building NE Corner

- Wind loads were copied from RAM and applied with STAAD.Pro.
- Code checks were run, similar to the process in RAM Structural Systems.
- All sections were passed with similar results for wave loadings as for the wind loadings.
- Riviera II was deemed intrinsically SAFE for a direct hit from an equivalent Category 4 hurricane, the 100-year MRI design storm.

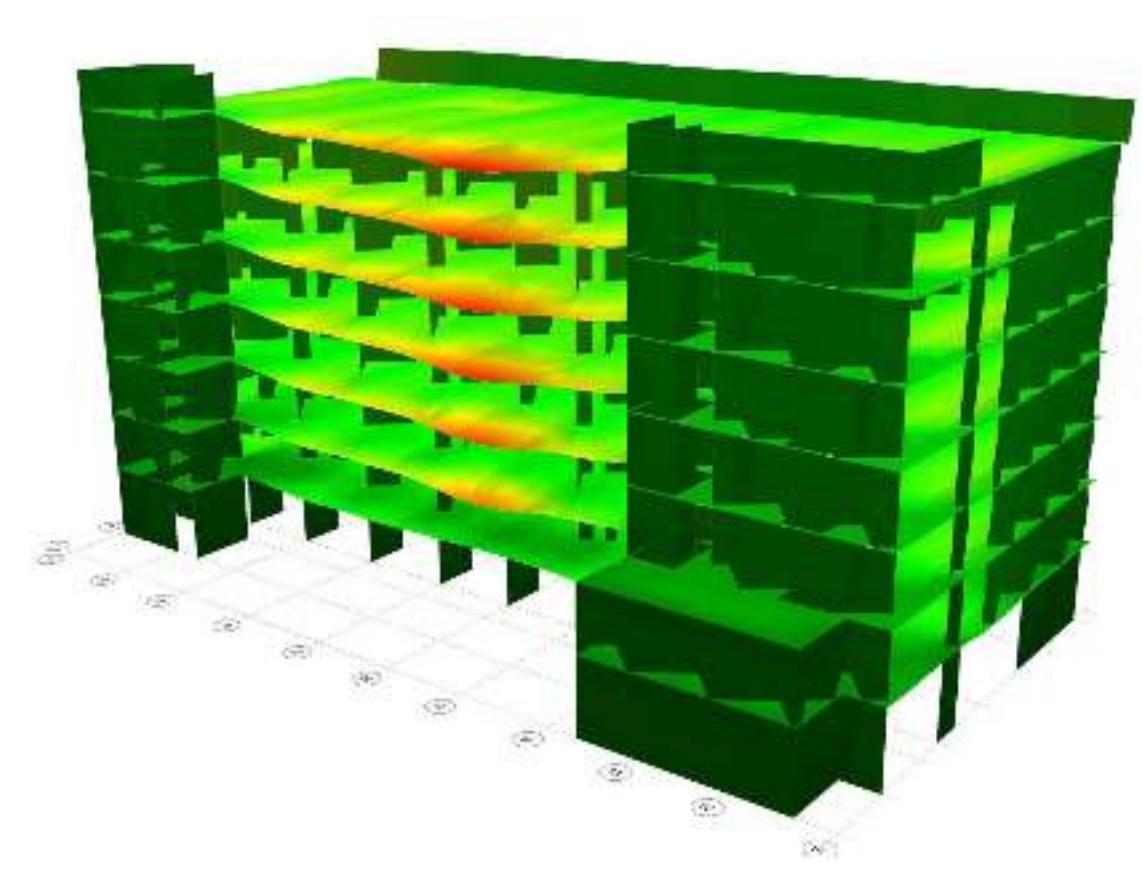
West Beach Grand deflections from Dead Loads viewed from NW Corner of the Building

- The West Beach Grand condominium was analyzed per ASCE/SEI 7-16 load cases and load combinations.
- Dead Loads were modeled from Self-Weight plus another 10-psf area load for mechanical/electrical/ plumbing loads.
- Deflections from the individual load cases and the integrated load combinations
- All deflections were within constructability and operability Codes and Standards.
