Project Site with Riviera I, Riviera II, West Beach Grand post-Hurricane Ike

Mark E Haas Engineering, LLC, with extensive experience in coastal and offshore engineering projects, was retained by the condominium HOA's to reassess their buildings.

To show that condominiums are "SAFE":

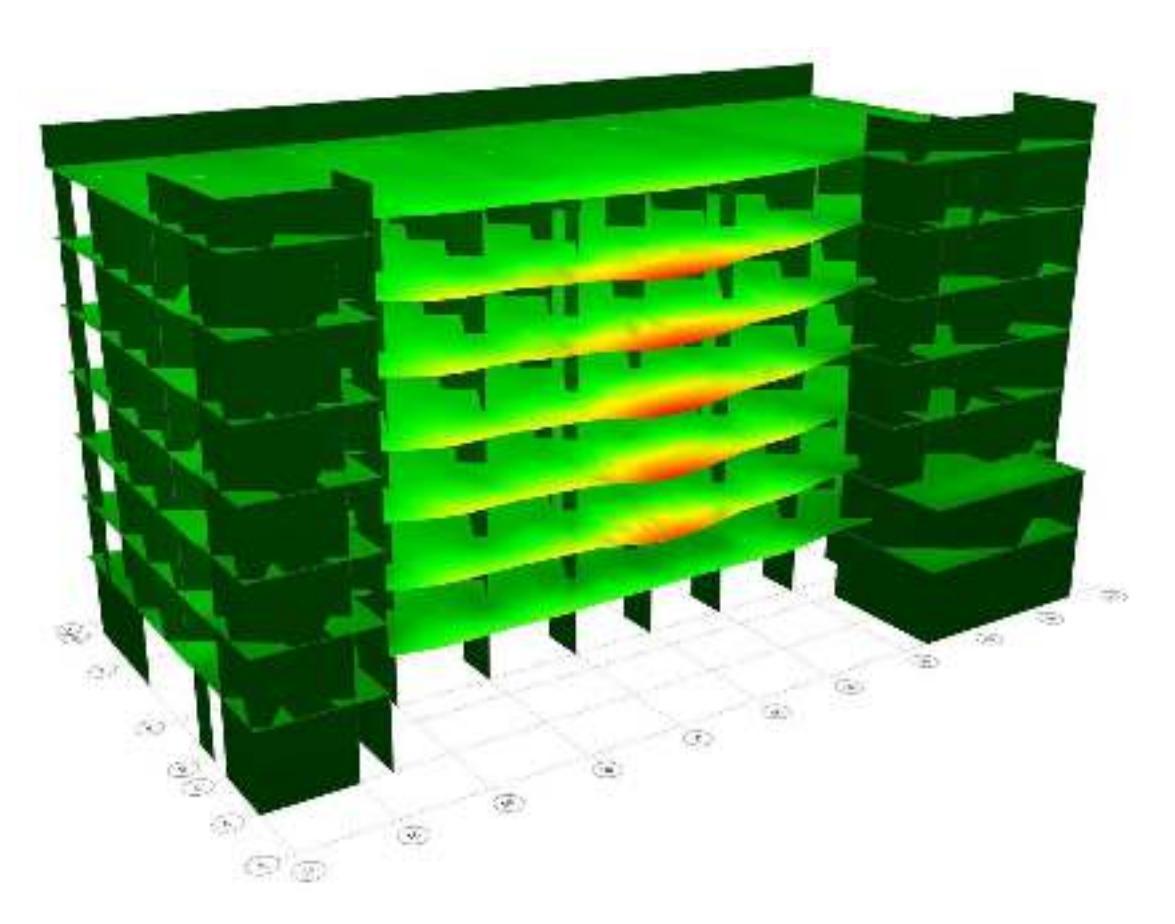
West Beach Grand deflections from Live Loads viewed from NW Corner of the Building

- The West Beach Grand condominium was analyzed per ASCE/SEI 7-16 load cases and load combinations.
- Live Loads were modeled with 40-psf area loads without reduction factors in the residences and with 100-psf area loads with reduction factors in public areas.
- Deflections from the individual load cases and the integrated load combinations
- All deflections were within constructability and operability Codes and Standards.

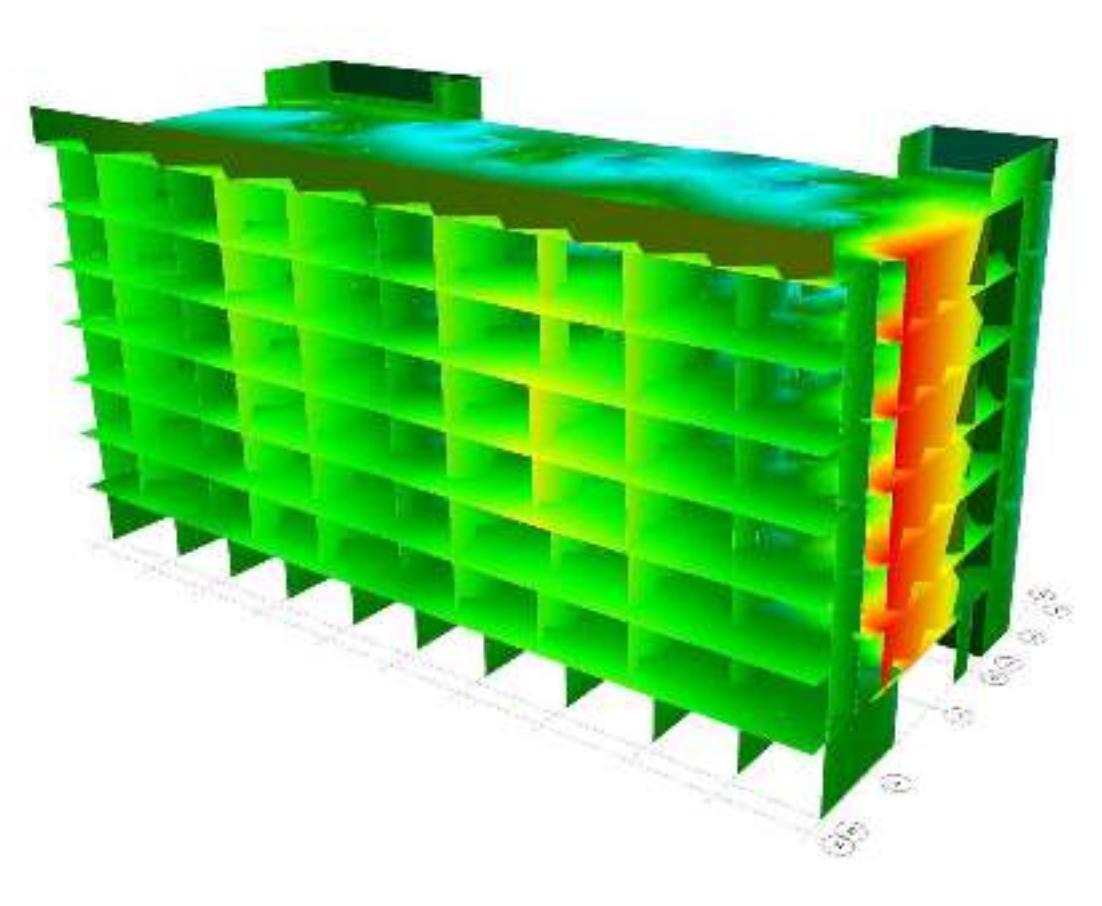
West Beach Grand deflections from Southerly 150-mph Wind Loads

- The West Beach Grand condominium was analyzed per ASCE/SEI 7-16 load cases and load combinations.
- Wind loads were the result of 150-mph winds applied to the individual floors and applied at the center of the floor diaphragm.
- Deflections from the individual load cases and the integrated load combinations.
- All deflections were within constructability and operability Codes and Standards.

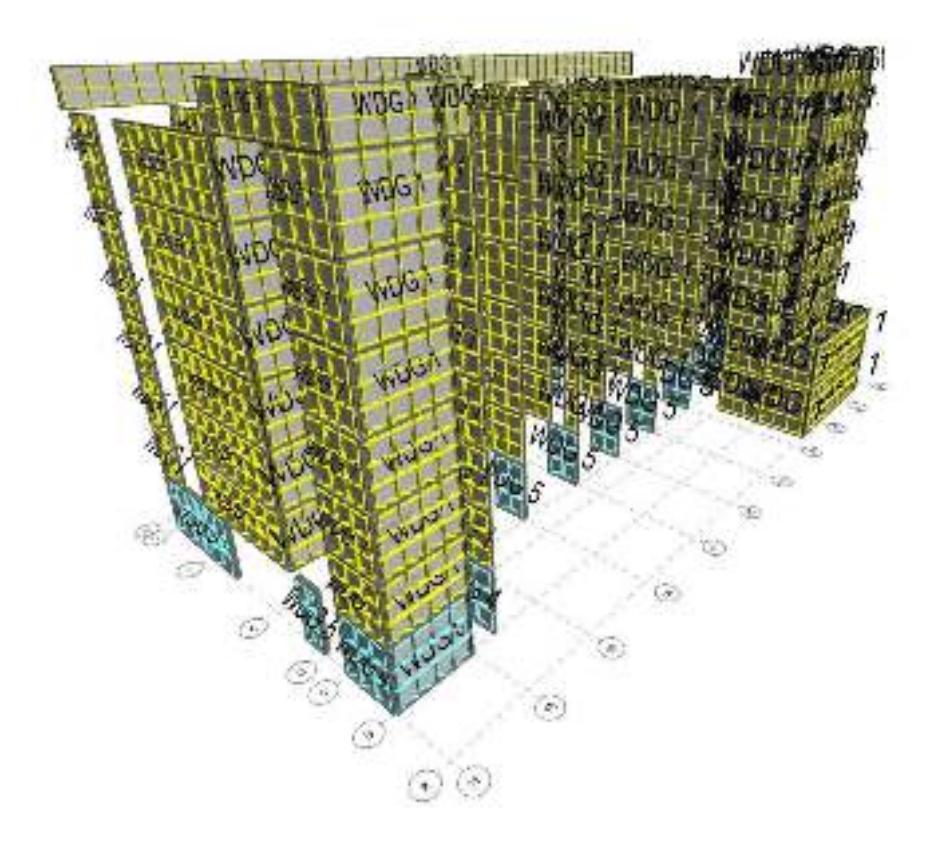
West Beach Grand condominium Code Check results, shown from the Northeast view

- The West Beach Grand condominium was analyzed per ASCE/SEI 7-16 load cases and load combinations.
- Code checks were performed across the Condominium at the shown section cuts.
- Across all sections, the concrete sections were adequate for strength, with Unity Checks typically between 0.2 to 0.3.
- Unlike Riviera II, where the section cuts were shown in Green, these section cuts are shown in Yellow.
- Across nearly all sections for the walls, but not for the floor sections, the sections did not, met, or just barely passed minimum rebar requirements or minimum concrete cover requirements.

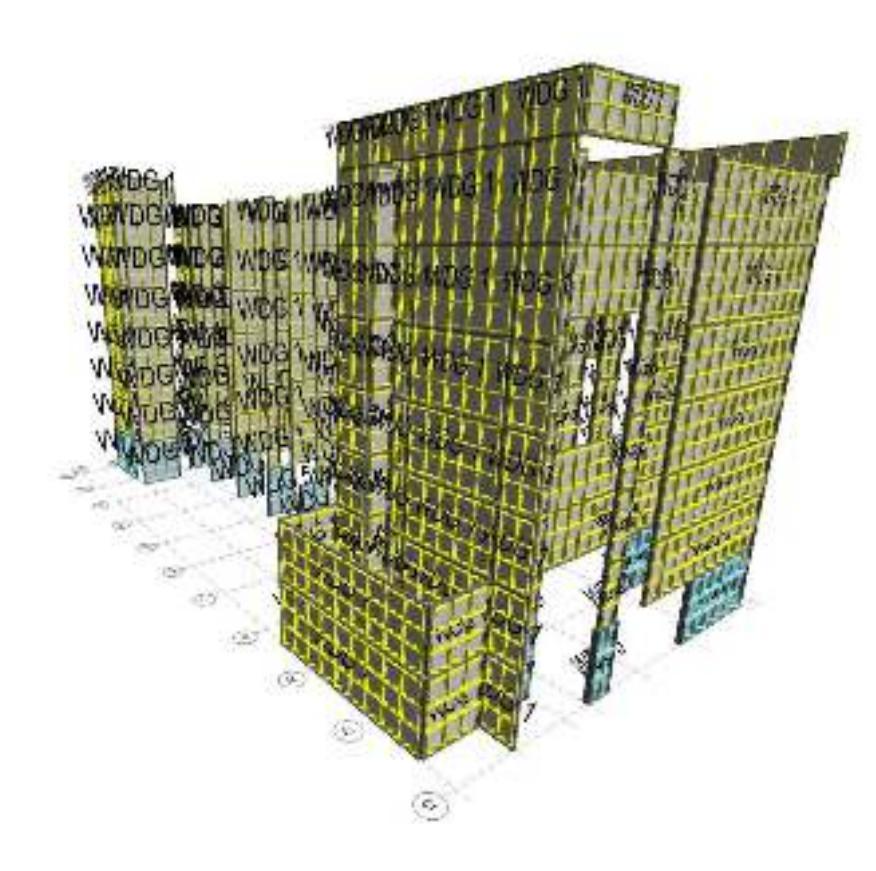
West Beach Grand condominium Code Check results, shown from the Northwest view

- The West Beach Grand condominium was analyzed per ASCE/SEI 7-16 load cases and load combinations.
- Code checks were performed across the Condominium at the shown section cuts.
- Across all sections, the concrete sections were adequate for strength, with Unity Checks typically between 0.2 to 0.3.
- Unlike Riviera II, where the section cuts were shown in Green, these section cuts are shown in Yellow.
- Across nearly all sections for the walls, but not for the floor sections, the sections did not, met, or just barely passed minimum rebar requirements or minimum concrete cover requirements.

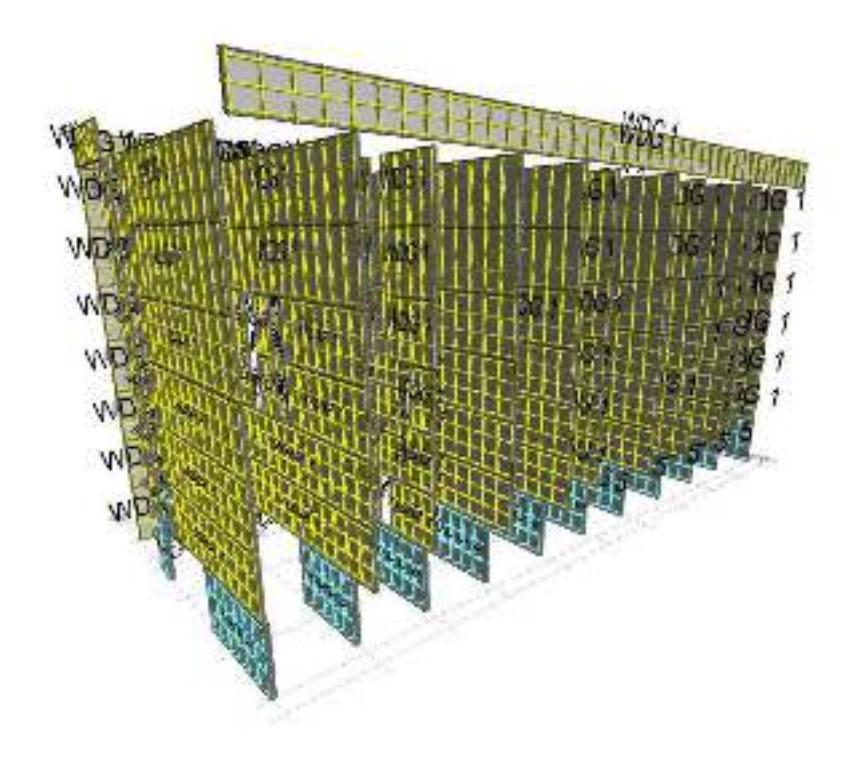
West Beach Grand condominium Code Check results, shown from the southwest view, sans floors for clarity

- The West Beach Grand condominium was analyzed per ASCE/SEI 7-16 load cases and load combinations.
- Code checks were performed across the Condominium at the shown section cuts.
- Across all sections, the concrete sections were adequate for strength, with Unity Checks typically between 0.2 to 0.3.
- Unlike Riviera II, where the section cuts were shown in Green, these section cuts are shown in Yellow.
- Across nearly all sections for the walls, but not for the floor sections, the sections did not, met, or just barely passed minimum rebar requirements or minimum concrete cover requirements.

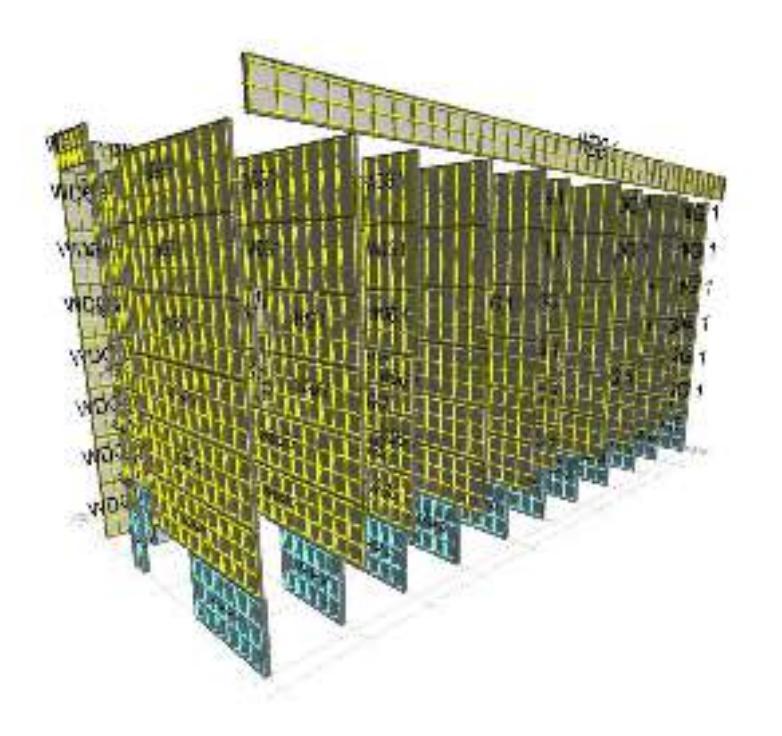
West Beach Grand condominium Code Check results, shown from the southwest view, sans floors for clarity

- As the section barely met or did not meet minimum rebar requirements, the Bentley software concealed the effective Unity Checks.
- The Architectural, Mechanical, Electrical, and Plumbing were drawn in CAD software, probably AutoCAD.
- Riviera II drawings were board drawn in 1985.
- Riviera II drawings were clearly damaged by water flooding.
- Due to the near-perfect minimum amount of rebar in the wall sections, suspicions and a hypothesis are formed that the condominium may have been deliberately shorted of its rebar during construction.
- Due to the rebar and cover issues, an enhanced inspection program is being developed for the HOA.
