**Foundation Performance Association  
Houston**

# **Causes and Cures of Cracking in Concrete**

**David Fowler**

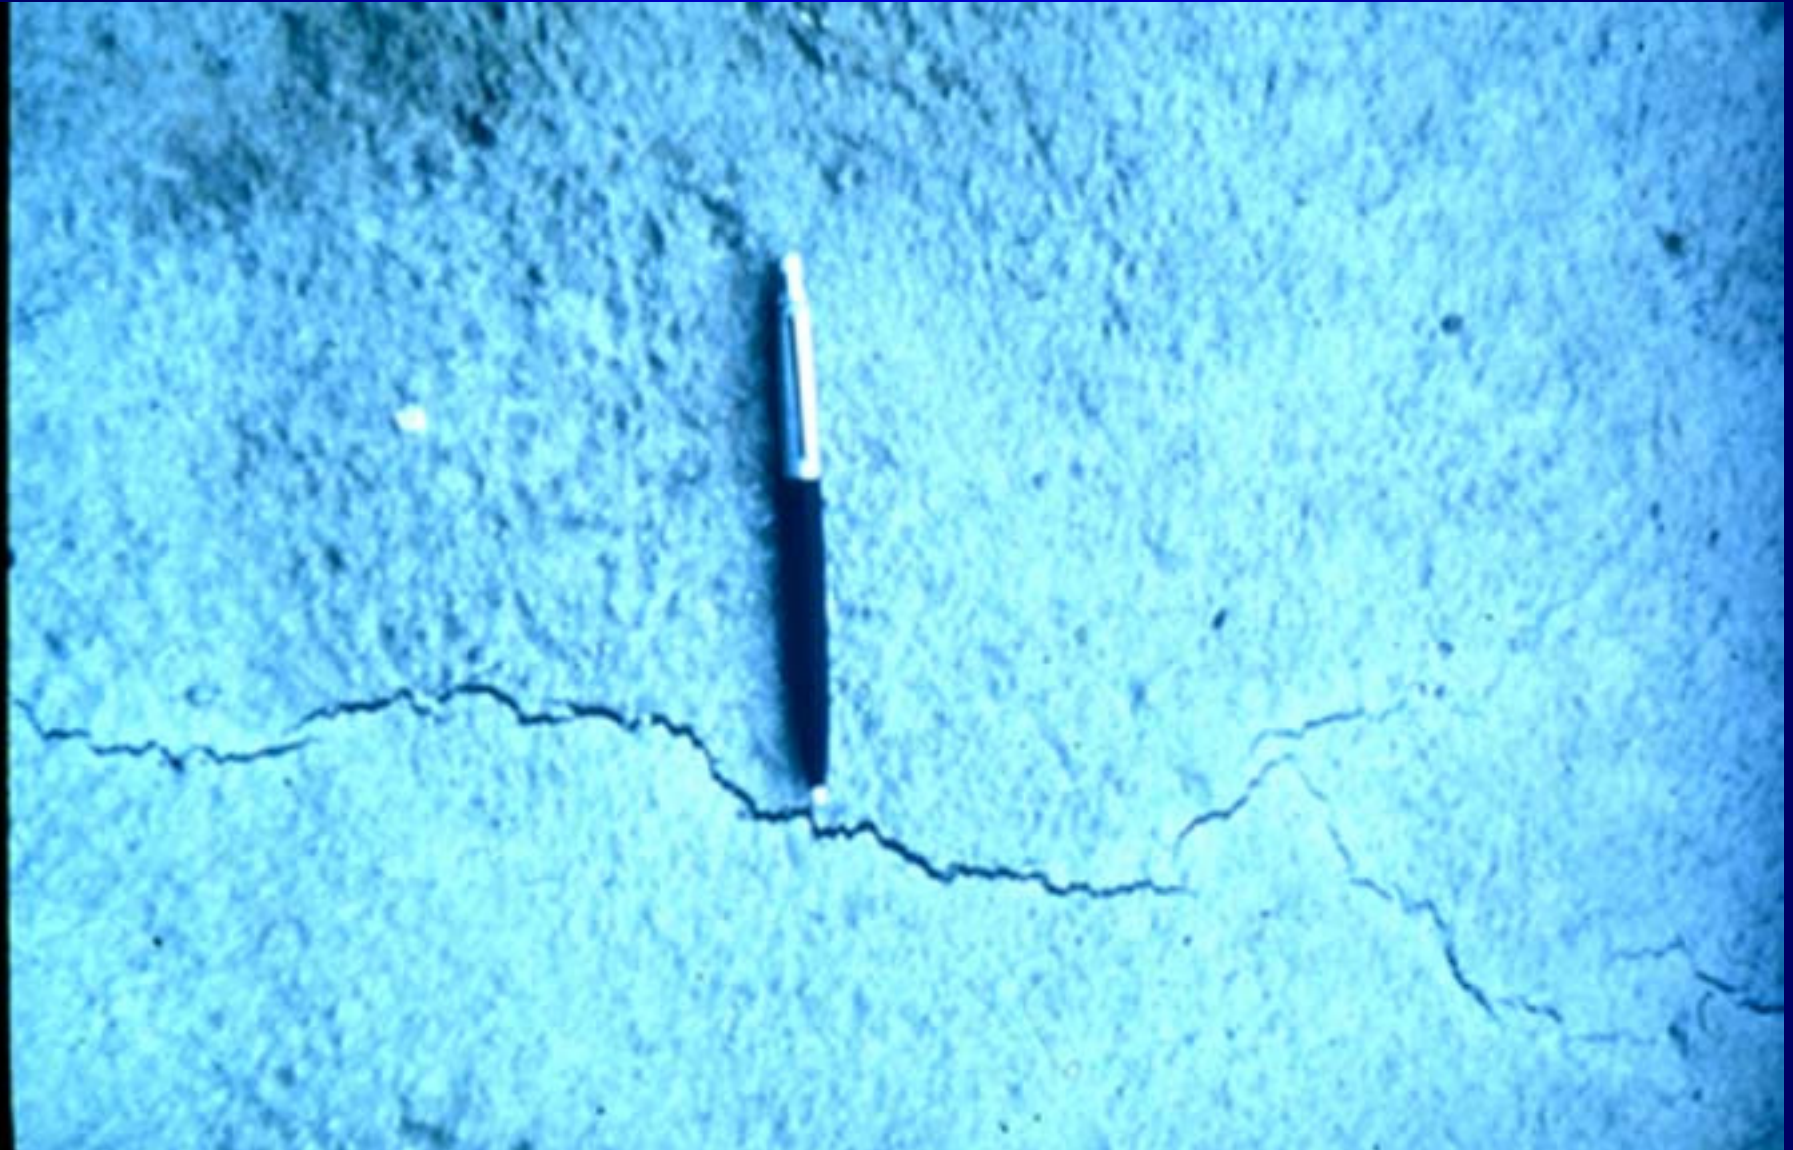
# Plastic Shrinkage Crack

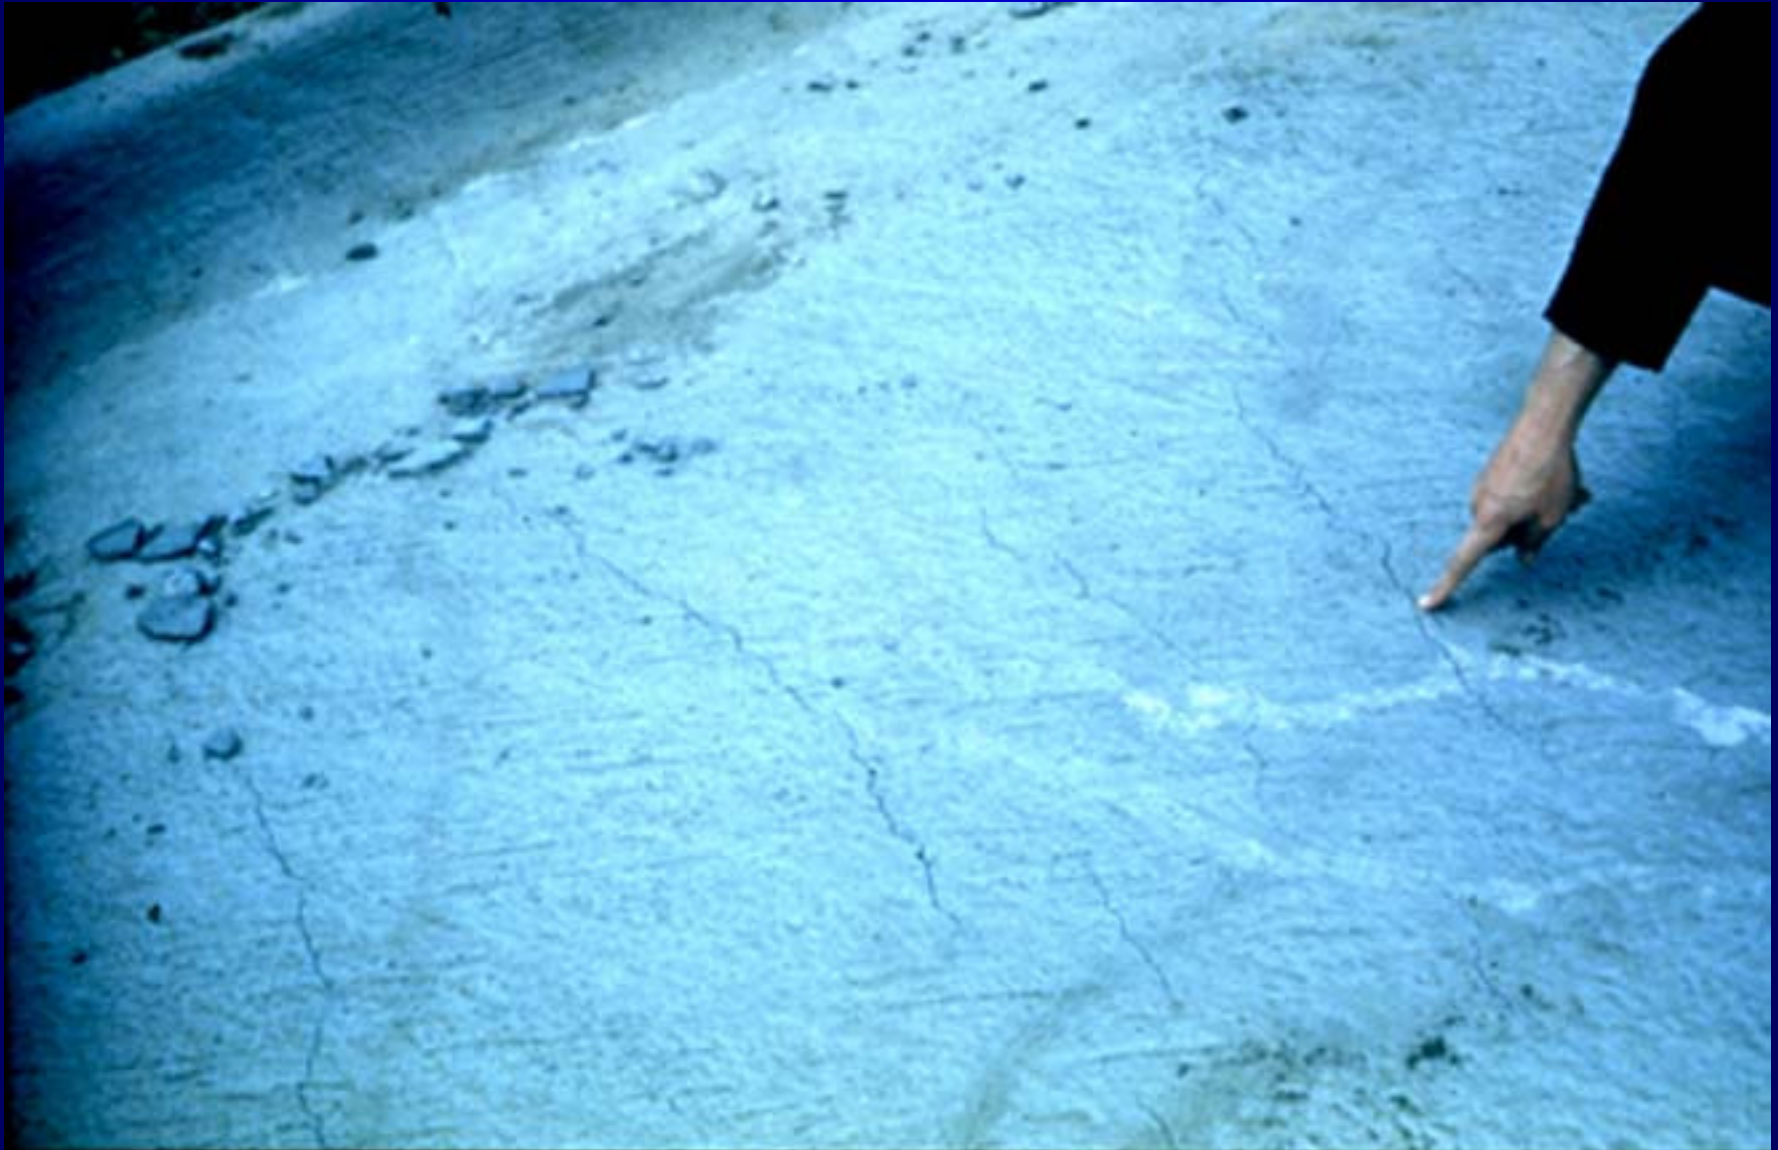
# Plastic Shrinkage Cracking

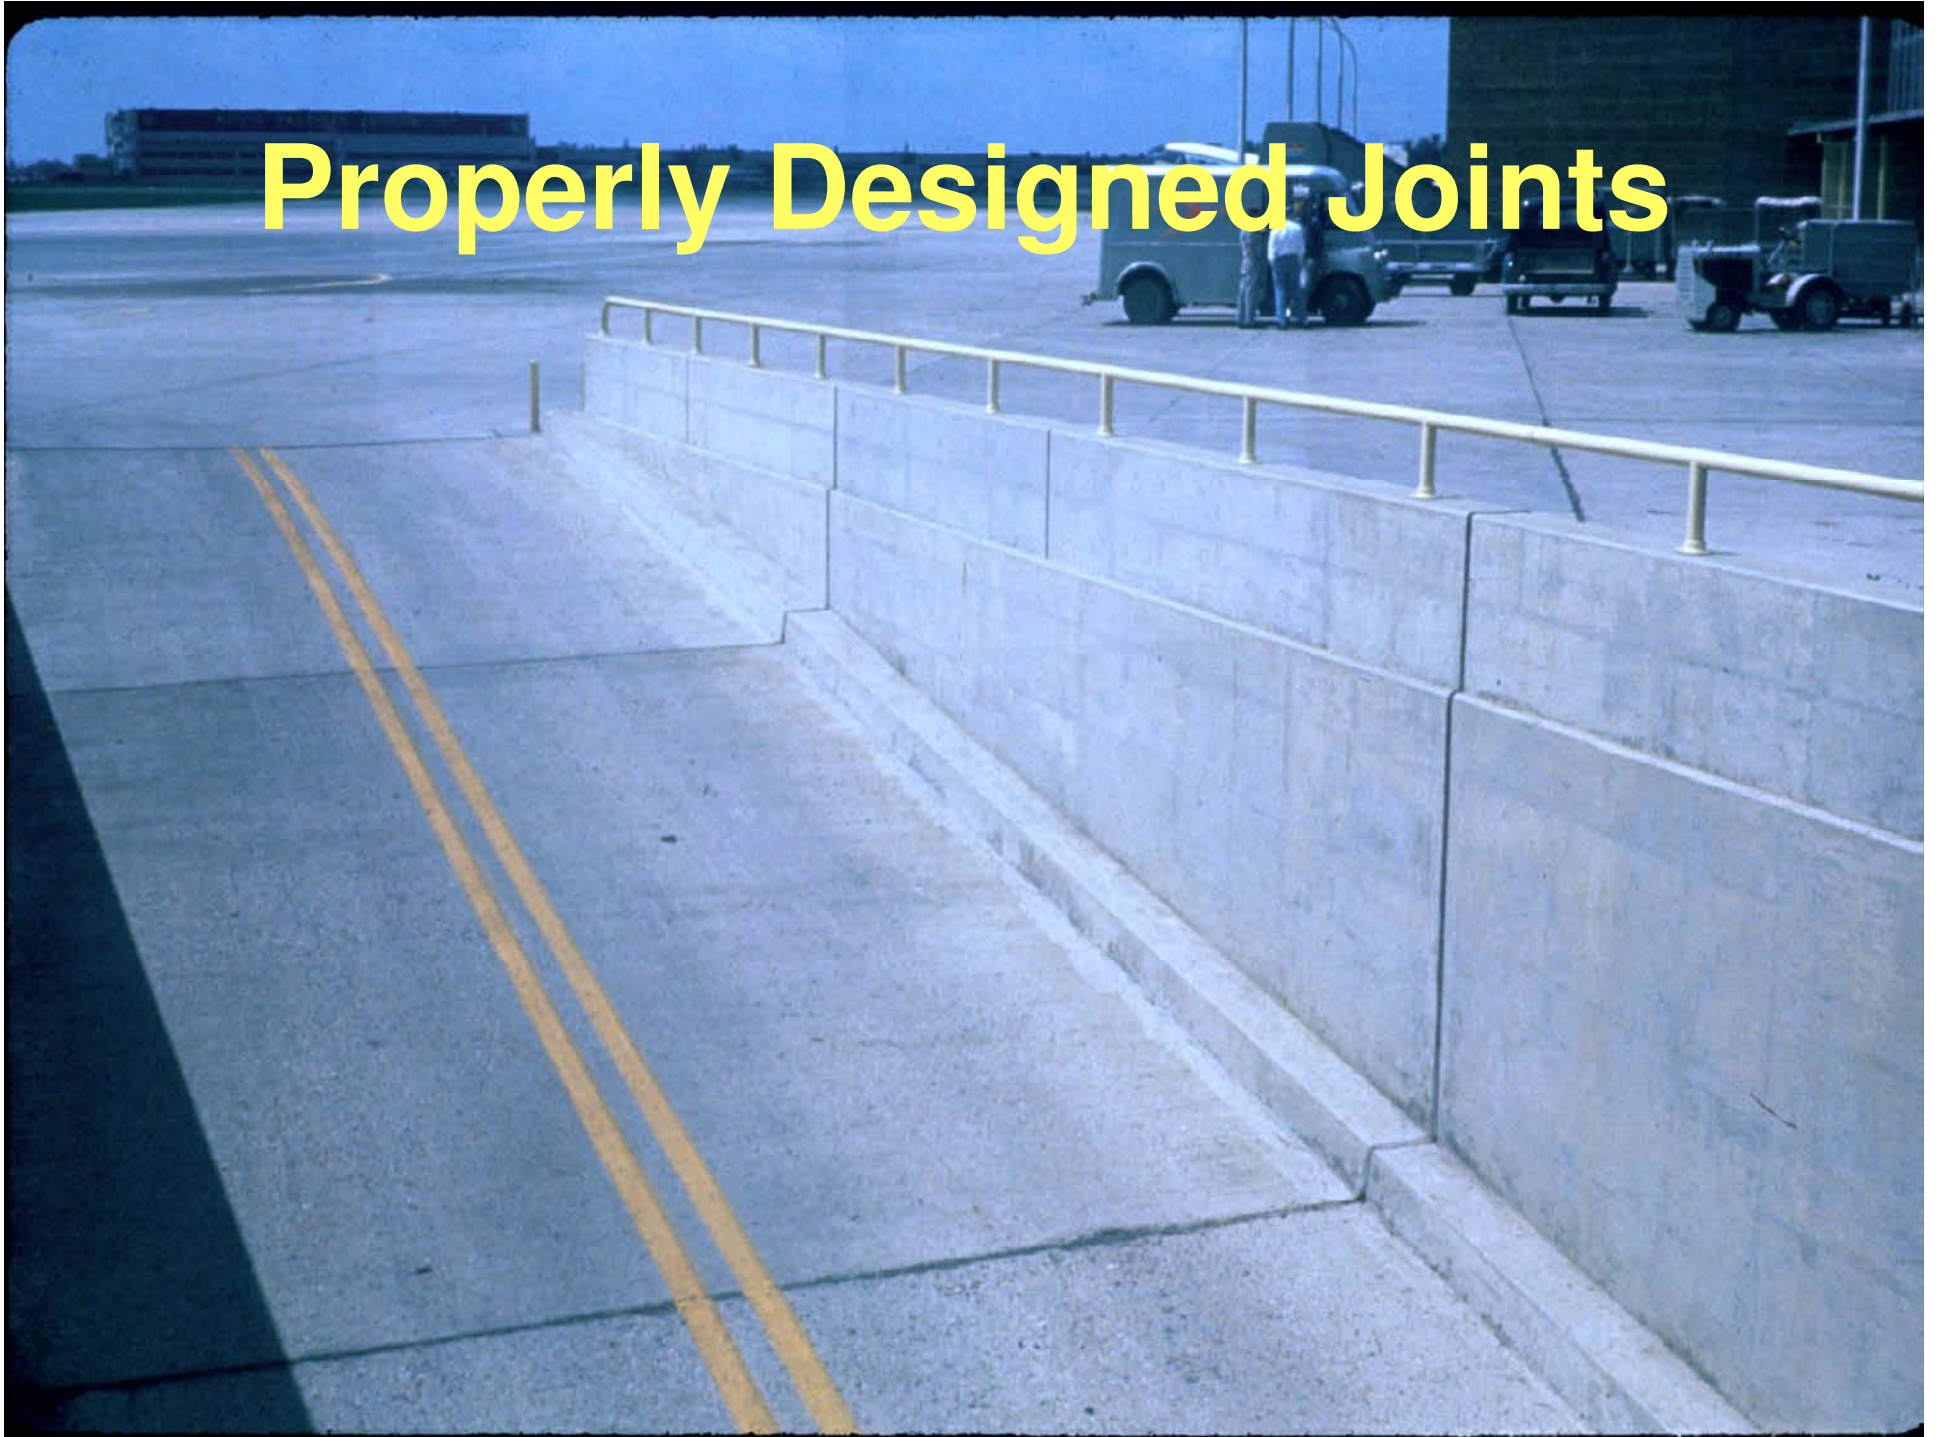
# Properly Designed Joints

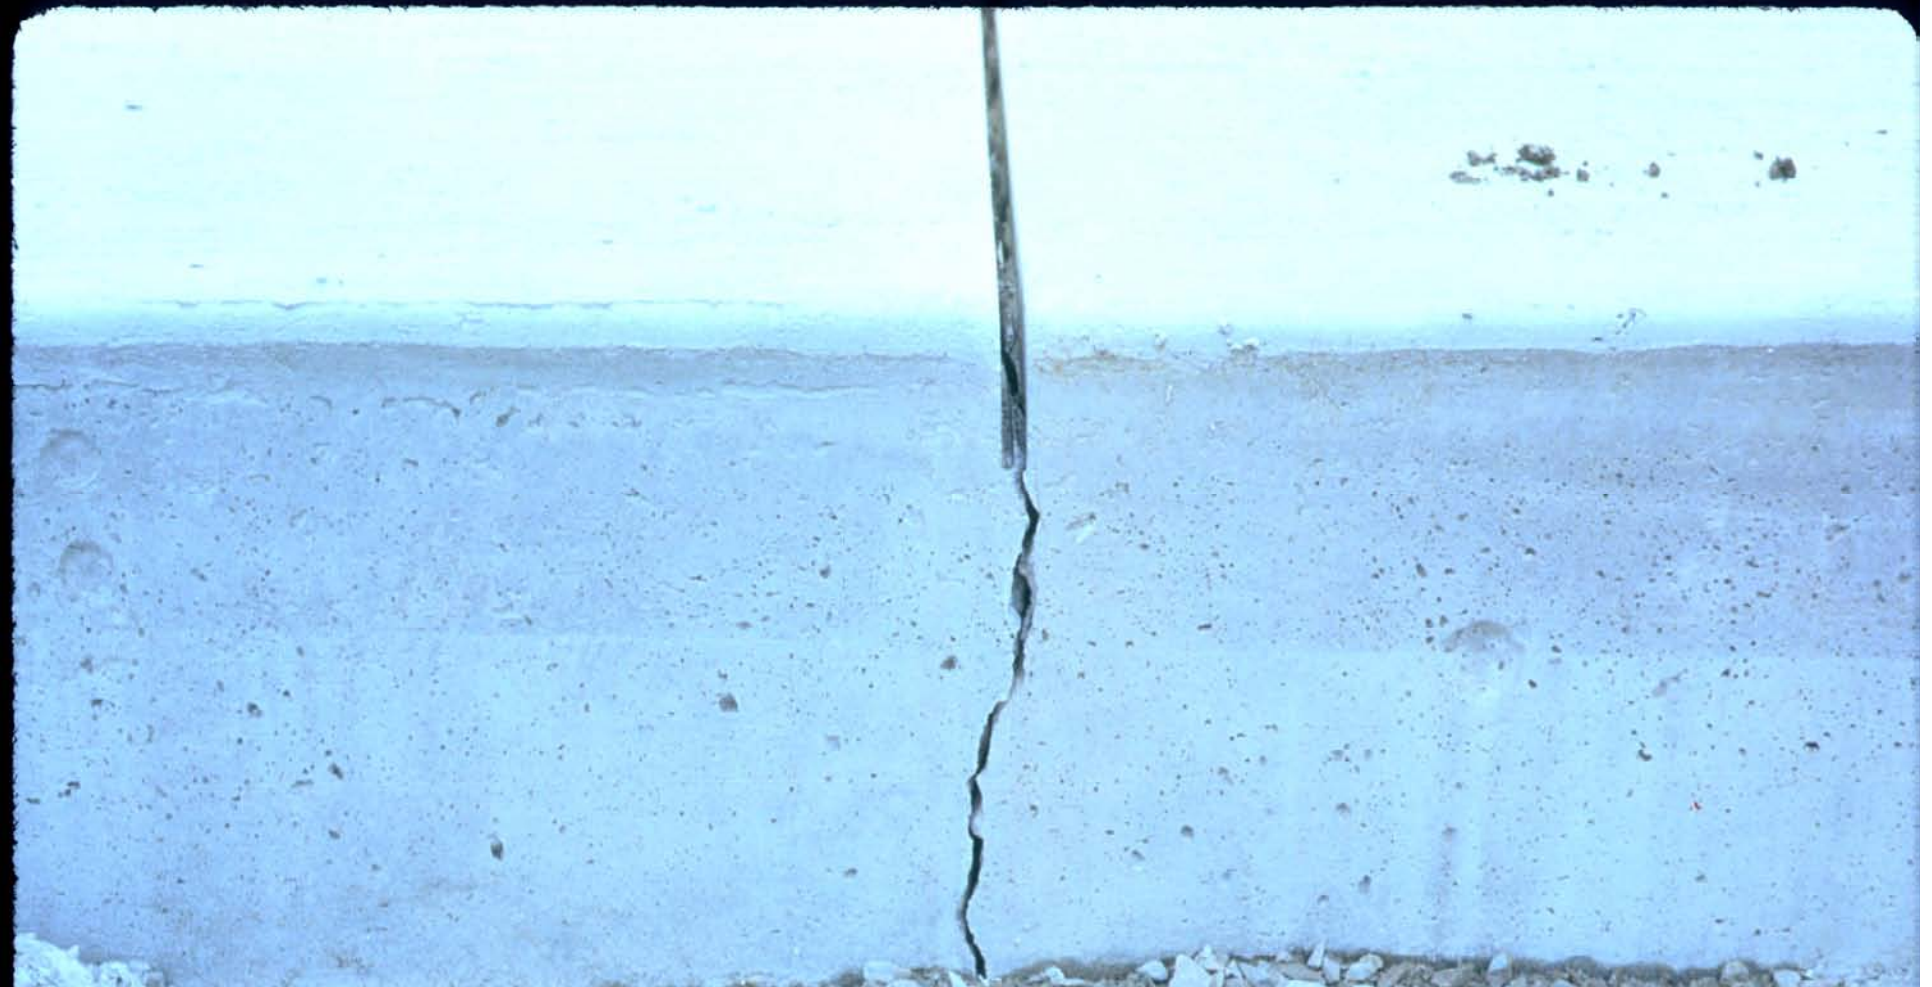
# Crack at Sawed Control Joint

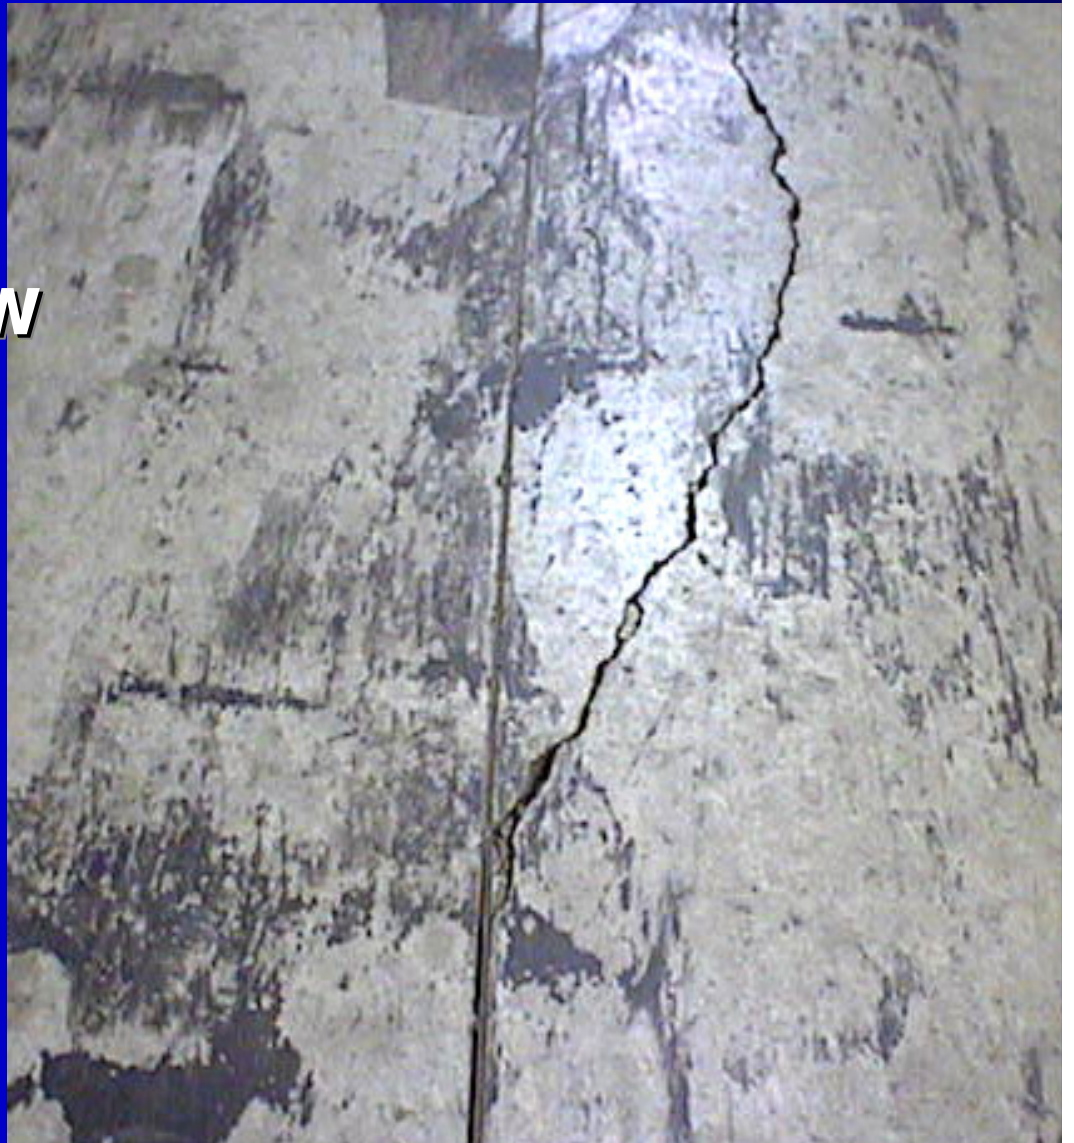
# Sawing Joint to Relieve Drying Shrinkage

**Too Late! Crack  
forms ahead of saw  
cutting**

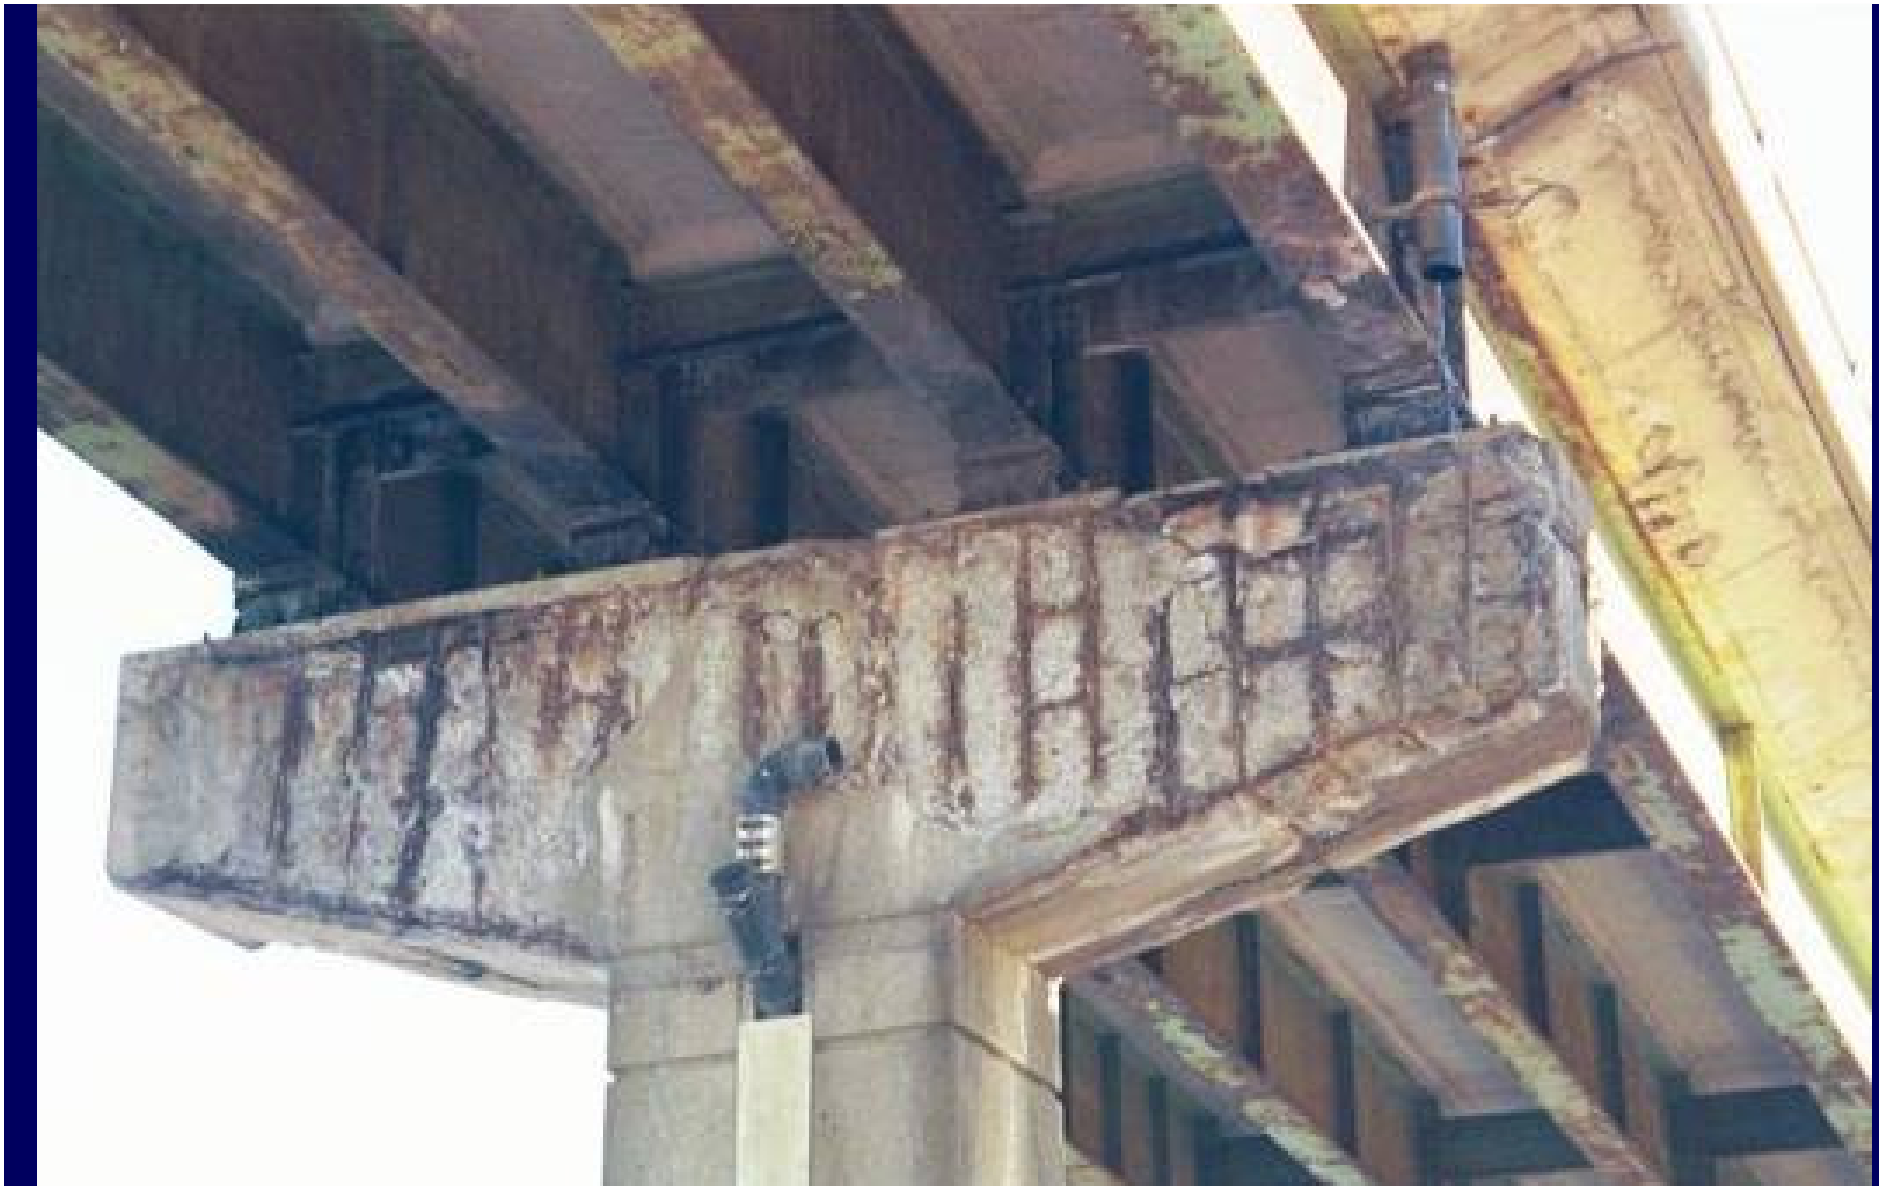
### Symptom

Spalling of concrete over rebar

### Cause

Corrosion of rebar initiated by chlorides (from roadway above)

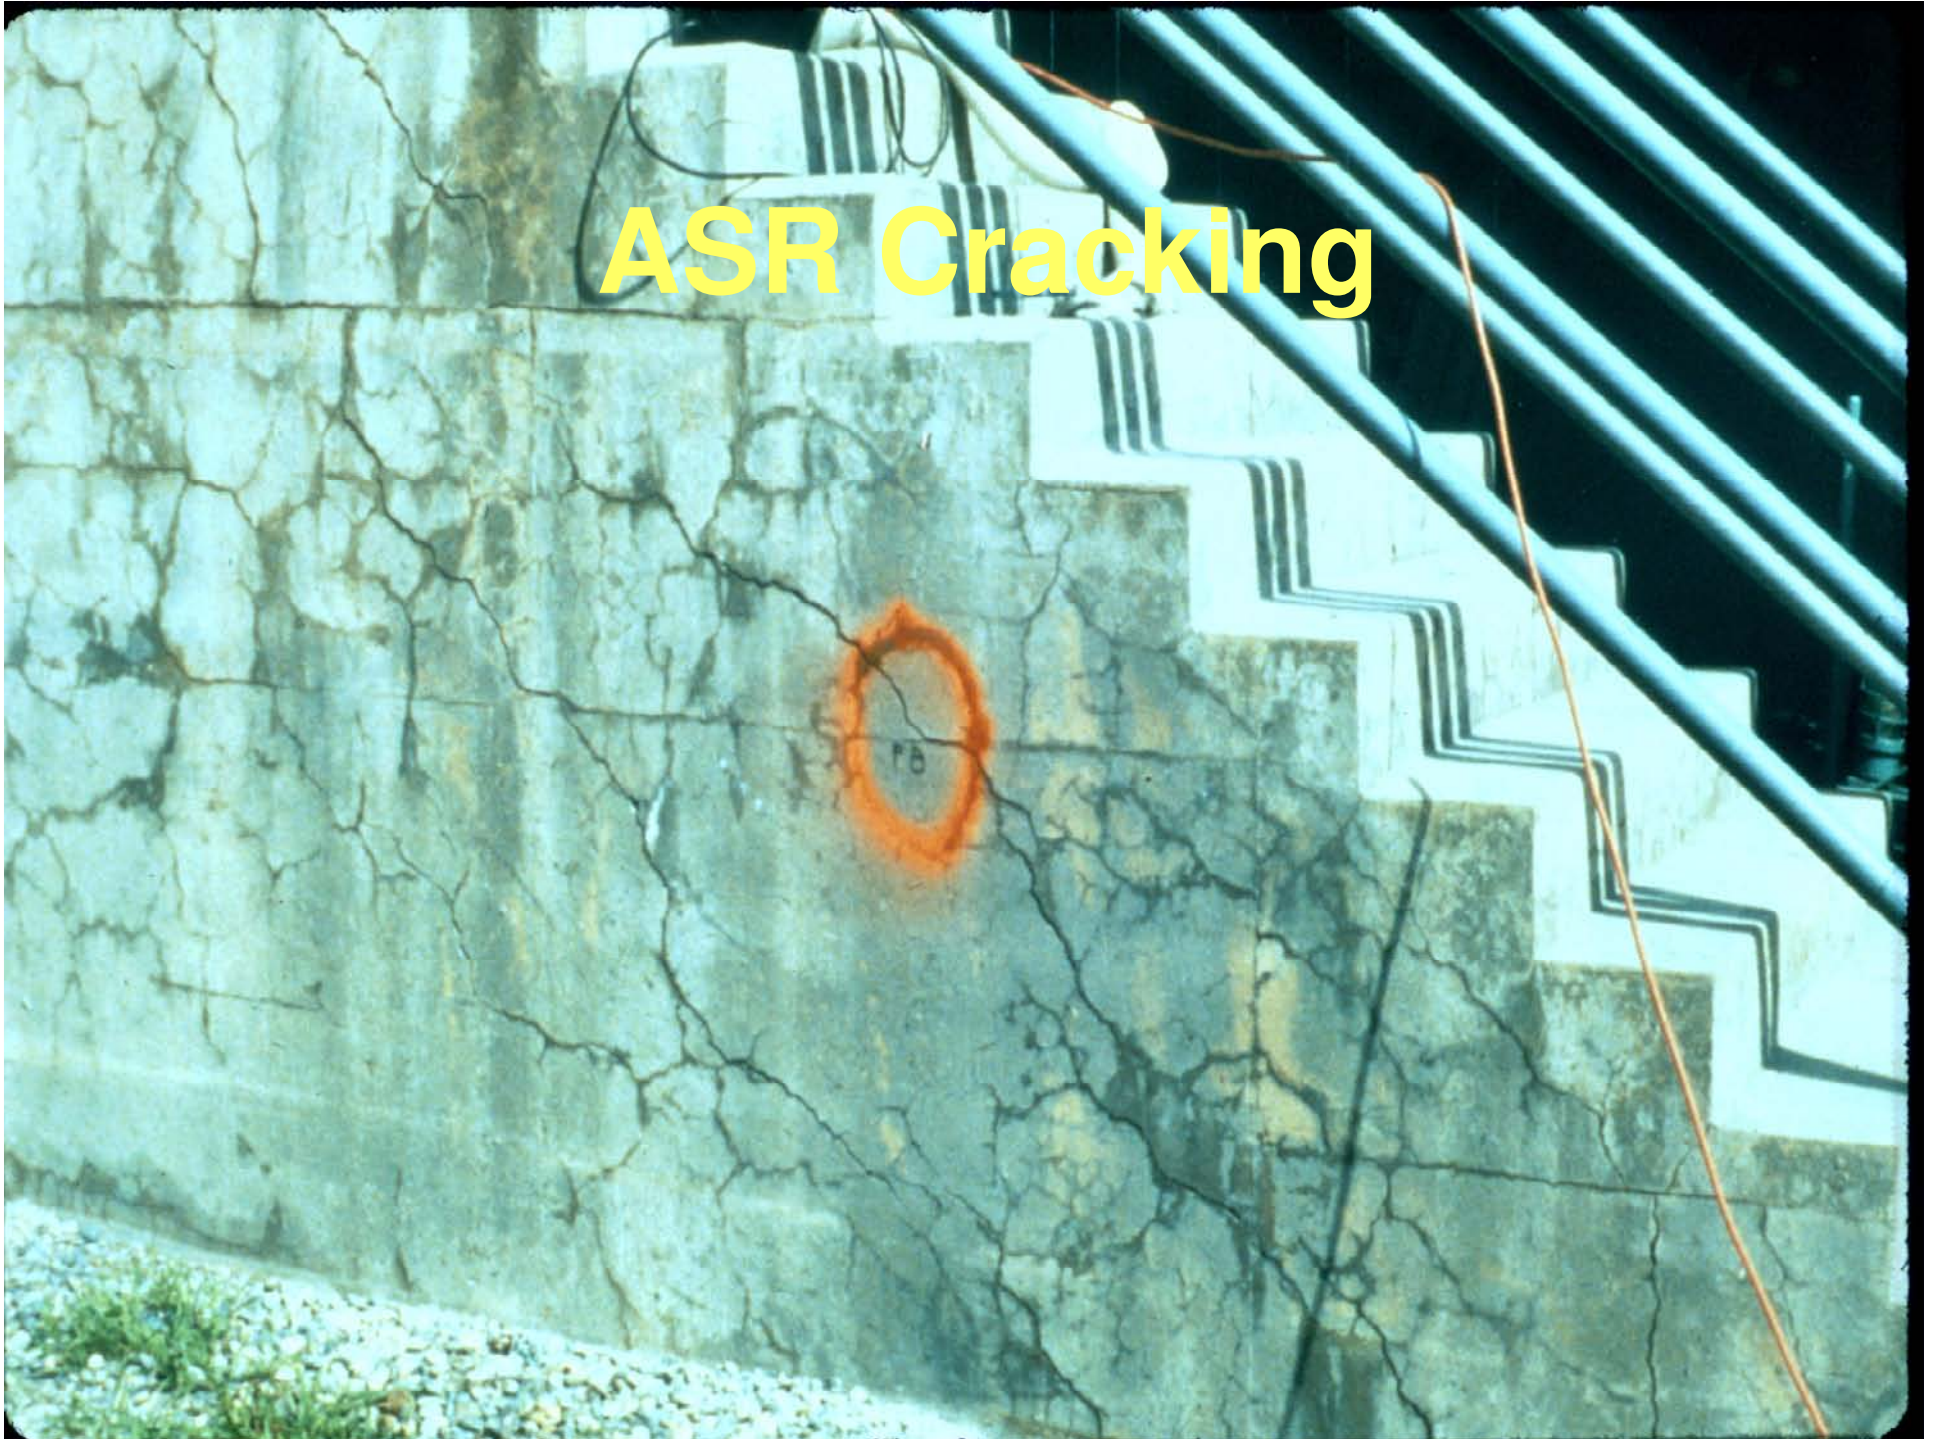
# ASR Cracking

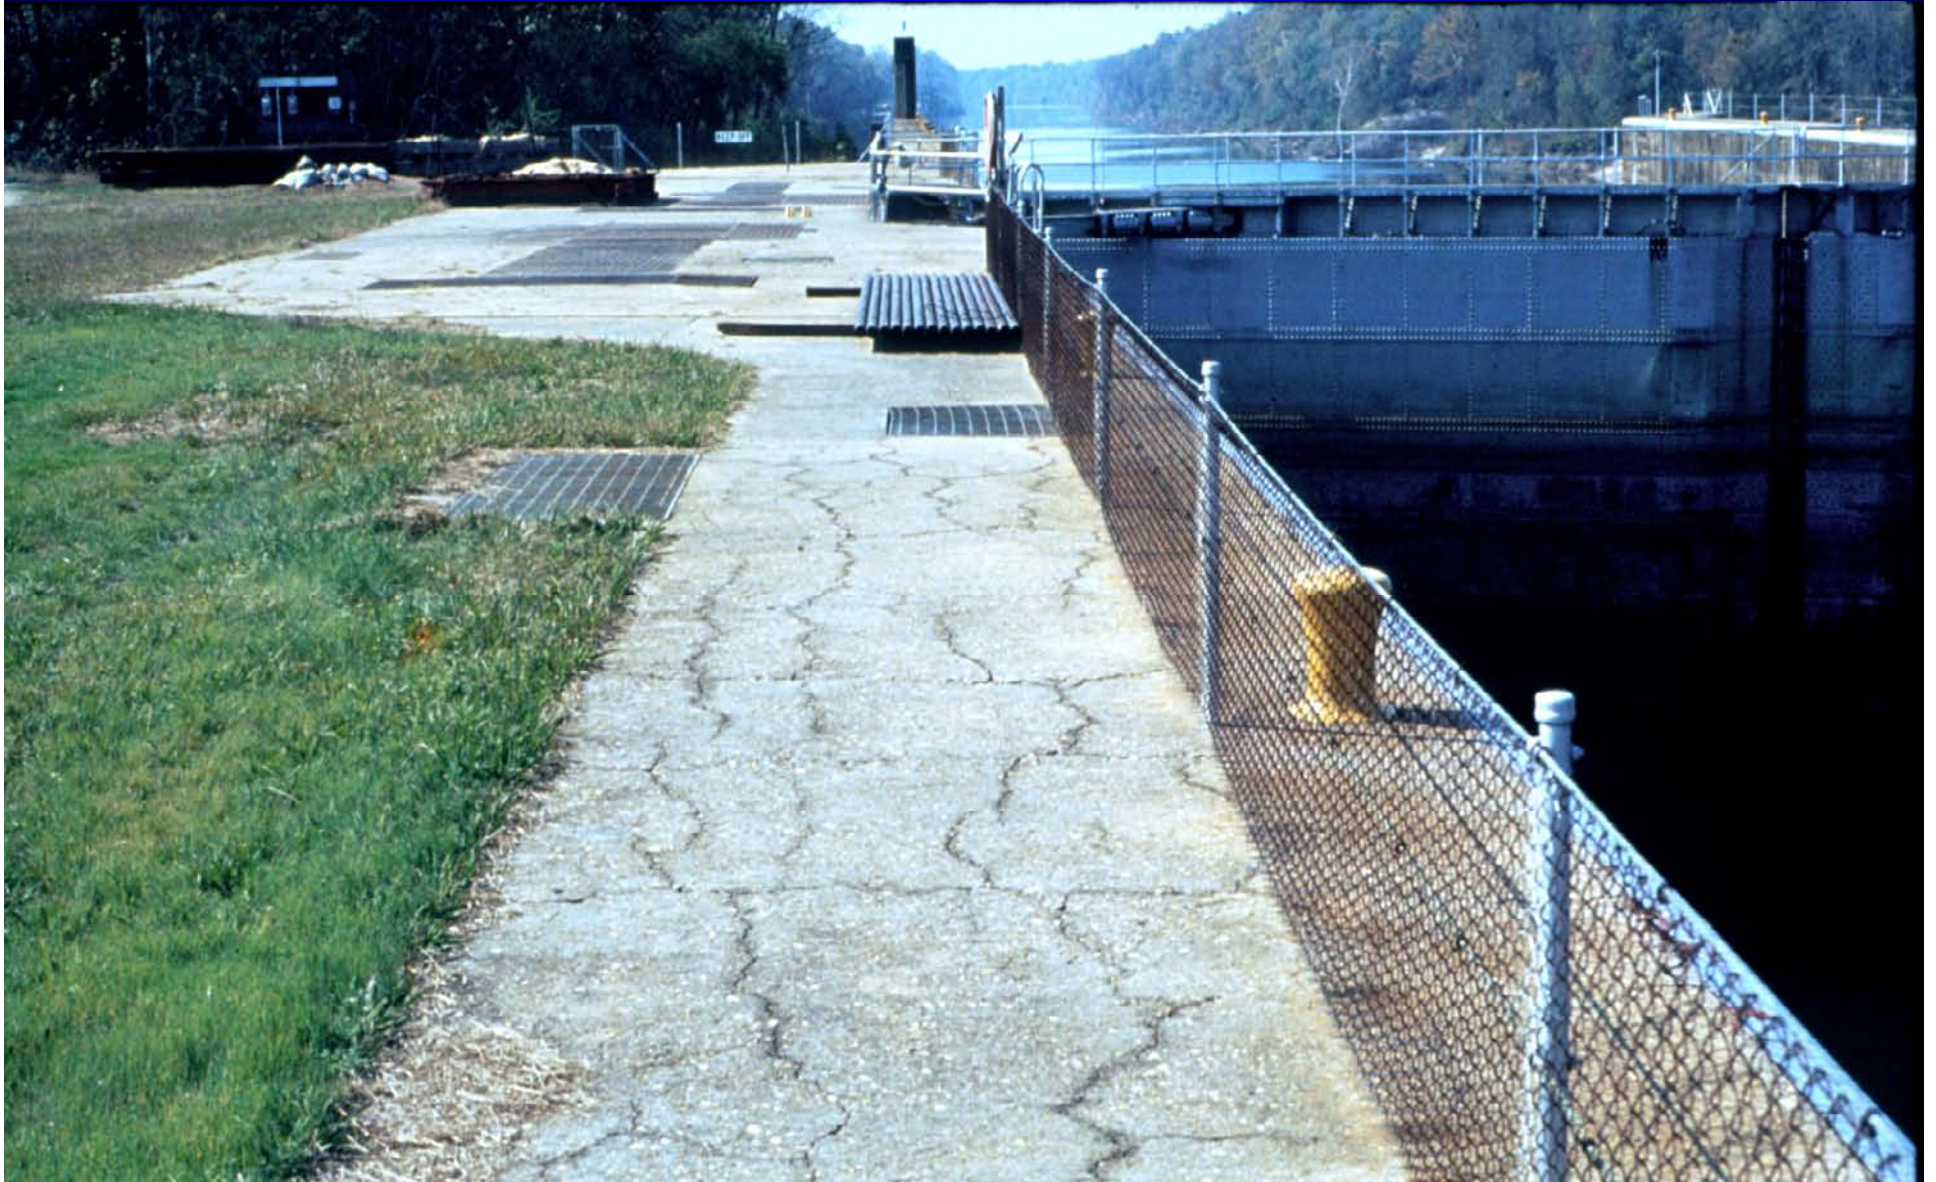
# ASR Cracking

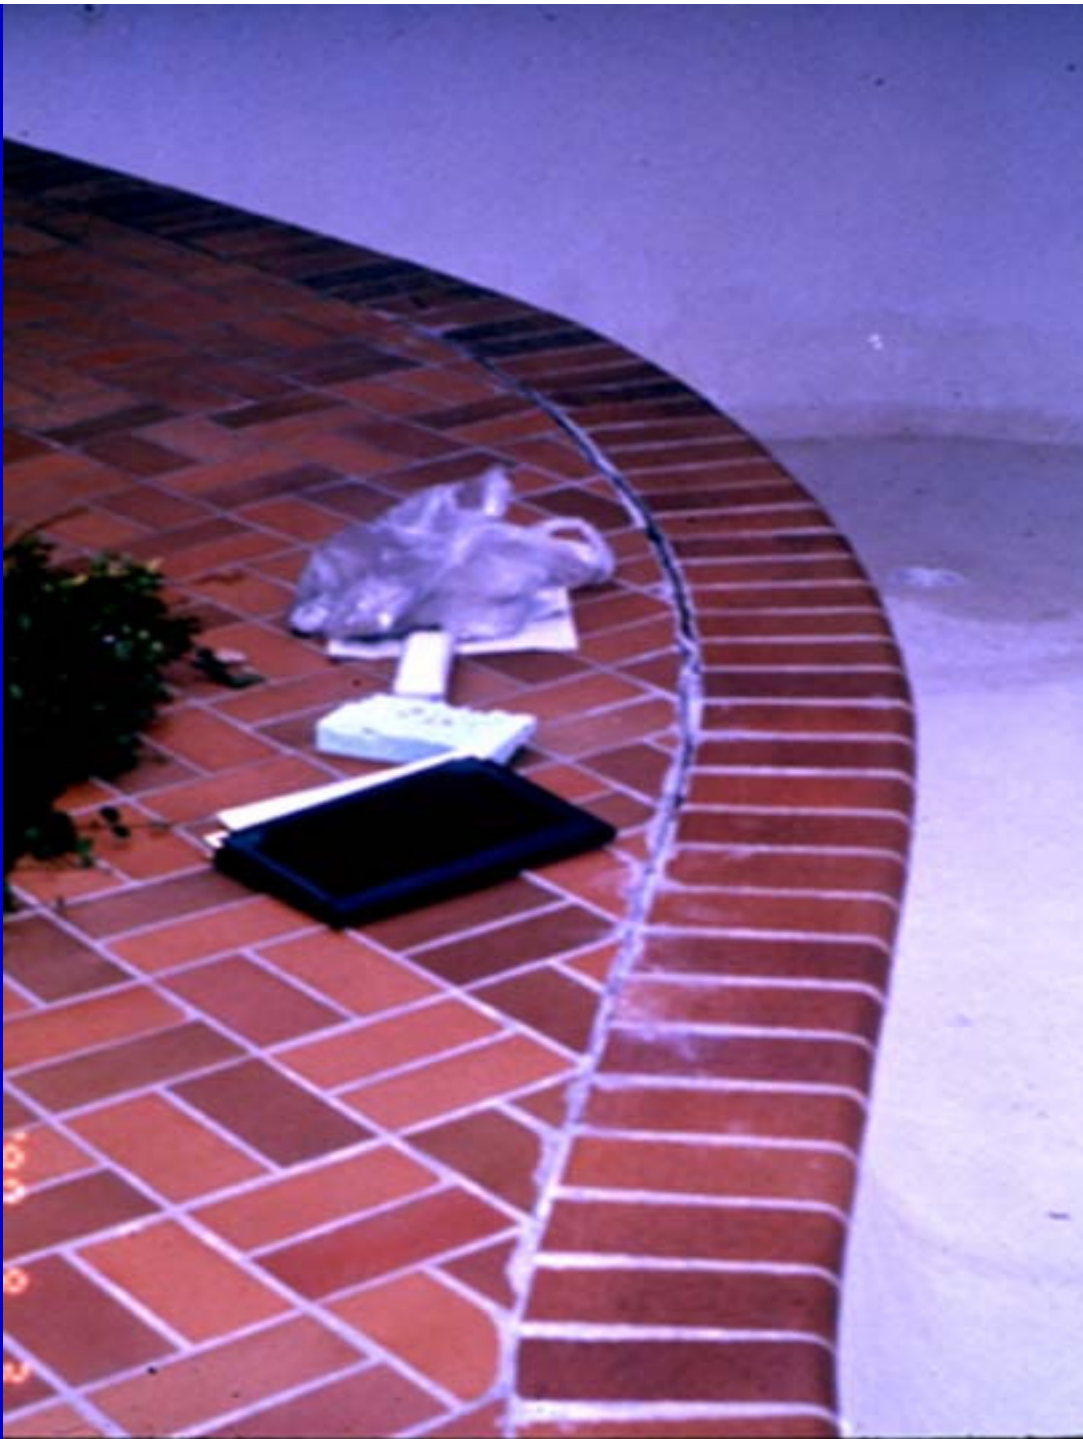
- Note separation at outside curve
- Only location of cracking in brick at inside of headers

- Moisture and thermal expansion of brick
- As brick expanded the radius got larger
- Nothing to prevent outward movement except wall and top of wall was missing vertical steel

- Outward force was large enough to shear concrete
- Inside corners were restrained from moving outward by sidewalk

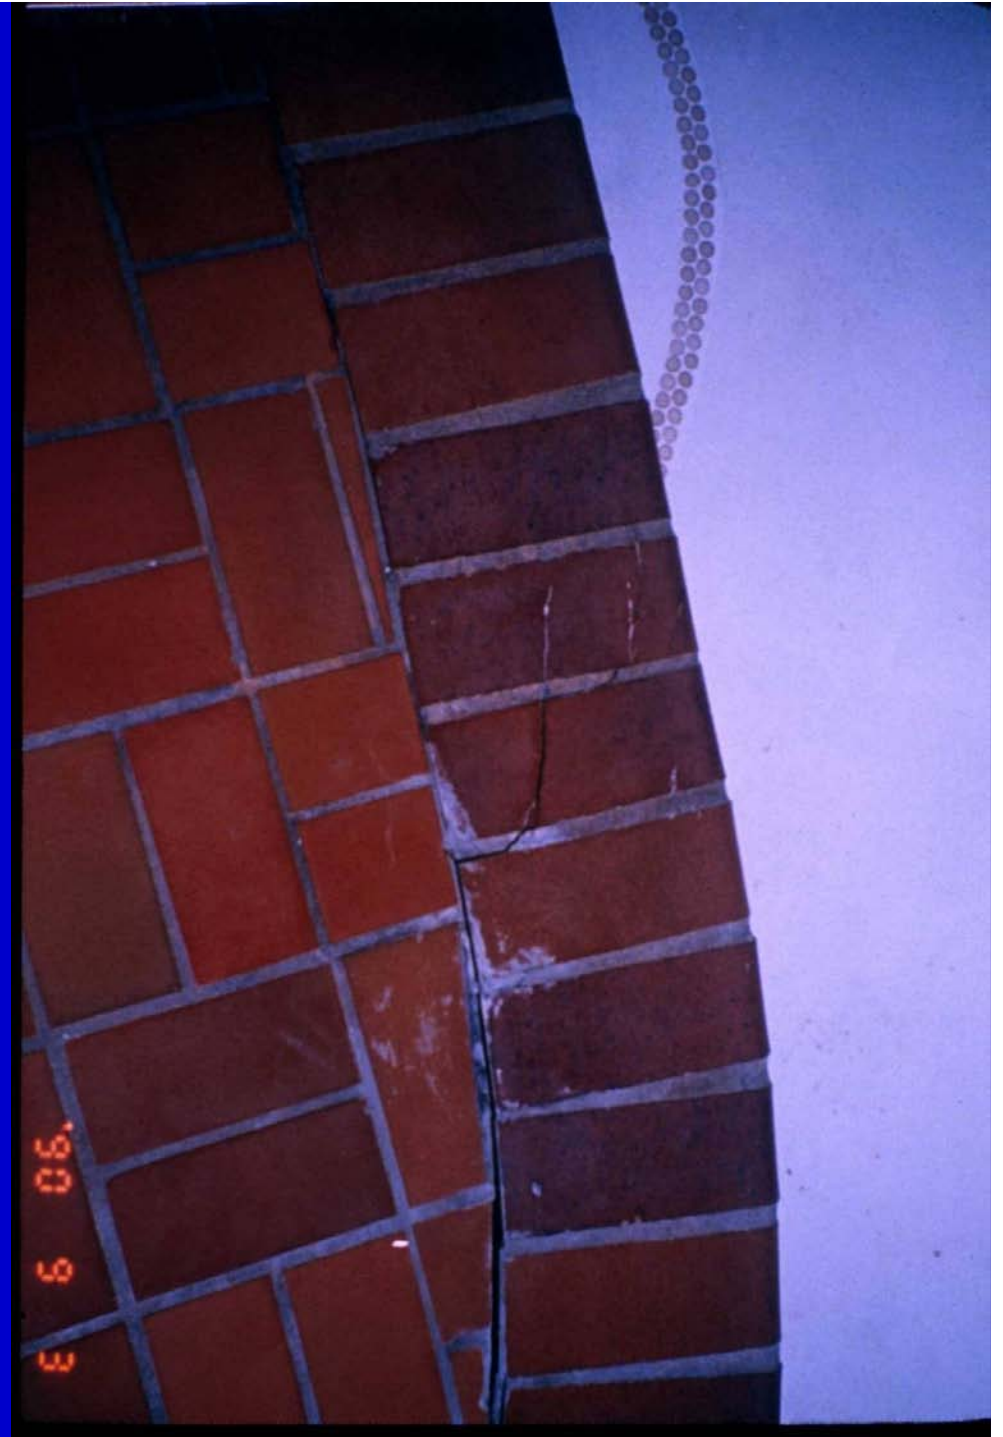
- Note location of beginning of crack at point of tangency

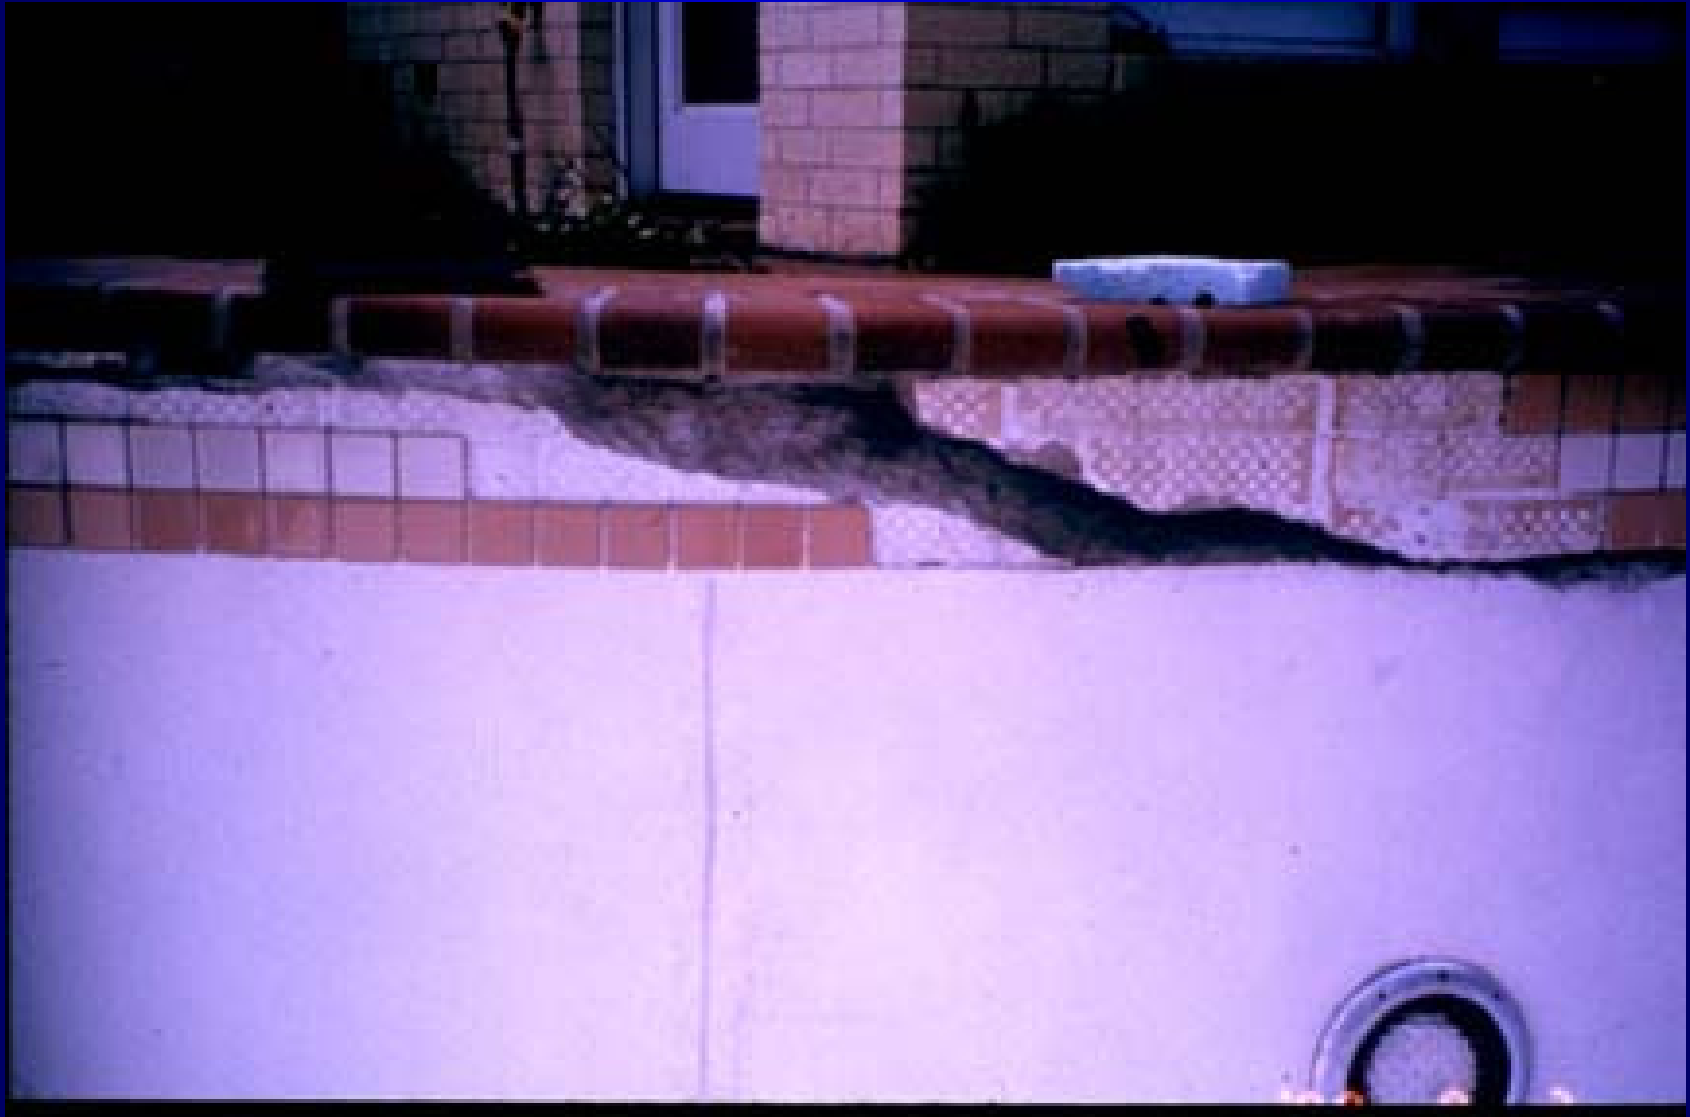
**Top of concrete wall moved out about  $\frac{3}{4}$  inch—no steel in top of wall**

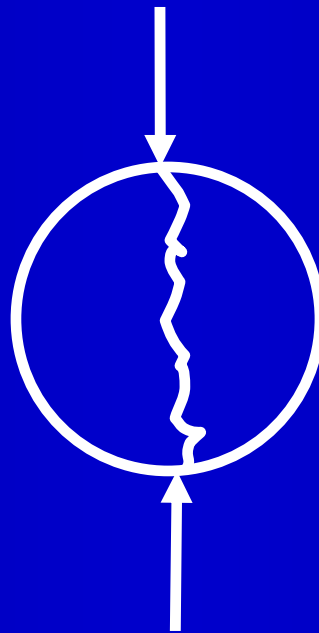
# Indirect Tension
