**Foundation Performance Association  
Houston**

# **Causes and Cures of Cracking in Concrete**

**David Fowler**

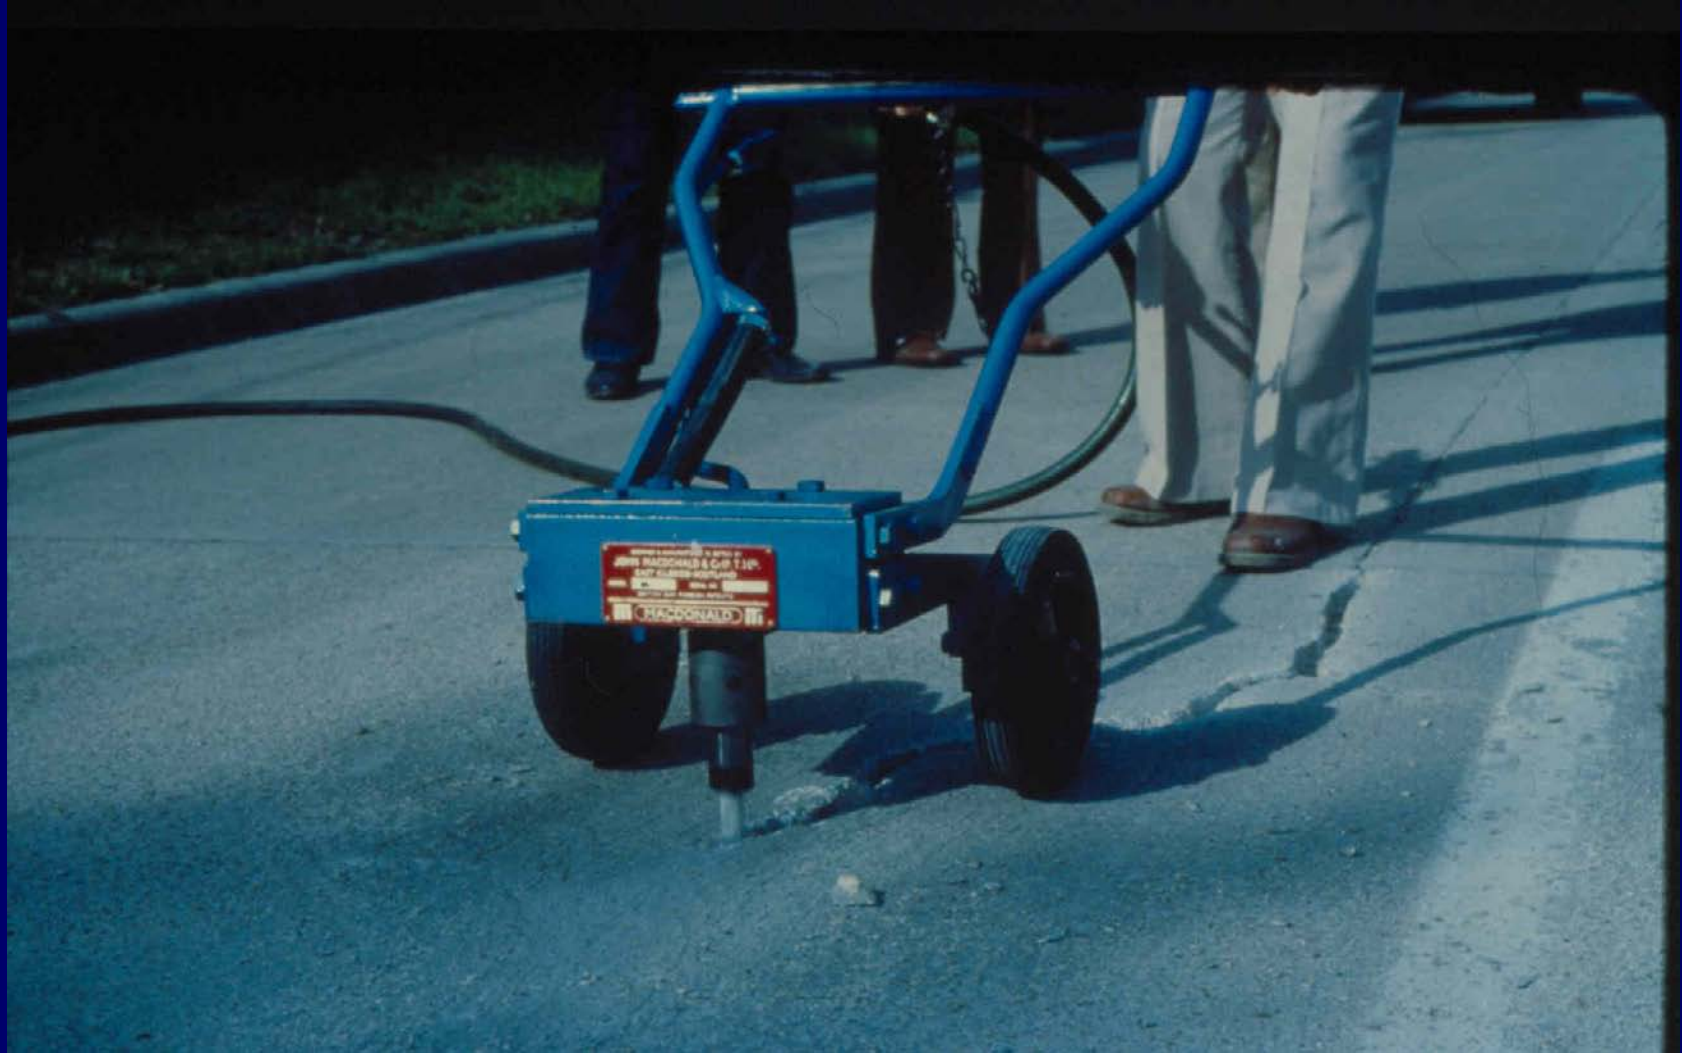
# Routing Cracks with Crack Chaser

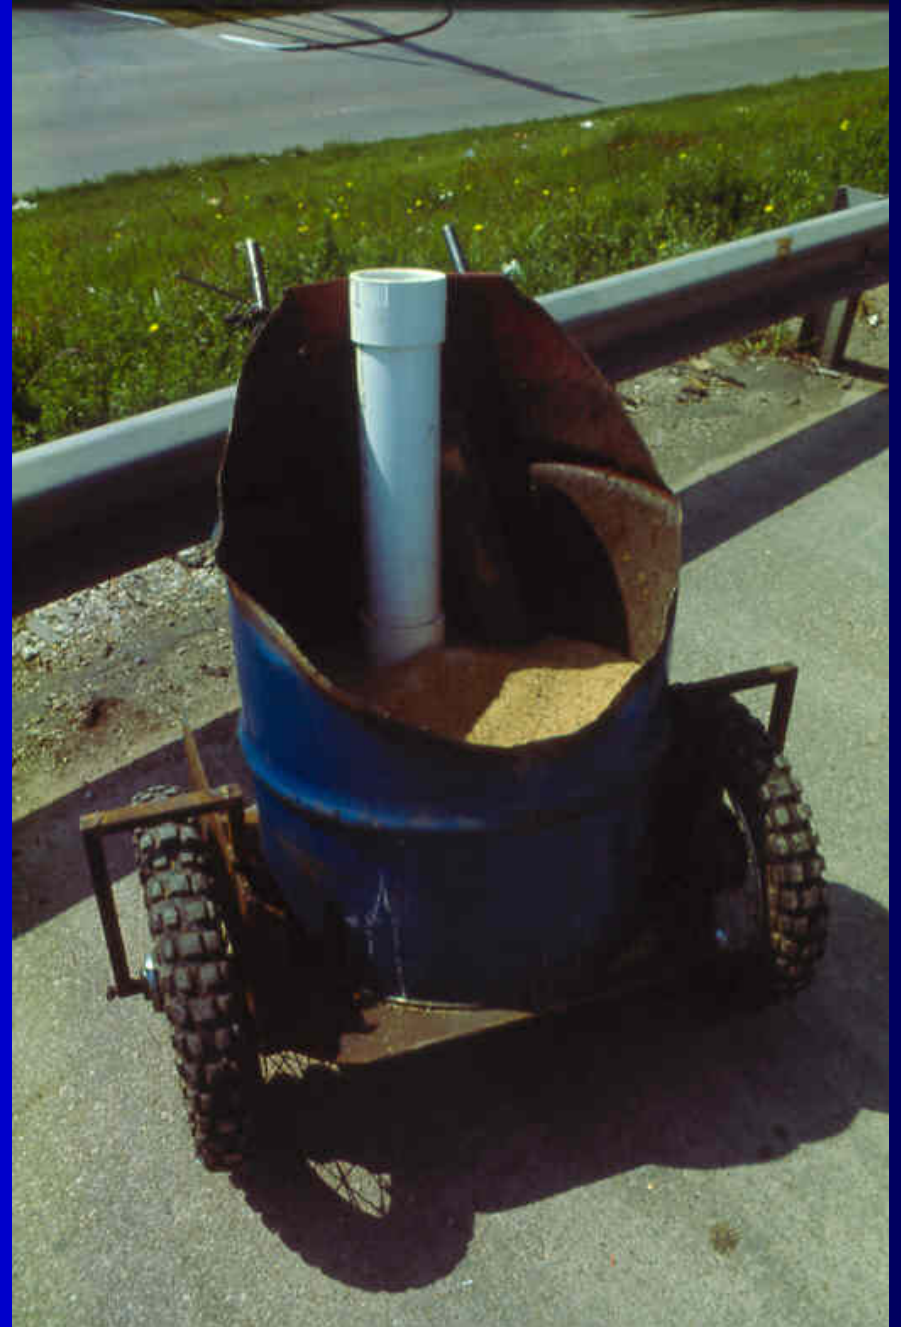
# Cart to Apply Sand to Crack

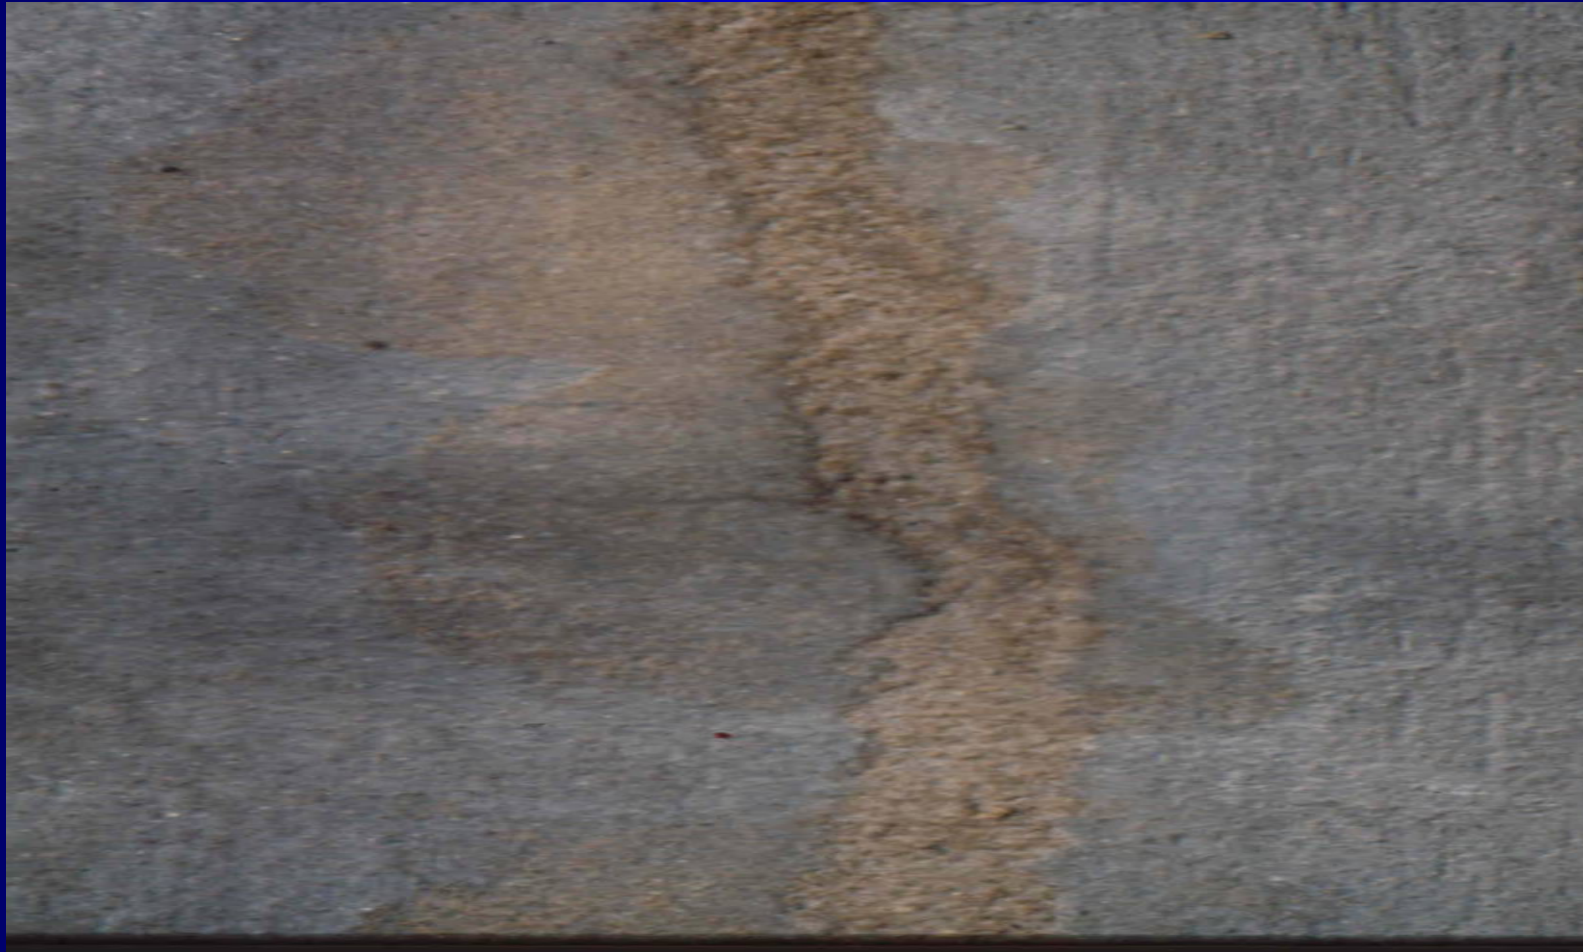
# Repaired Crack

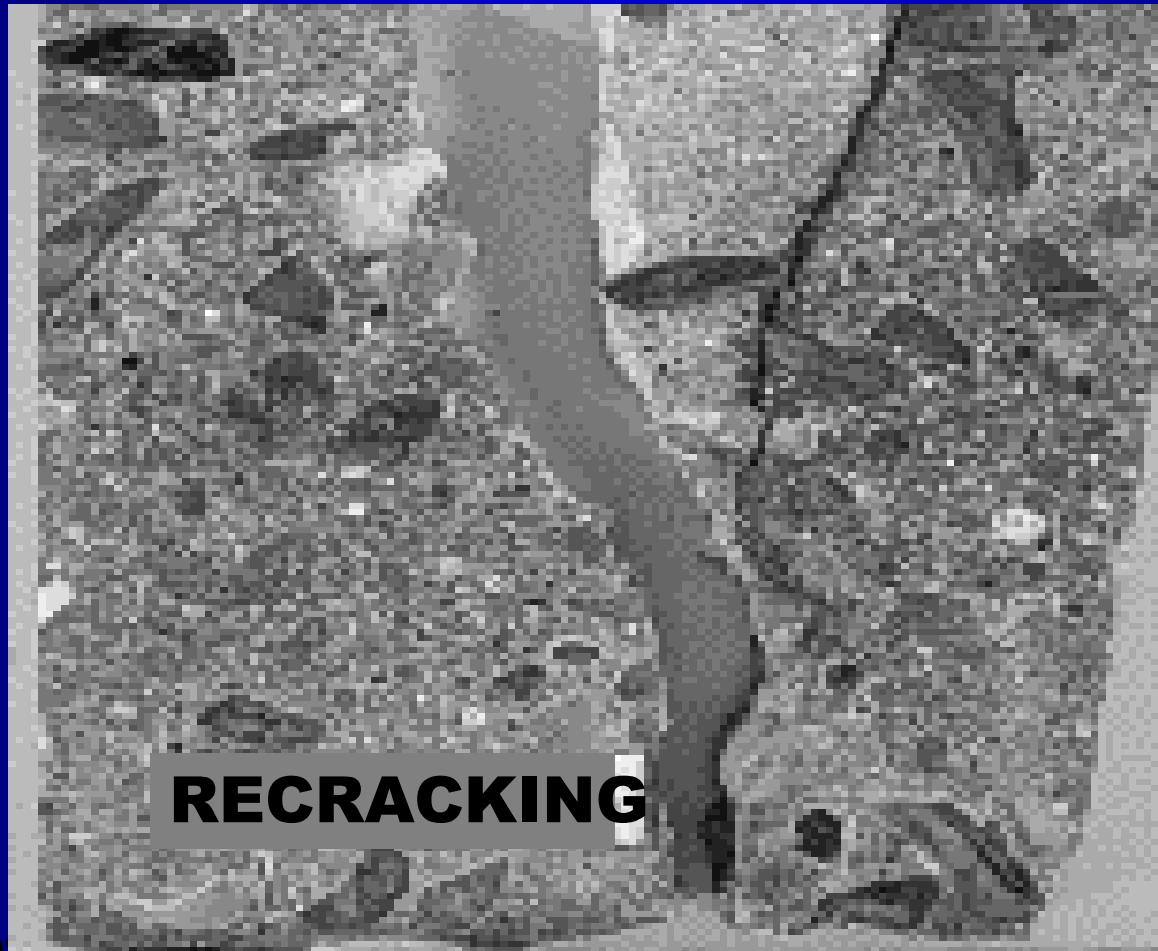
# Recracked Slab— Broke Outside of Repair

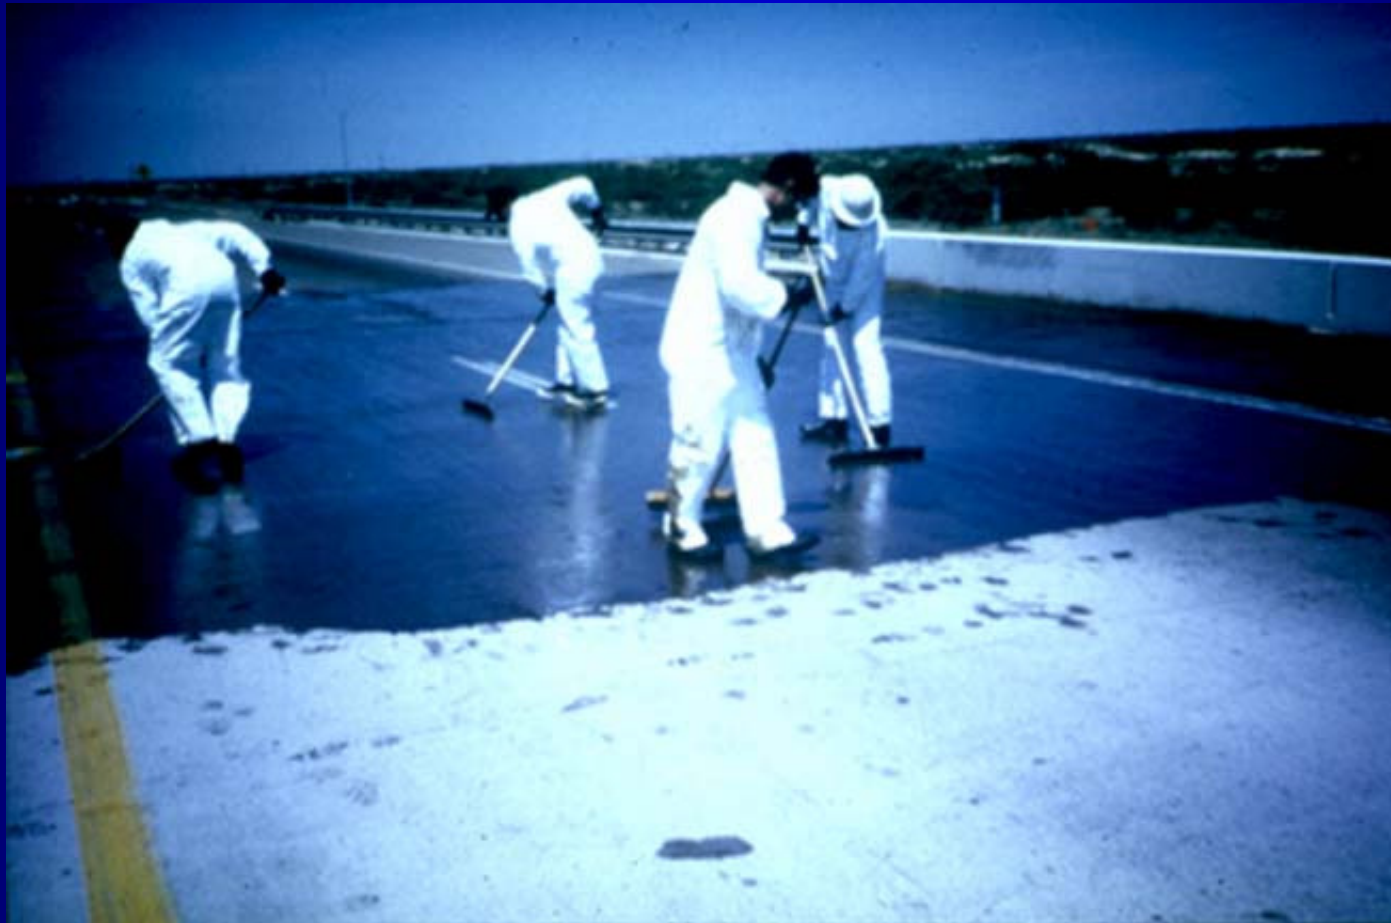
# Applying HMWM to Cracked I-20 Bridge

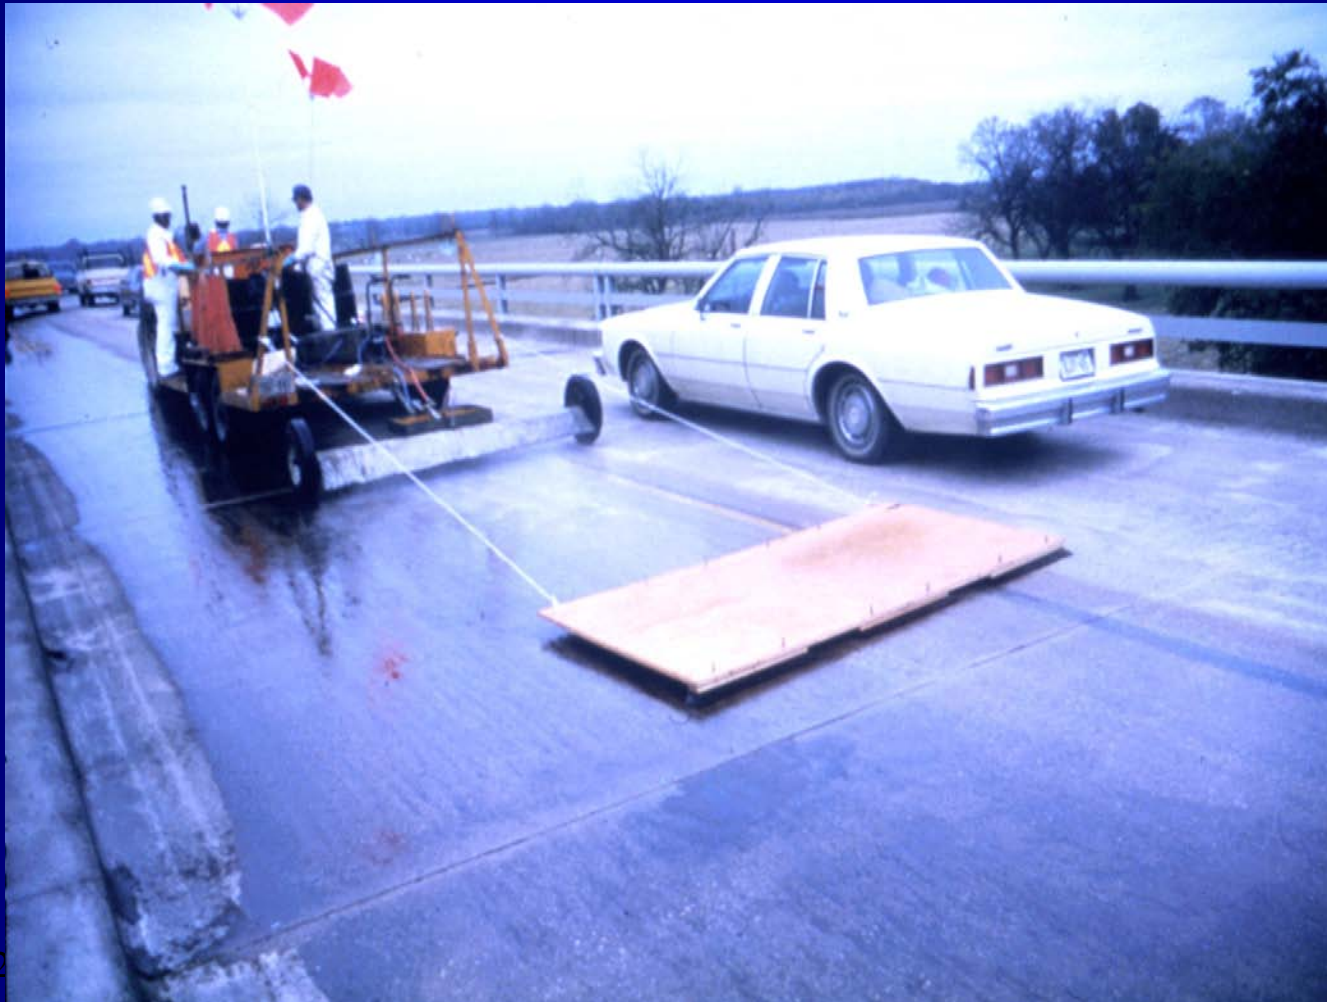
# Applying HMWM with Spray Bar

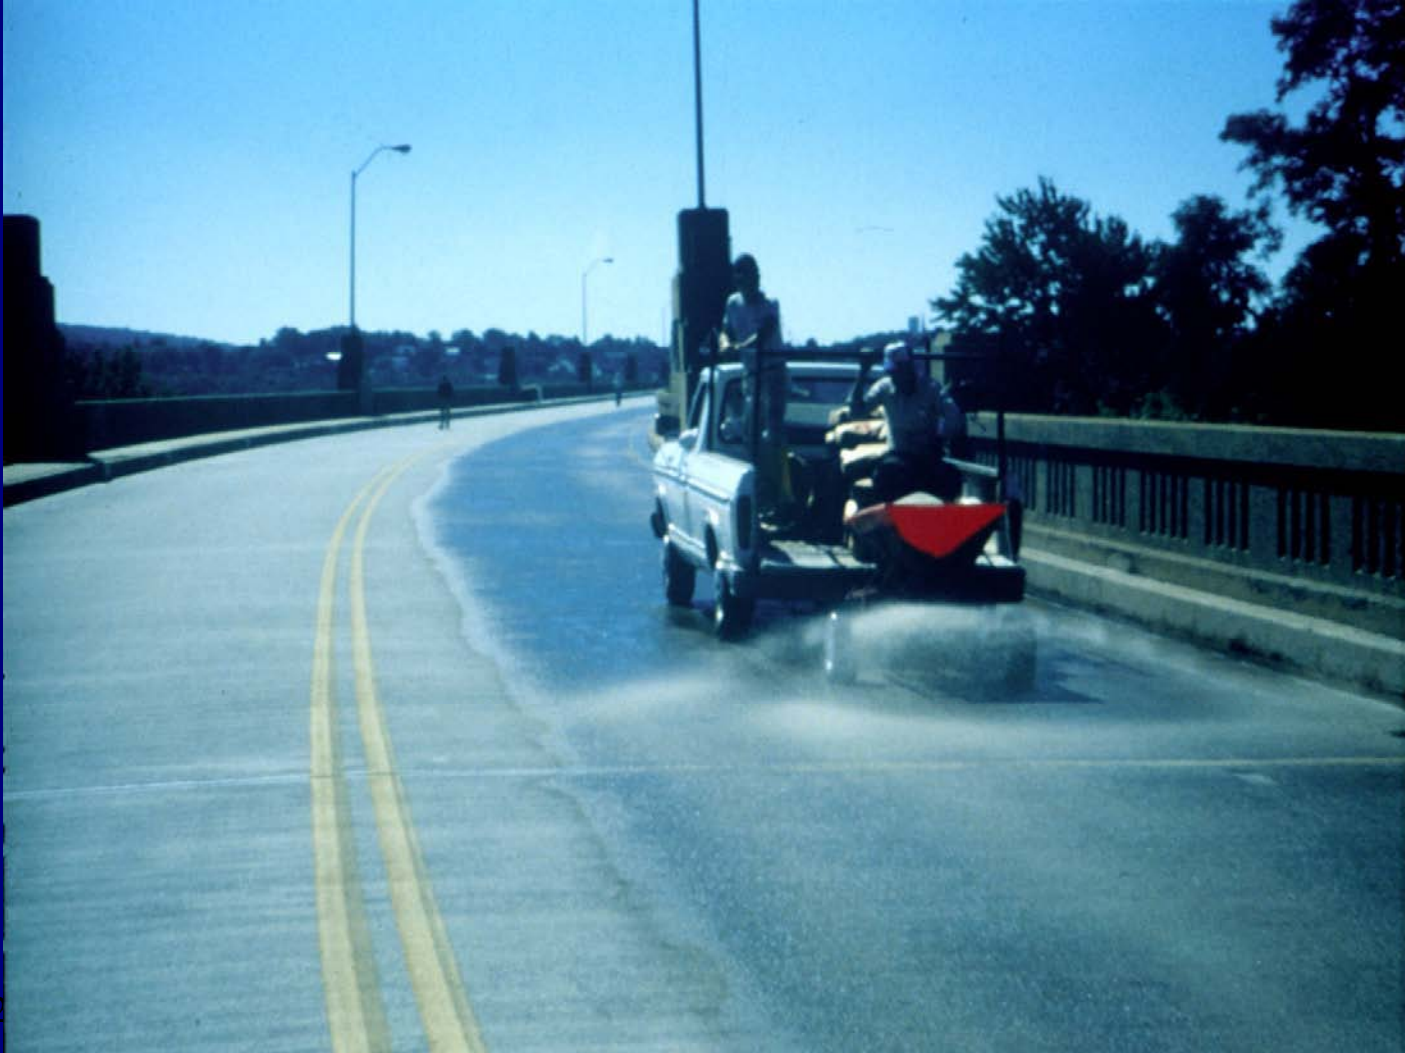
# Applying Sand

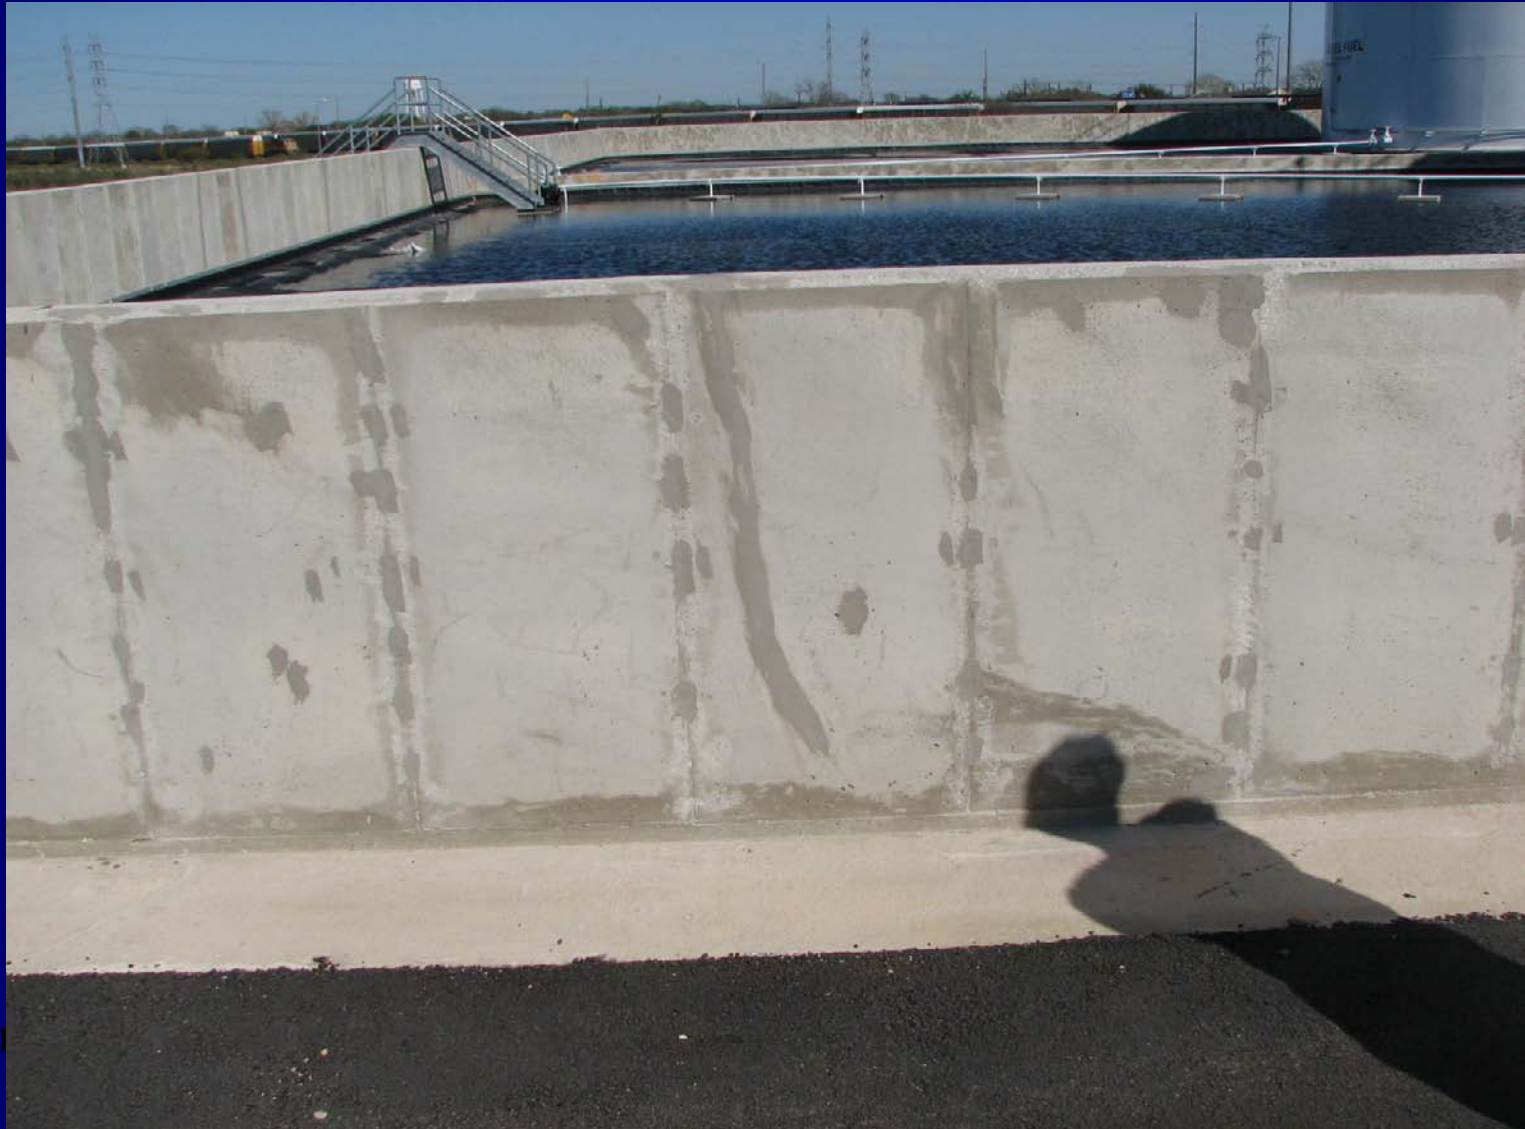
# Cracks in Walls

- Footing was placed first—free to shrink
- Wall was placed one to two months later after most of wall drying shrinkage had taken place
- As wall tried to shrink, it was restrained by rebars that tied wall to footing.
- Remember: no restraint, no cracking.
- Likely cause: drying shrinkage cracking.

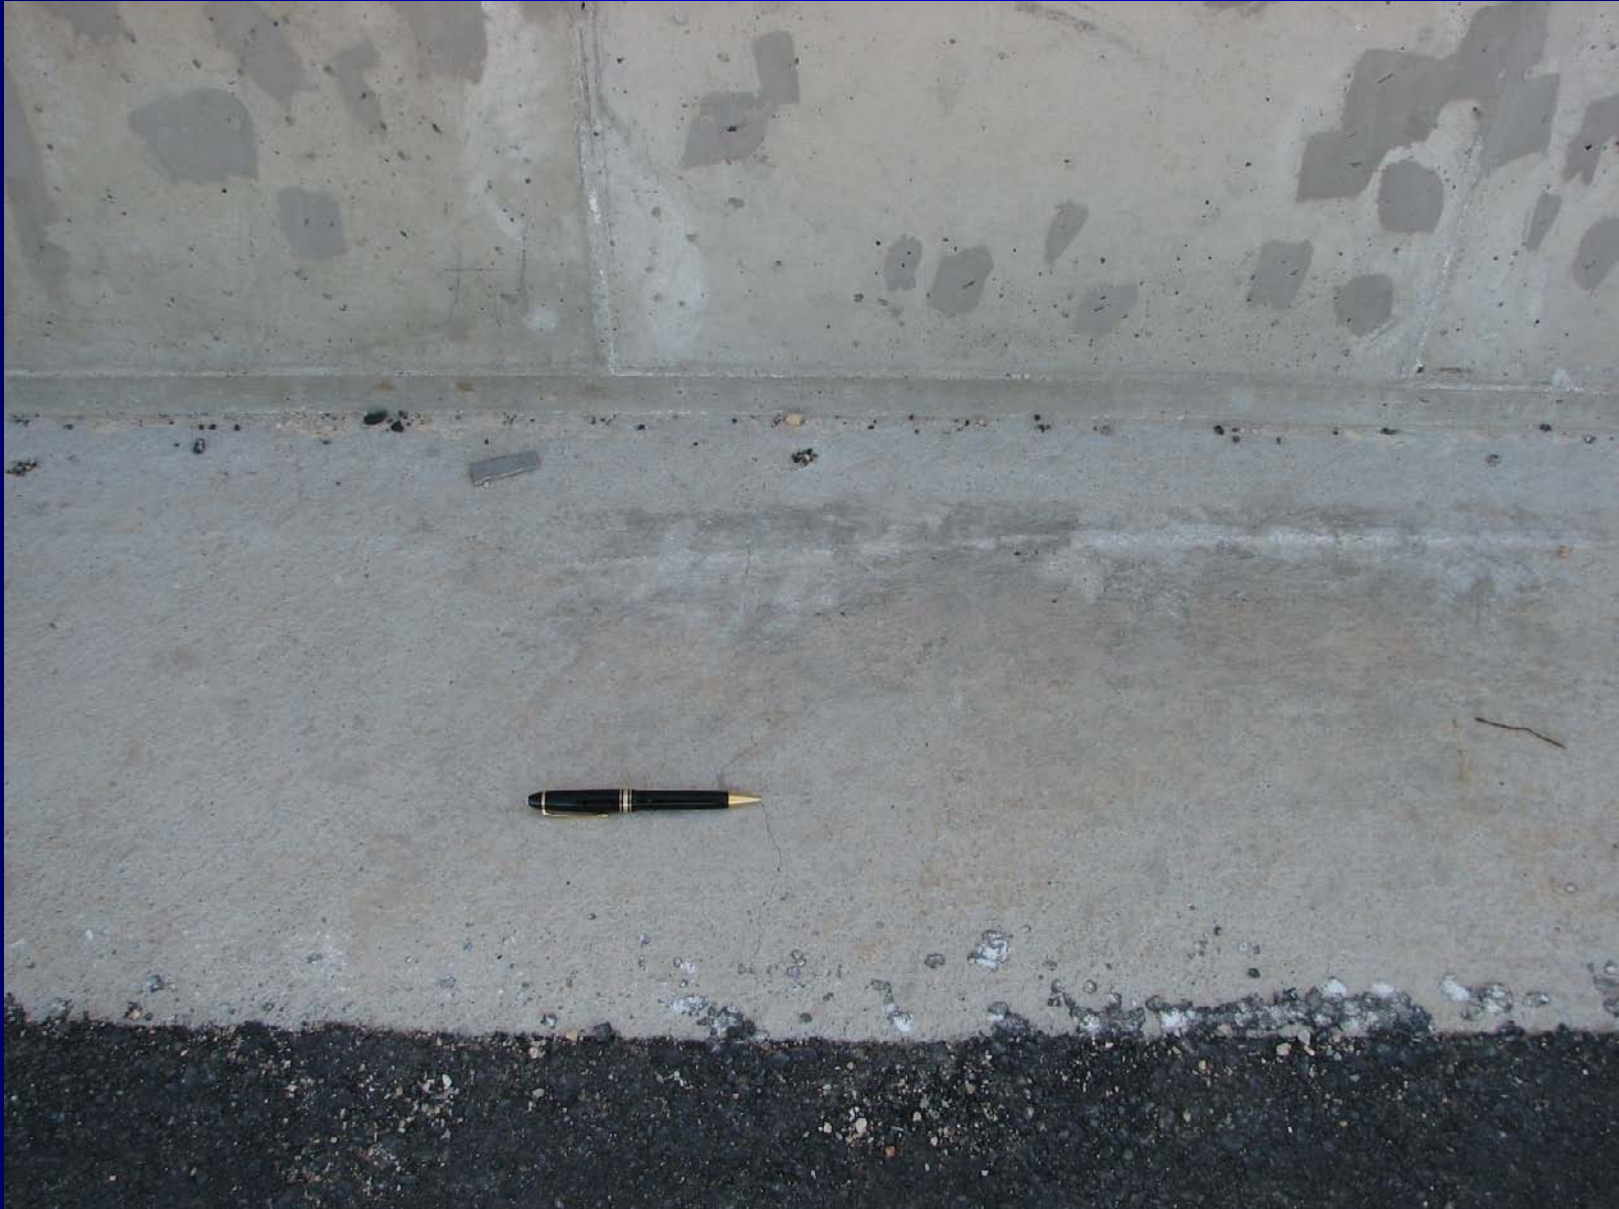
# Footing Cracks

- All cracks measured 0.01 in.
- West wall: two cracks
- North wall: none
- East wall: one
- South wall: four

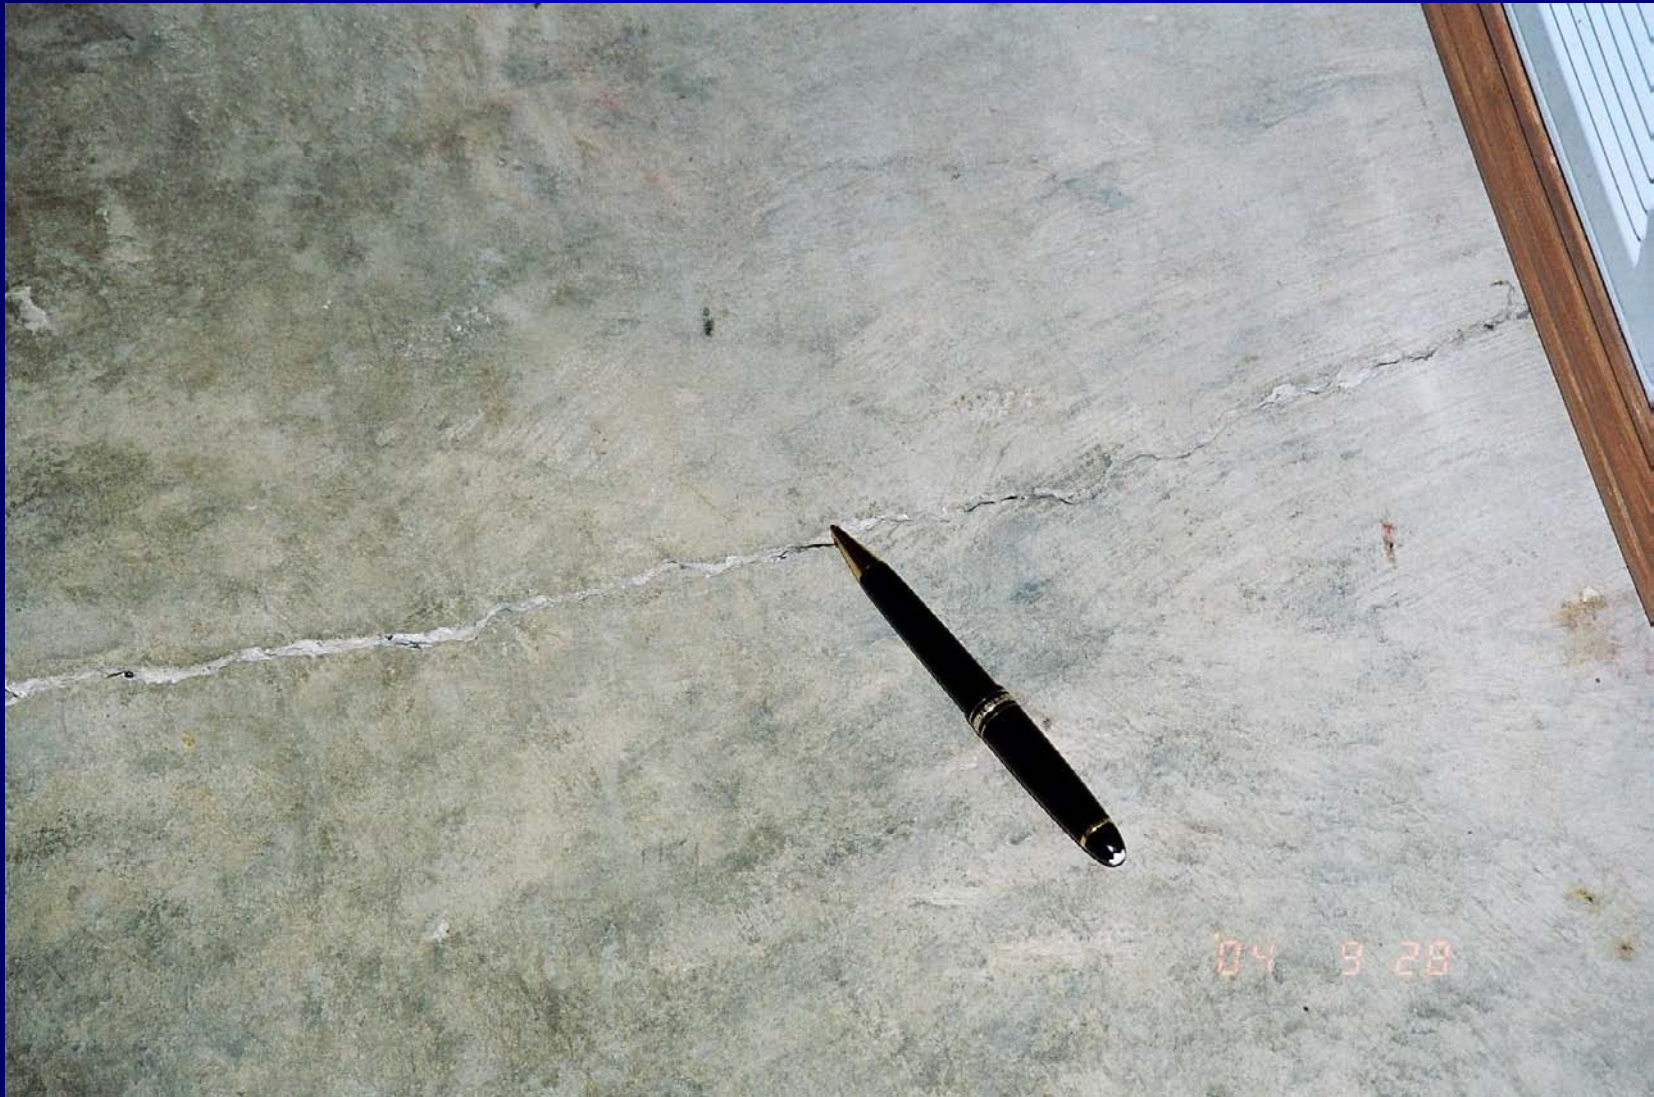
# 0.125-in. in hall in BR wing

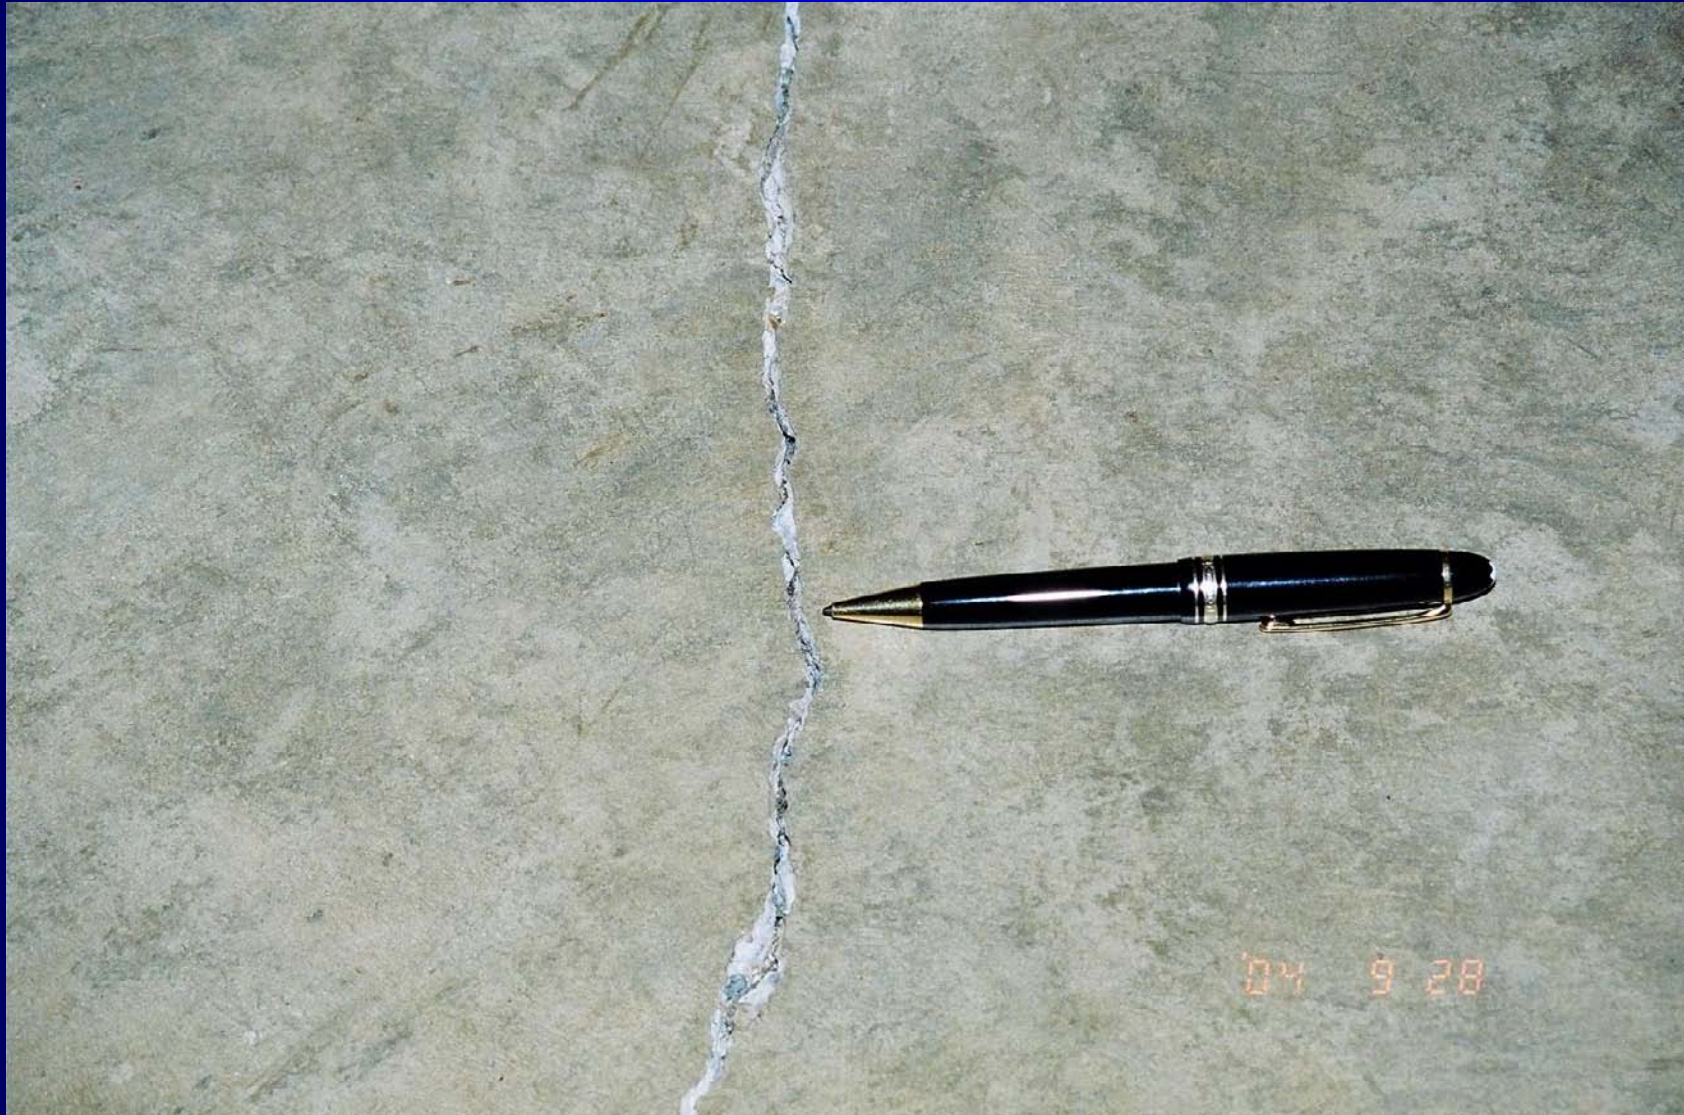
# 0.125-in. crack in Living Room
