Forensic Engineering = Causes of Distress in Concrete

David W. Fowler

The University of Texas at Austin

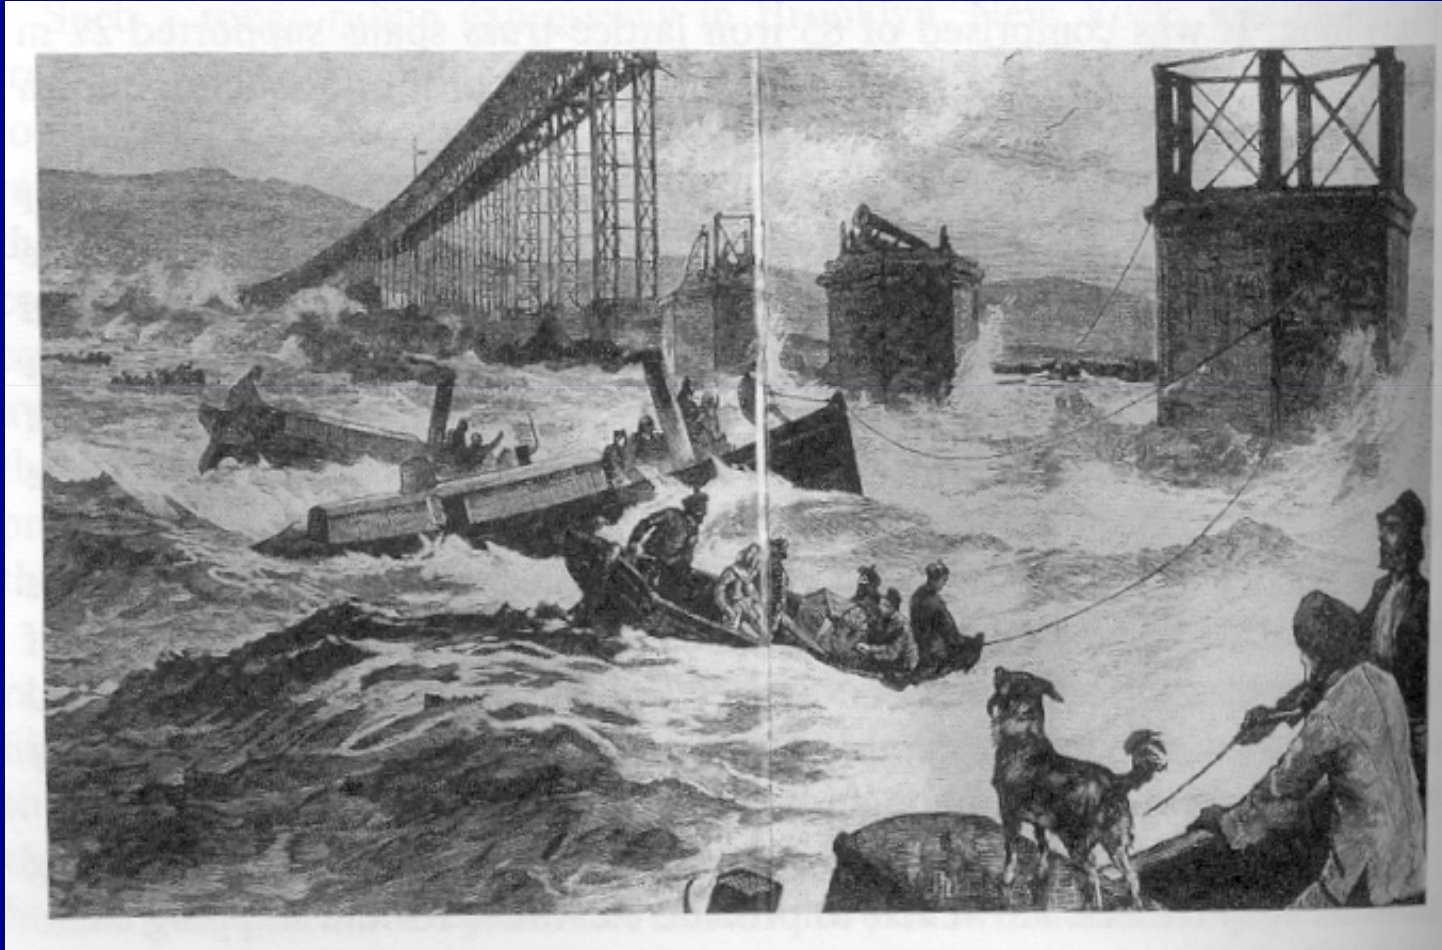
Tay Bridge, Scotland (1879)

- Completed in 1828
- Length: 10,321 ft. (3146 m)
- 85 simply supported iron lattice-truss spans
- Failure occurred during a major storm
- Train was passing over bridge
- 75 people died
- Cause of failure: improper estimation of wind force in design
 - 10 psf (0.5 kPa) instead of 50 psf (2.5 kPa)

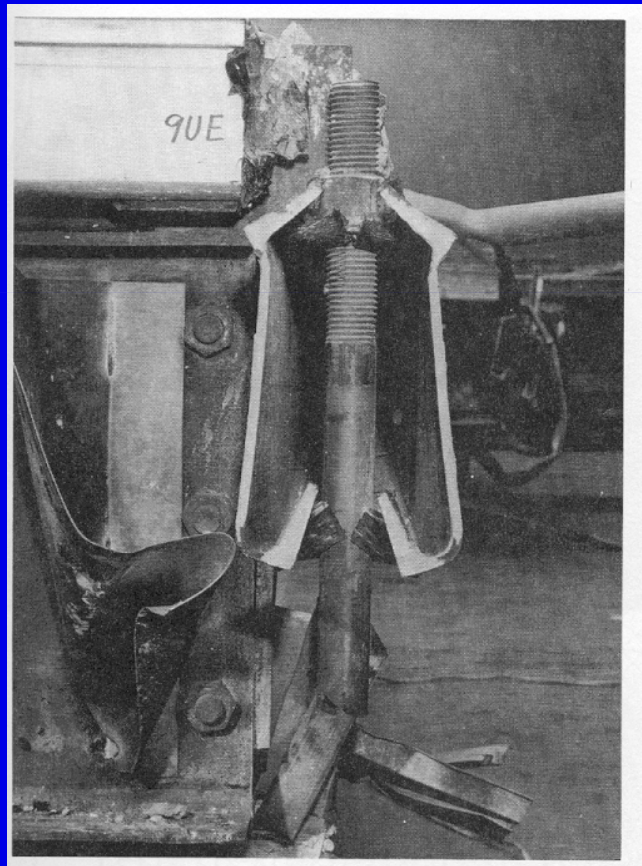
Hanger rod – box beam
connection

- Original Design: Ultimate capacity of connection only 60% of required capacity
- As Built: Ultimate capacity was just a little higher than the self weight of the structure
- Either way, connection was bound to fail!

- Hanging walkway supported by steel rods
- Collapsed, killing 113 people
- Cause: poor connection detail
- Poor communication between engineer and steel fabricator involved

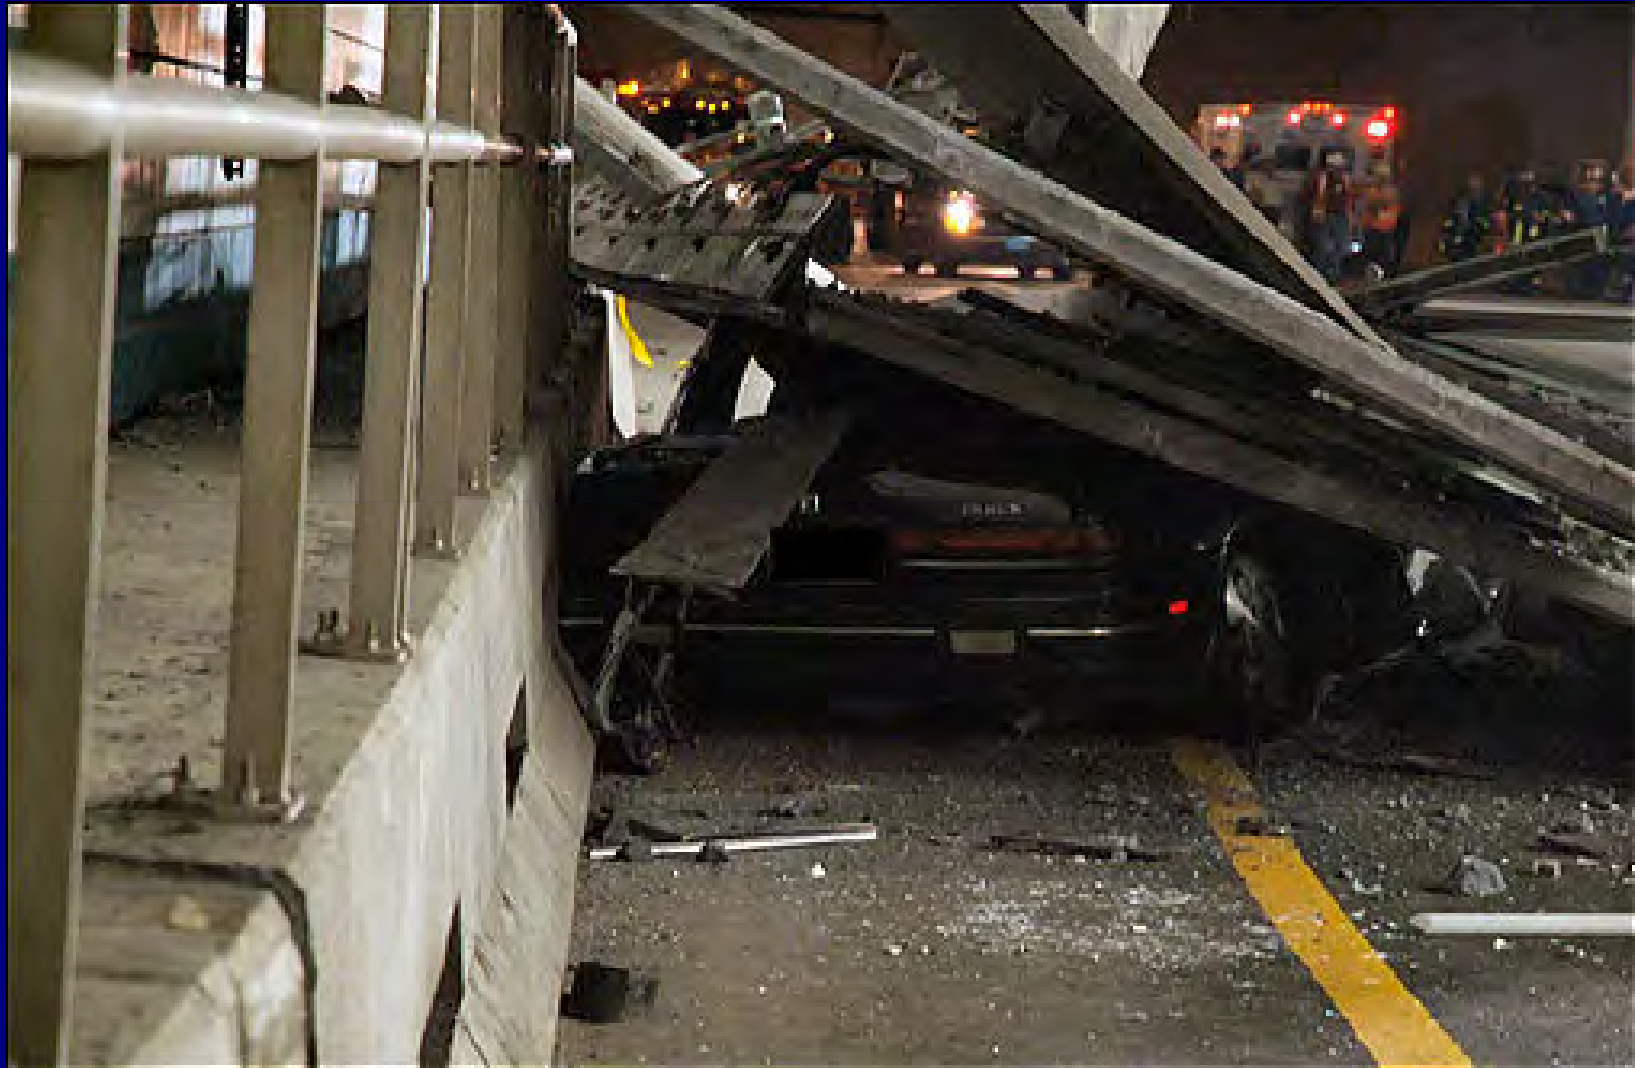
The Accident Scene

- On 11 pm, July 10, 2006, four sections of precast concrete ceiling panels fell in a connector tunnel in Boston.
- 38-year-old Milena Del Valle, on the way to Logan Airport with her husband, was killed.
- The epoxy anchors holding the ceiling panels failed due to faulty construction and design.

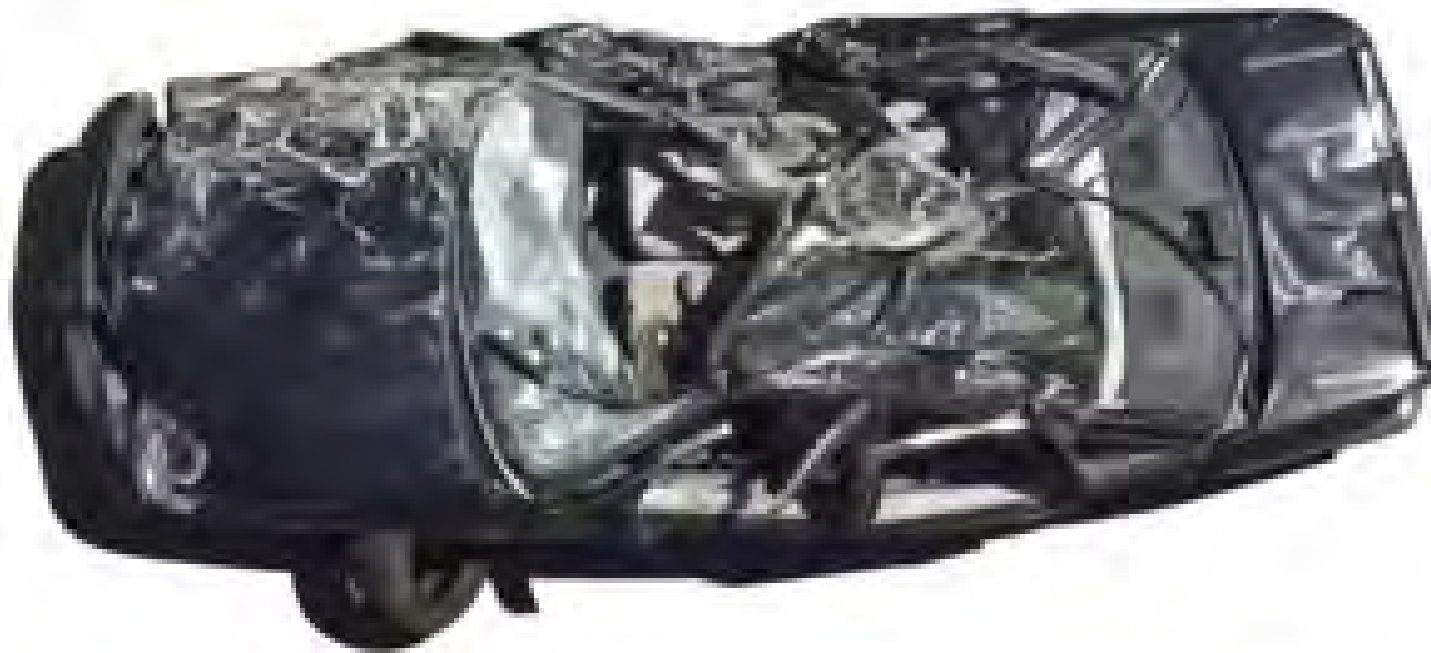
Car Crushed by Ceiling Panel

The car that was crushed by falling ceiling panels, killing passenger Milena Del Valle in a Big Dig Tunnel in Boston.

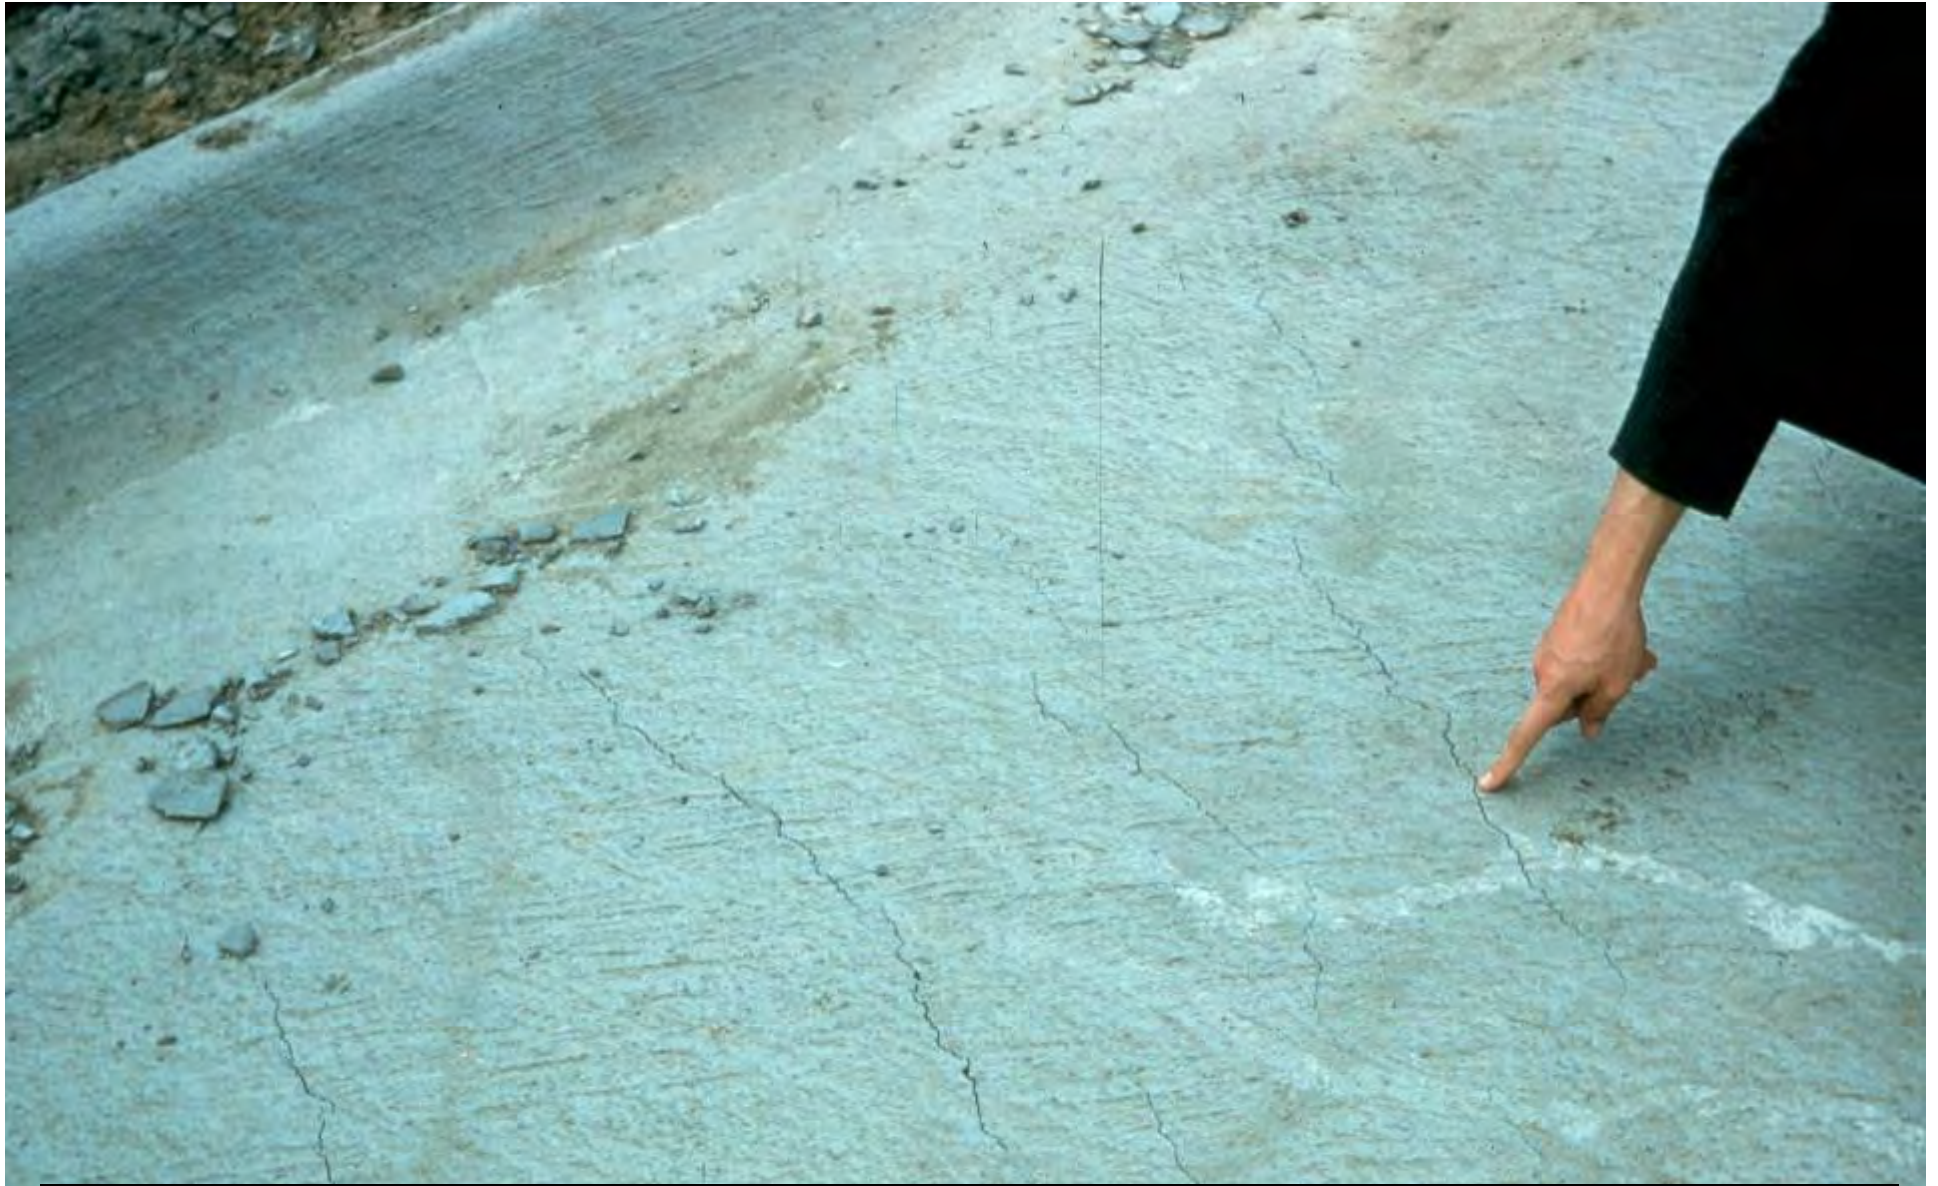
Symptom	Cause
Cracking shortly (minutes to hours) after placing (before setting)	Plastic shrinkage cracking (rate of evaporation > rate of bleeding)

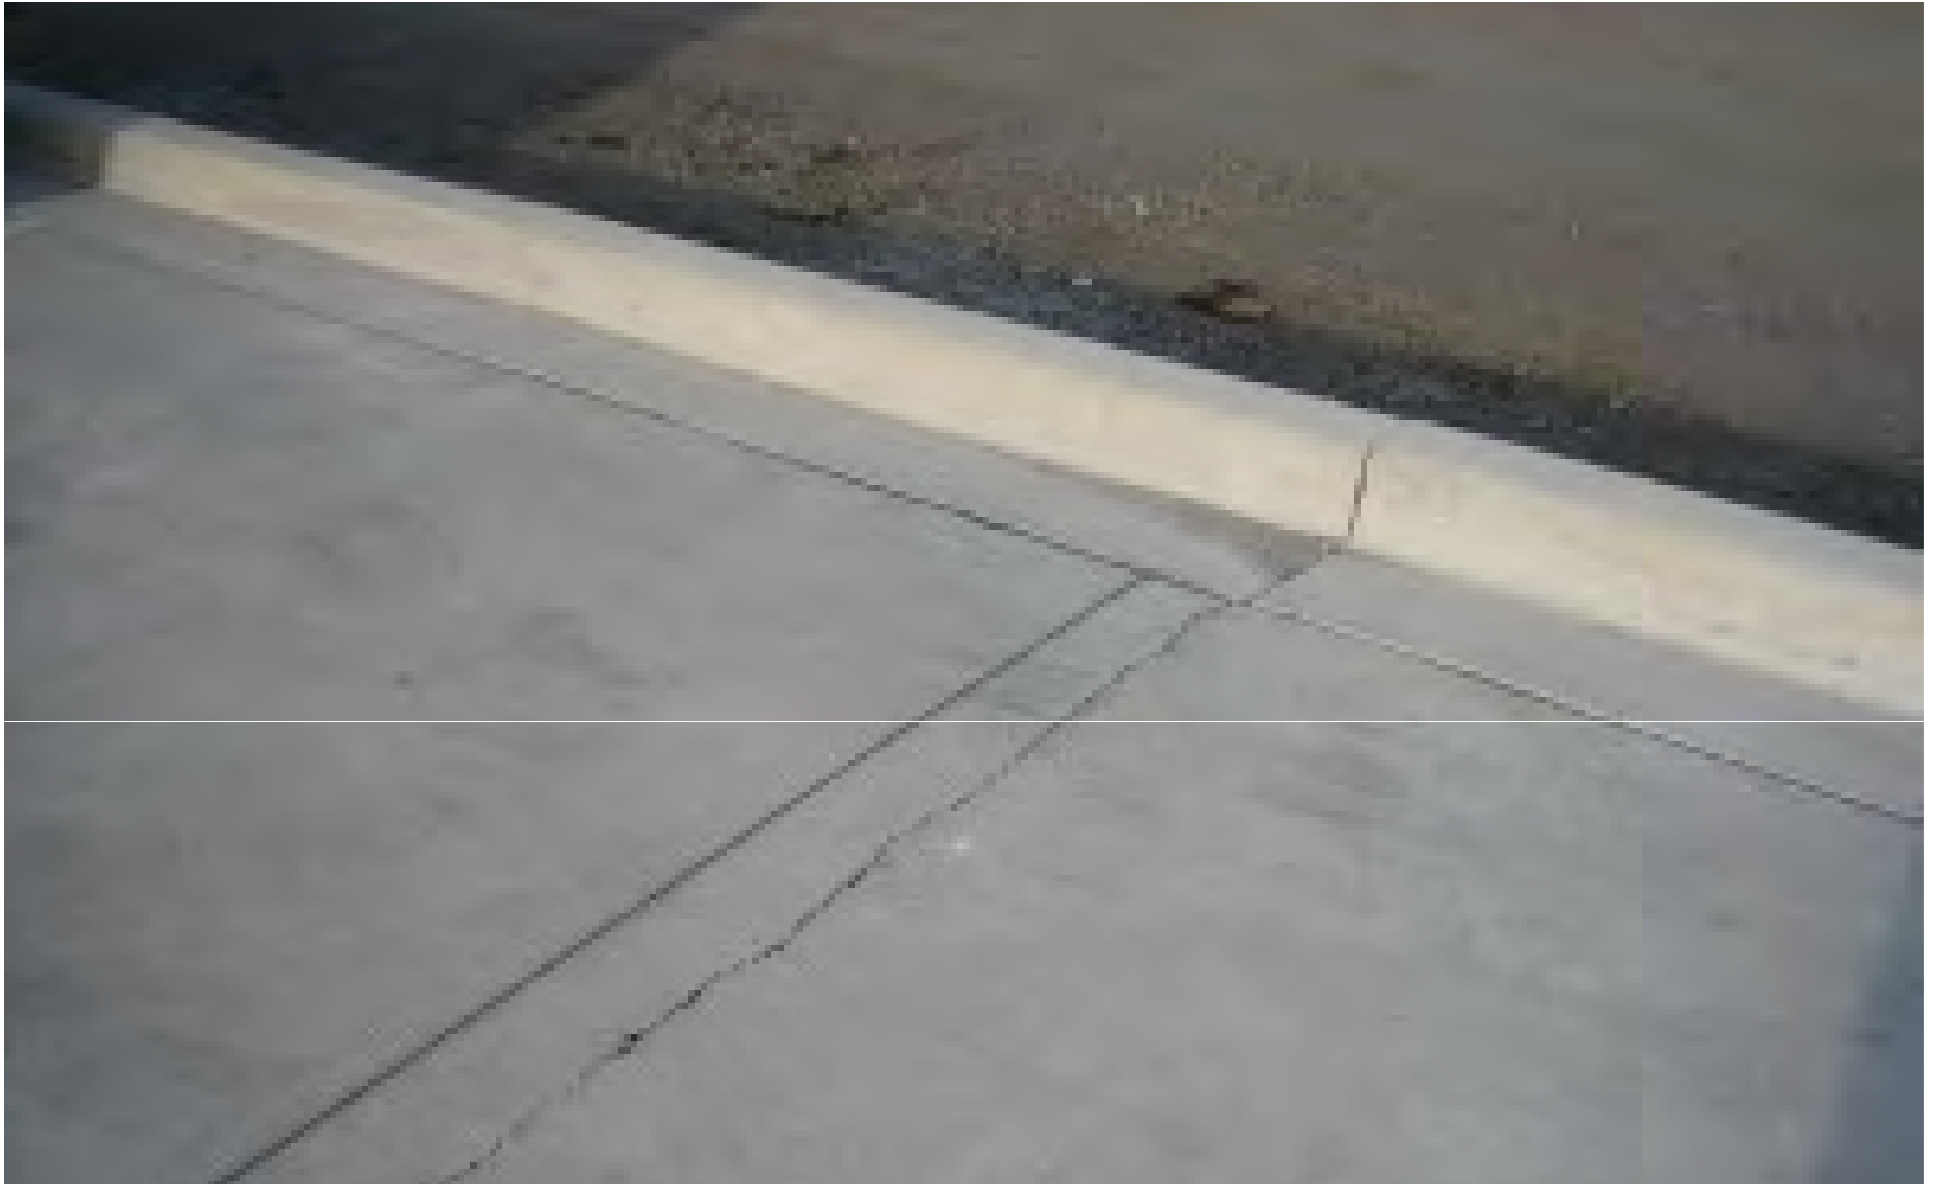
Symptom	Cause
Cracking shortly (hours to days) after placing (after hardening)	Drying/thermal cracking (improper timing of spacing of joints)

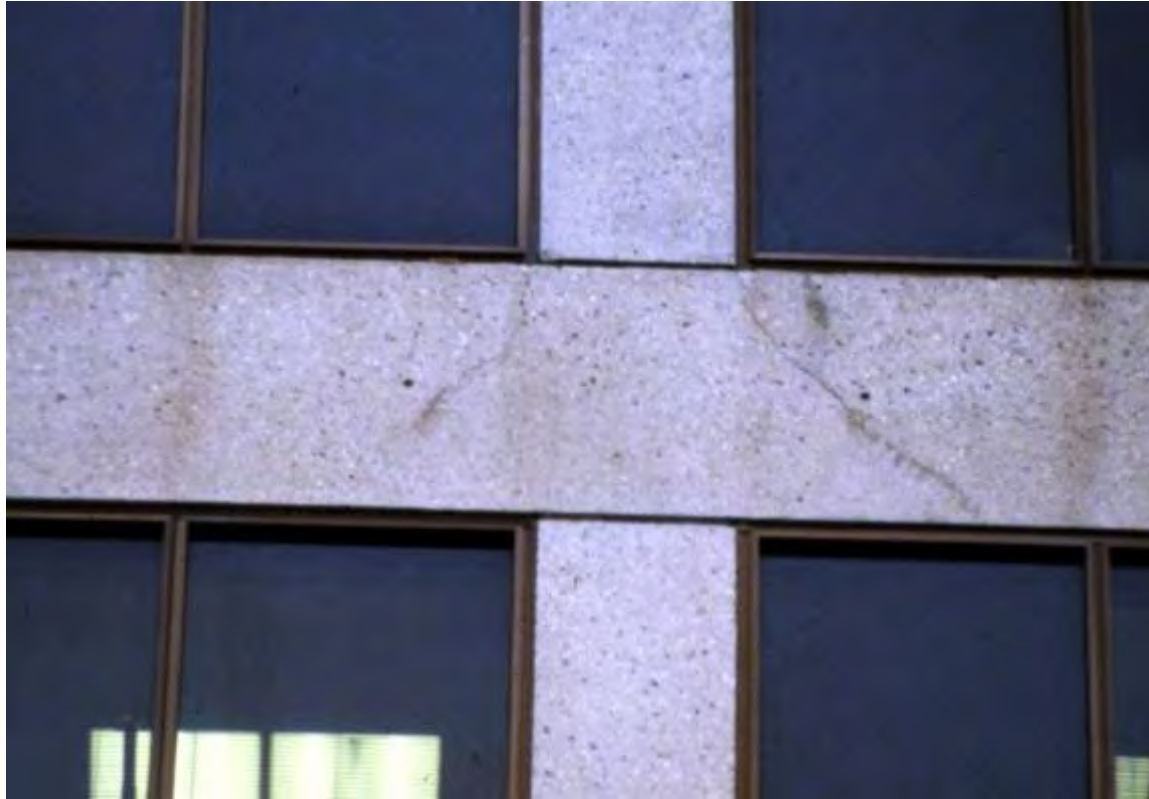
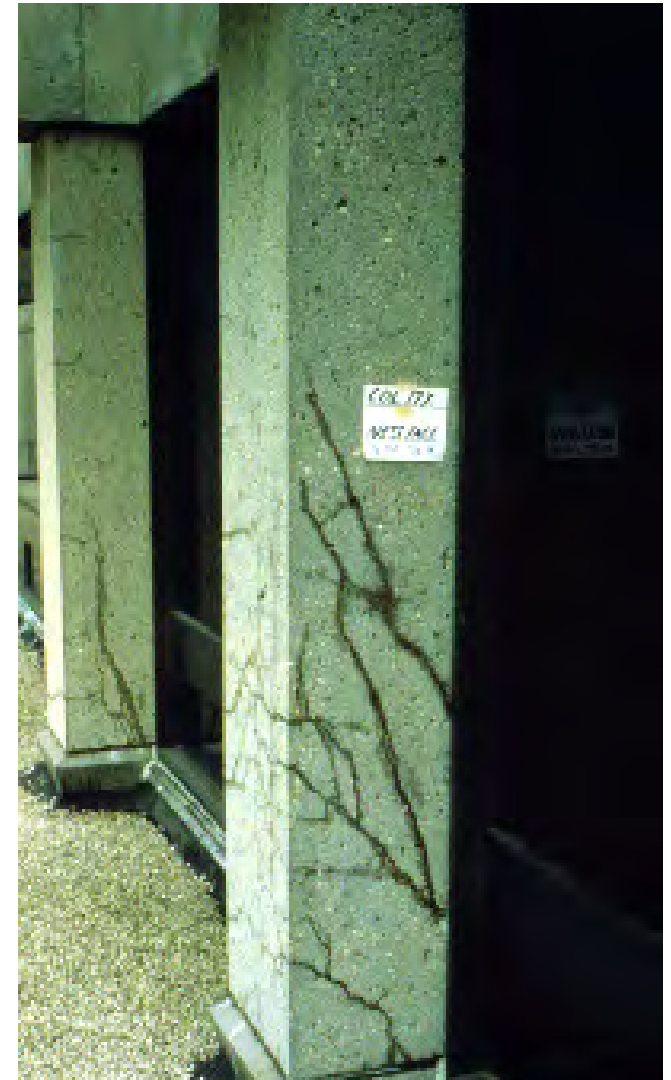
Symptom	Cause
Cracking occurring after structure is in service	Structural cracking (improper placing or insufficient reinforcement)

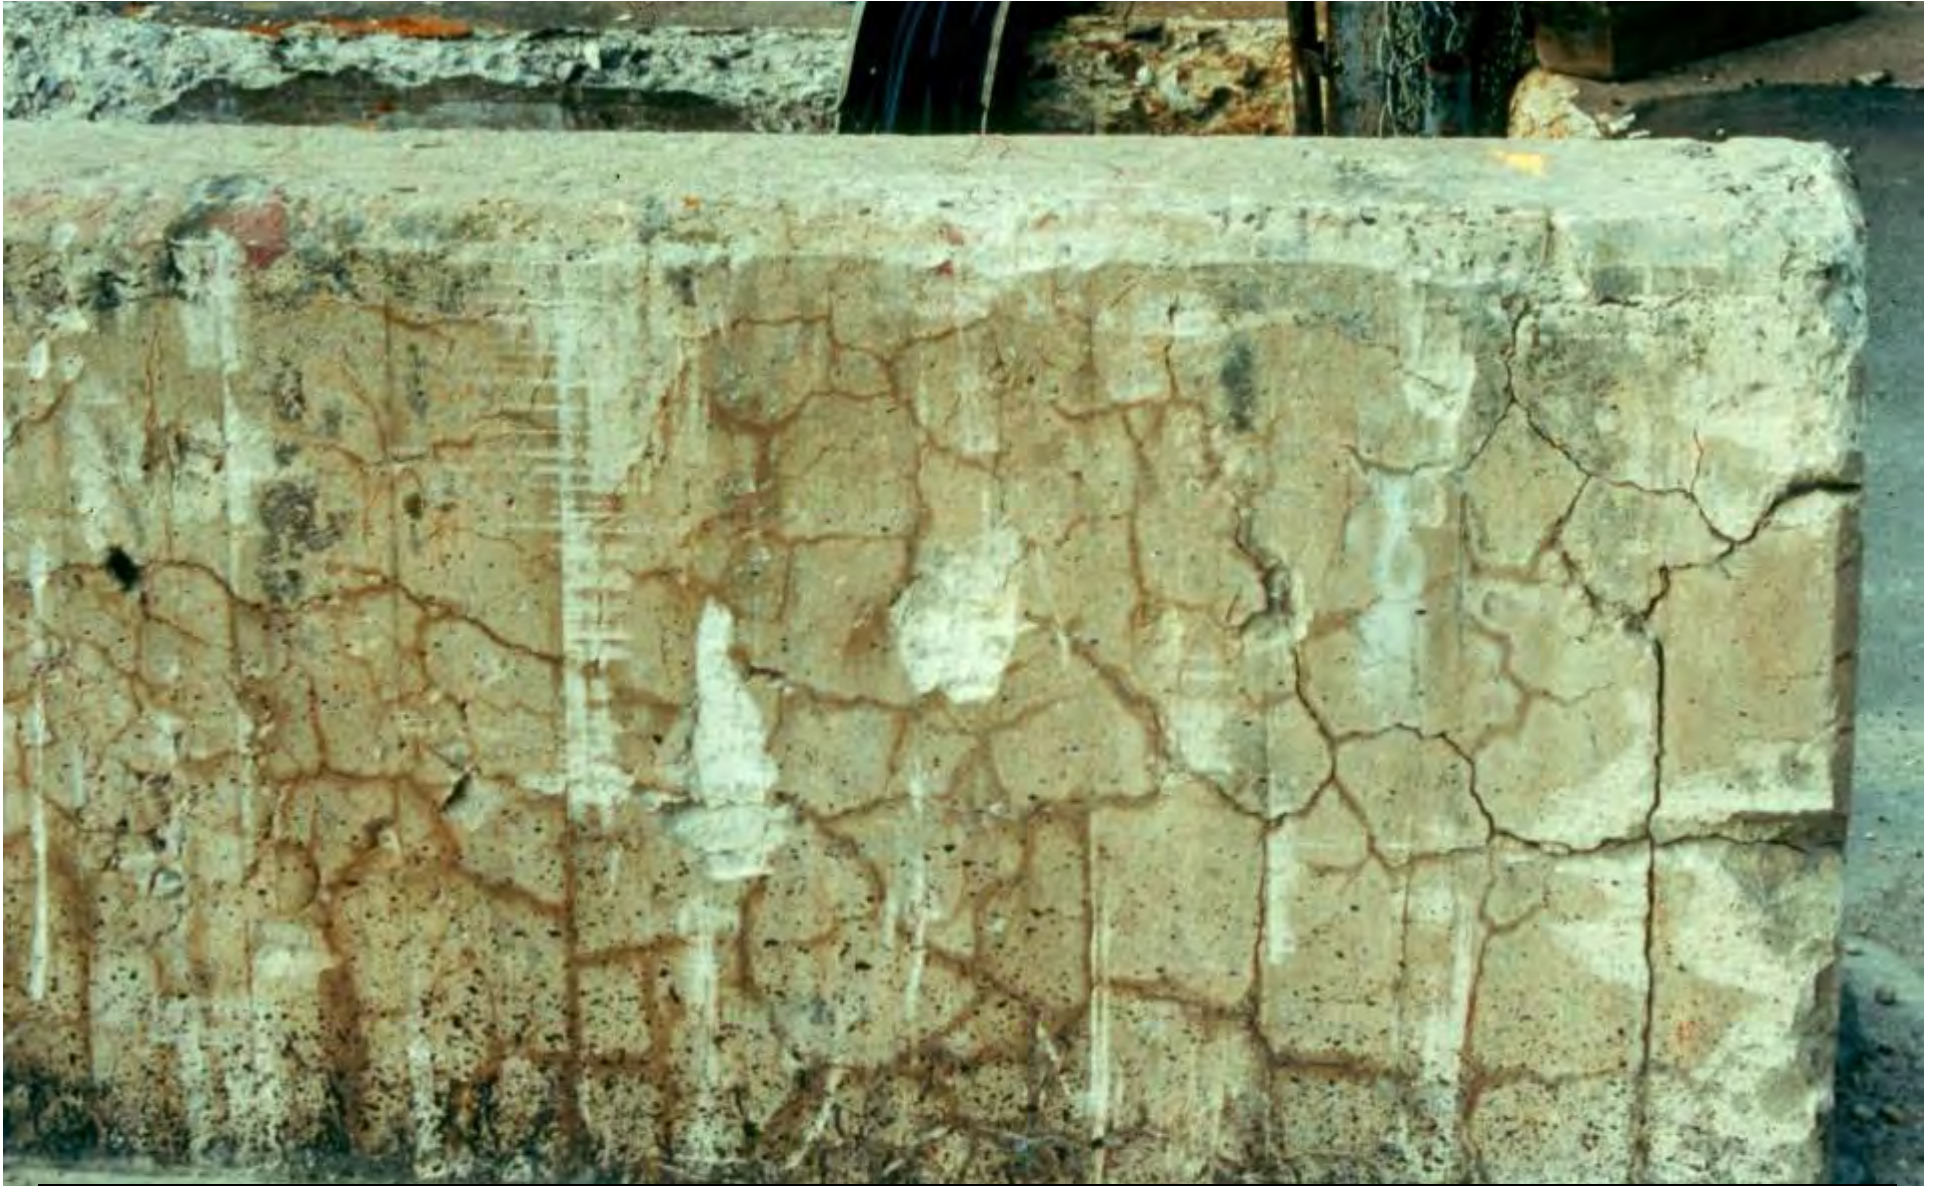
Symptom	Cause
Map cracking – typically occurring after 5 to 10 years	Volumetric expansion of concrete (in this case ASR)

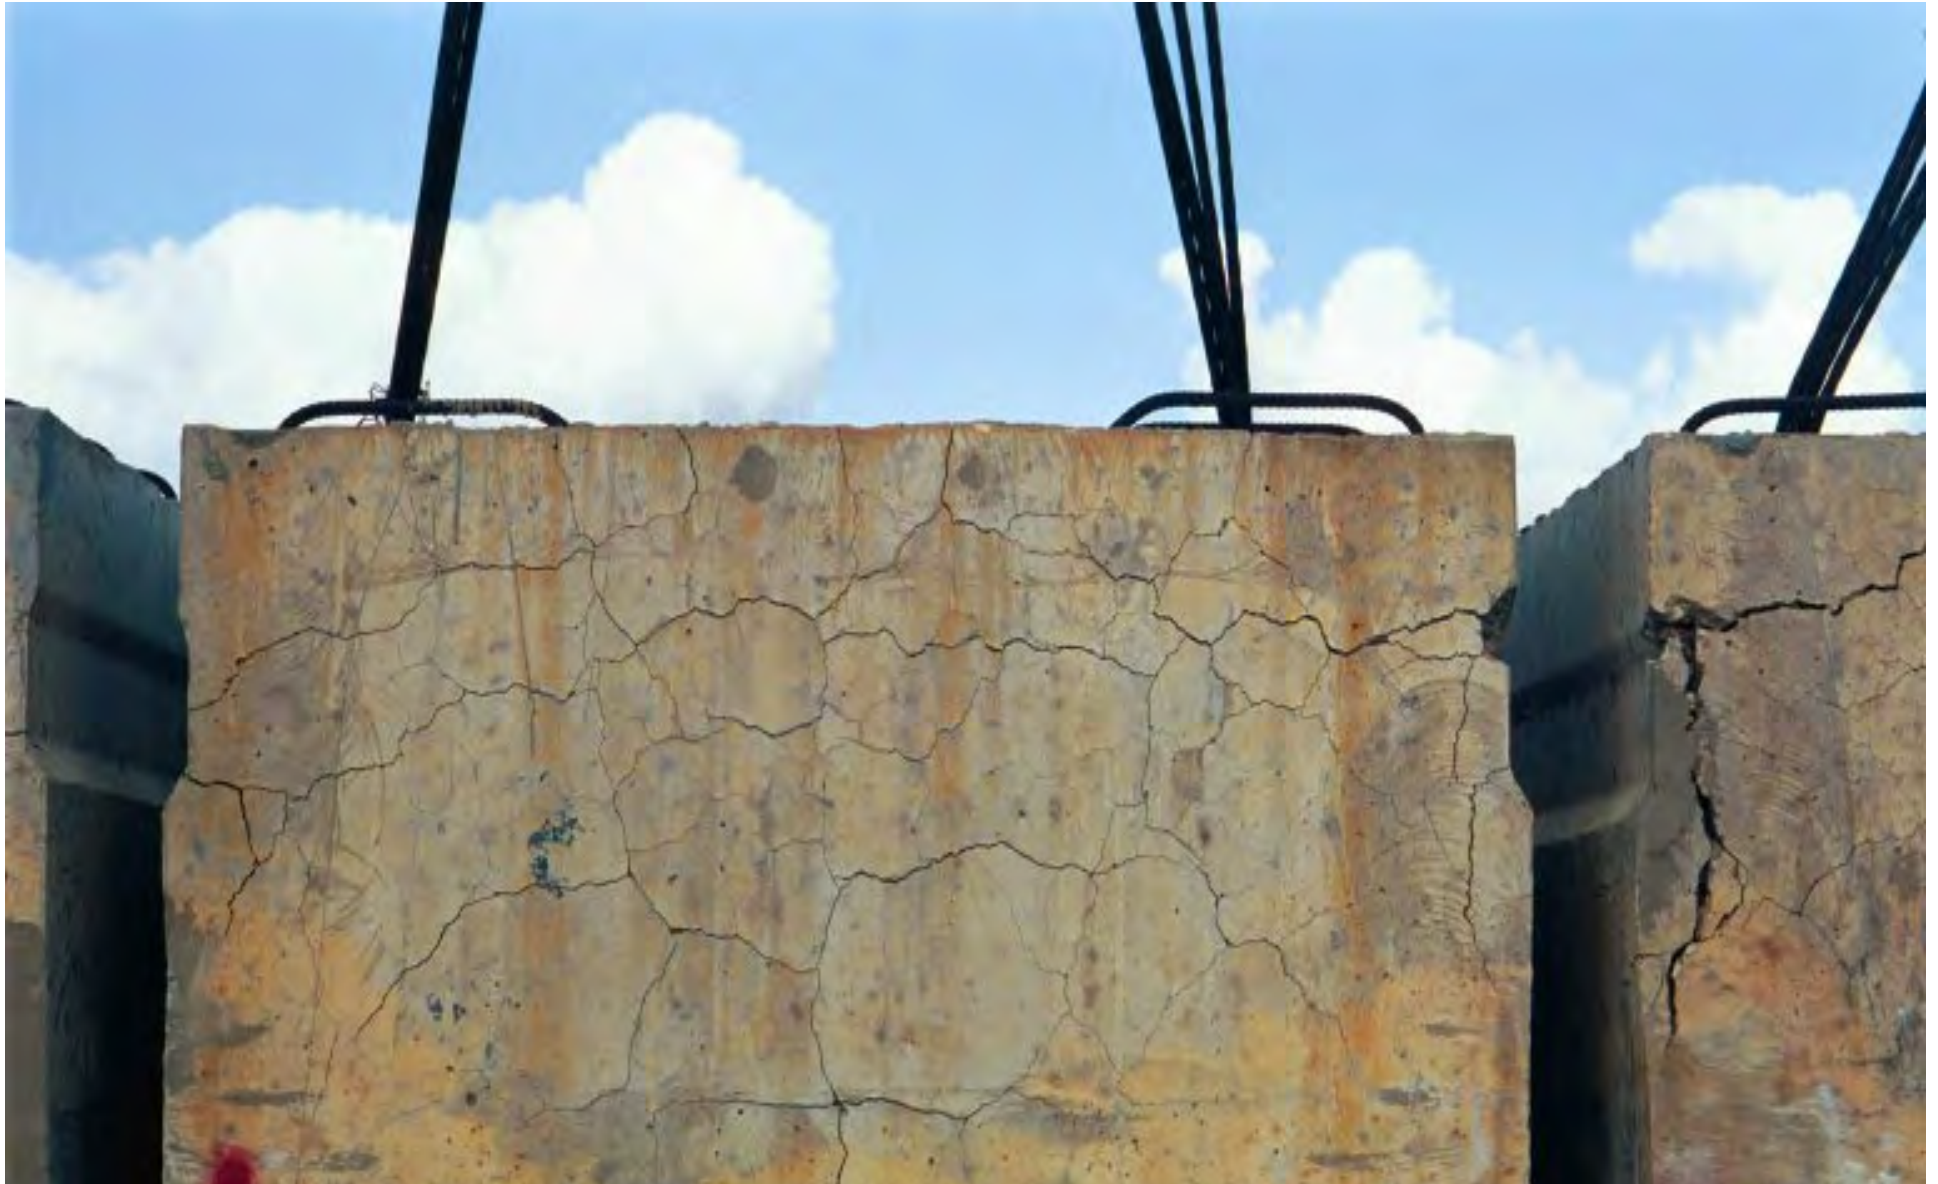
Symptom	Cause
Map cracking – typically occurring after 5 to 10 years	Volumetric expansion of concrete (in this case ASR & DEF)

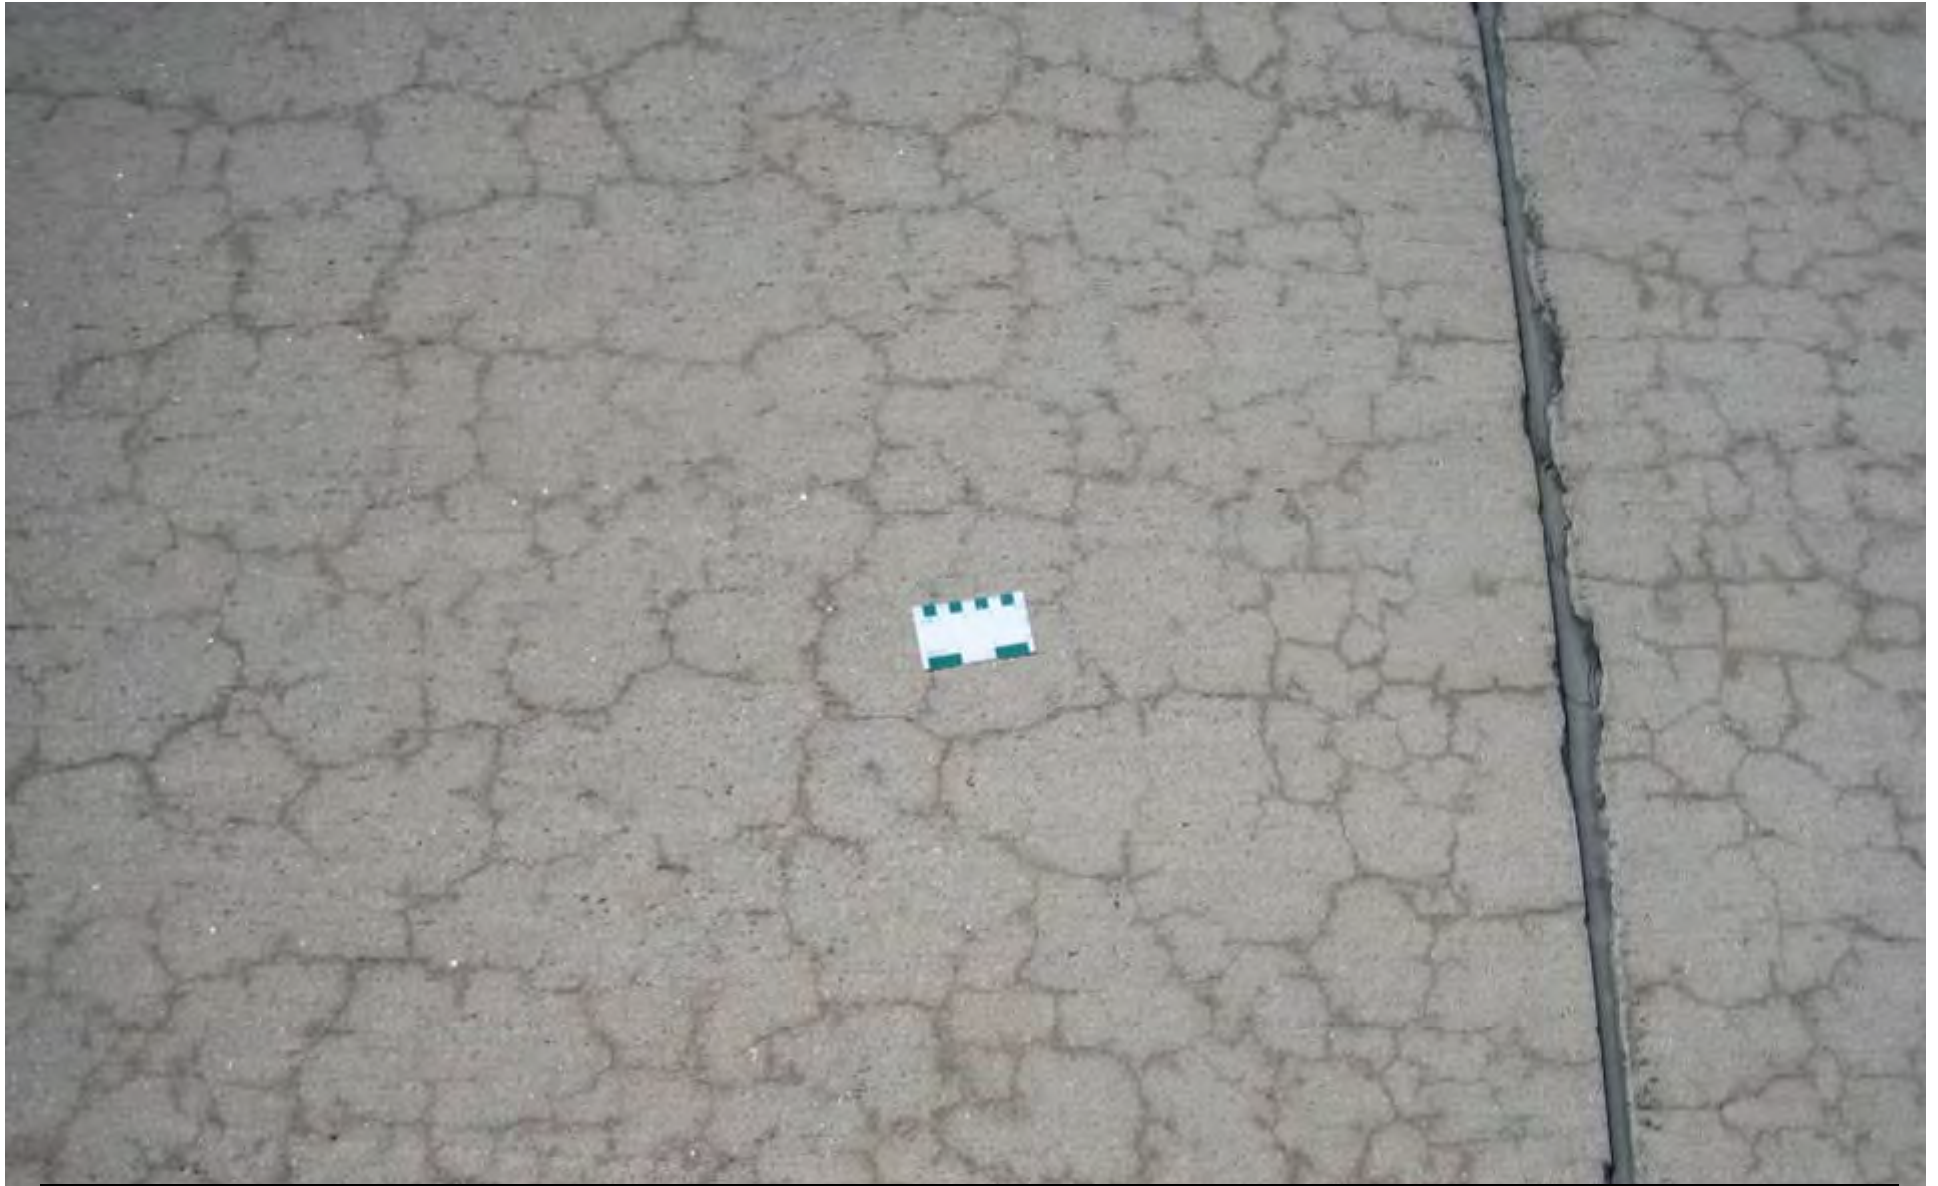
Symptom	Cause
Map cracking – occurring anytime from weeks to years	Excessive drying shrinkage

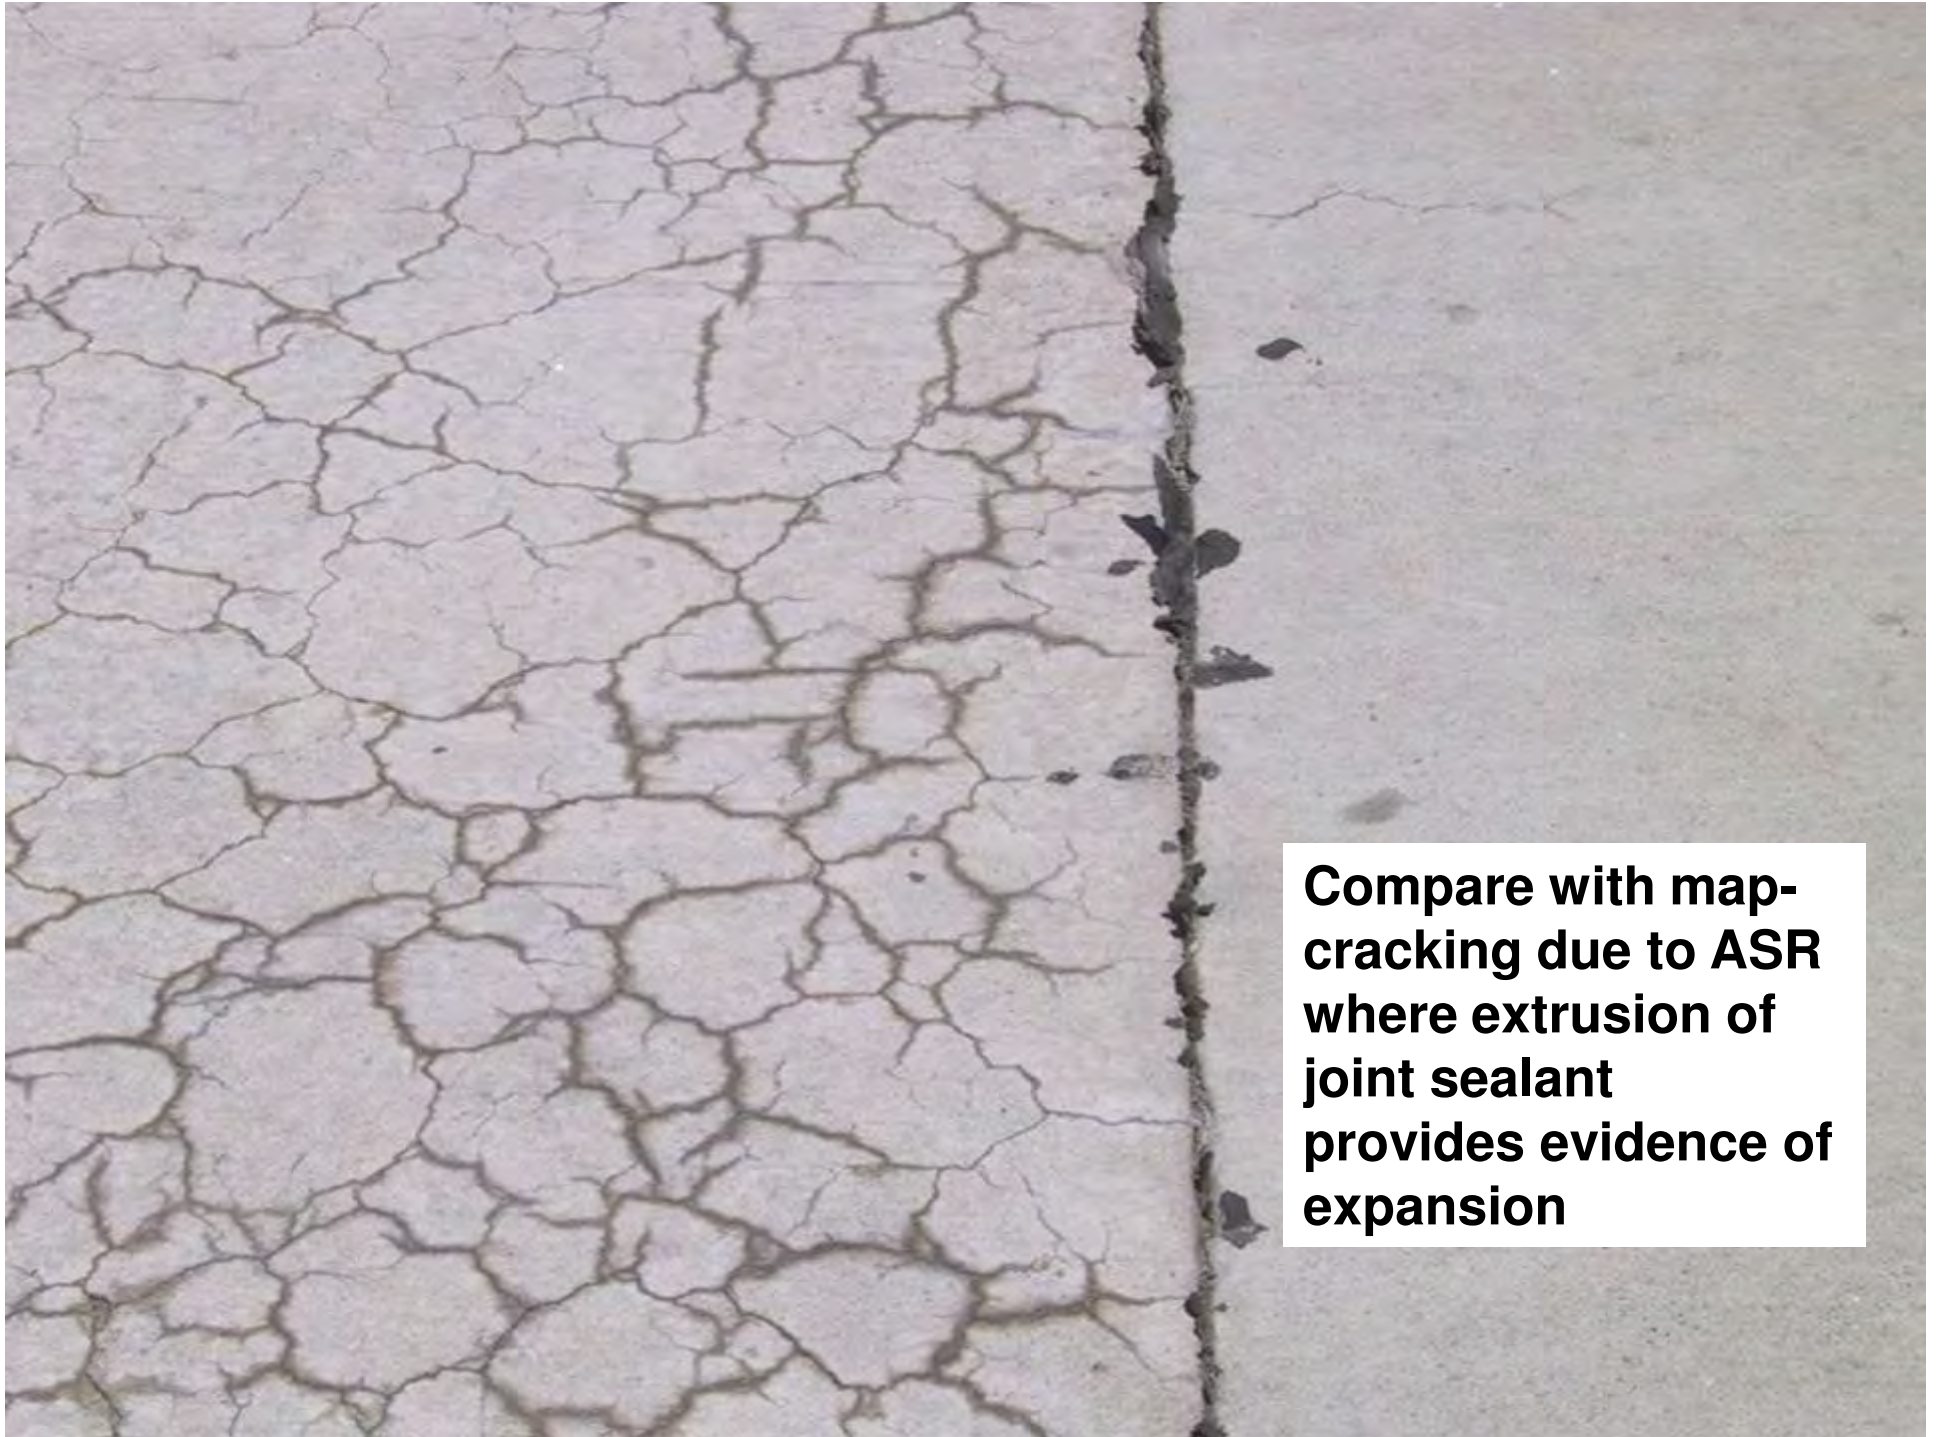
Compare with map-cracking due to ASR where extrusion of joint sealant provides evidence of expansion

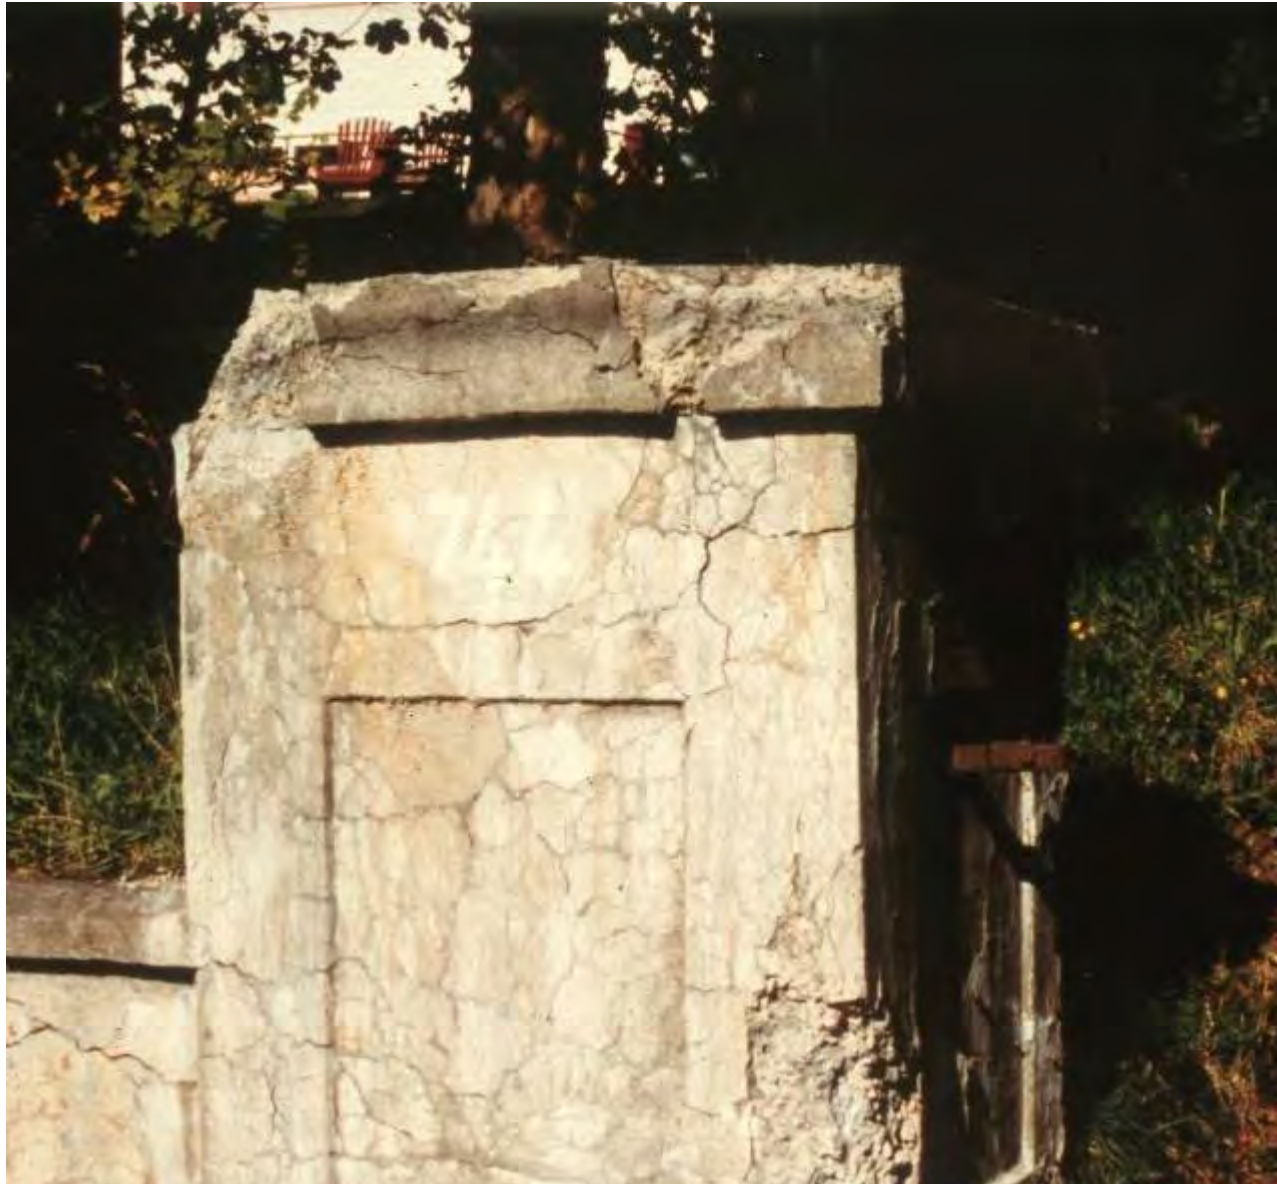
Symptom	Cause
Map cracking – typically occurring anytime from months to years	Freeze-thaw attack (non-air-entrained concrete that was also hit by truck)
