Forensic Engineering = Causes of Distress in Concrete

David W. Fowler

The University of Texas at Austin

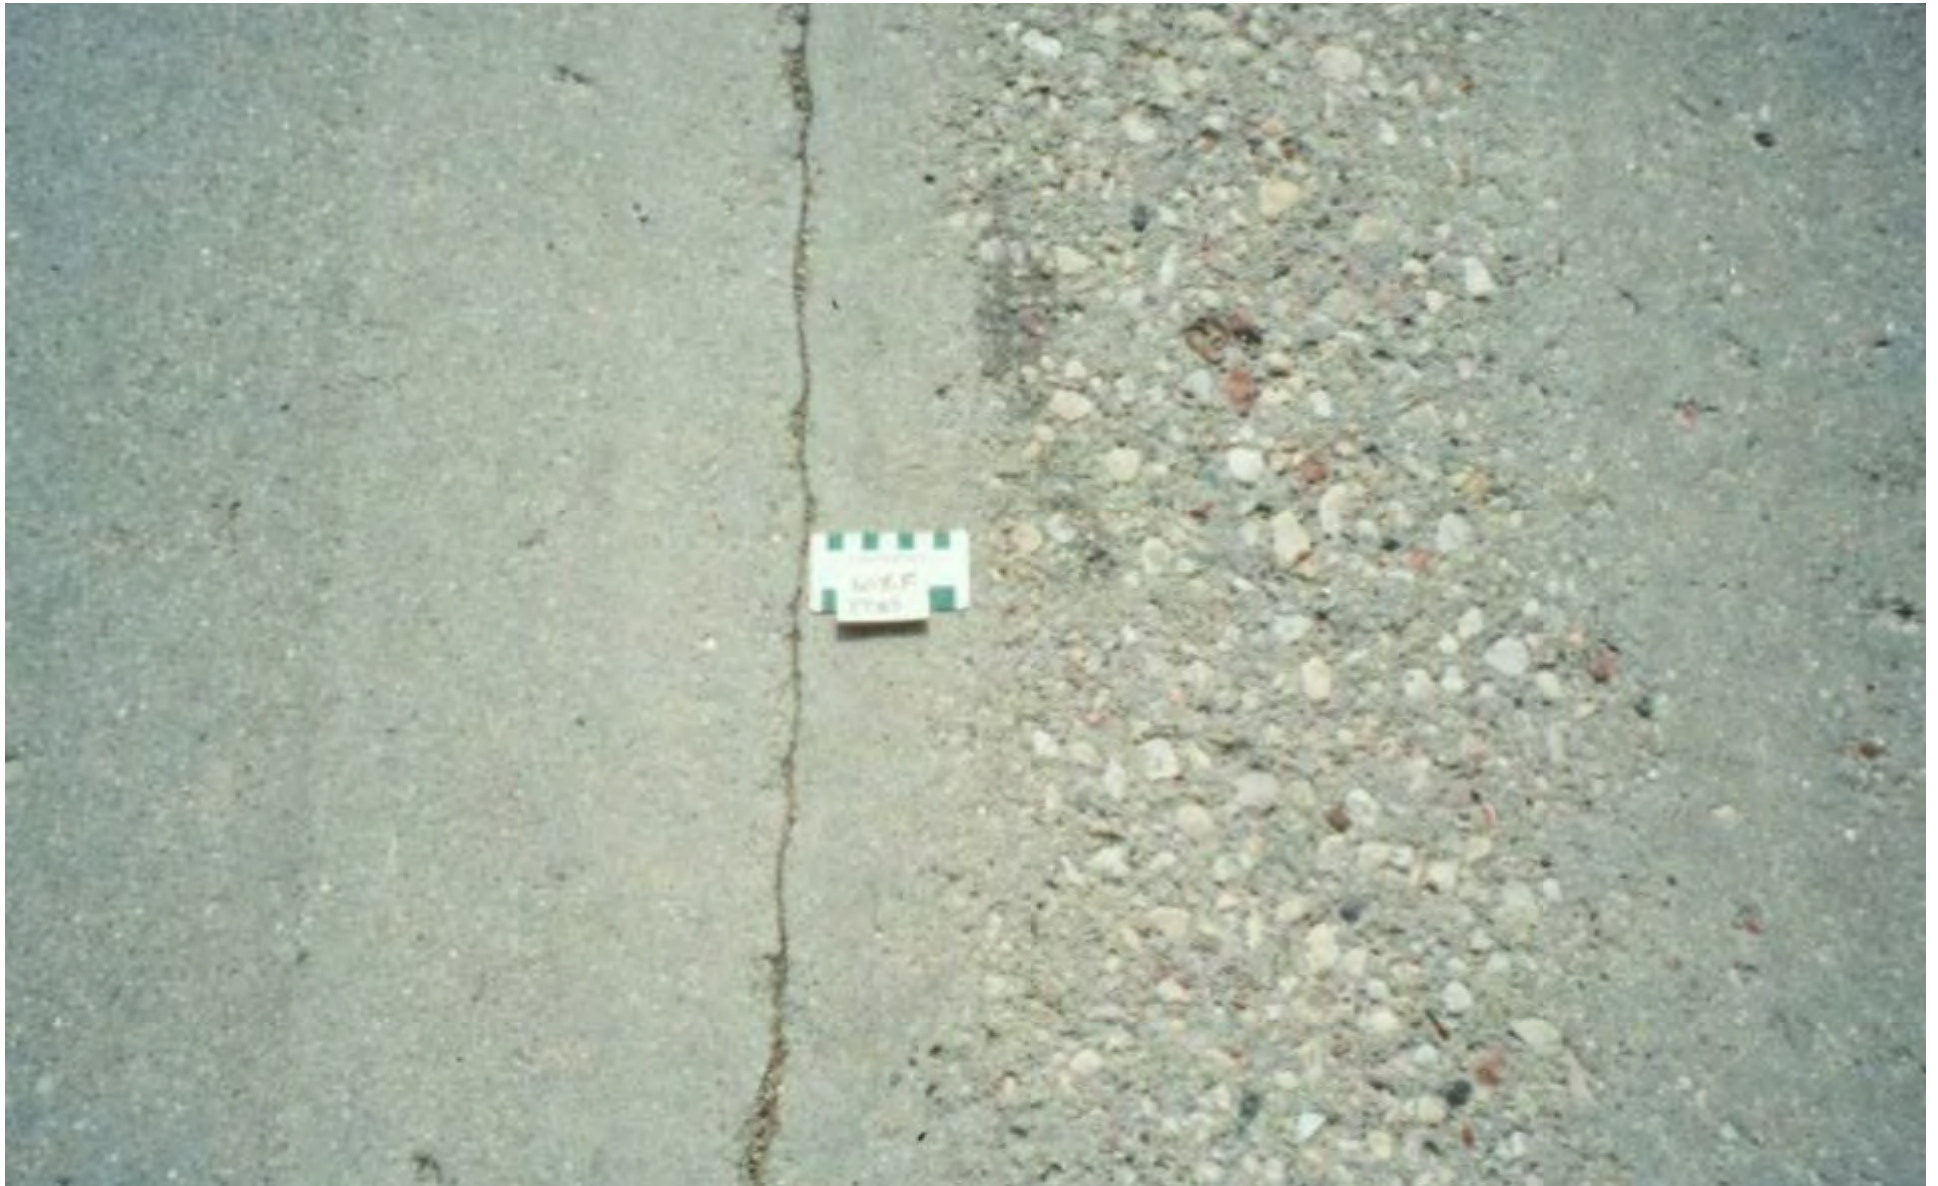
Symptom	Cause
Surface scaling – occurring after approximately 5 years	Abrasion by vehicular traffic (in wheel path)

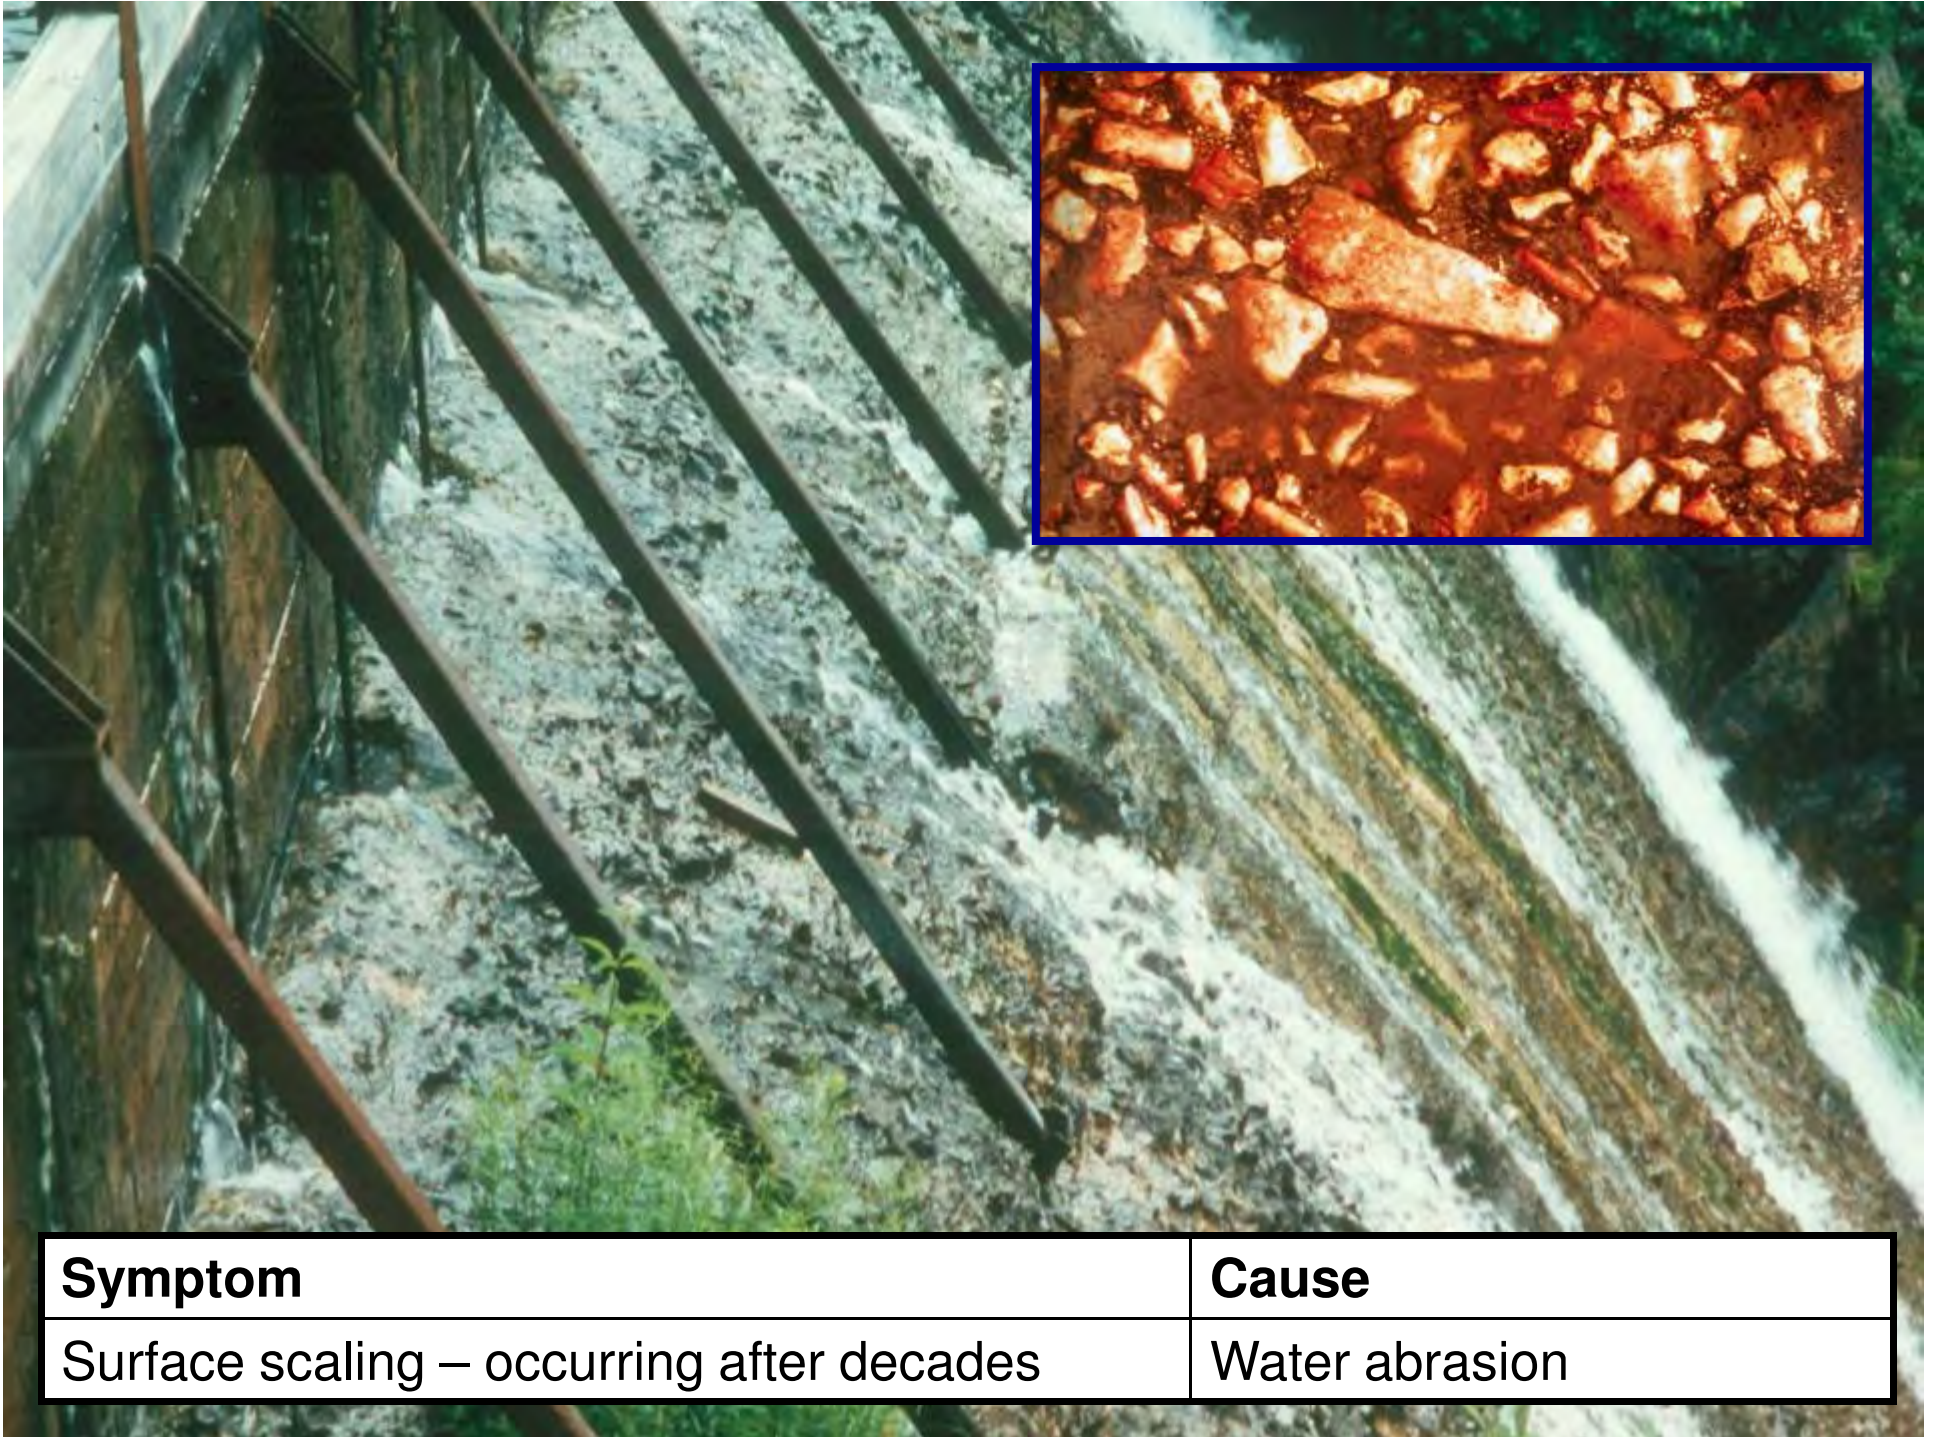
Symptom	Cause
Surface scaling – occurring after decades	Water abrasion

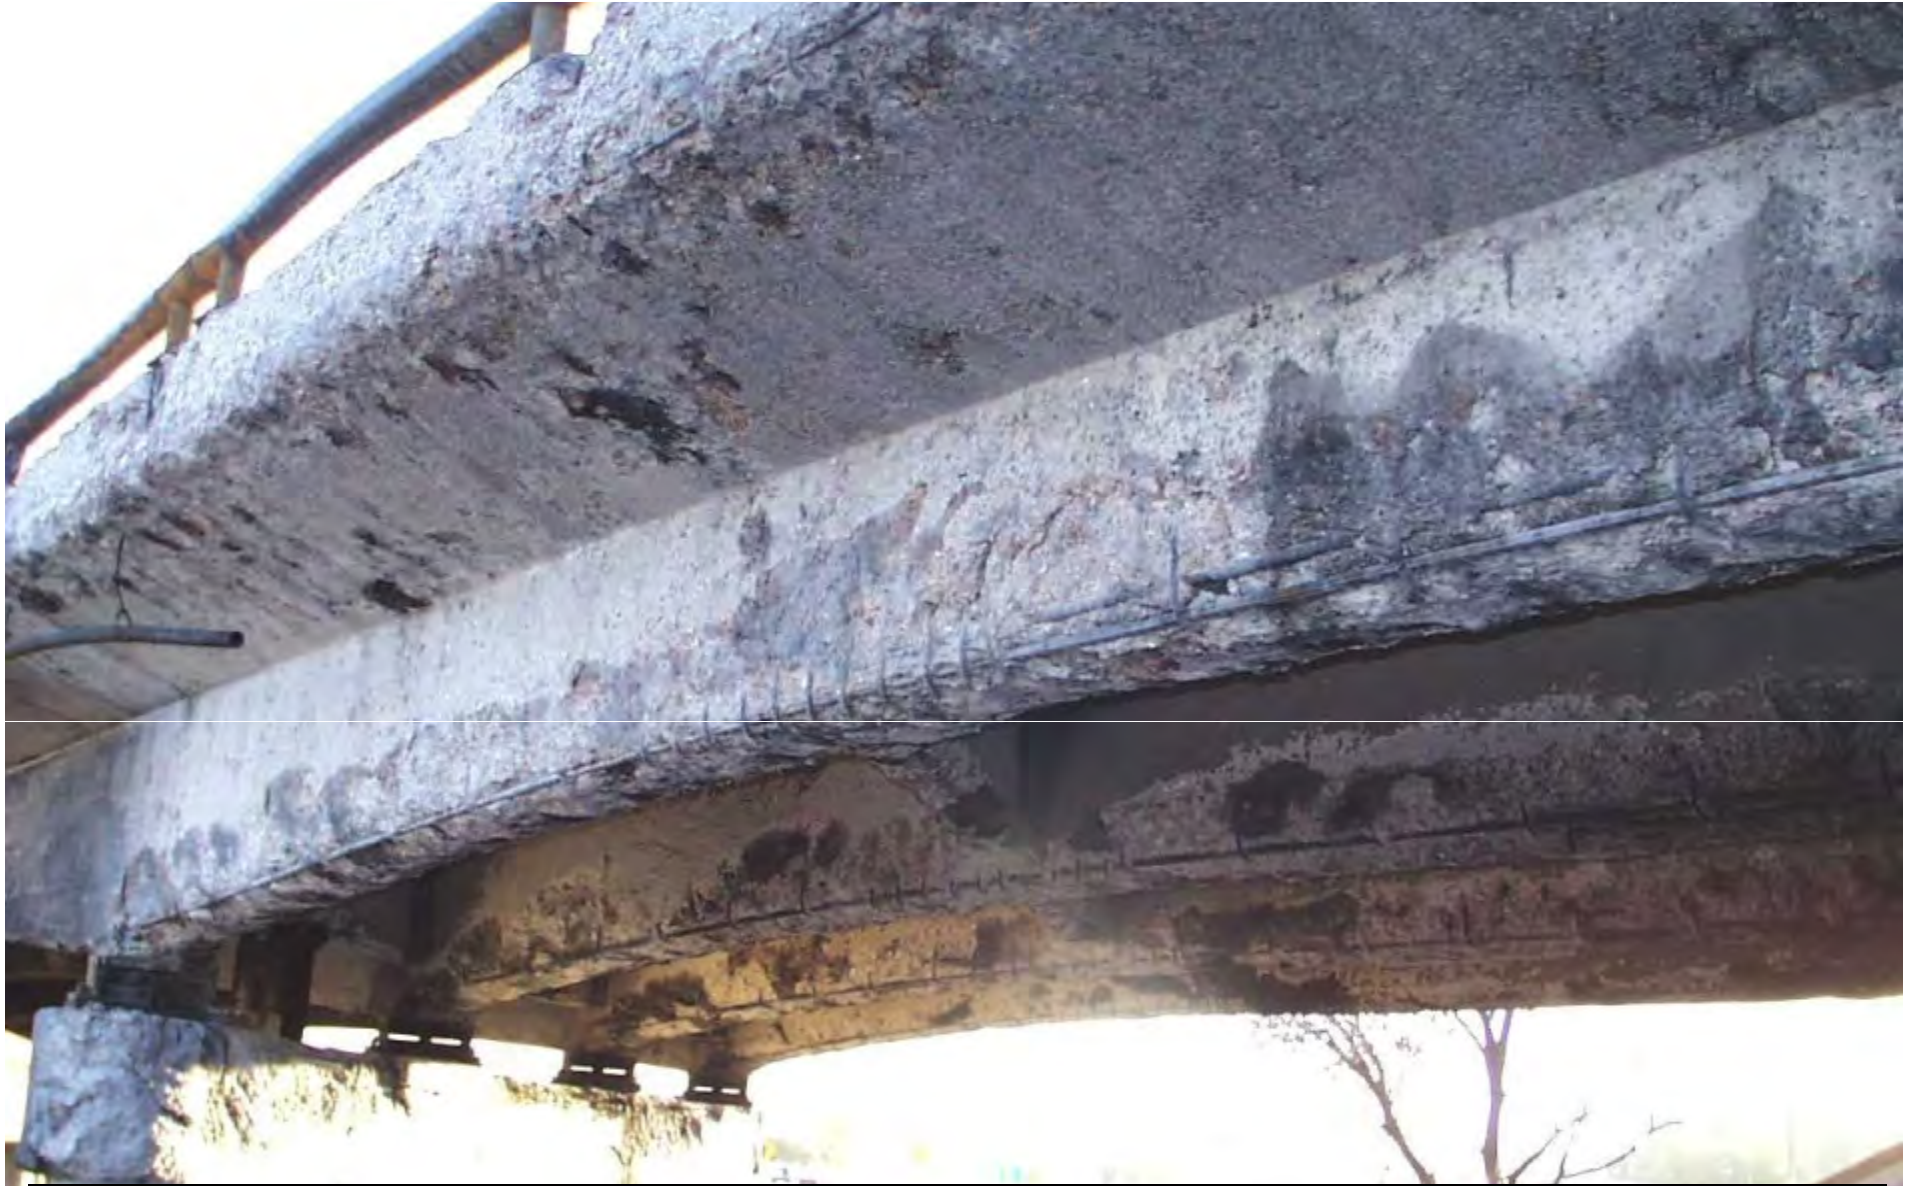
Symptom	Cause
Severe spalling of concrete surface	Fire damage (petroleum tanker crashed into bridge pier and ignited)

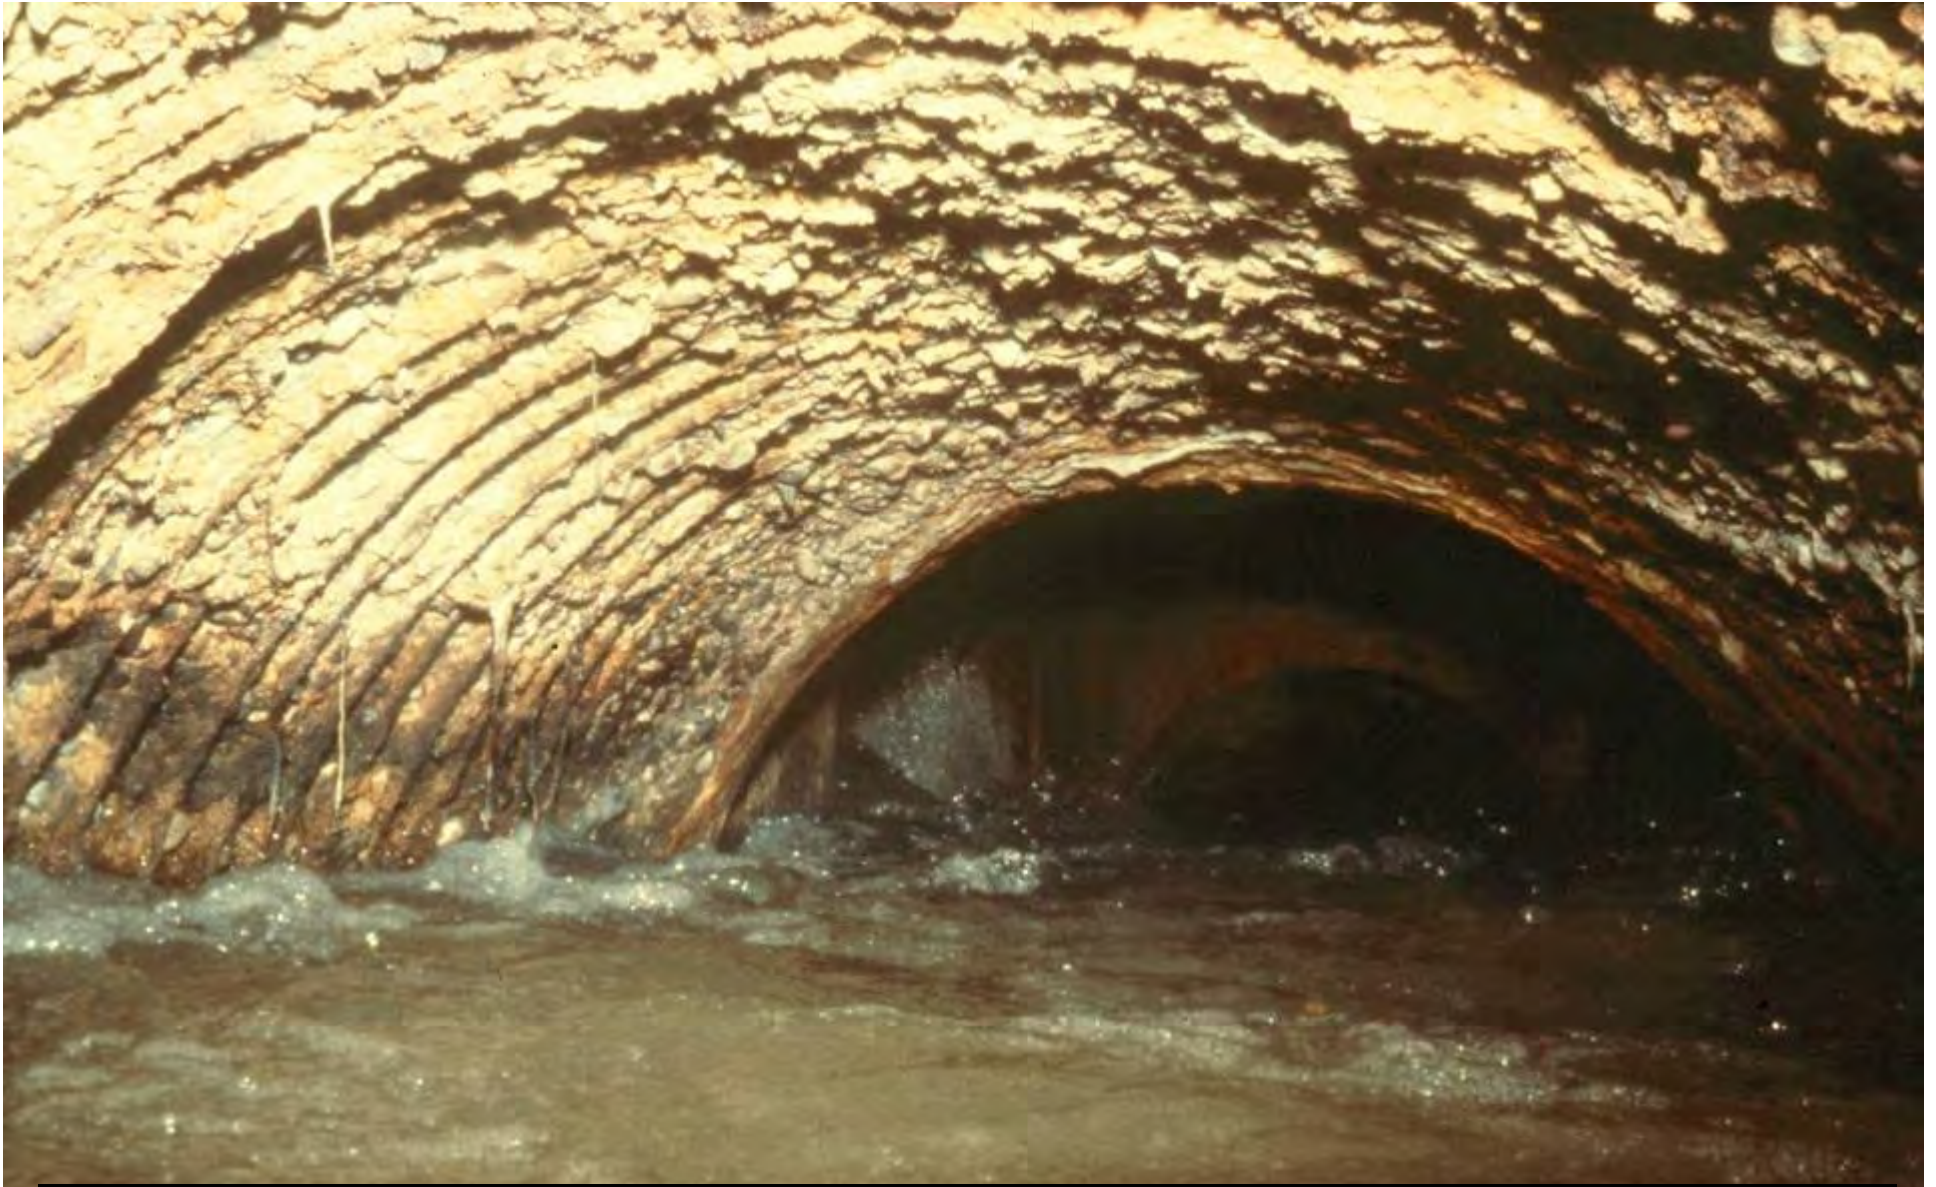
Symptom	Cause
Severe erosion of concrete – occurring after years	Sewer-pipe corrosion (chemical-biogenic attack of paste by sulfuric acid)

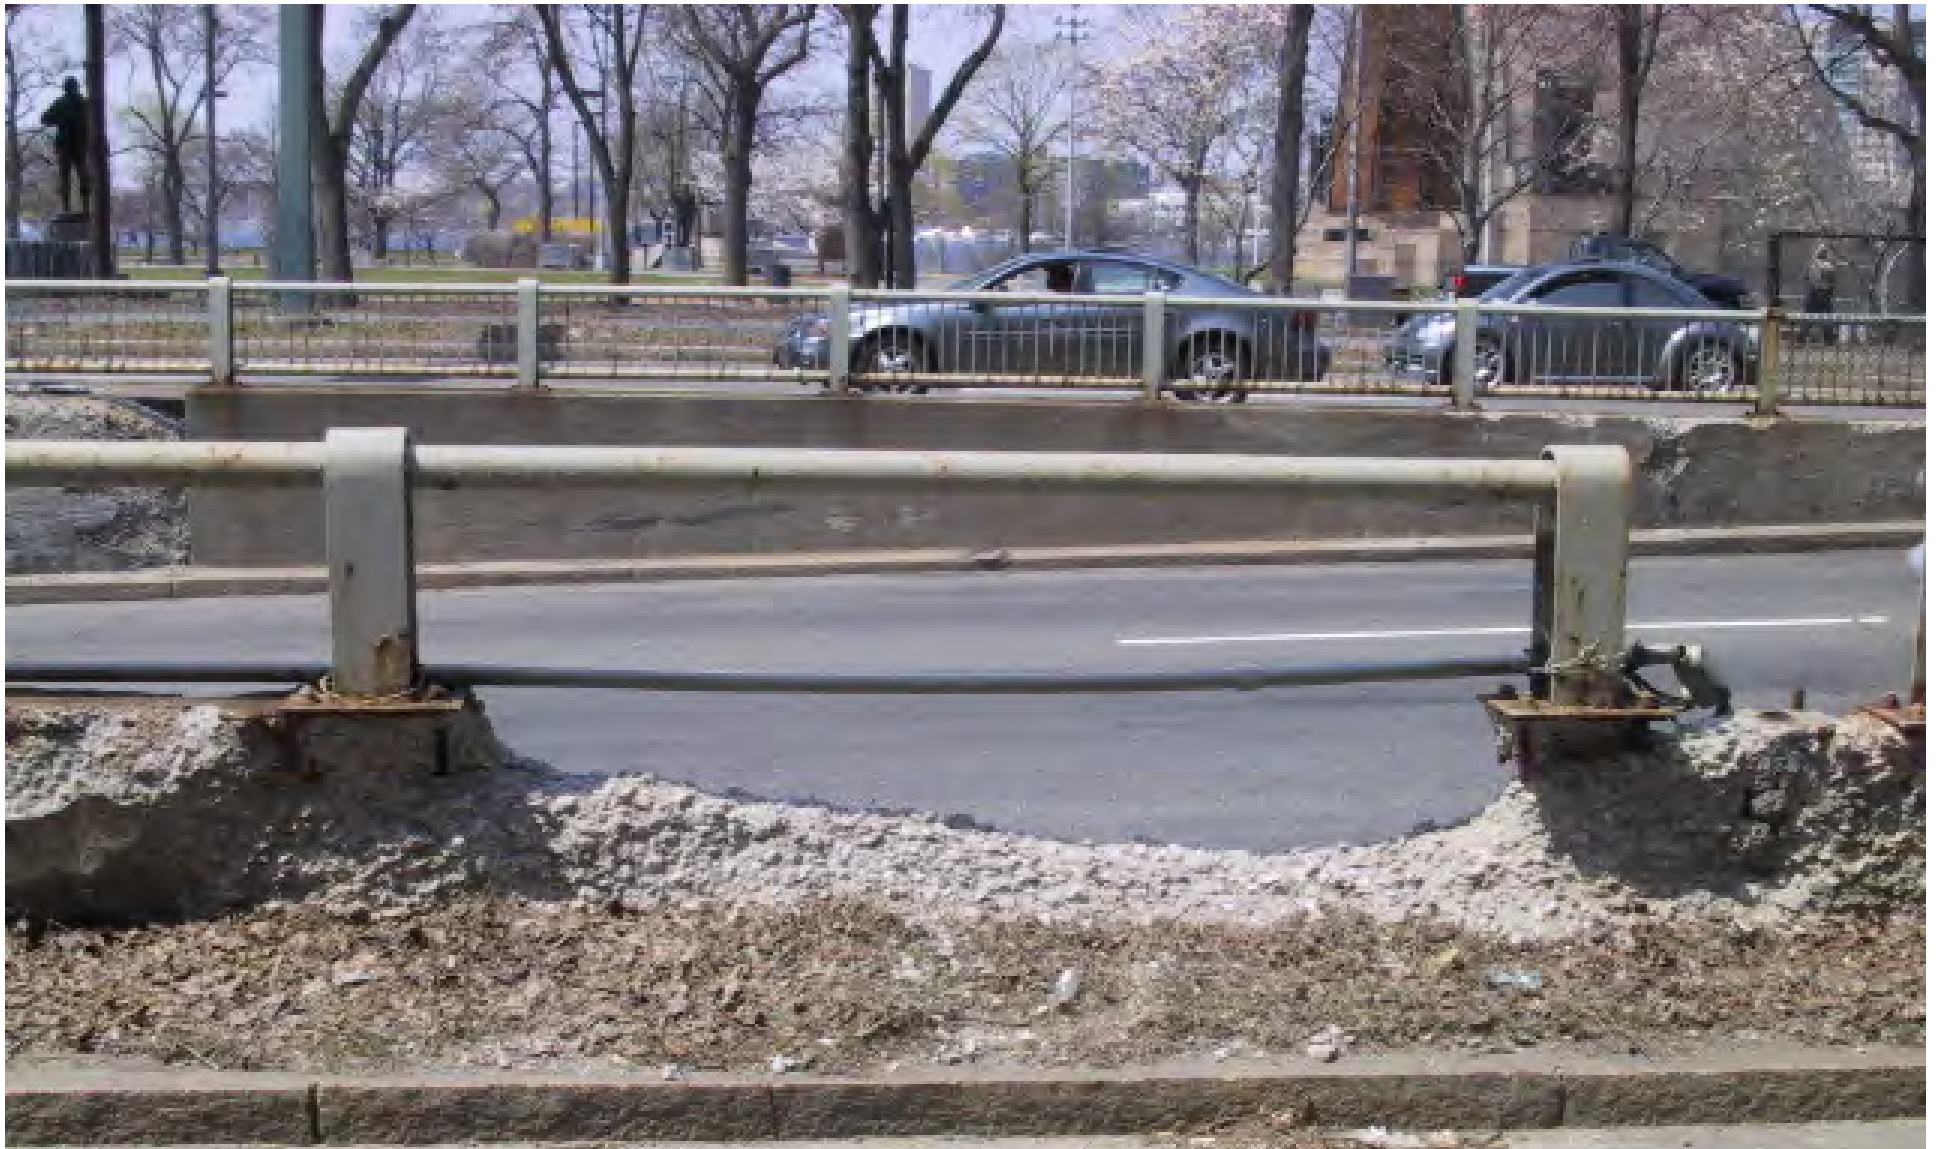
Symptom	Cause
Spalling and disintegration – occurring after a few years	Freeze-thaw attack (non-air-entrained concrete)

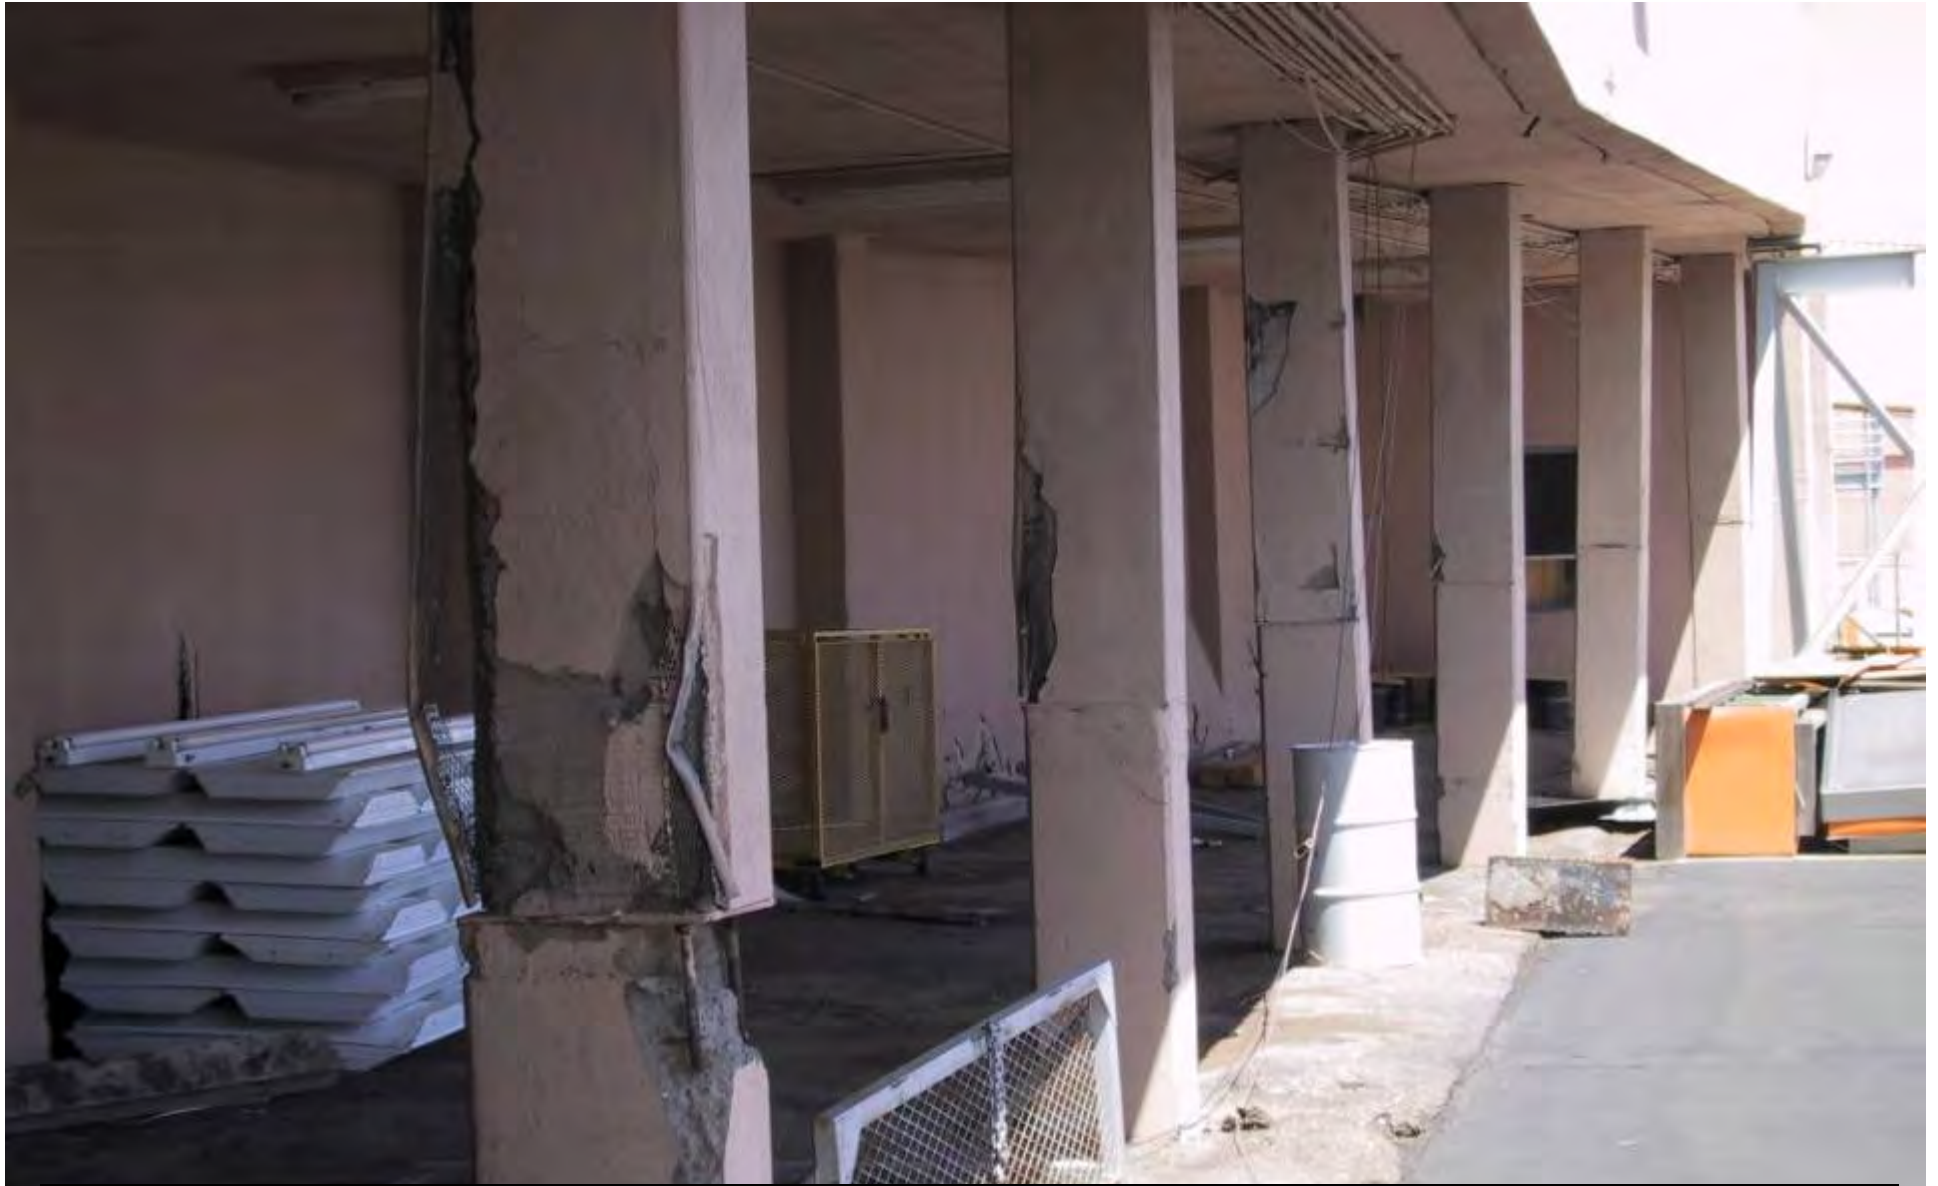
Symptom	Cause
Shearing of concrete column and spalling of concrete cover	Shoving of foundation due to expansion of adjacent pavement (ASR)

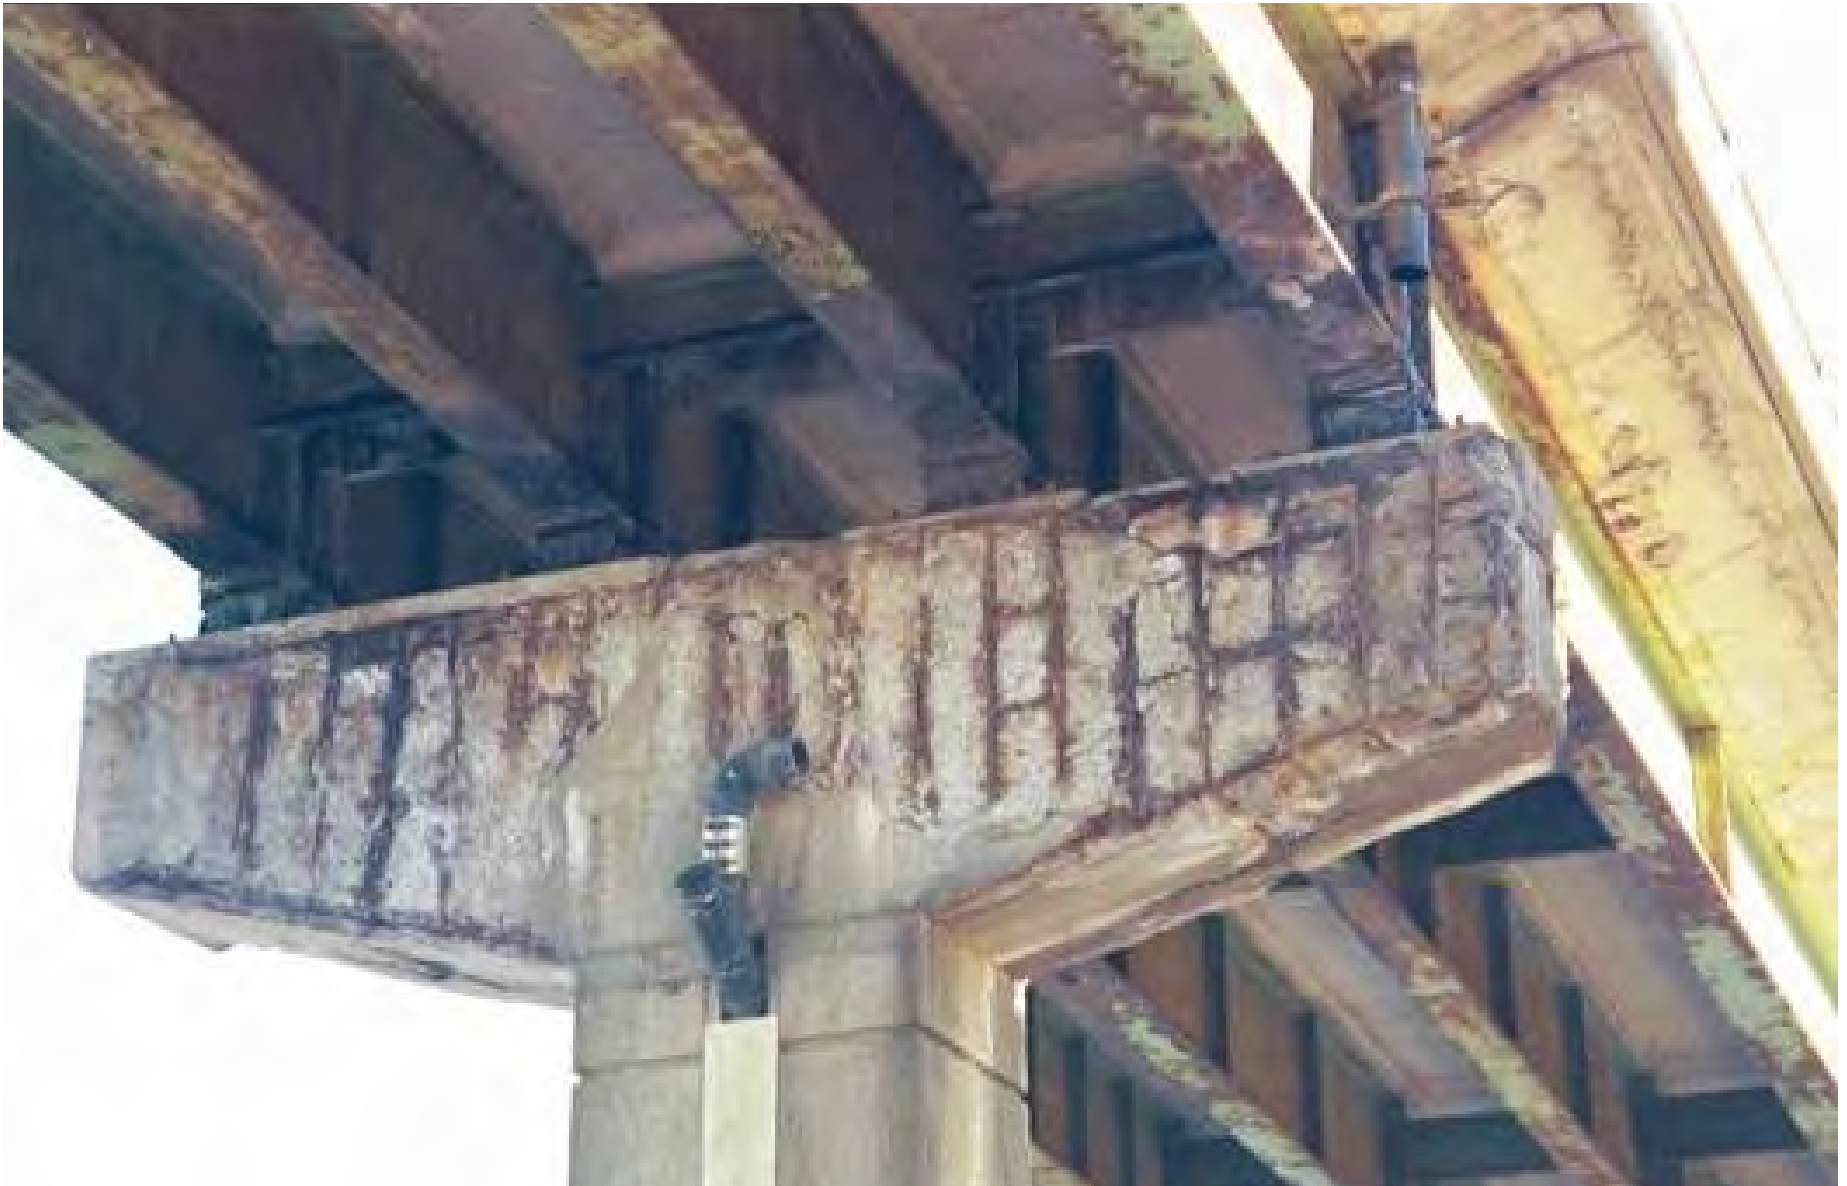
Symptom	Cause
Spalling of concrete over rebar	Corrosion of rebar initiated by chlorides (from roadway above)

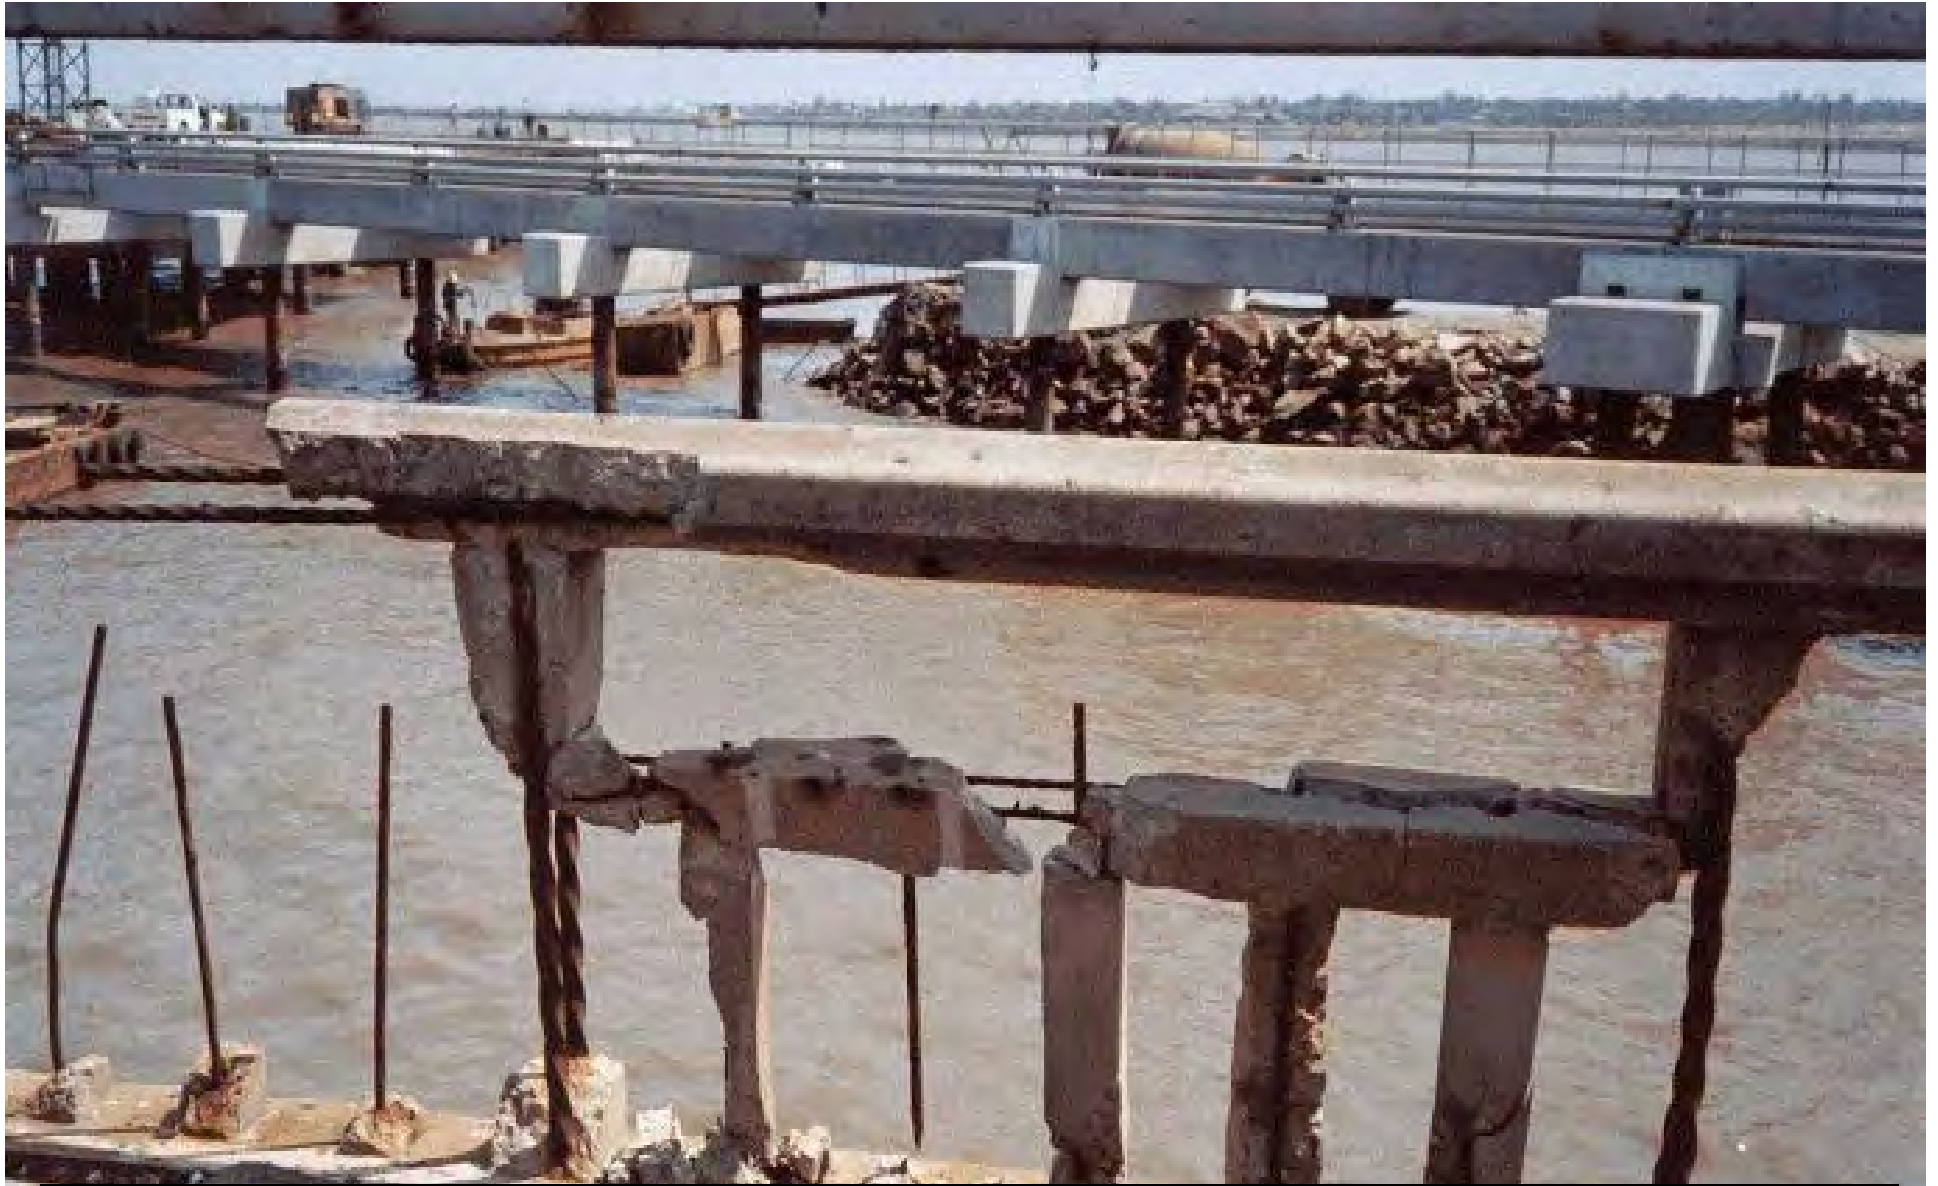
Symptom	Cause
Spalling of concrete over rebar	Corrosion of rebar initiated by chlorides (from unwashed sea-dredged sand)

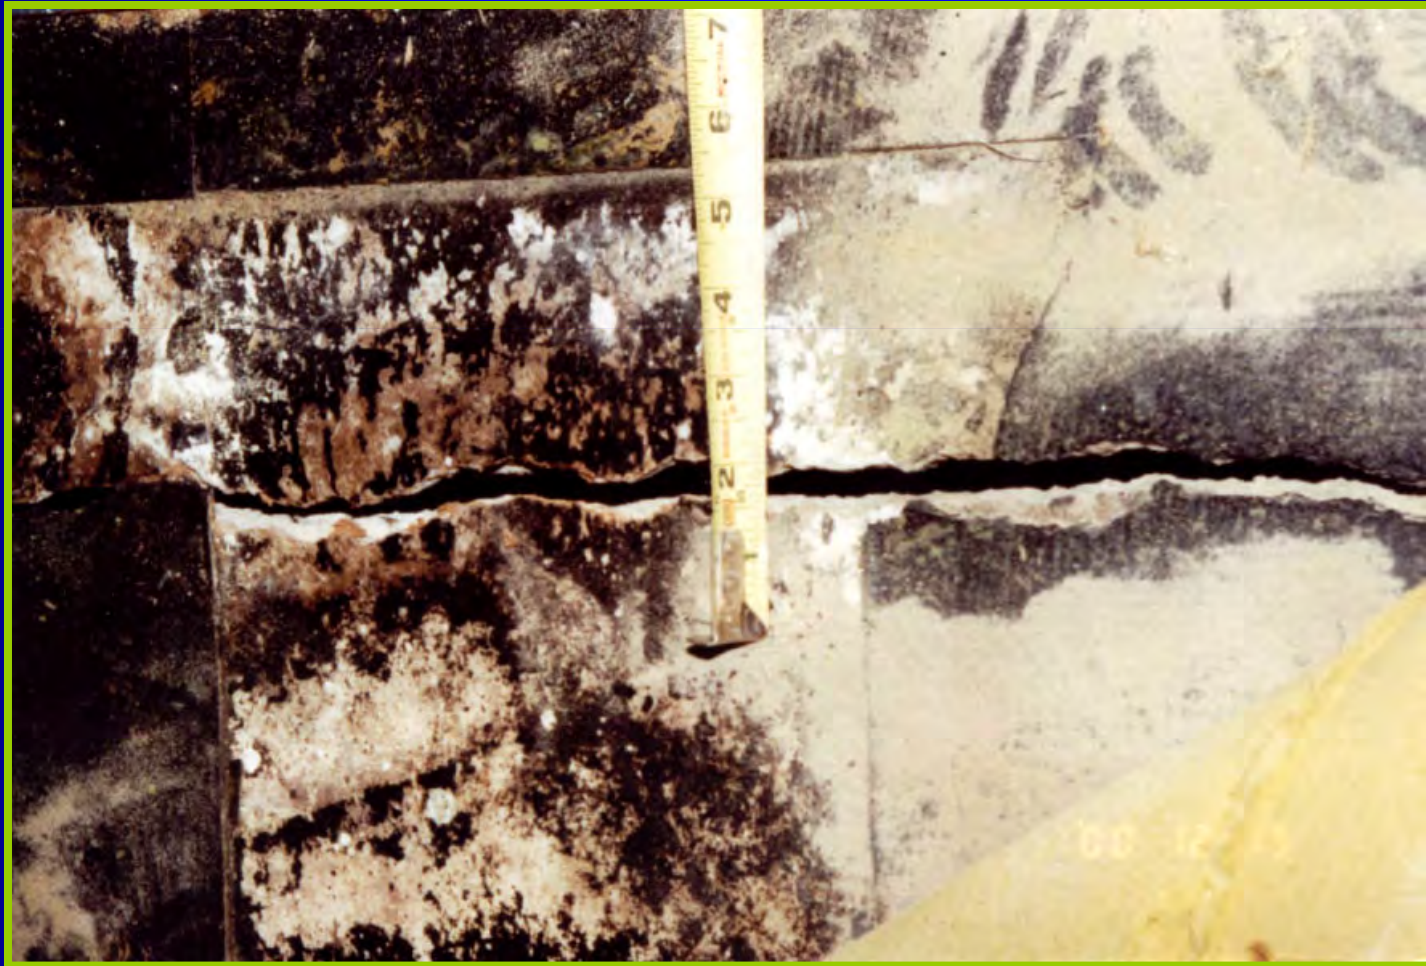
N-S Slab Crack: Looking down on crack after carpet removed

- N-S slab crack extending from north wall through house to utility
- Crack was in line with location of leak location
- Numerous other cracks in floor and walls

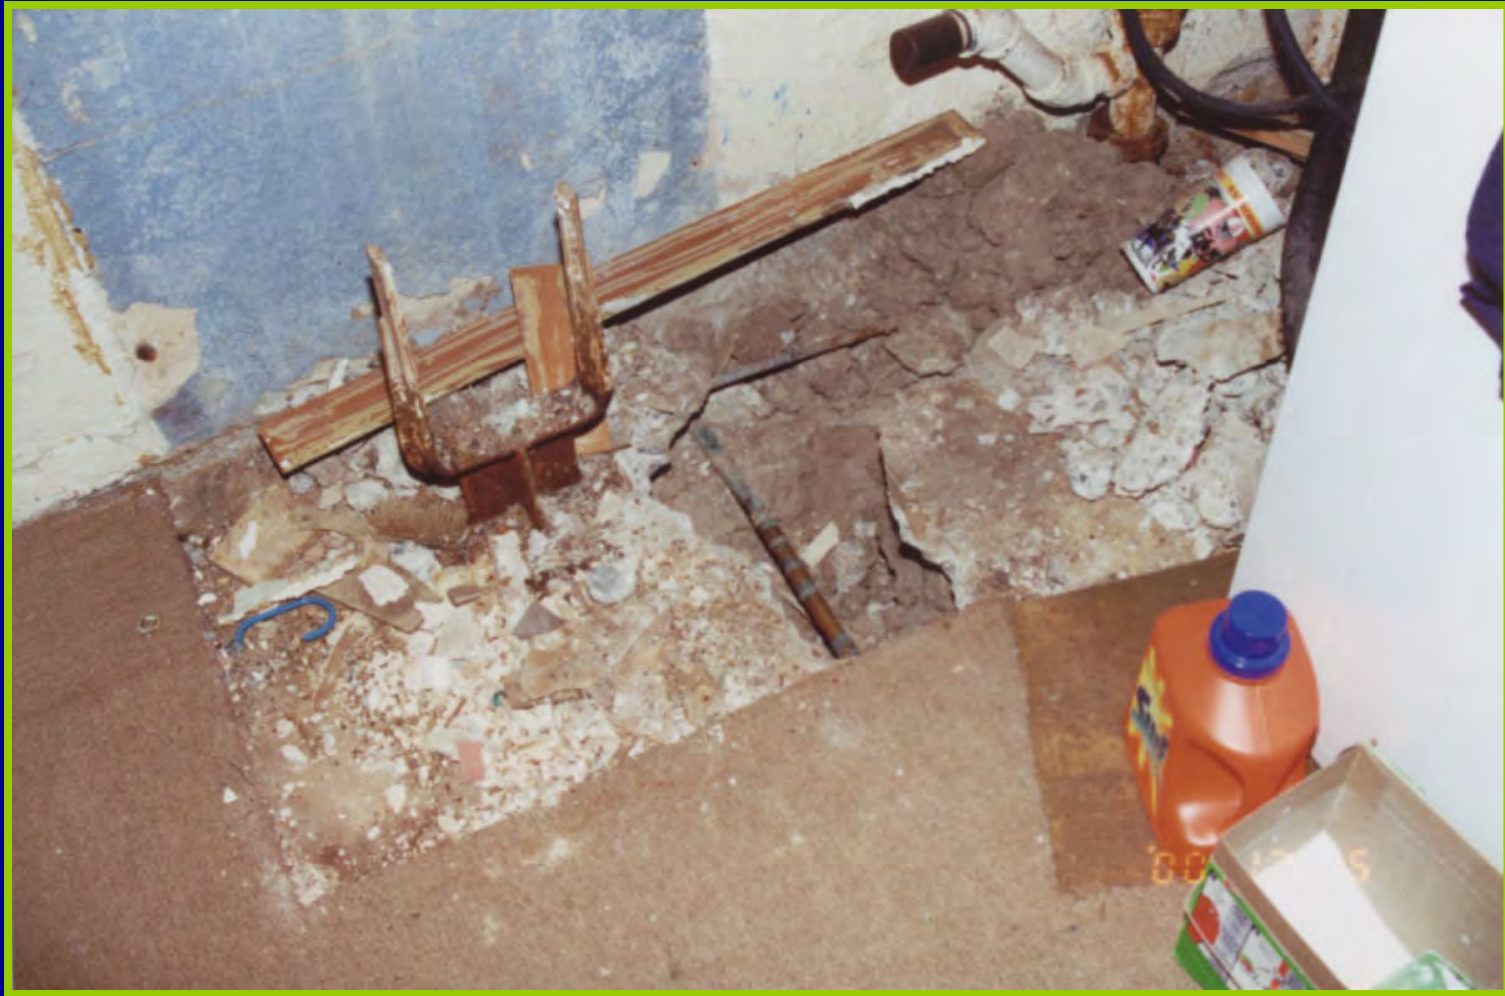
Location of Pipe Separation

- Owner discovered that no water pressure existed on April 15, 2000
- Water going through meter; meter turned off
- On April 17, plumber located leak beneath laundry room slab.
- Broke slab and found copper water supply pipe had completely separated
- Pipe was repaired.
