Forensic Engineering = Causes of Distress in Concrete

David W. Fowler

The University of Texas at Austin

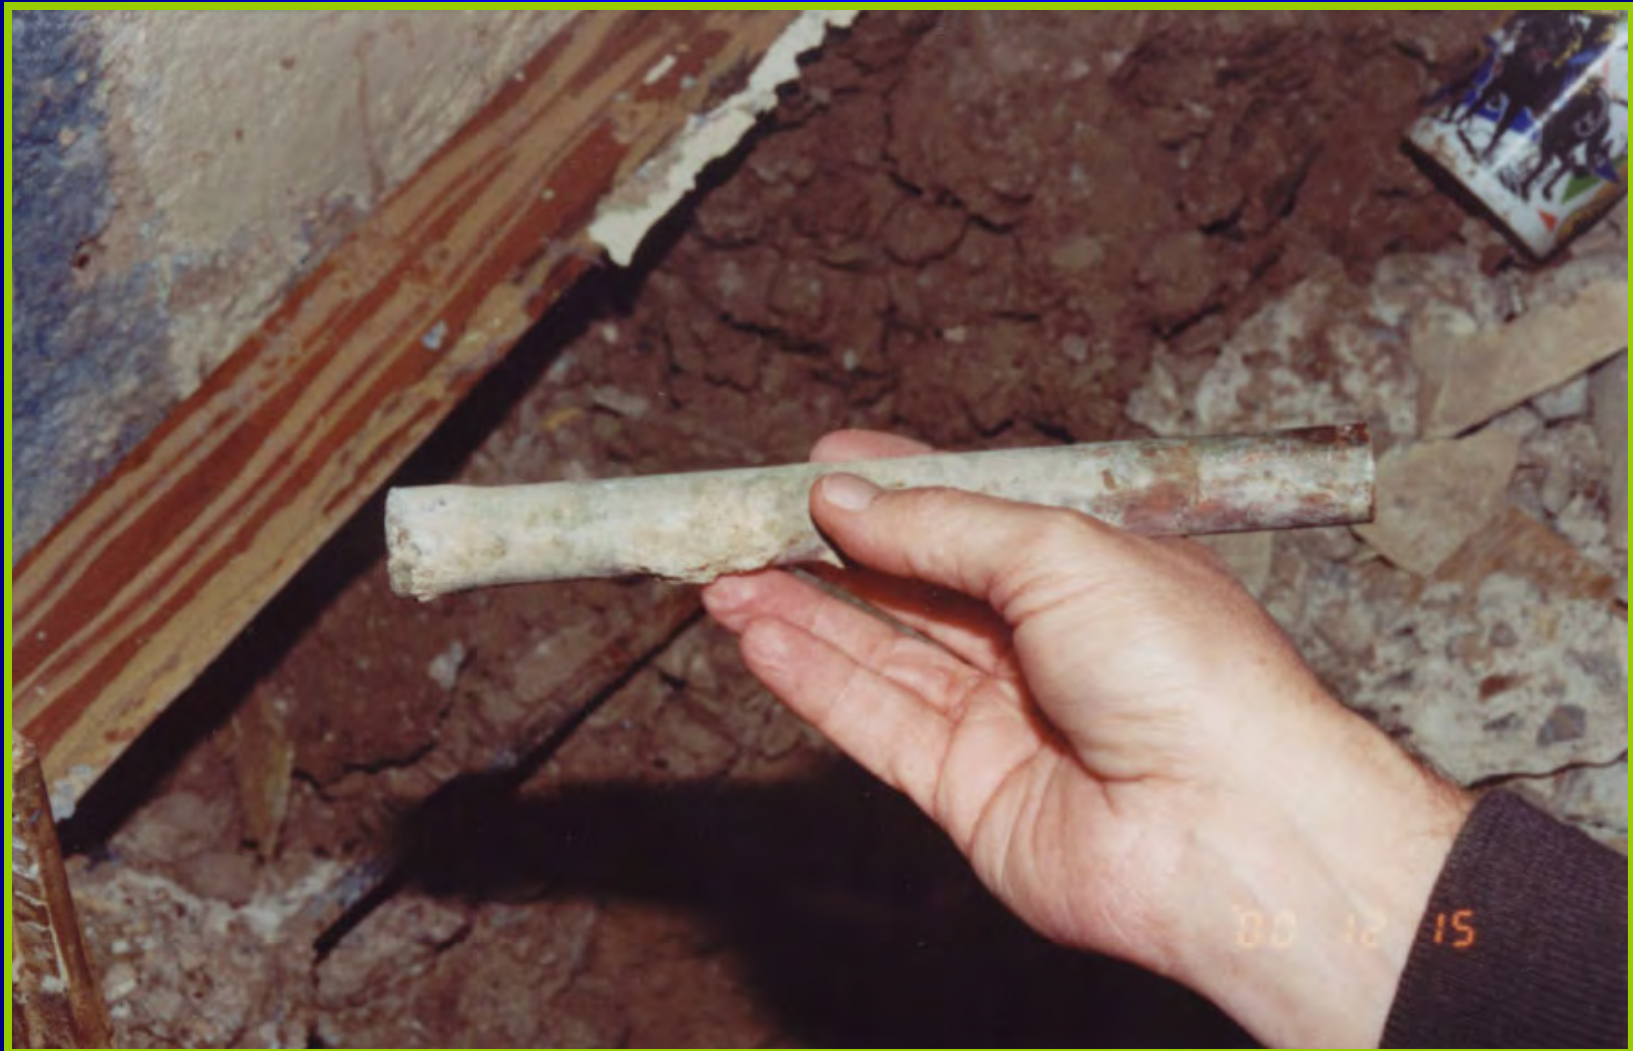
Cut Out Section of Pipe

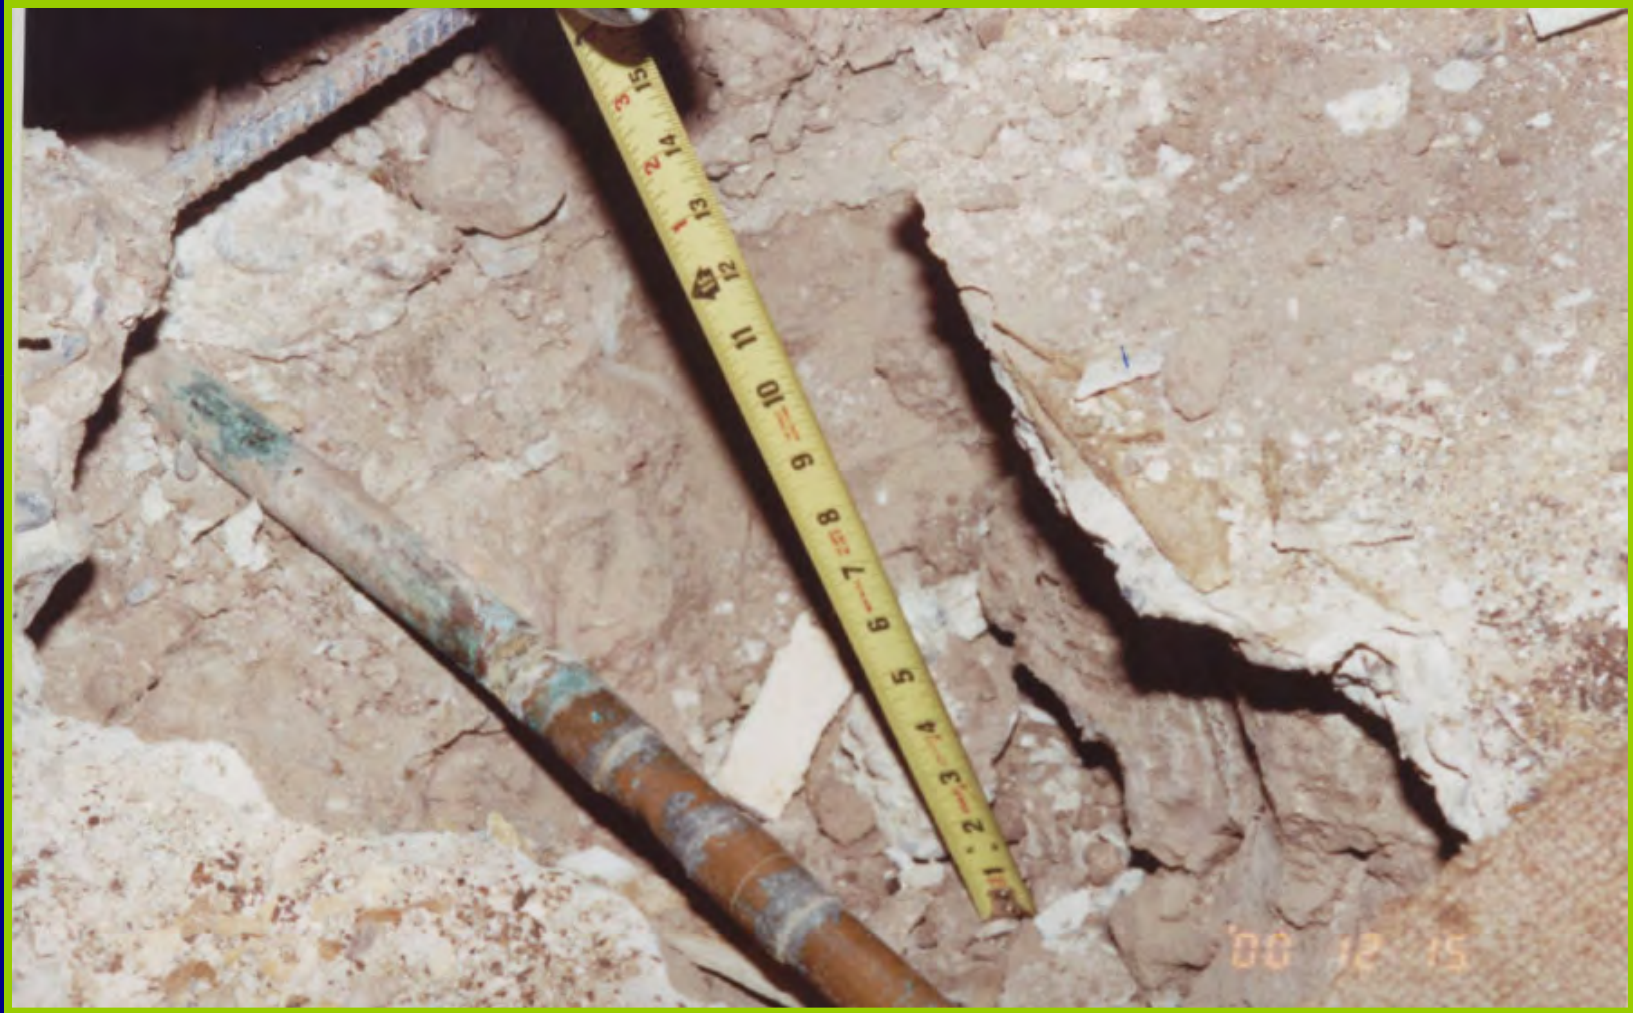
Repaired Water Pipe

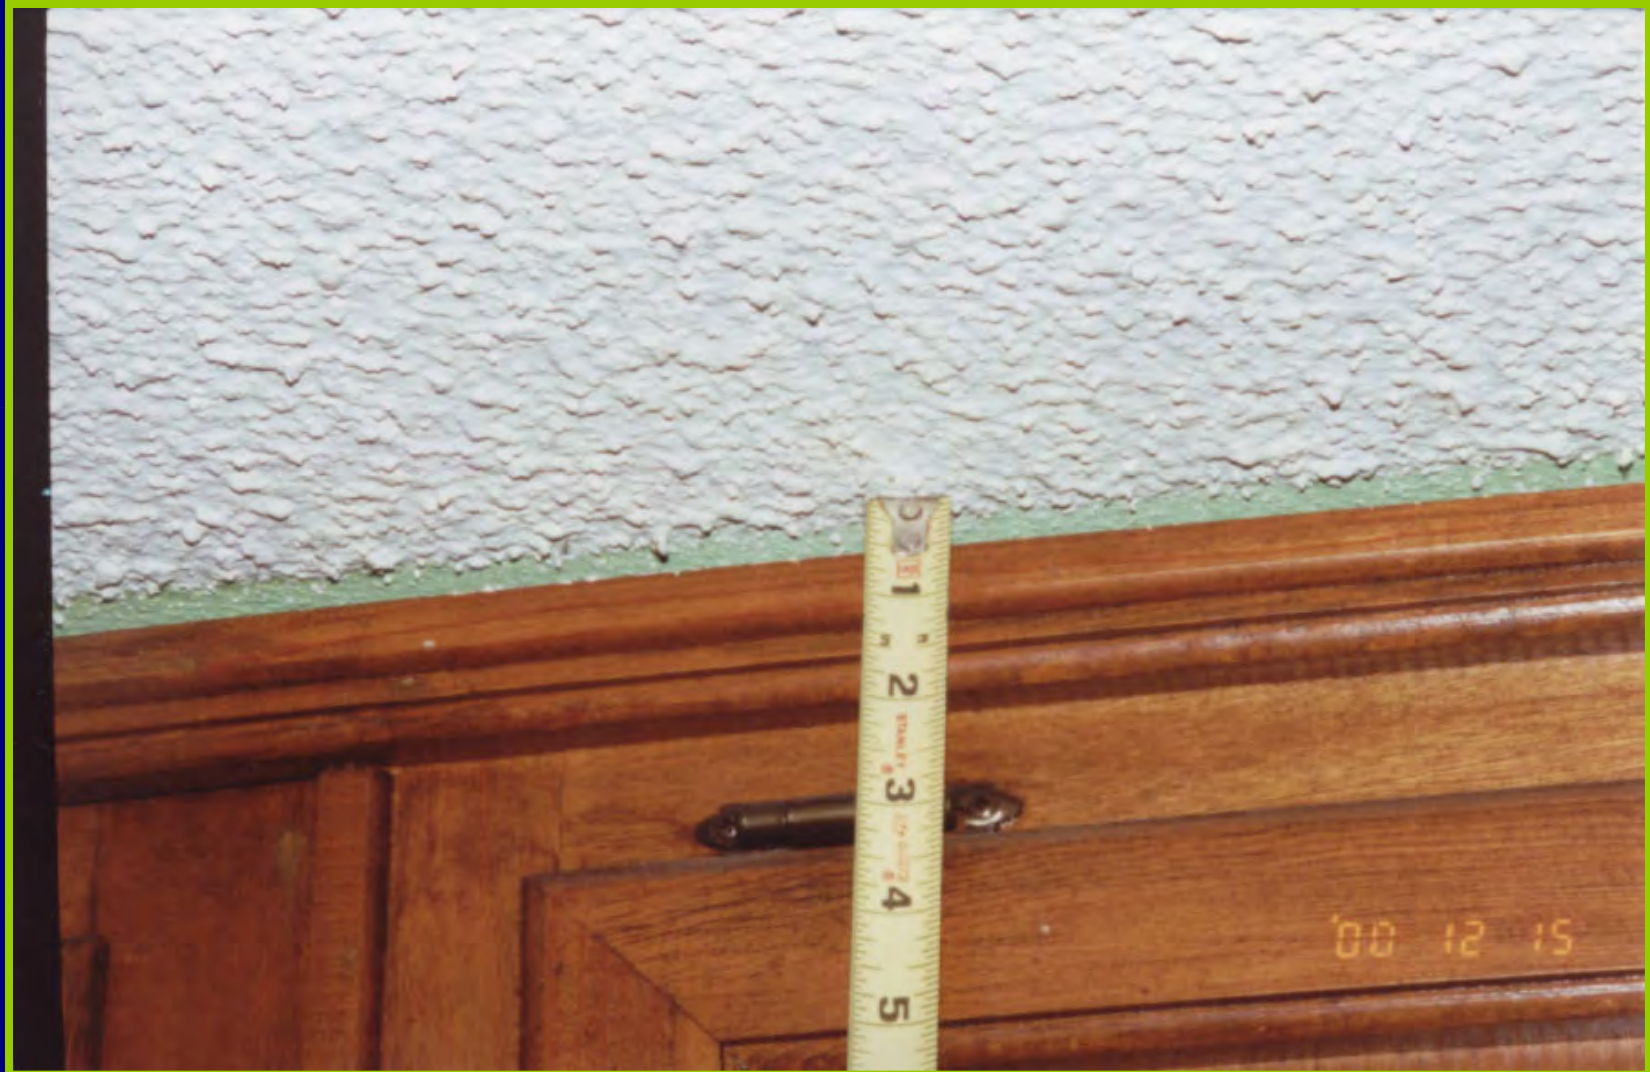
Separation of Cabinet at Ceiling

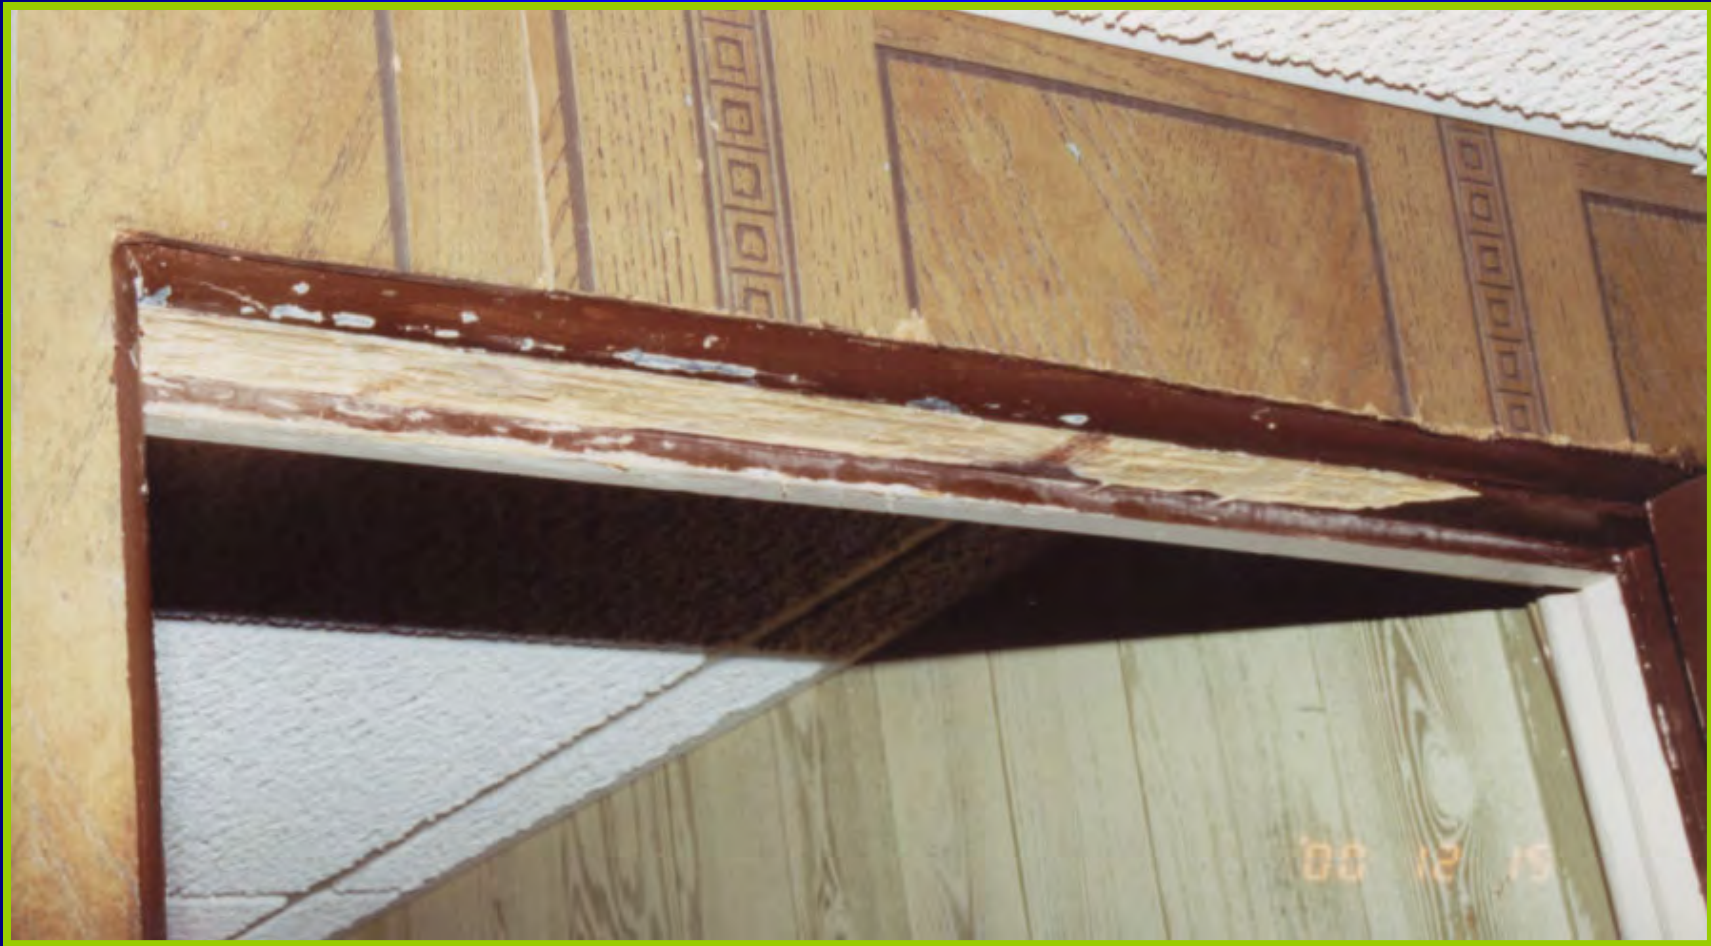
Door Frame Planed due to Sticking Door

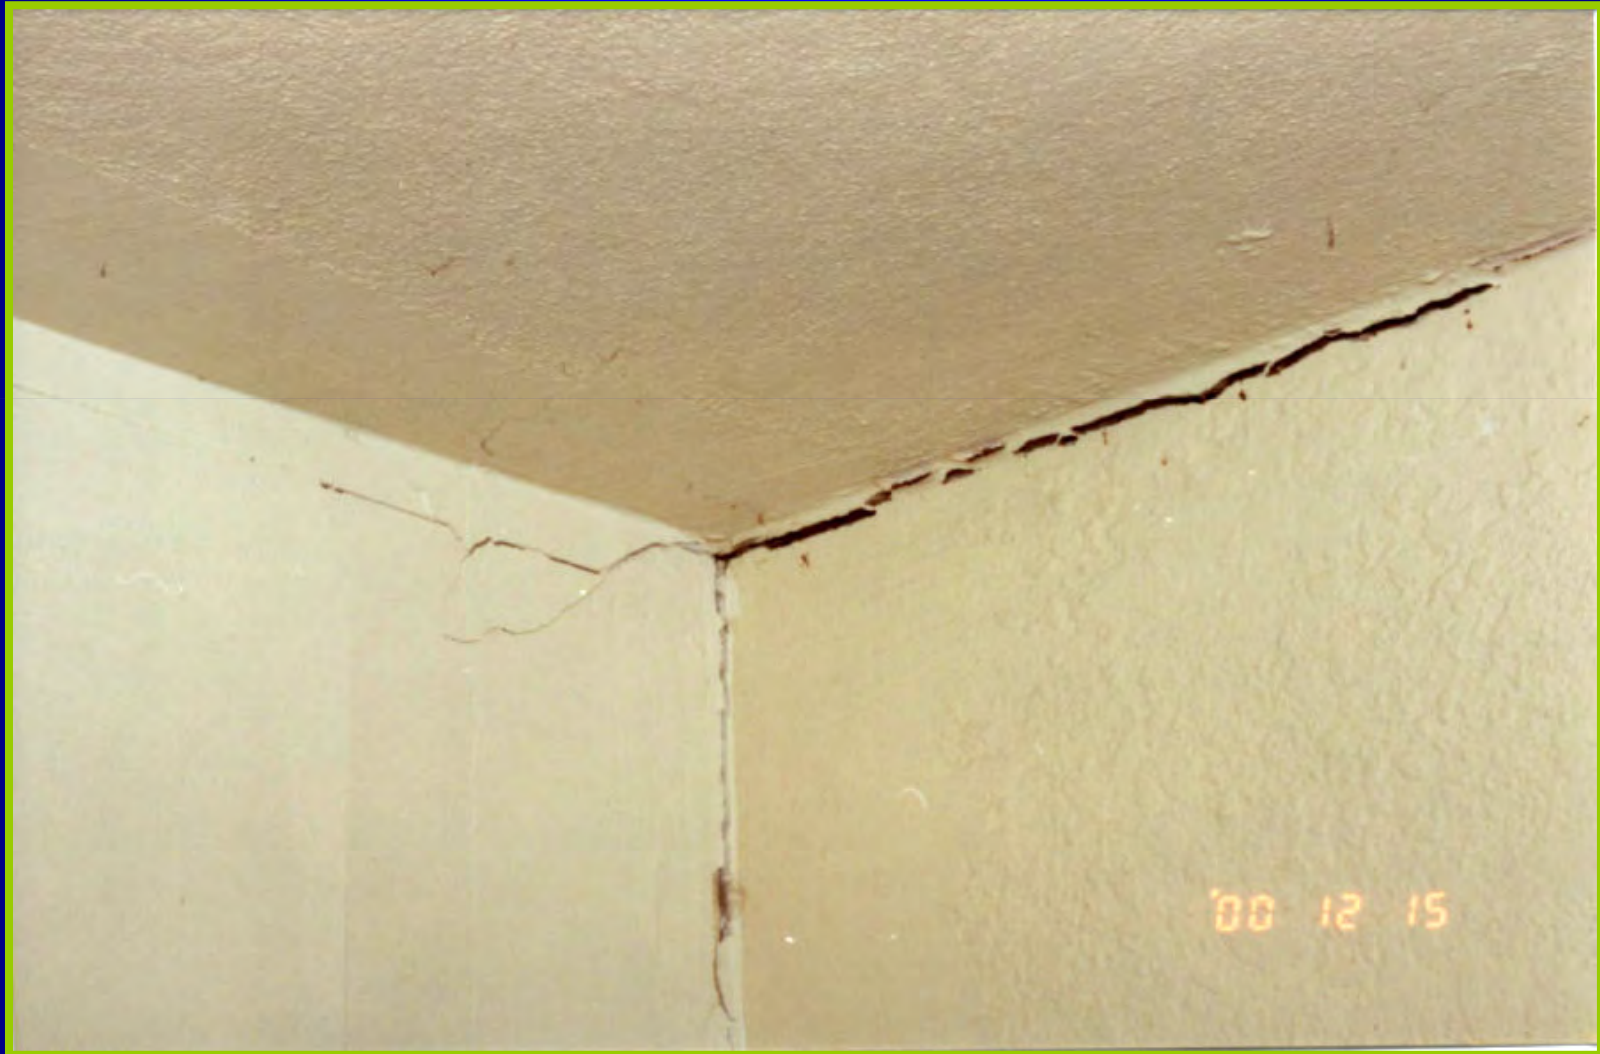
Wall-Ceiling Crack

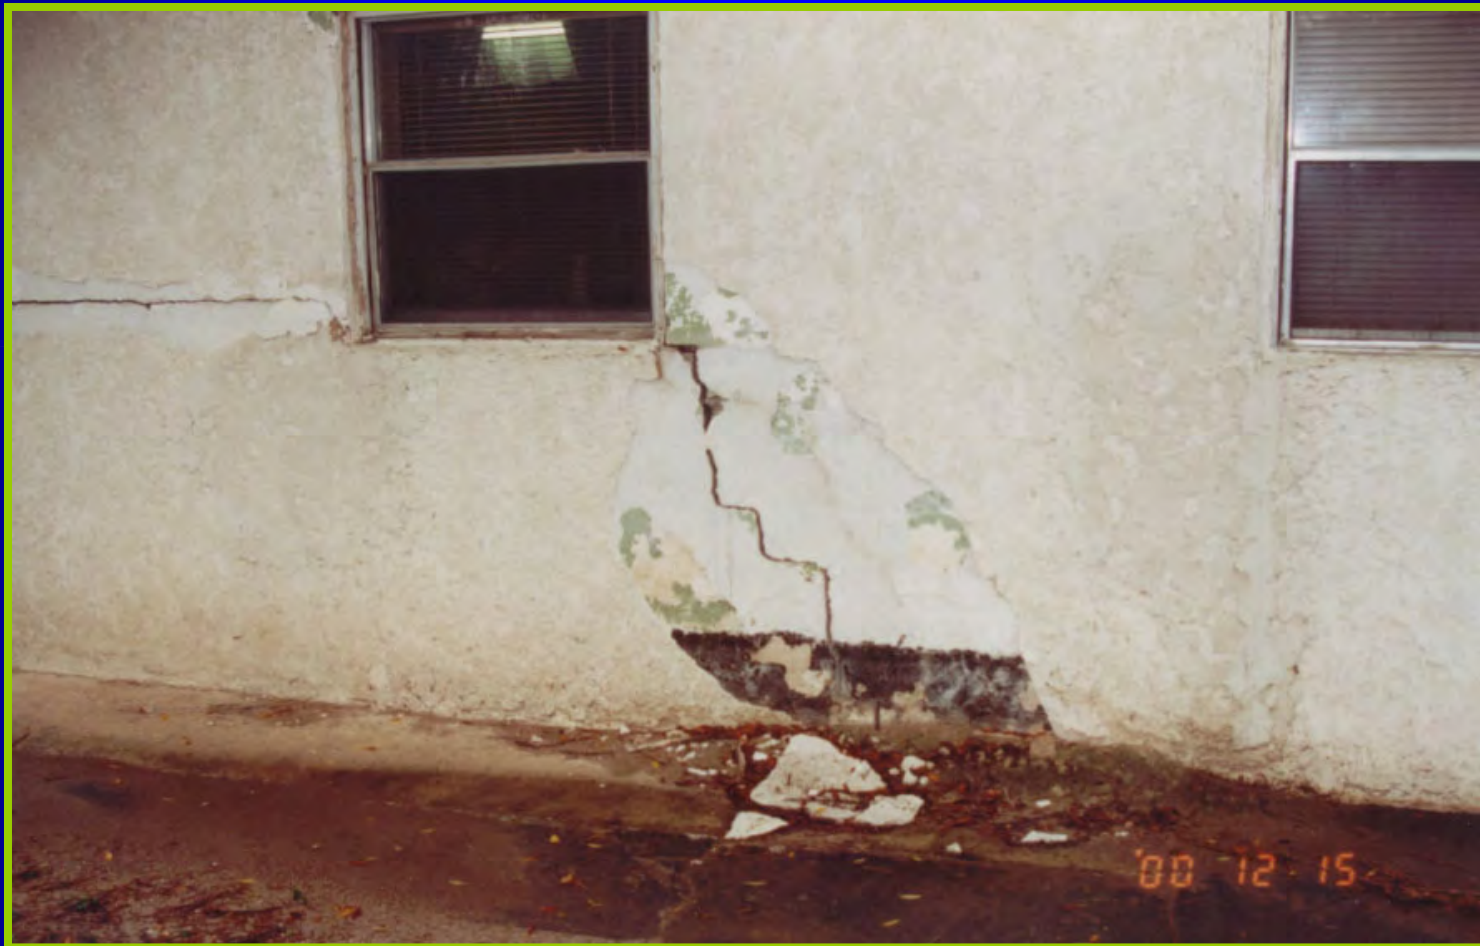
Severe Wall Cracking on North Side

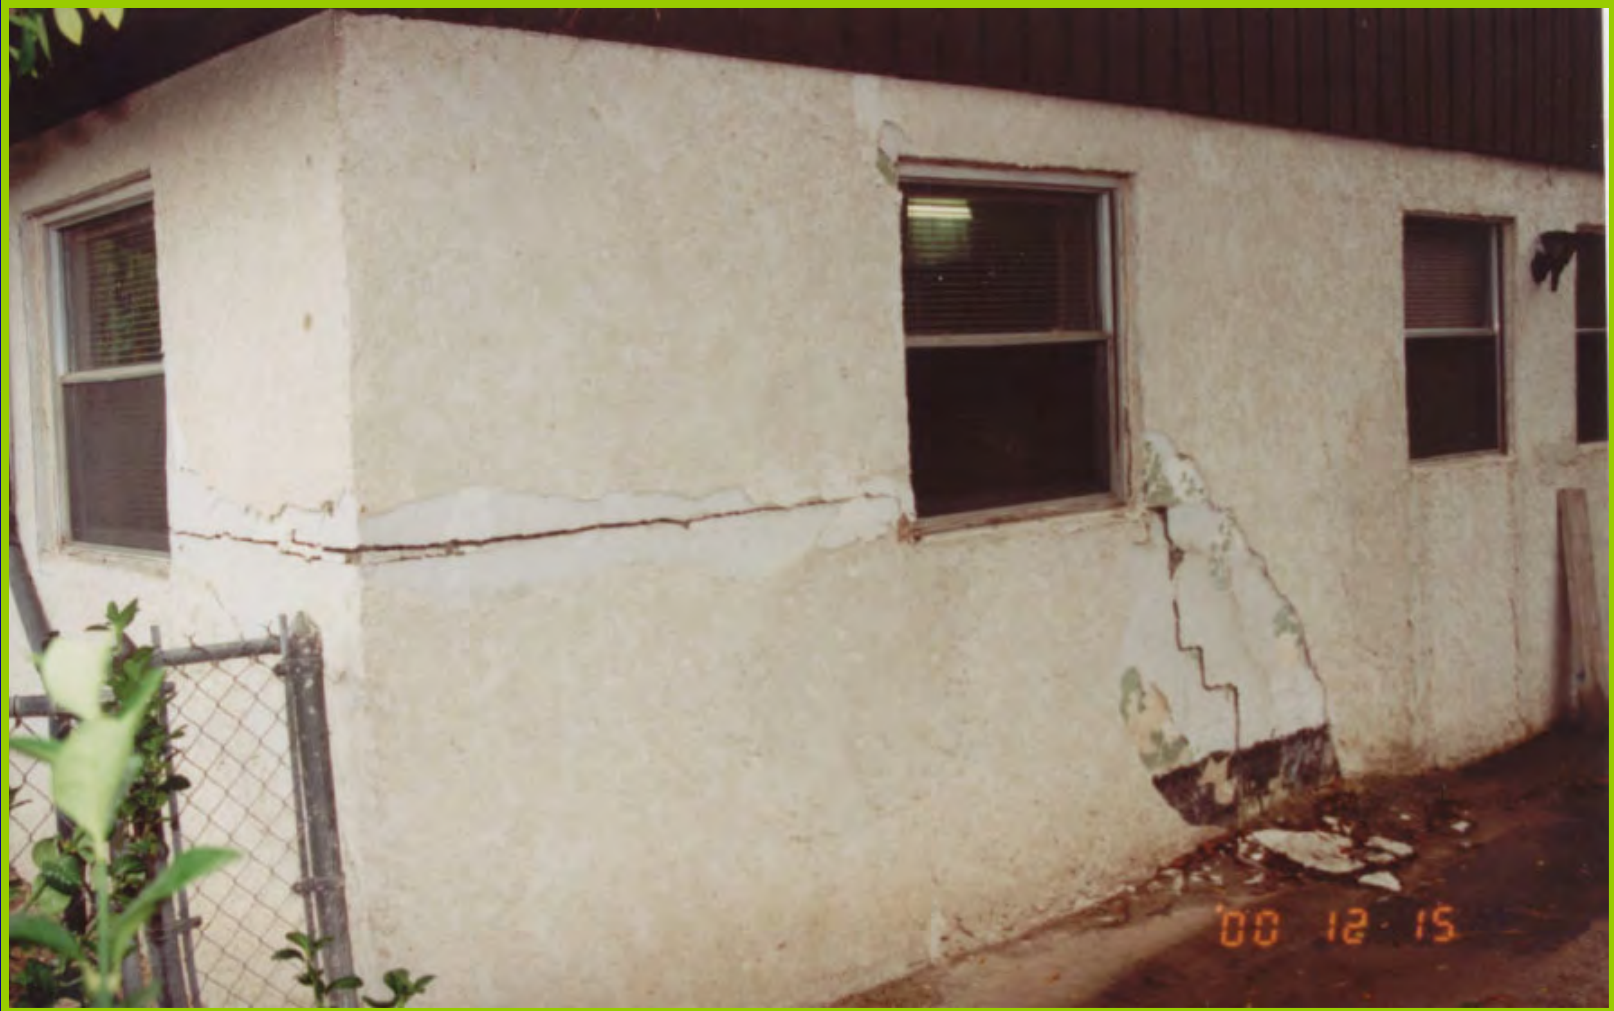
Cracking at NE Corner

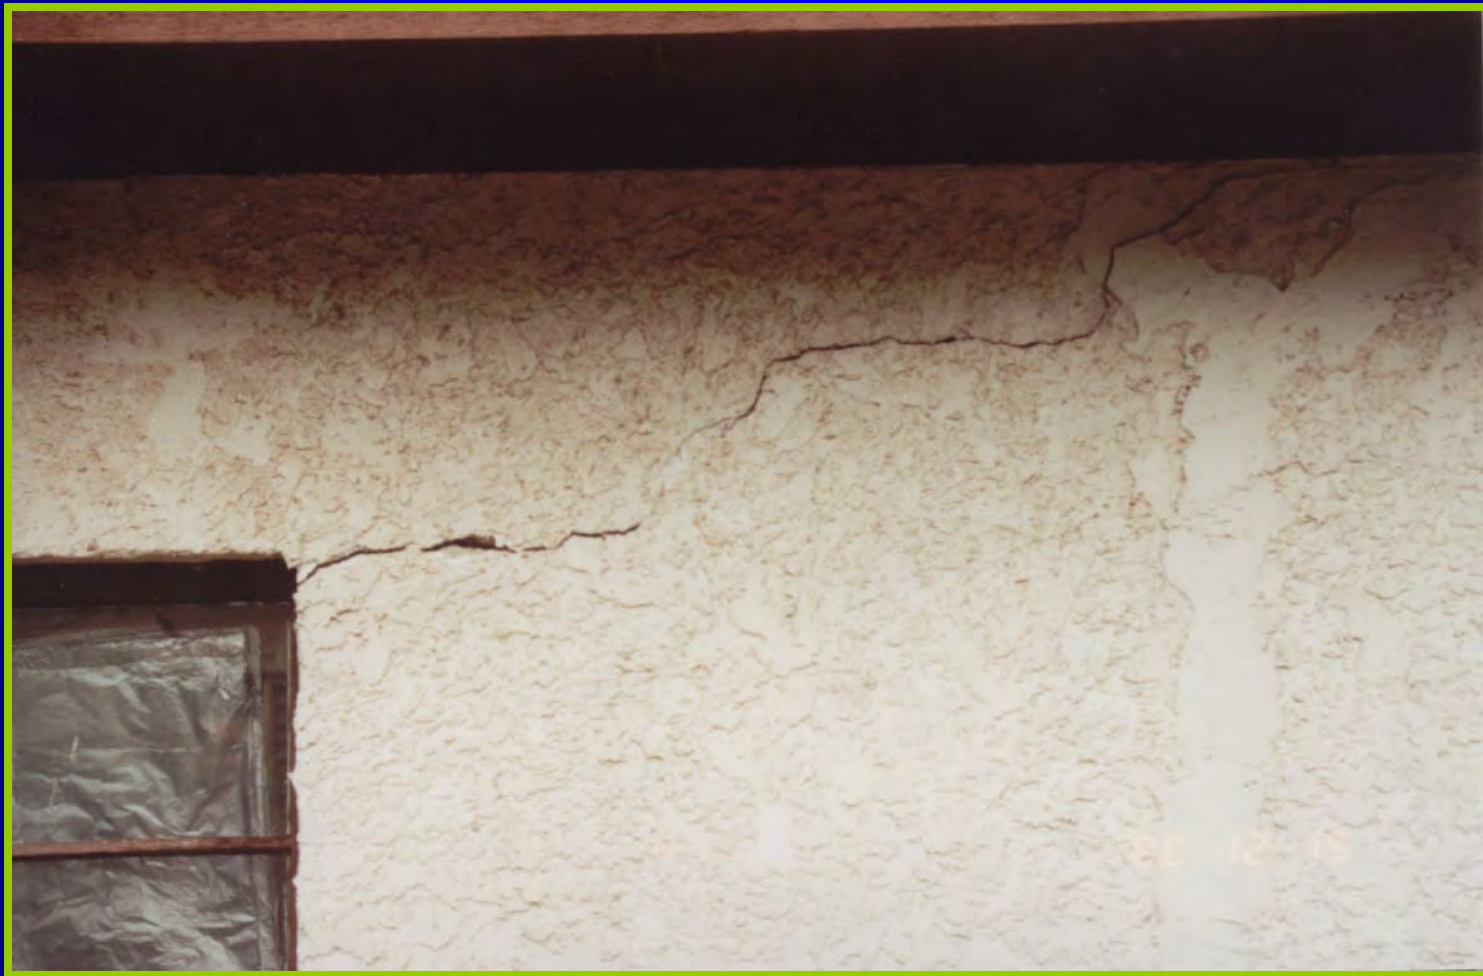
Stucco Cracking at Window

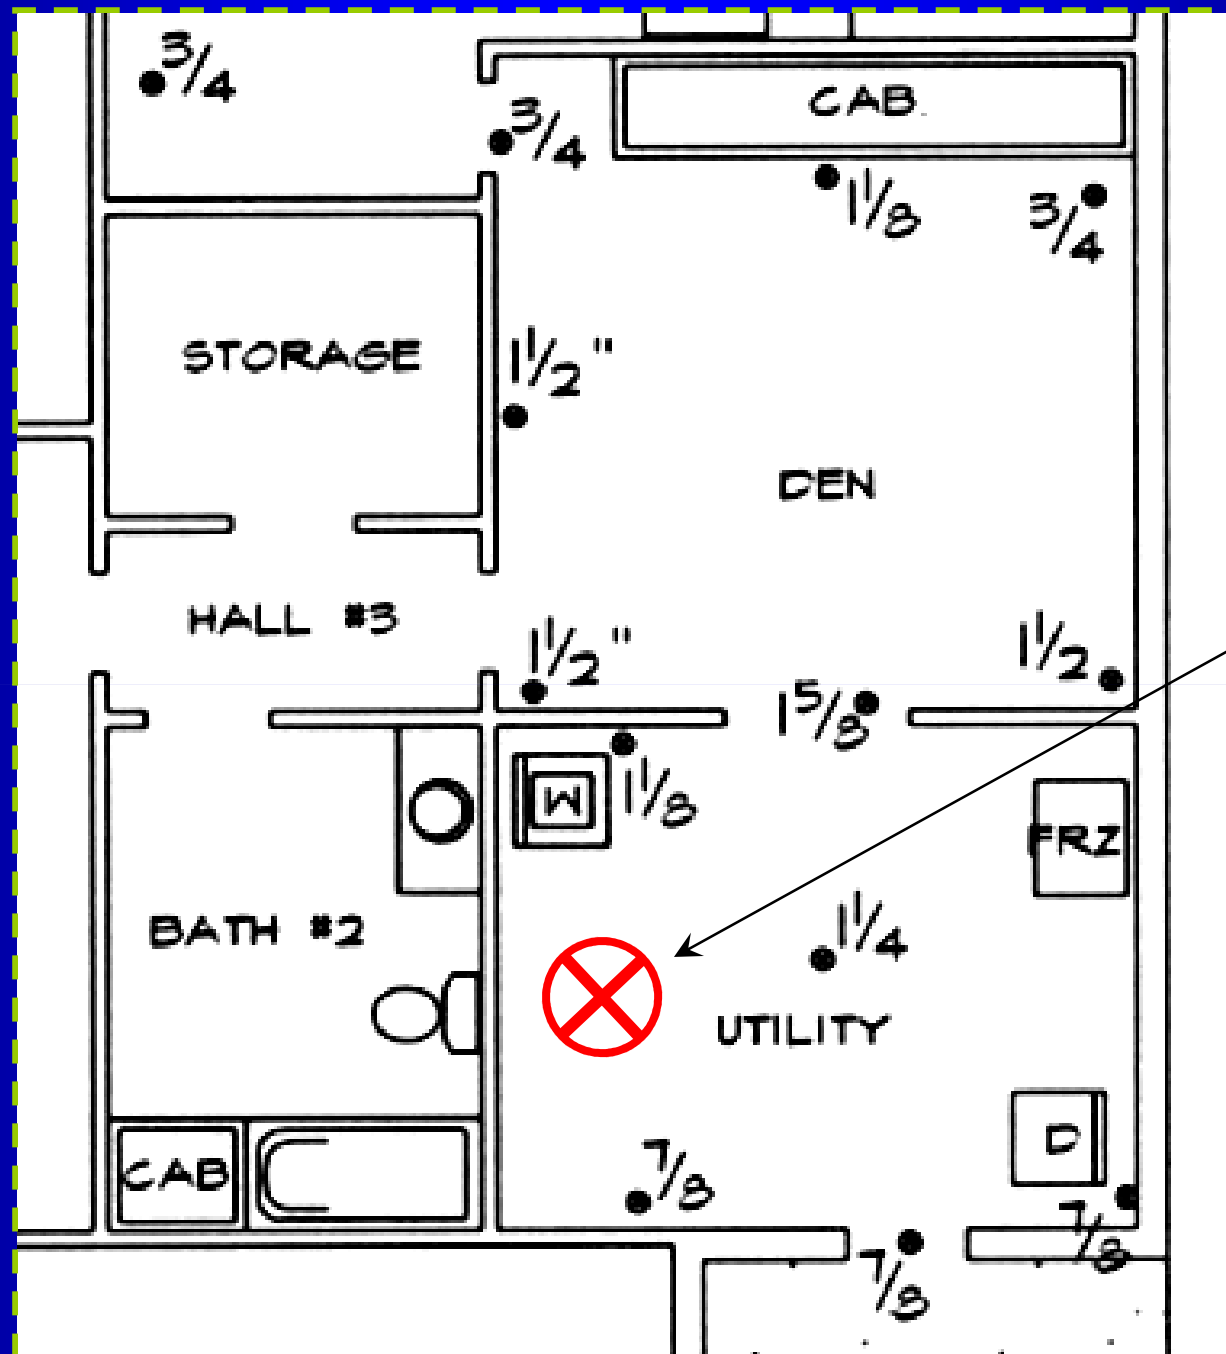
Leak

- Floor levels were taken in June 2000 by defendant's expert; showed a "mound" in vicinity of leak.
- Floor levels taken by me in December 2000 were similar to those taken by defendant's expert.

- However, defendant's report provided strong supporting evidence for leak as being the cause.
 - Levels (Found “mound” near leak)
 - Water usage; admitted that leak probably resulted in loss of 6000 gal.
 - Documented cracking (except N-S crack)

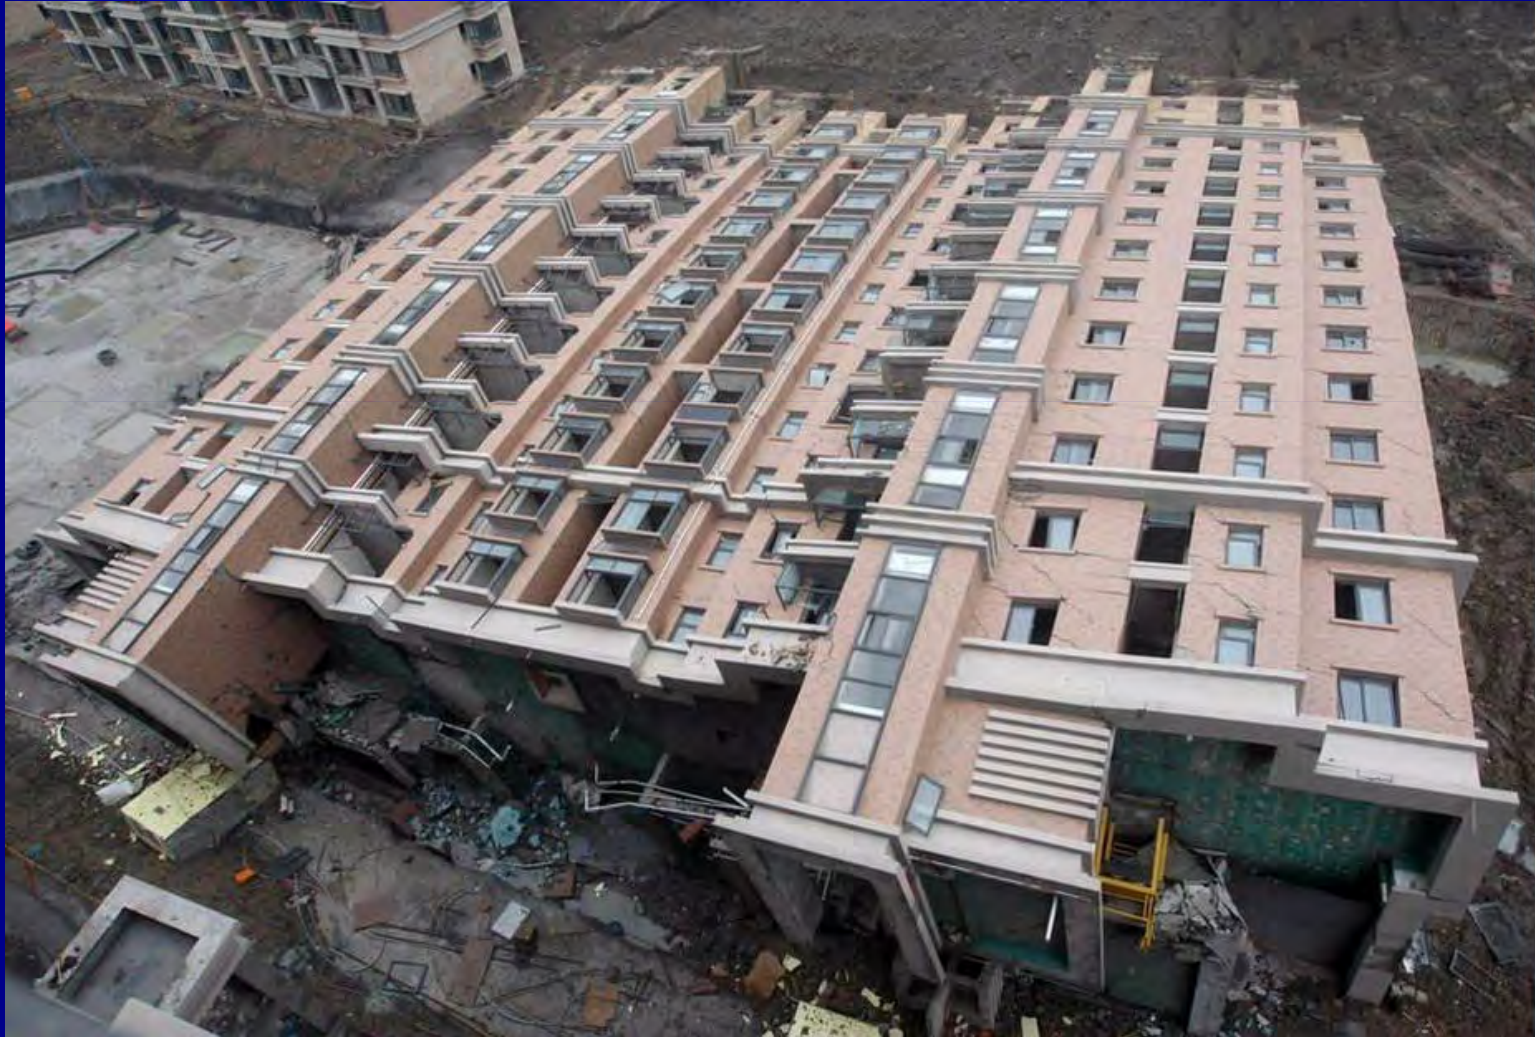
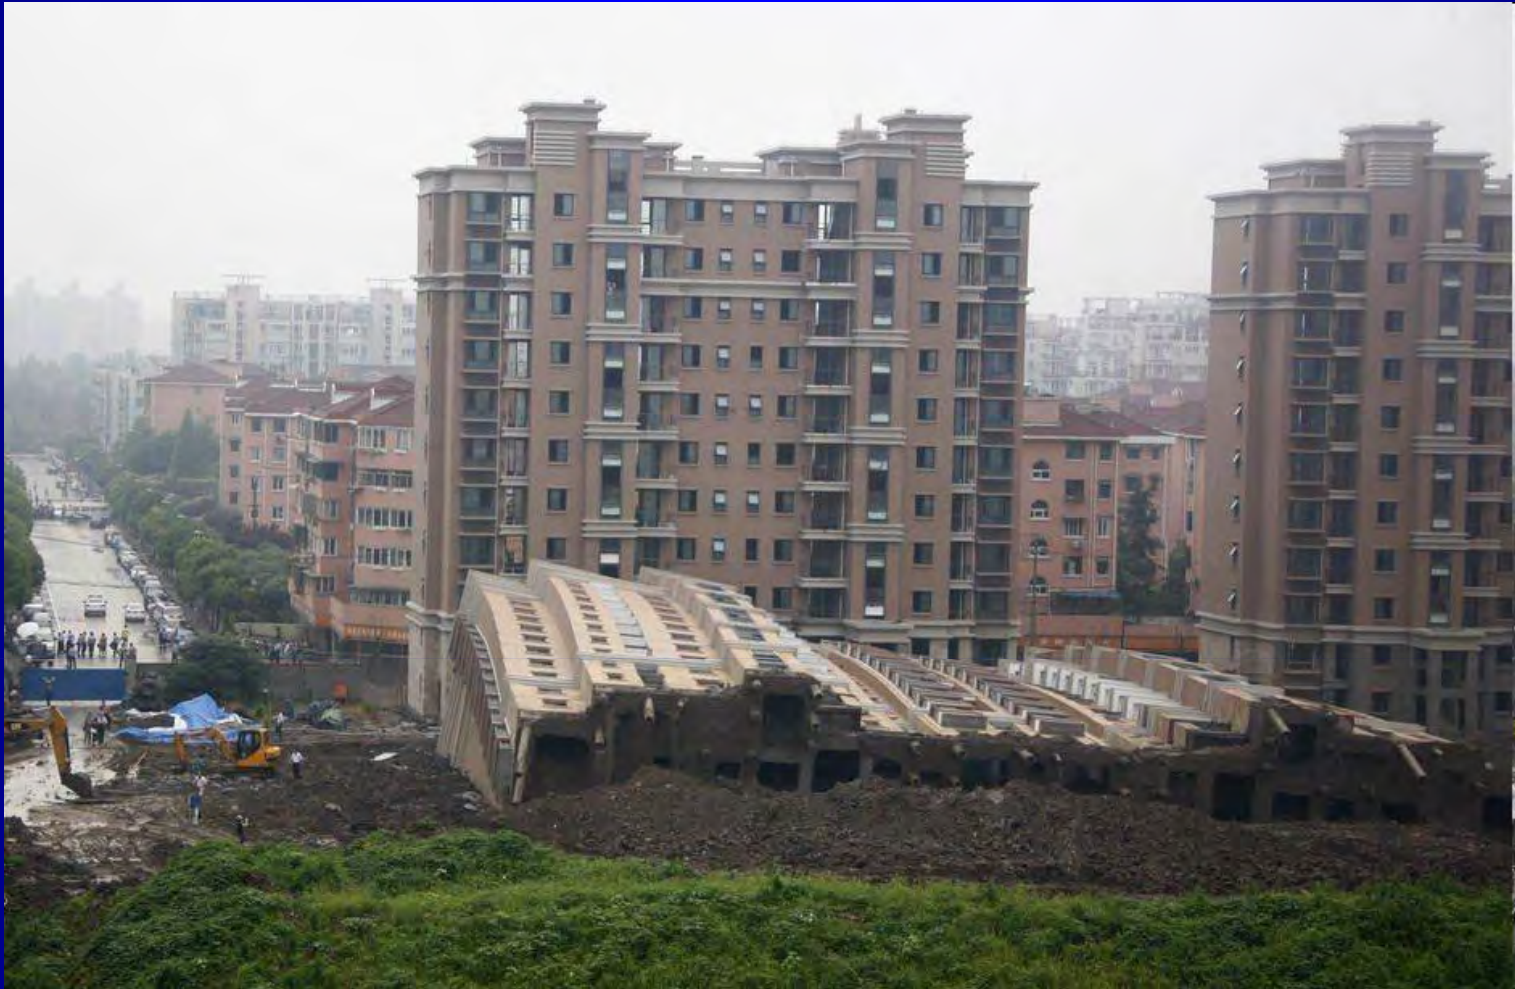
A 12-STORY BUILDING LYING ON THE GROUND in CHINA

- An underground garage was being dug on the south side, to a depth of 4.6 meters
- The excavated dirt was being piled up on the north side, to a height of 10 meters
- The building experienced uneven lateral pressure from south and north
- This resulted in a lateral pressure of say 3,000 tonnes, which was greater than what the pilings could tolerate. Thus the building toppled over in the southerly direction

If the buildings were closer together there could also have been a domino effect.

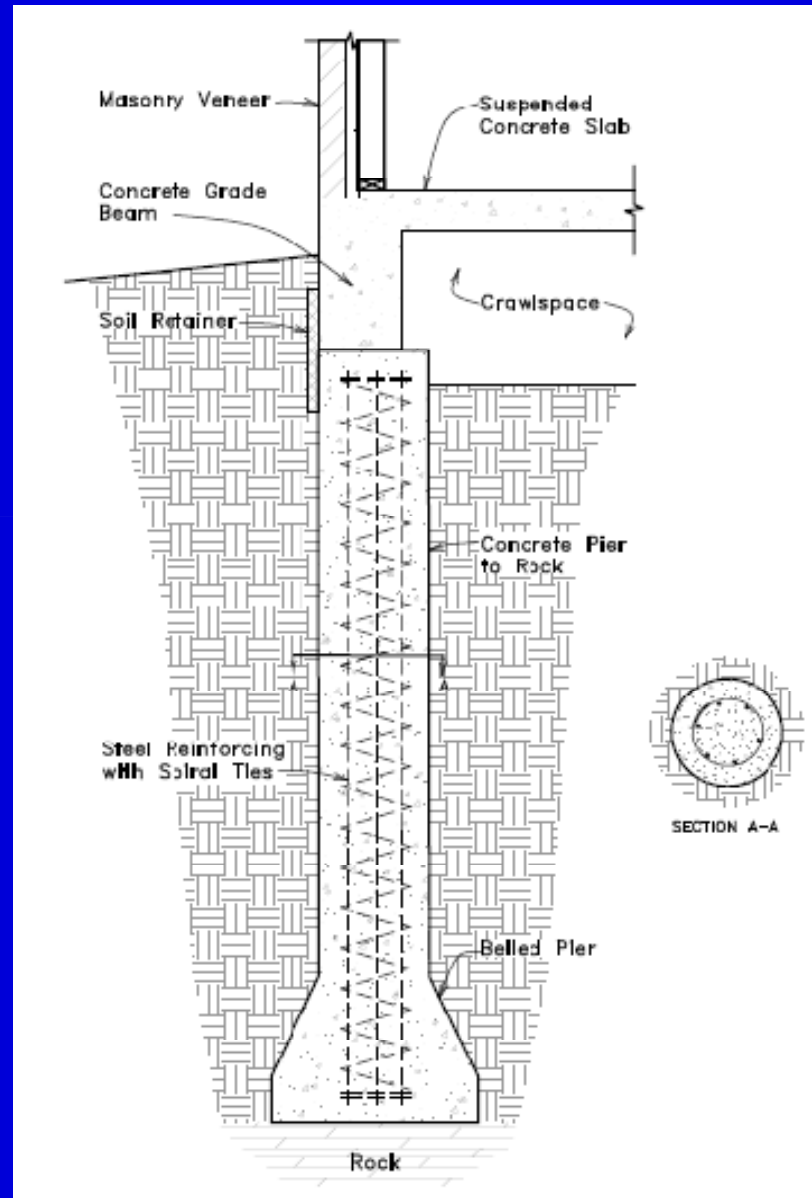
Pier as designed

- An educational building for a church was constructed on expansive clay.
- The structural engineer had a soil investigation performed and designed the piers to go about 20 ft. into the clay.

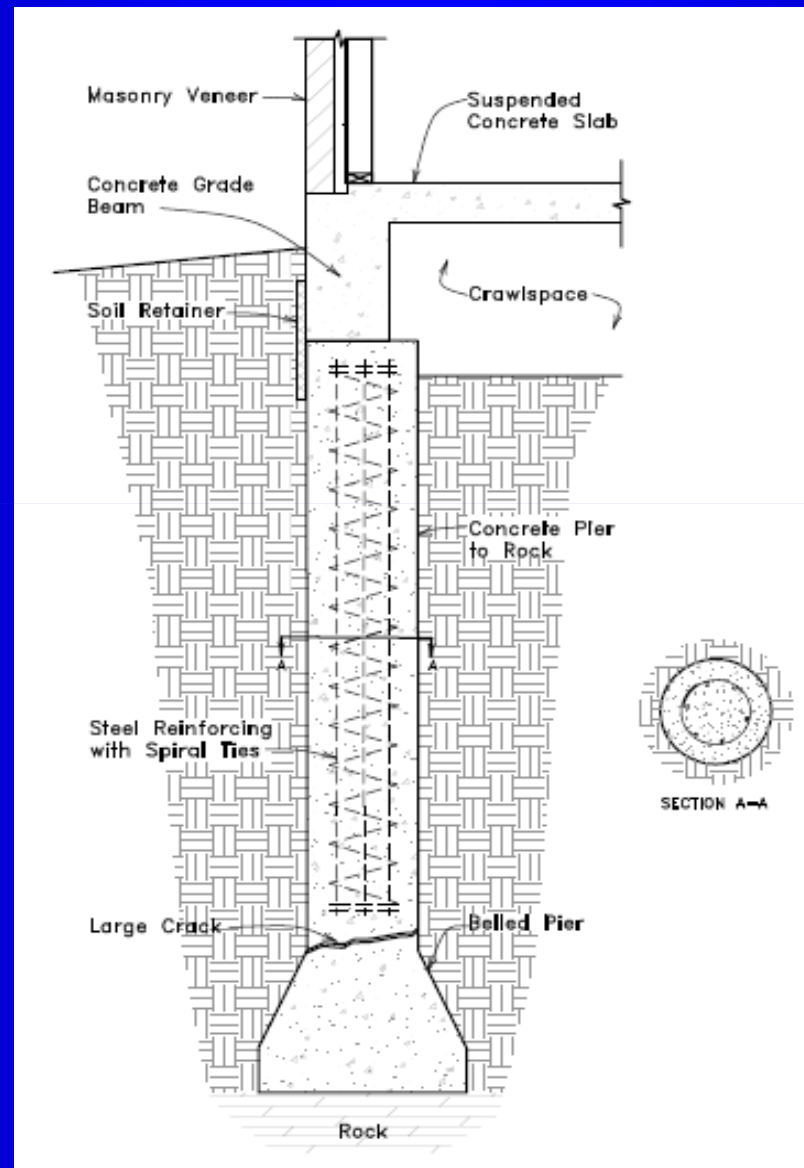
Pier as built

- The crack was at the top of the bell.
- A close inspection indicated no steel across the crack.
- The steel stopped just above the bell.
- What happened?

- The total uplift provided by the soil on the pier is over 100,000 lbs.
- Had the steel been placed to the bottom of the bell, it would not have stopped the crack from forming but it would have kept the crack from opening wide.
- The bell would have served as an anchor preventing the pier from moving upward.
- But this illustrates the force clay can exert in lifting up a structure.

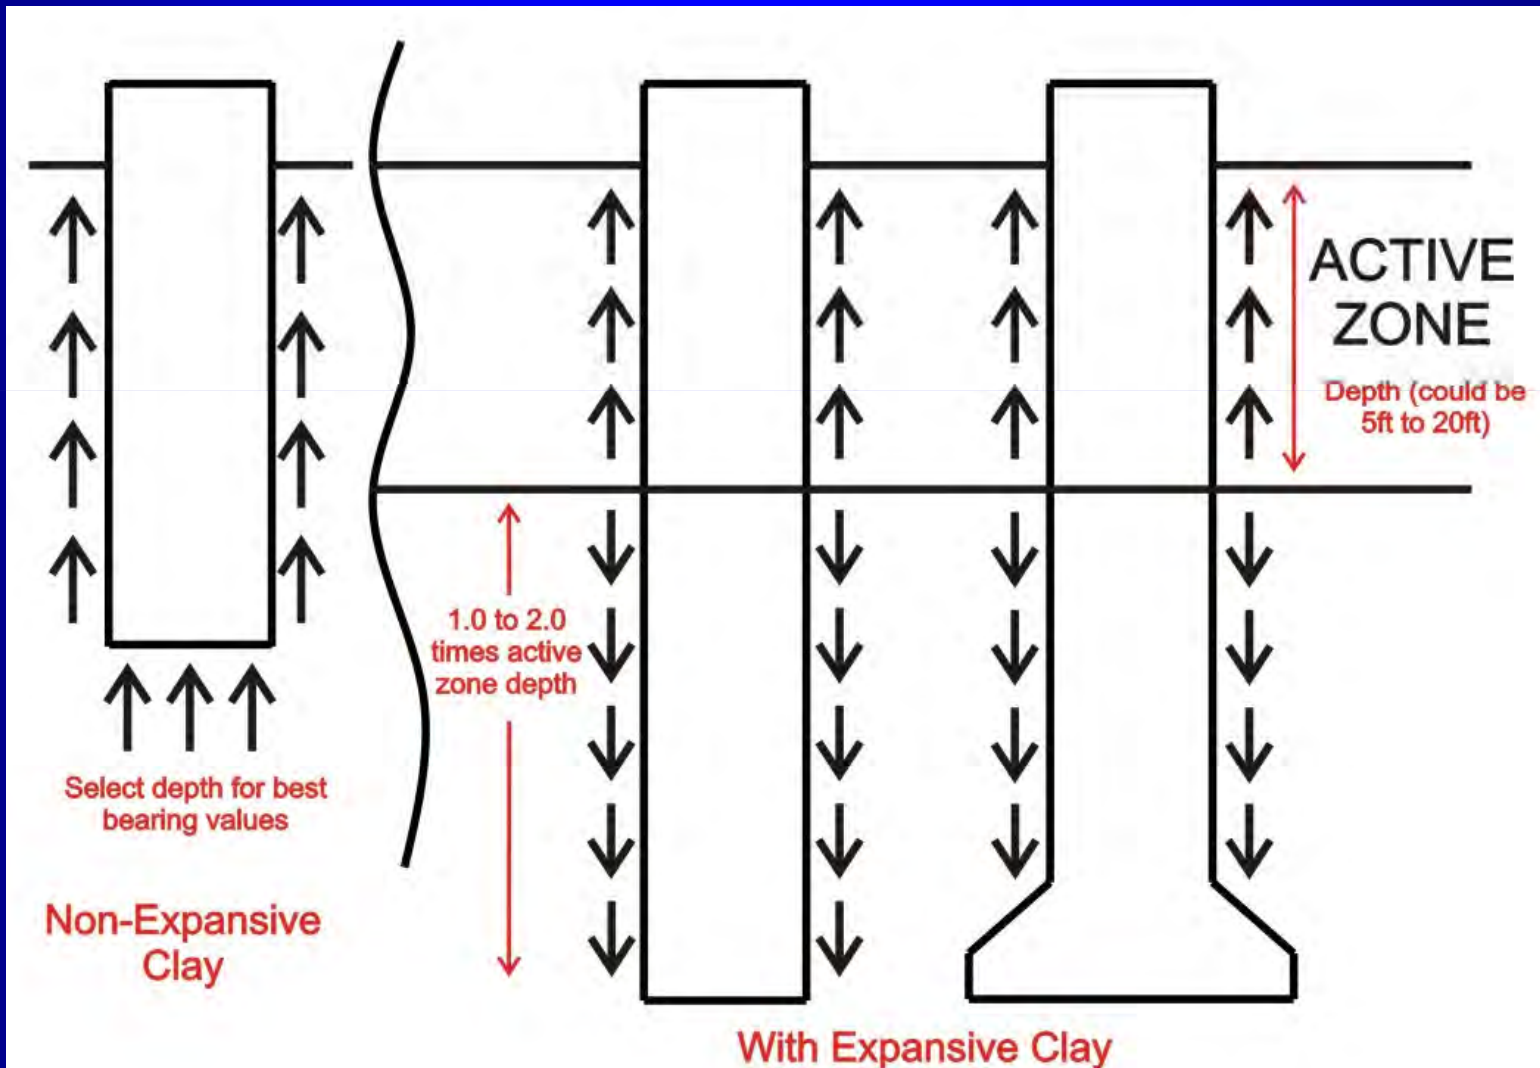
Design of Pier Foundations

- When the drought broke, the moisture caused swelling of the soil, the clay in the active zone created skin friction on the surface of the pier and lifted it up.
- But how could the skin friction uplift break the concrete?
- How much force would it take to break the pier?
- How much stress would it take to break the concrete?

- Stress required to break concrete in tension is about 10% of compressive strength, $0.1 \times 3000 \text{ psi} = 300 \text{ psi}$
- An 18-inch diameter pier has an area of $18 \times 18 \times \pi/4 = 254 \text{ sq. in.}$
- The uplift required to break concrete is $254 \text{ sq. in.} \times 300 = 76,300 \text{ lbs.}$
- But in addition to the upward force to break the concrete, it also has to hold up the weight of the building which is about 30,000 lbs.

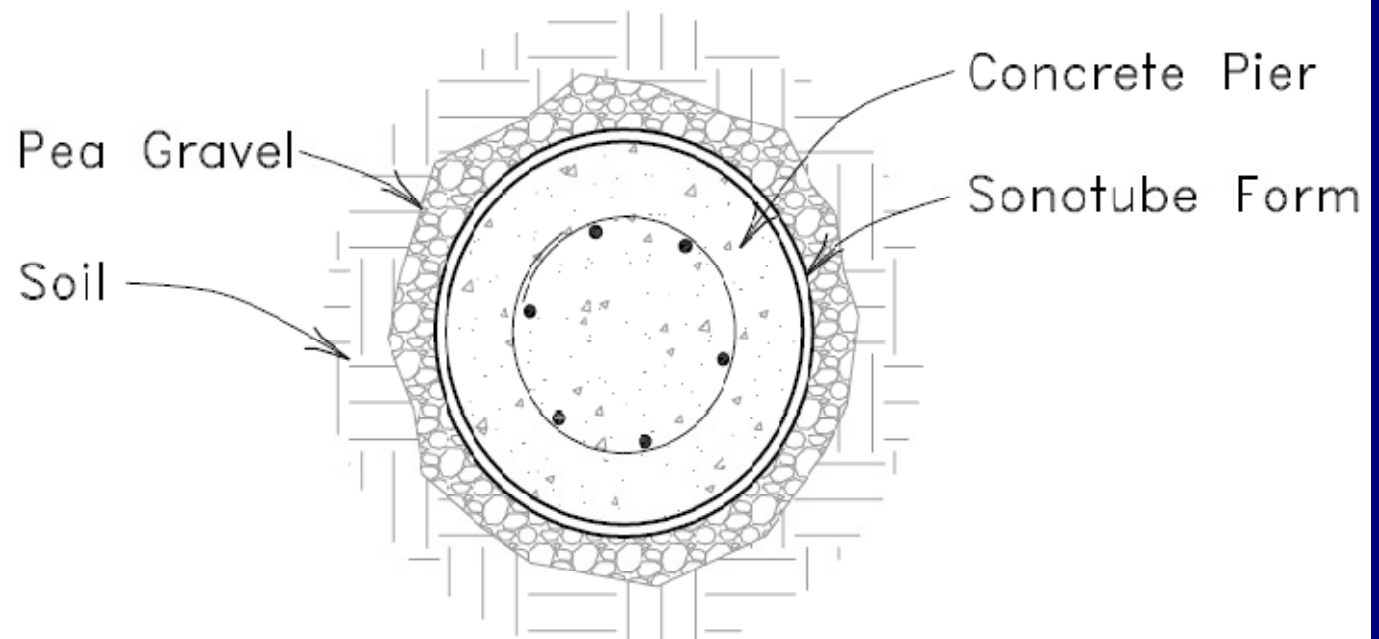
SECTION A-A

Alternate
Design
