AUGUST 2010 MEETING

TECHNICAL PROGRAM

Test Methods for Evaluating Existing Foundations

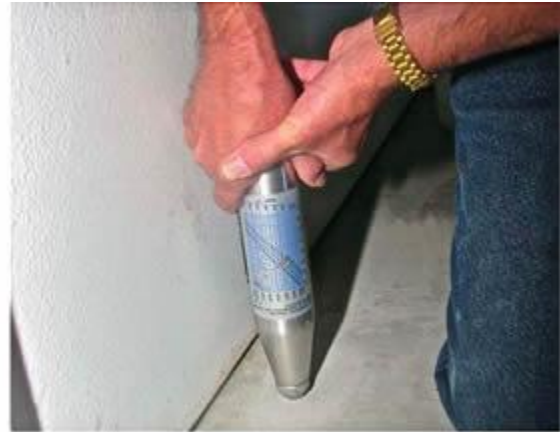
Figure 2.21.1 Rebound hammer testing
