# Case Study #1

**Poor Geotechnical Engineering + Poor  
Structural Engineering + Poor  
Construction**

Location: McKinney, Texas

Size/Use: 60,000 SF – Office Building

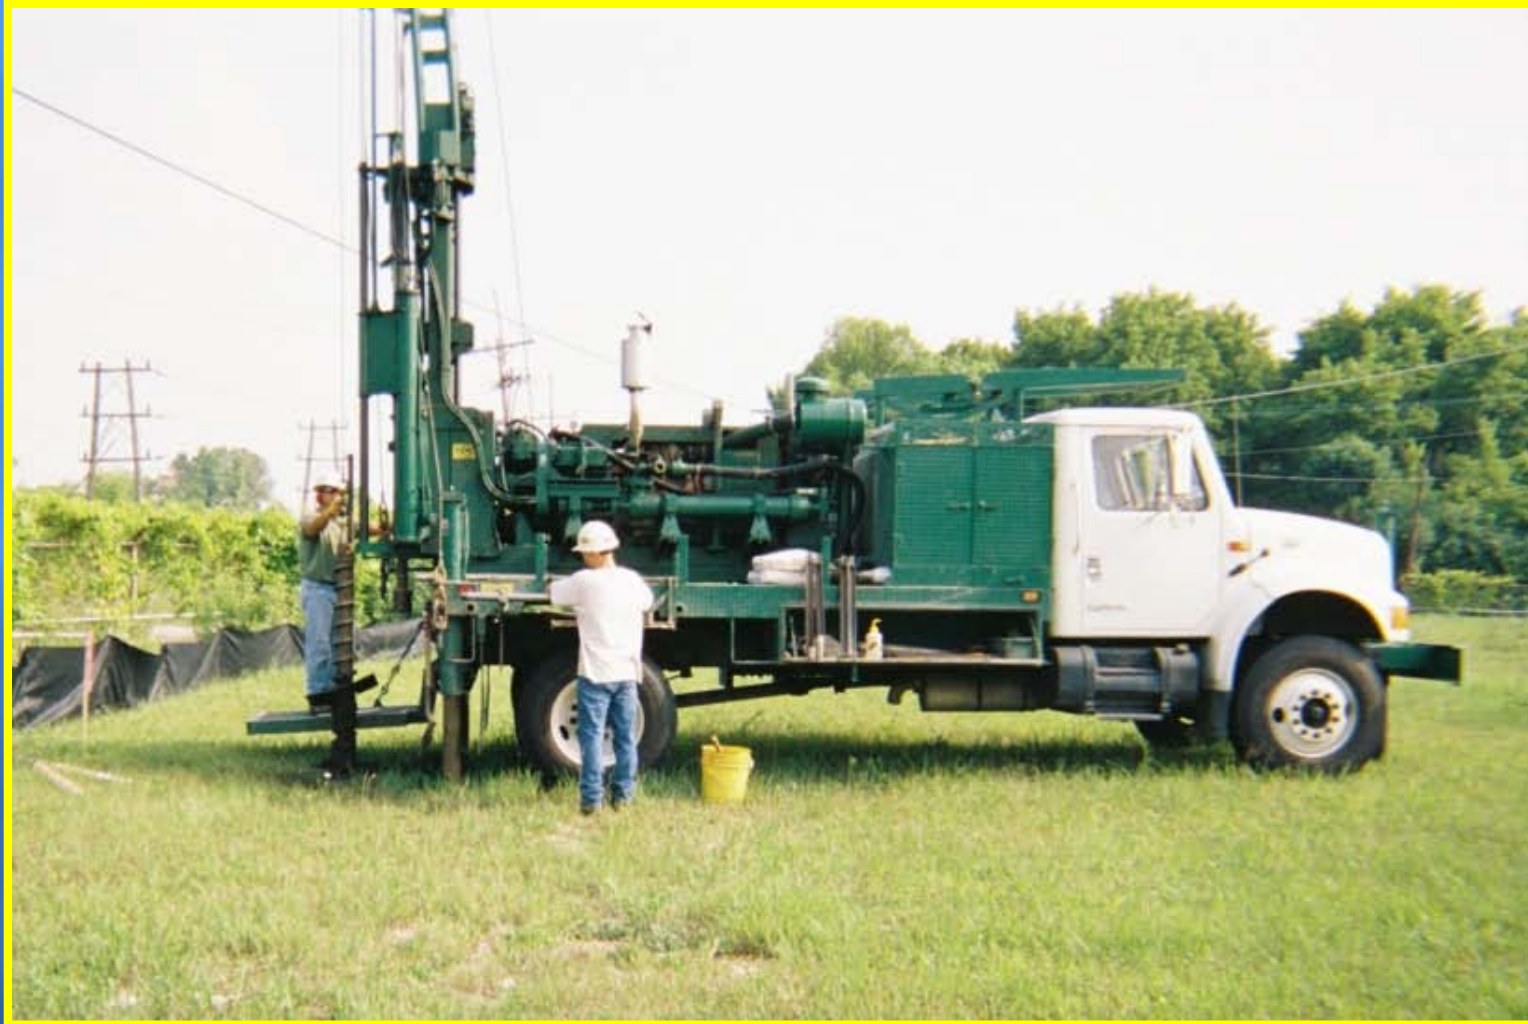
## Geotechnical Engineering

- 2 borings (20'-25' deep) performed in 60,000+ s.f. building pad:
  - Fat clays at 4' to 8';
  - Calcareous clays below 12';
  - Gray limestone at 15' to 20'

- Fat clays:
  - PI = 35% to 47%
  - Swell potential from 0.0% to 1.0%
  - Potential Vertical Rise (PVR) = 2" to 3"

- ❑ Insufficient number of pre-construction borings performed
- ❑ No moisture content specification for compaction
- ❑ Miscalculated (underestimated) PVR

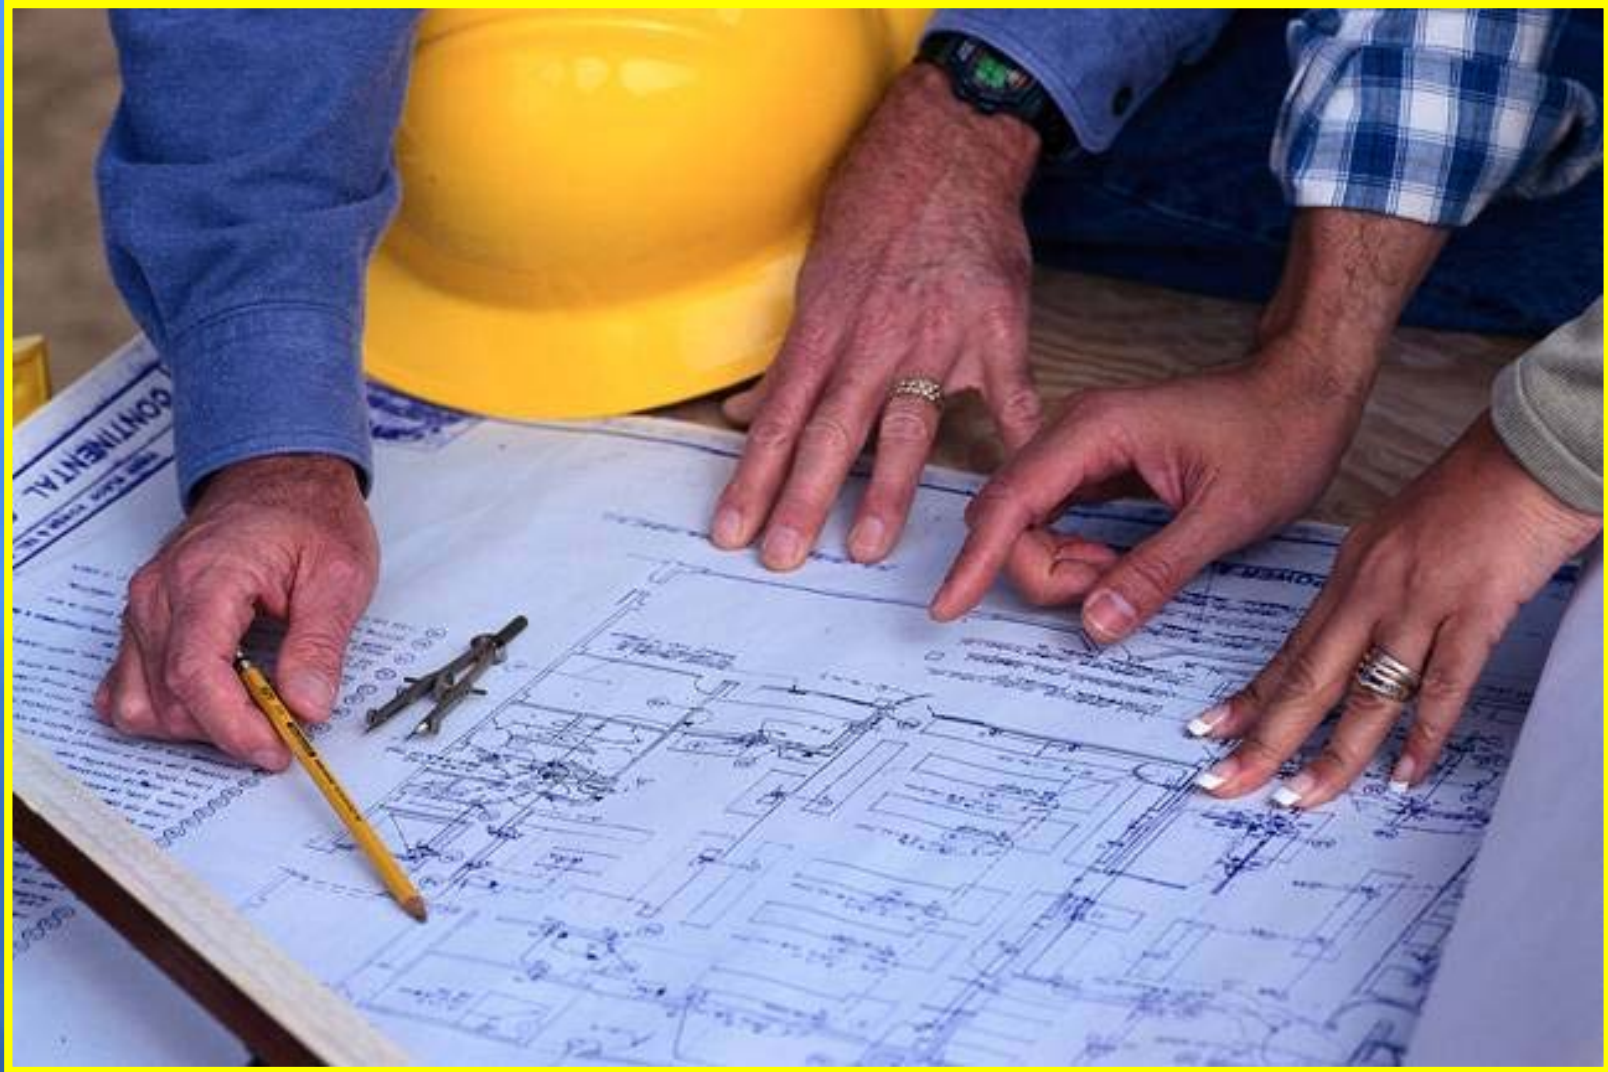
Structural Engineering

- ❑ 40,000 psf end bearing pressure
- ❑ 6,000 psf skin friction for portion embedded into limestone **below 2'**
- ❑ Uplift pressure 2,200 psf to a depth of 12'
- ❑ Uplift force to be resisted by dead load plus skin friction

All piers to be embedded into limestone ONLY 2'

Piers embedded into limestone to 2.2' maximum (from pier logs)

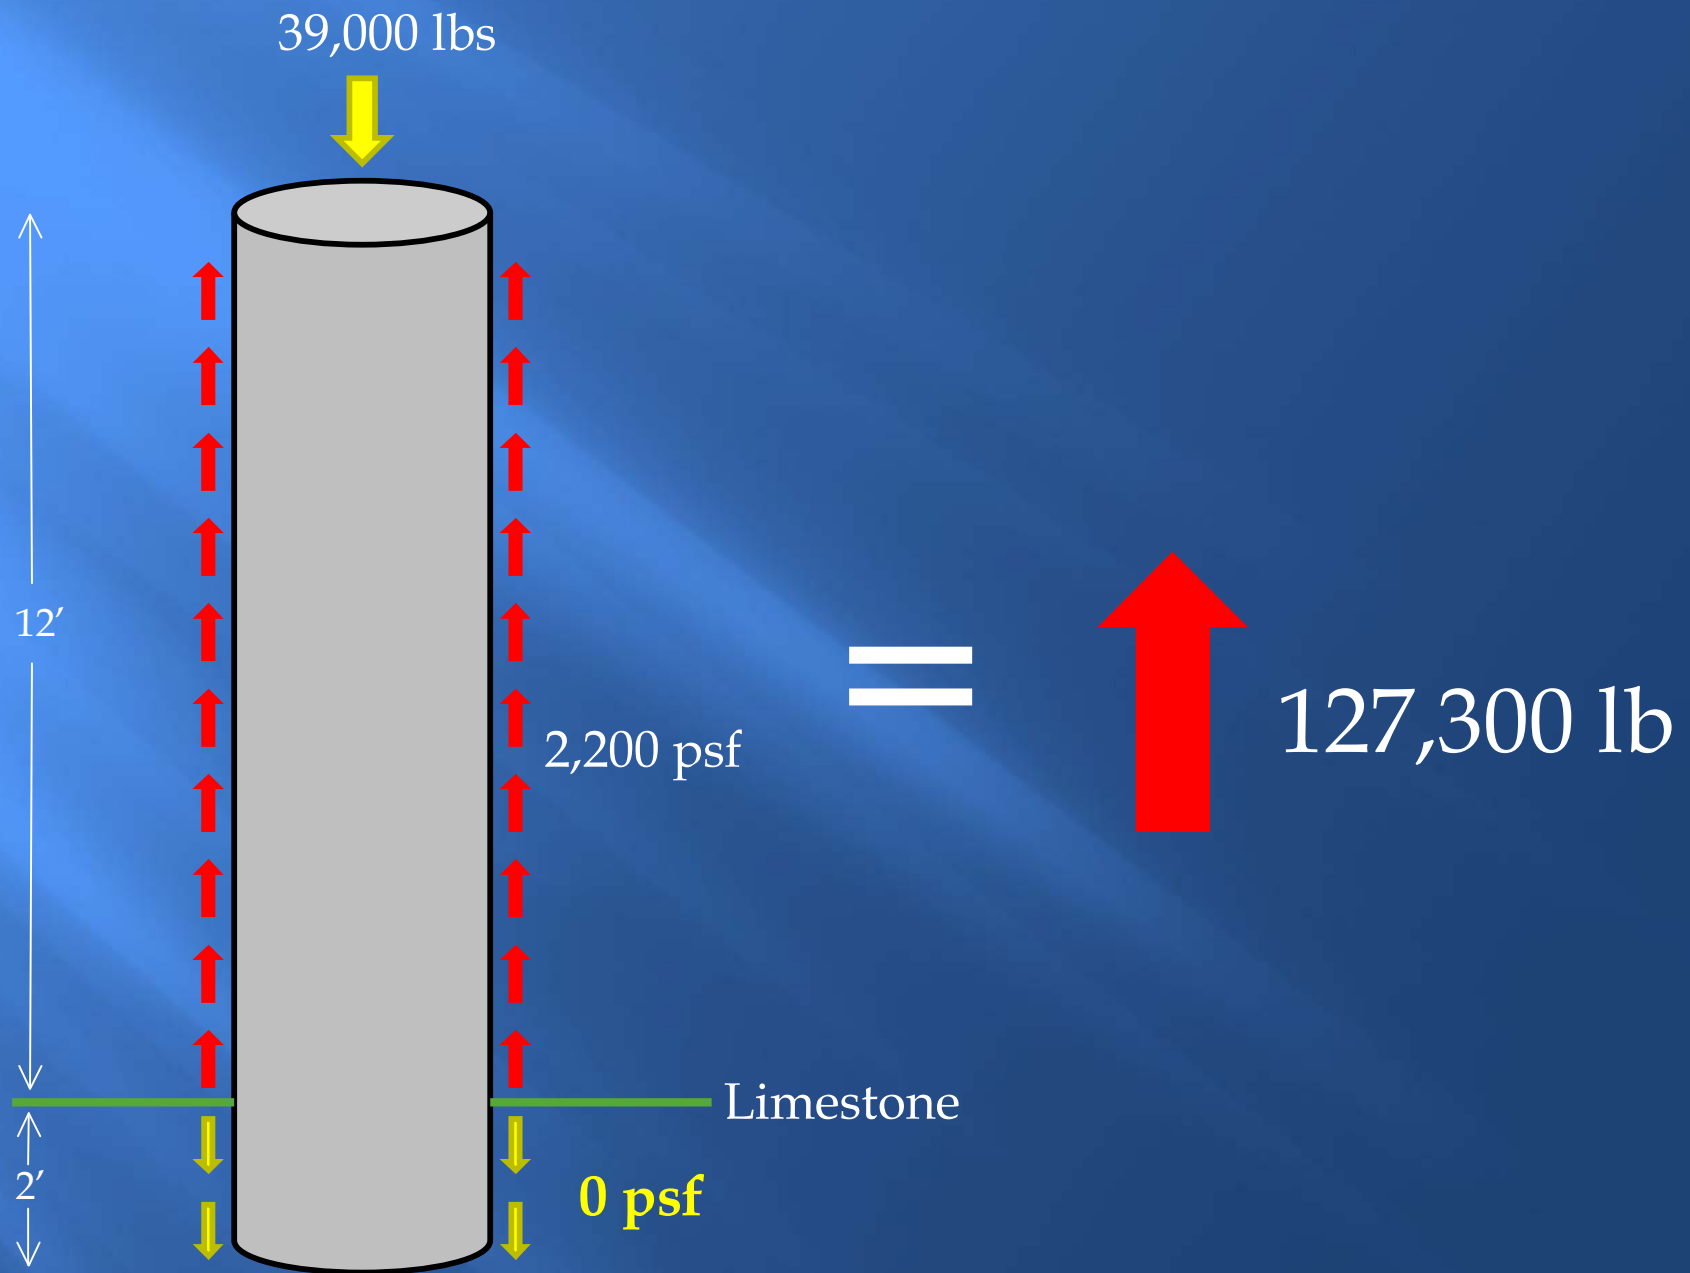
12' active clays @ 2,200psf = **166,300 lb uplift / pier**

**0 psf allowable** skin friction resistance to uplift

DL (building + pier + grade beam)  $\approx$  **39,000 lb / pier**

$166,300 - 39,000 =$  **127,300 lb NET UPLIFT / pier**

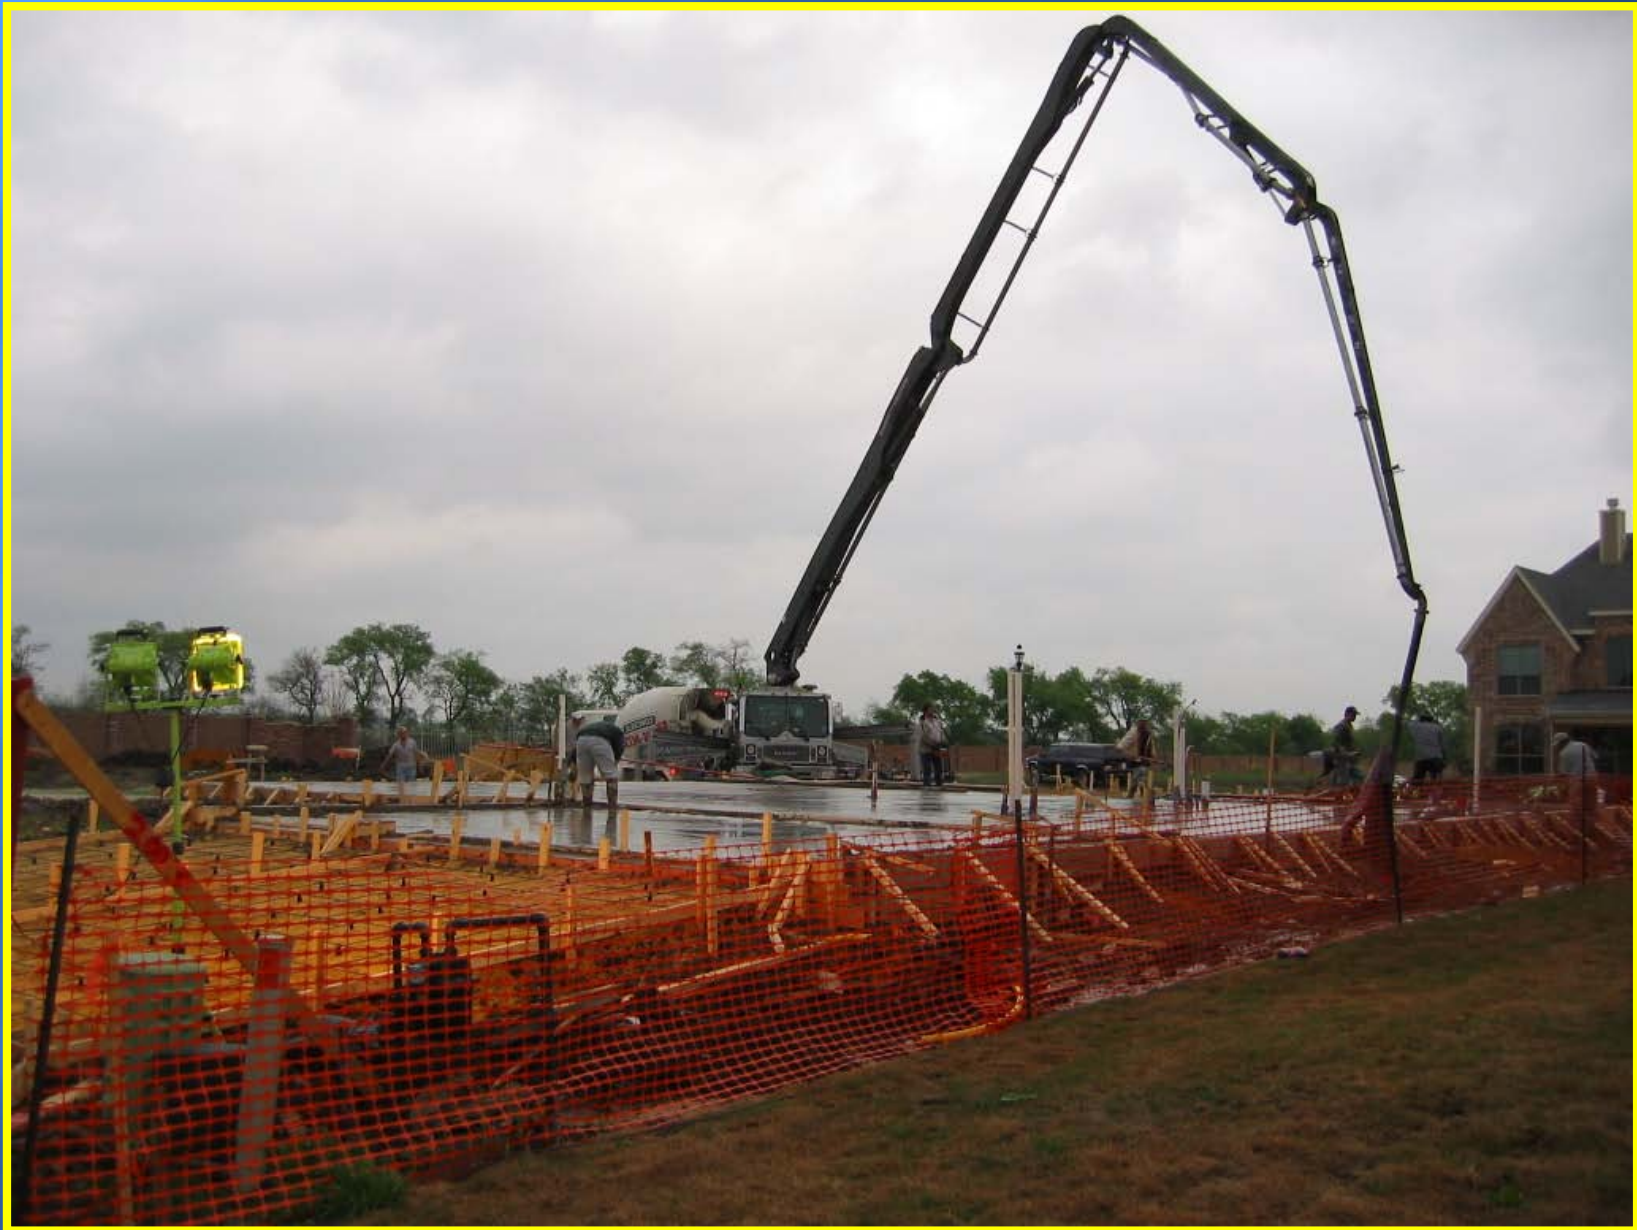
Undercut pad 4', moisture condition and replace 3', cap with 1' of select fill or lime-stabilized native soil

- ❑ No select fill used; lime stabilization inconsistent
- ❑ Moisture conditioning poorly performed
