Project Site with Riviera I, Riviera II, West Beach Grand post-Hurricane Ike

Mark E Haas Engineering, LLC, with extensive experience in coastal and offshore engineering projects, was retained by the condominium HOA's to reassess their buildings.

To show that condominiums are "SAFE":

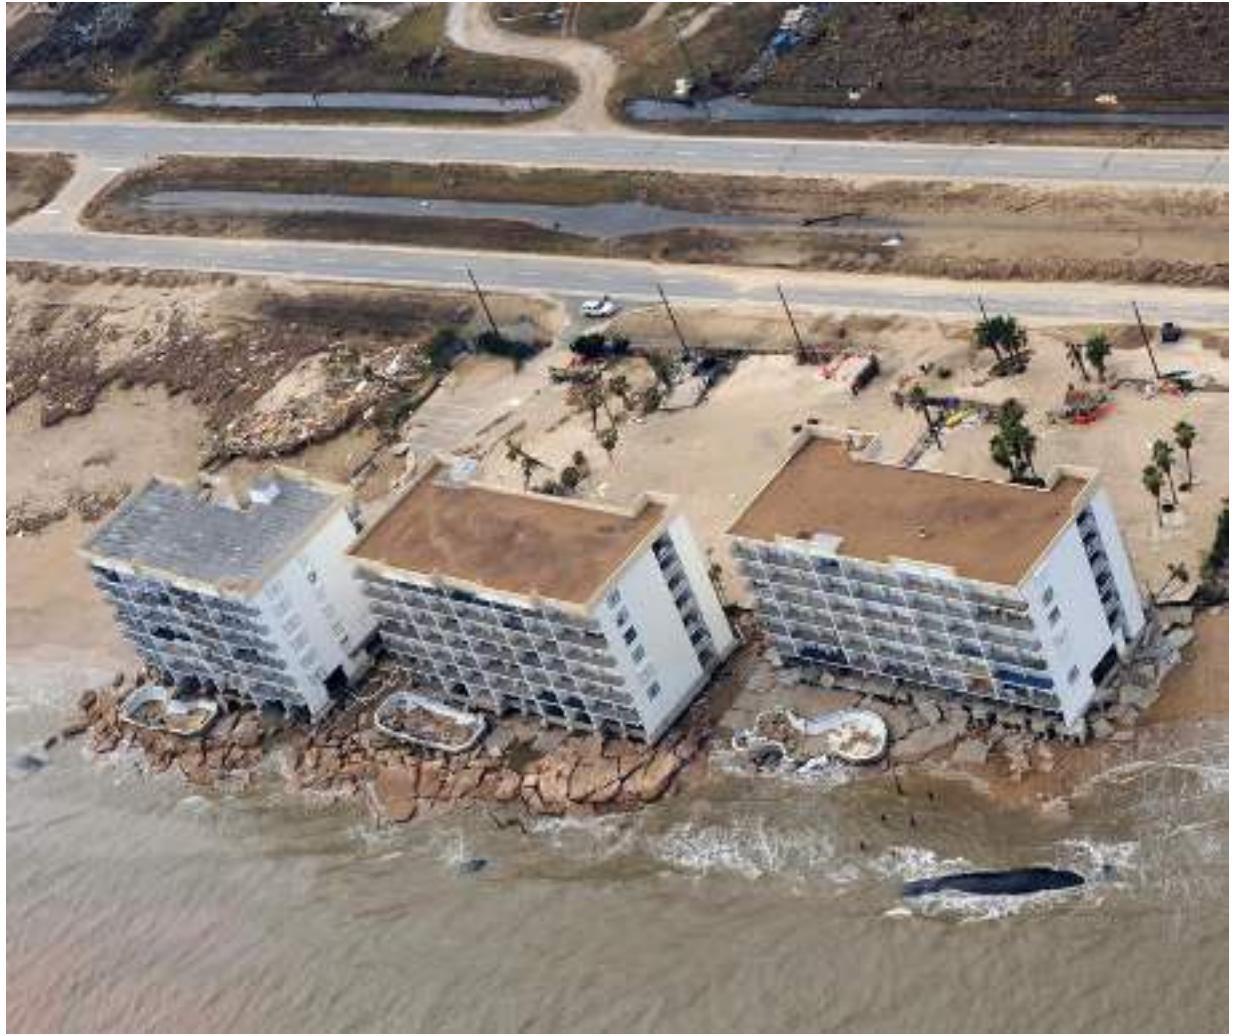
- Site of the engineering project: City of Galveston, Texas
- Condominiums, which had experienced significant beach erosion, following 2008 Hurricane Ike
- Following the 2021 Champlain Towers collapse, City of Galveston building officials revisited these condominiums
- Another civil/structural engineer declared the condos "UNSAFE" per 2018 IEBC Codes

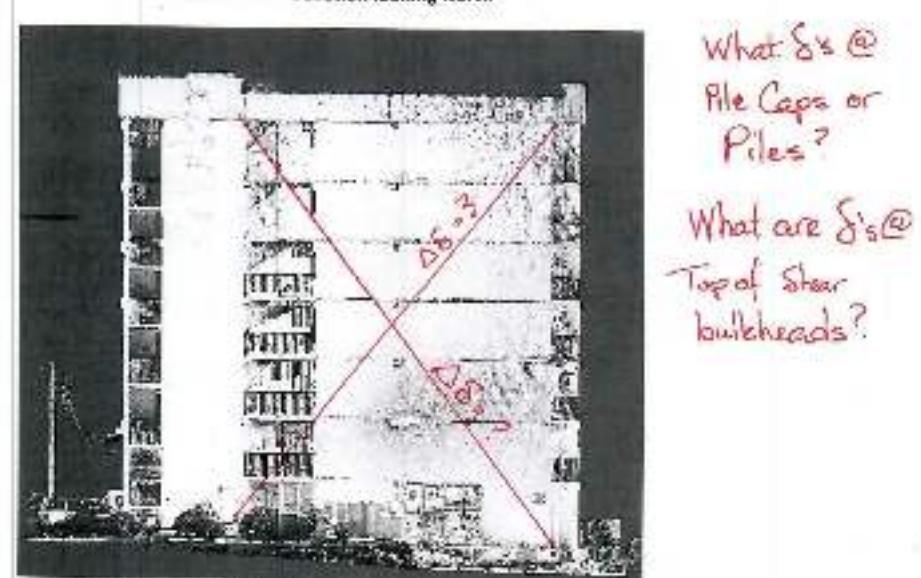
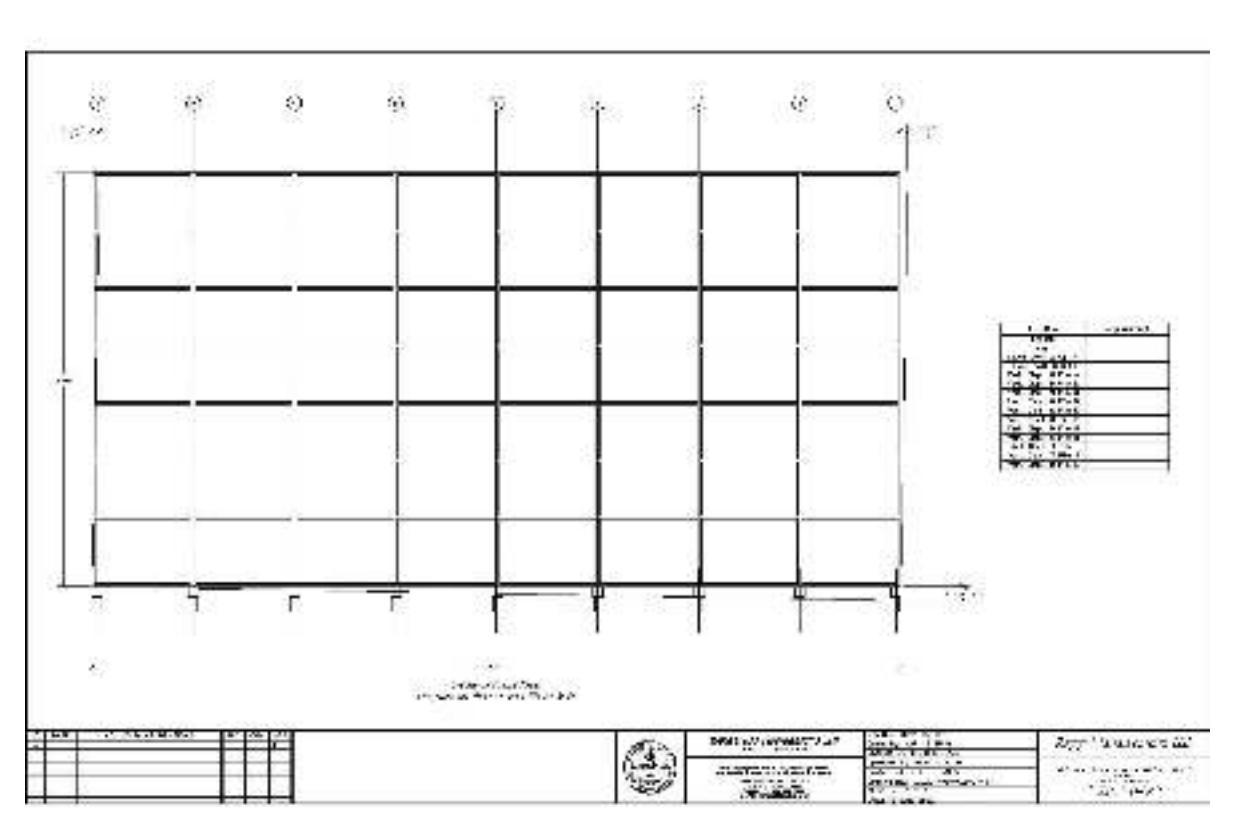
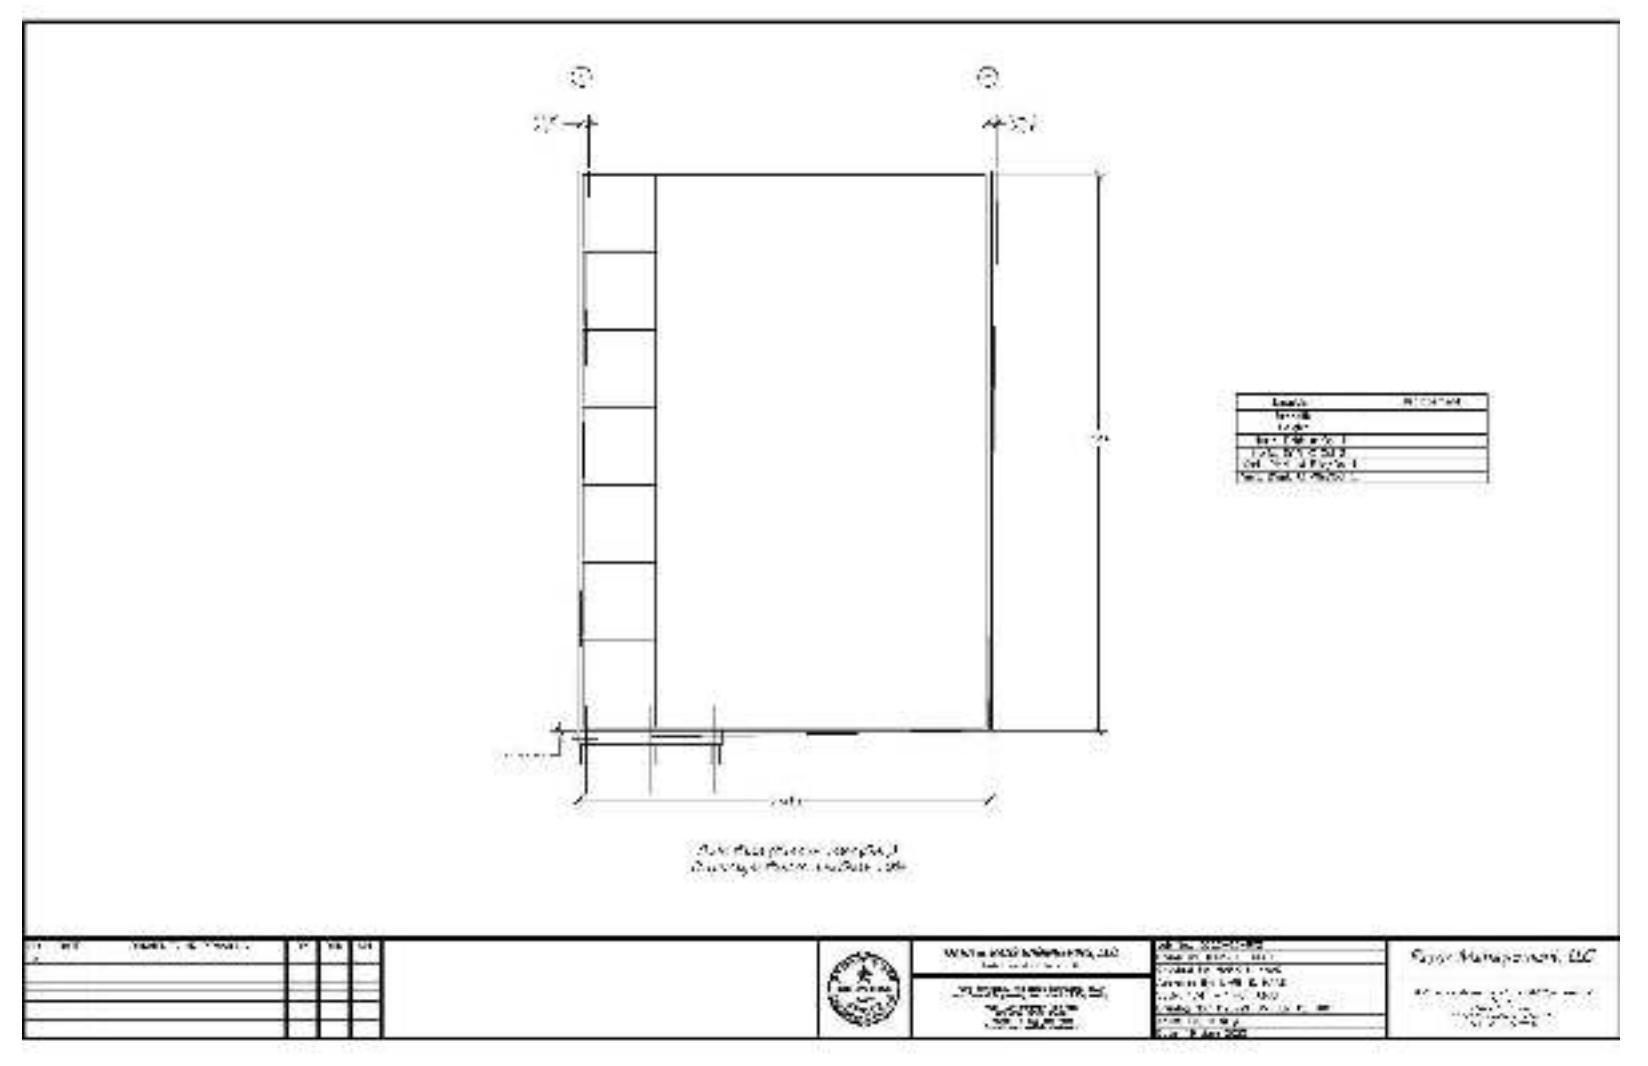
- Deflections were noted by hand and transferred to an AutoCAD template of the condominium elevation views
- Deflections were compared against applicable construction and operability tolerances per ASCE, ACI, and IBC Codes

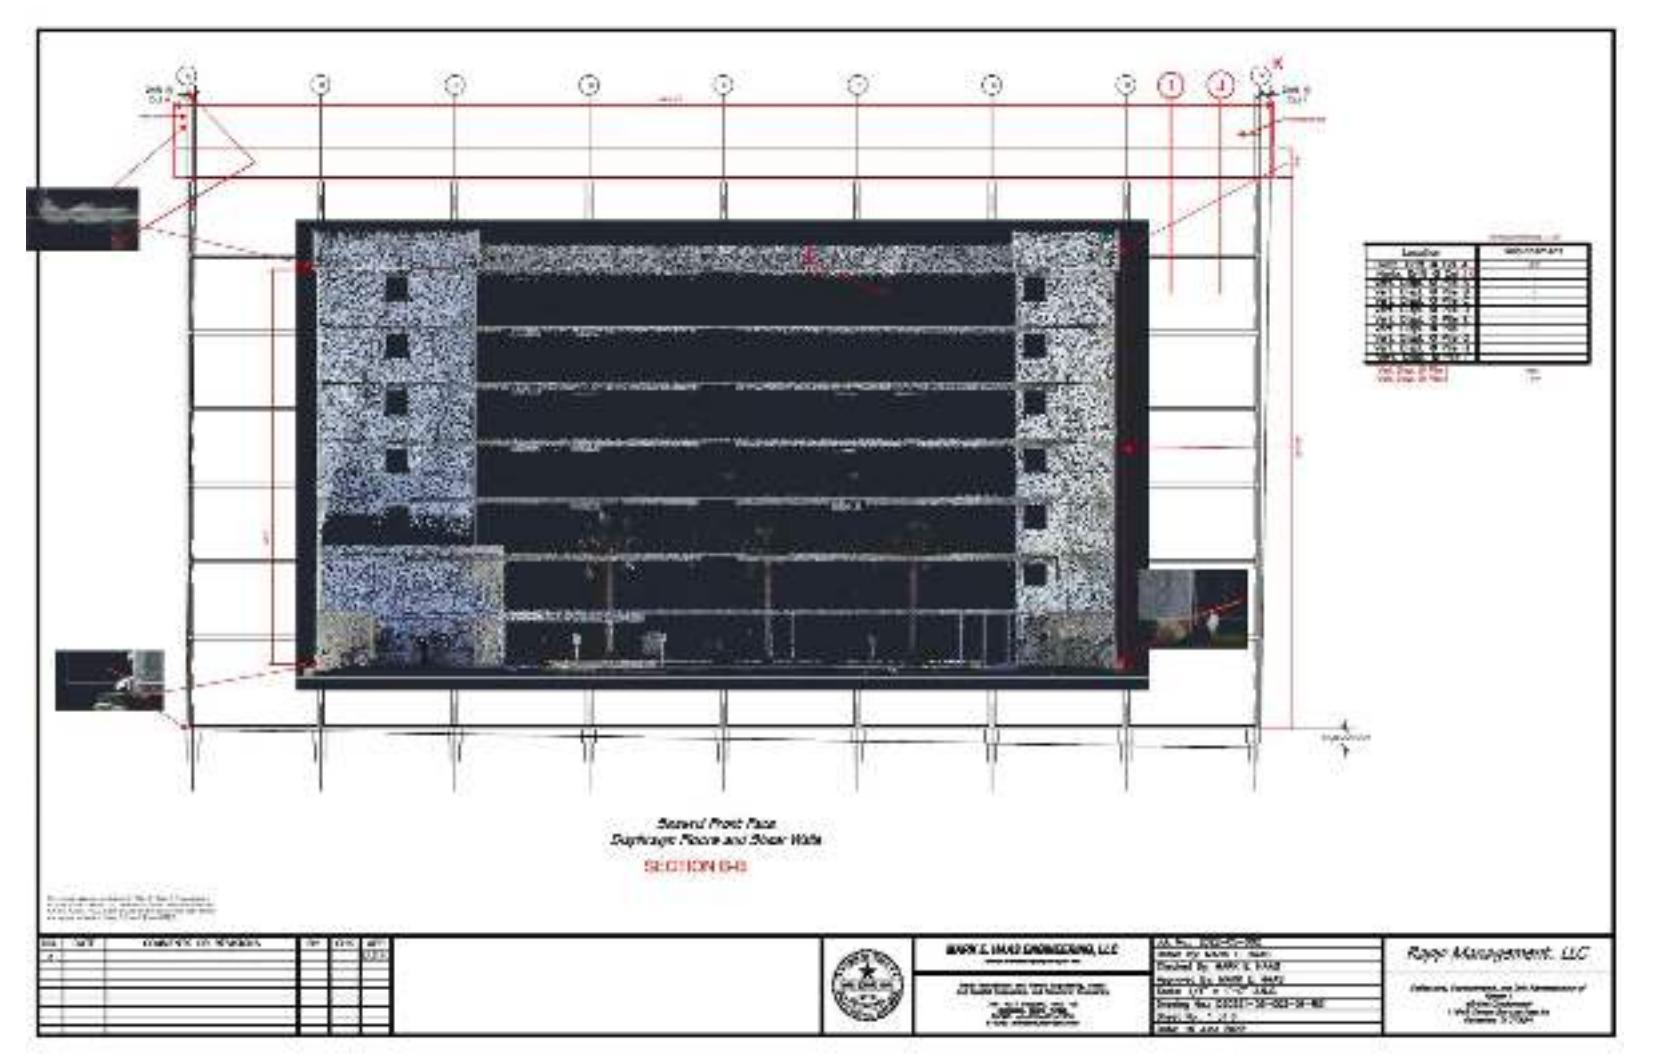
Riviera II - Plotting of Deflections

- Deflections were noted by hand and transferred to an AutoCAD template of the condominium elevation views
- Deflections were compared against applicable construction and operability tolerances per ASCE, ACI, and IBC Codes

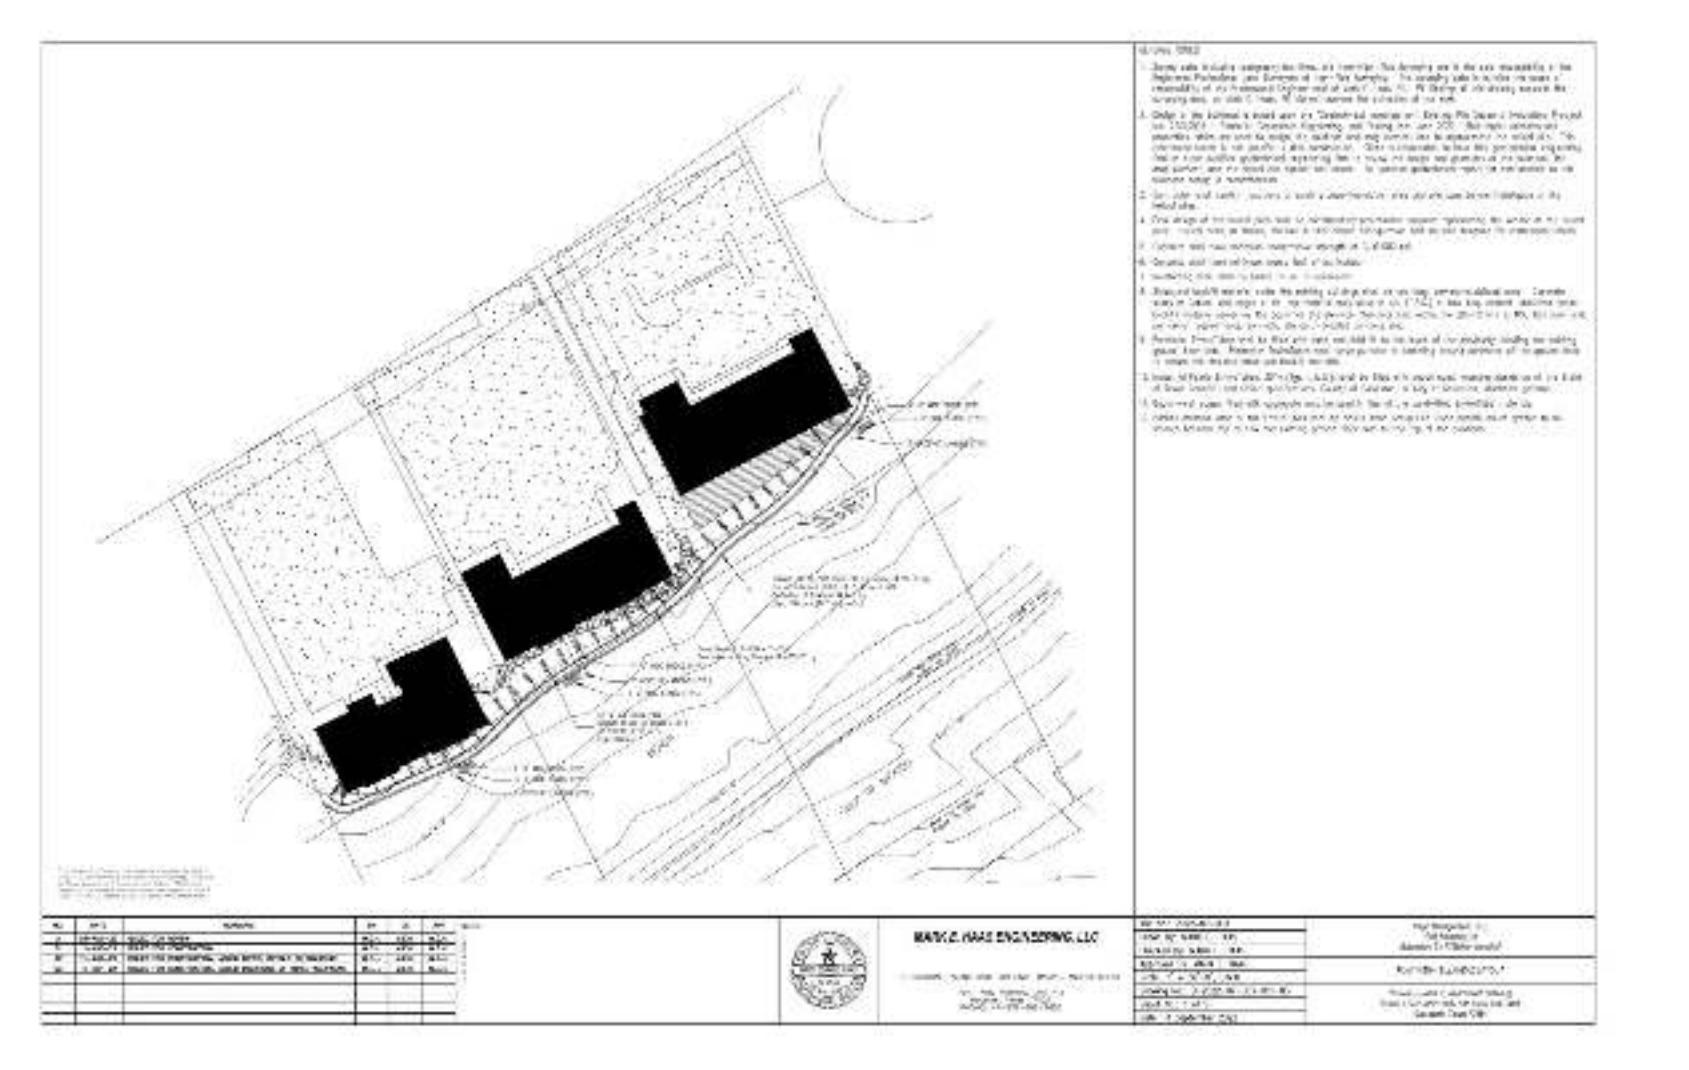
Planning of Proposed Bulkhead

- The plan view for a proposed bulkhead was developed.
- The plan view shows lines of vegetation, of Mean Low Water, of 200-ft offset, of current and original property lines, and of the deadman and of the bulkhead.
- A "random" serpentine pattern was drawn to mitigate rip currents and minimize scouring

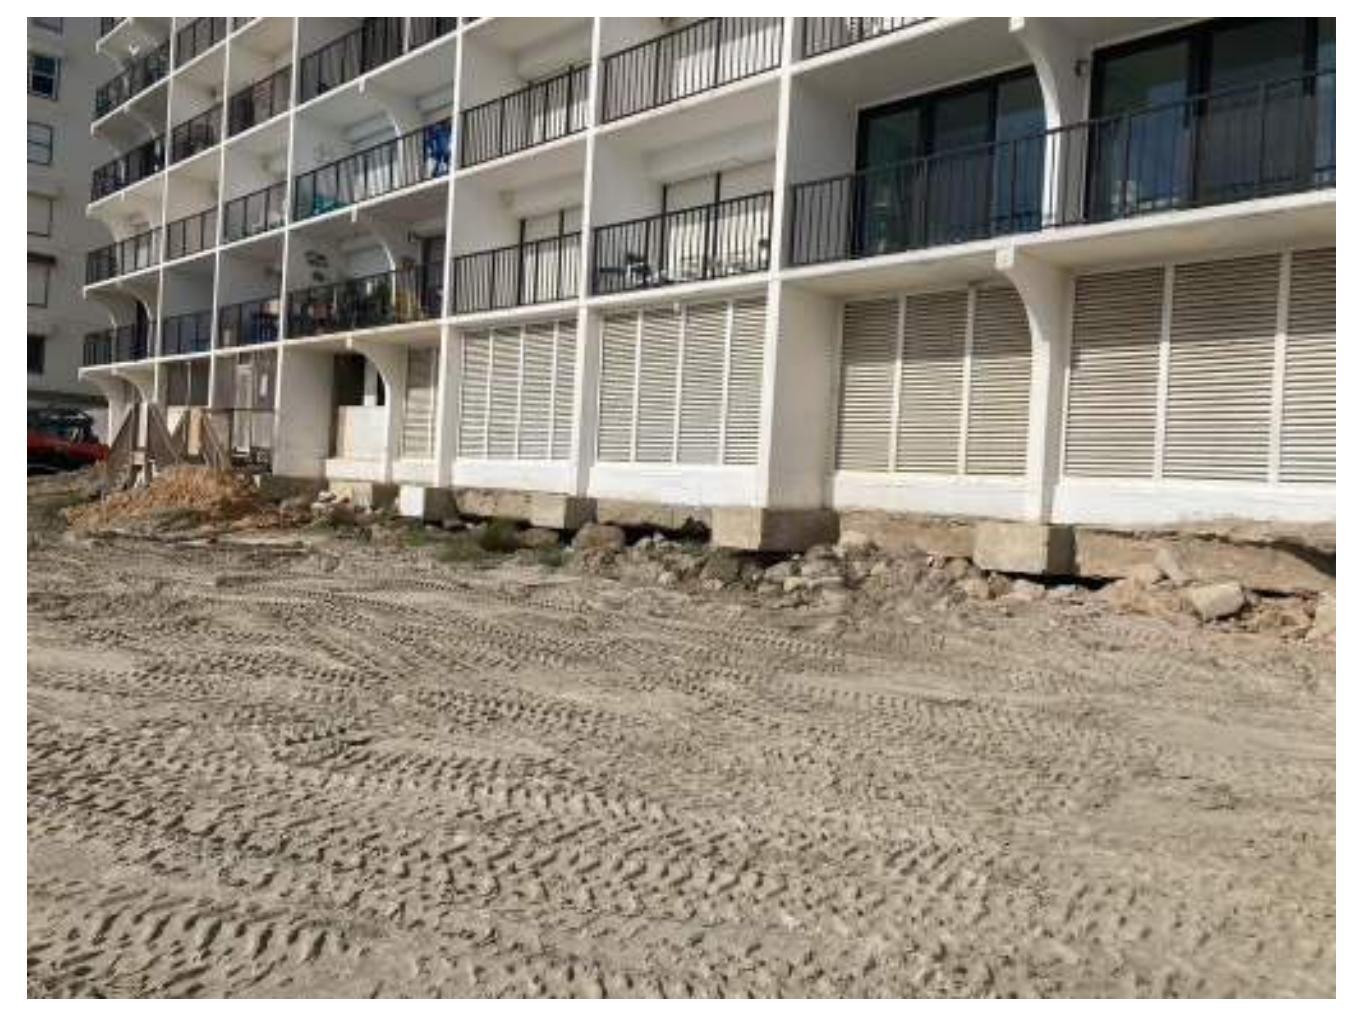
Formwork for the Backfill of Cement-Stabilized Sand @ Riviera I, Riviera I Shown in Background (Typical at the Three Condominiums)

The areas were cleared of debris from Hurricanes Ike, Harvey, Laura, and Delta. Other debris had accumulated from 2020 winter storms.

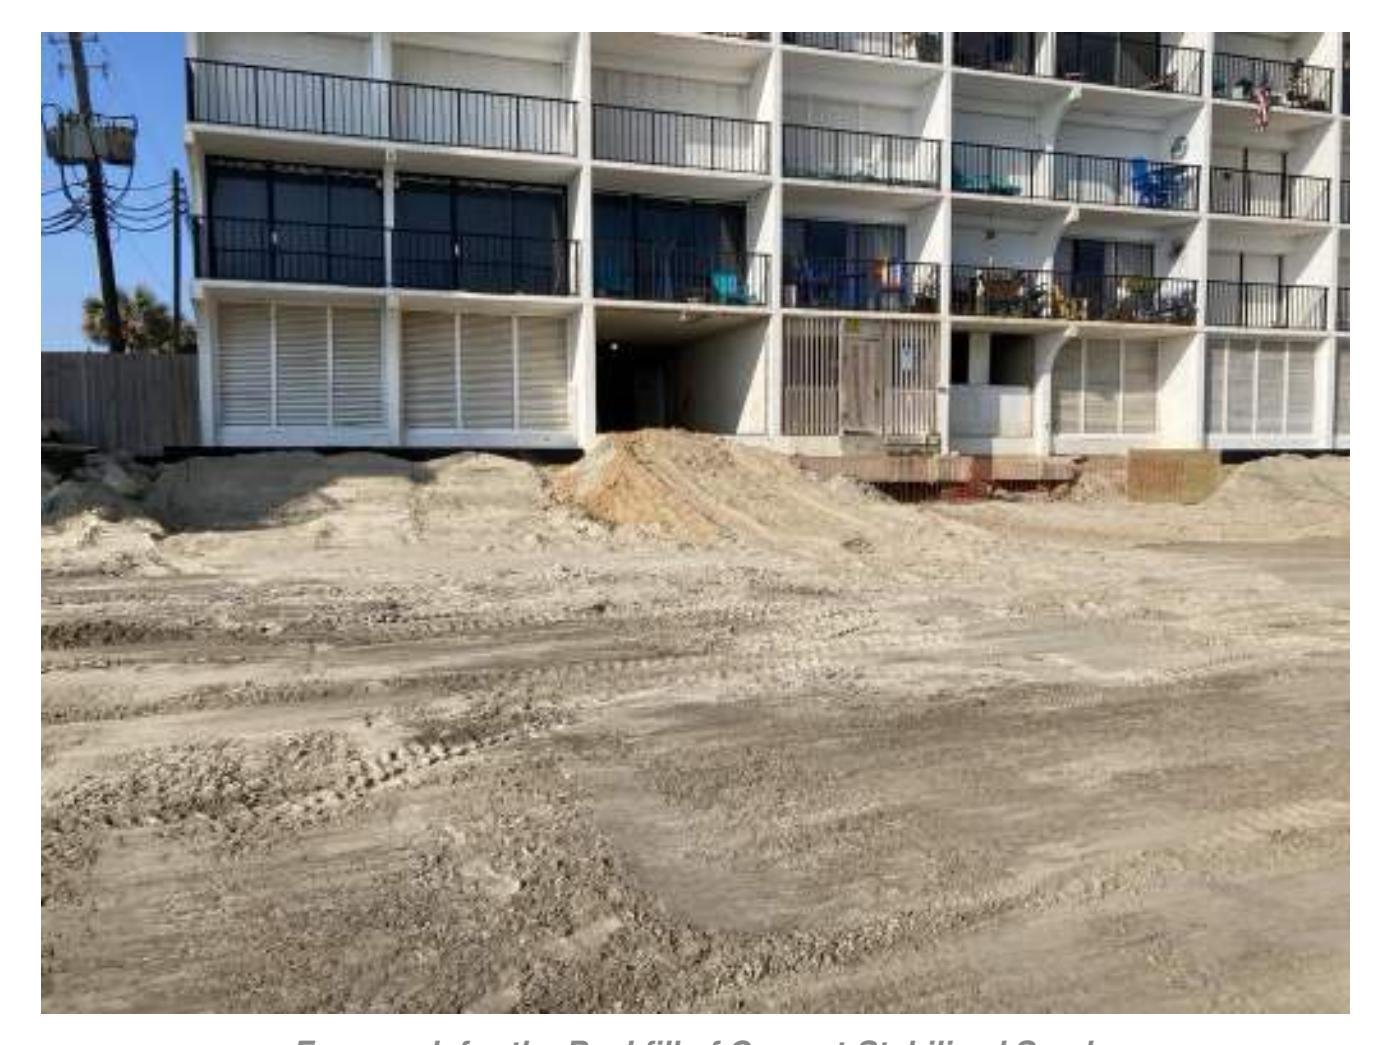
Formwork for the Backfill of Cement-Stabilized Sand @ Riviera I, Riviera I Shown in Background (Typical at the Three Condominiums) The areas were cleared of debris from Hurricanes Ike, Harvey, Laura, and Delta. Other debris had accumulated from 2020 winter storms.

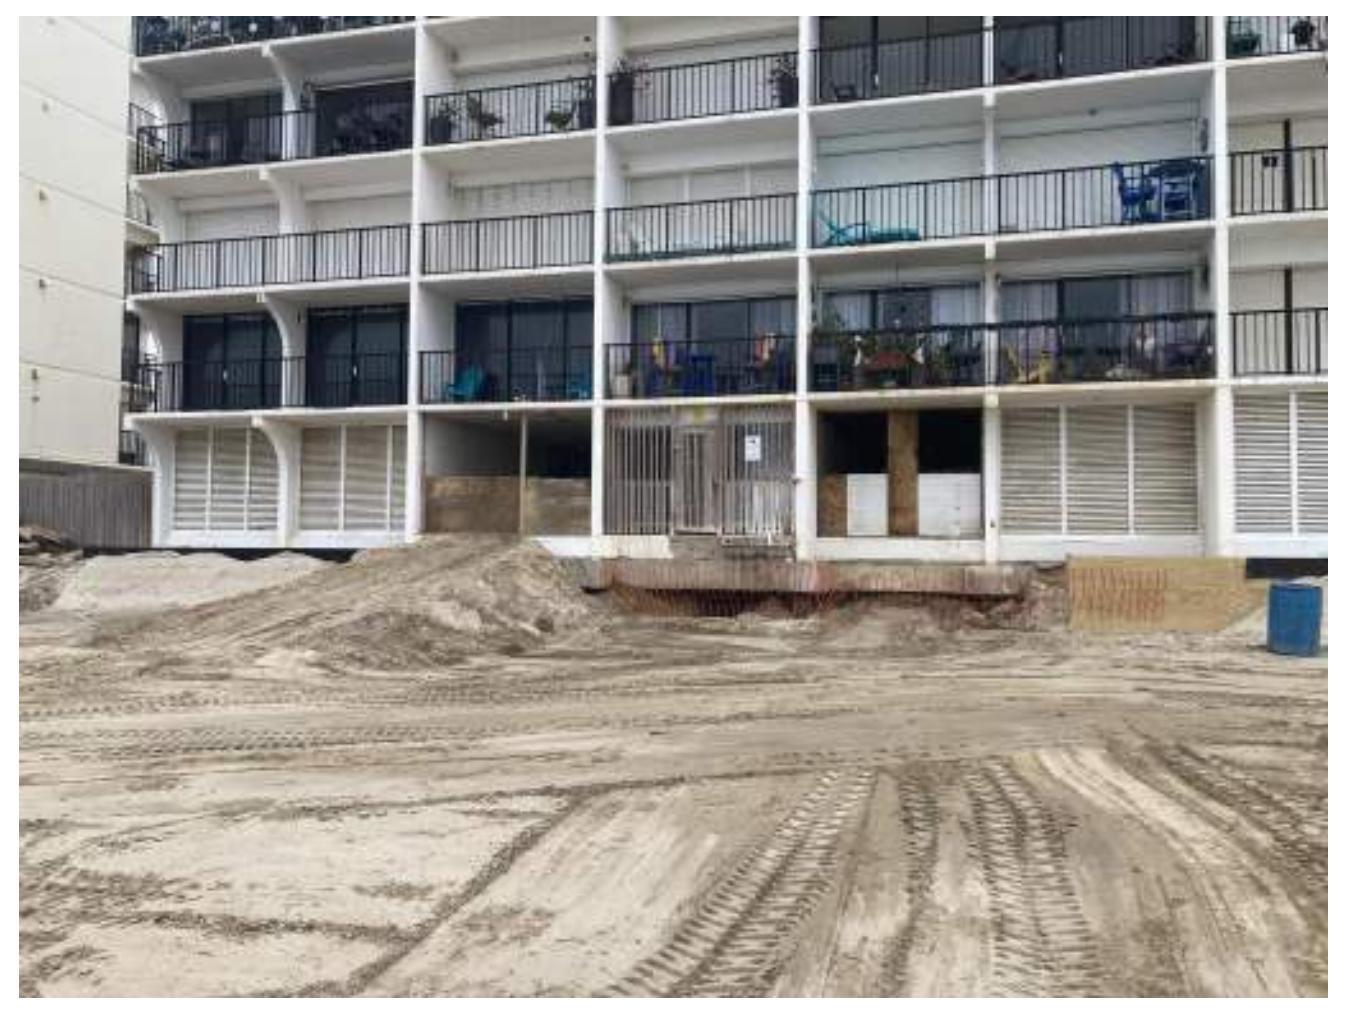
Formwork for the Backfill of Cement-Stabilized Sand @ Riviera I, Riviera I Shown in Background (Typical at the Three Condominiums)

The areas were cleared of debris from Hurricanes Ike, Harvey, Laura, and Delta. Other debris had accumulated from 2020 winter storms.

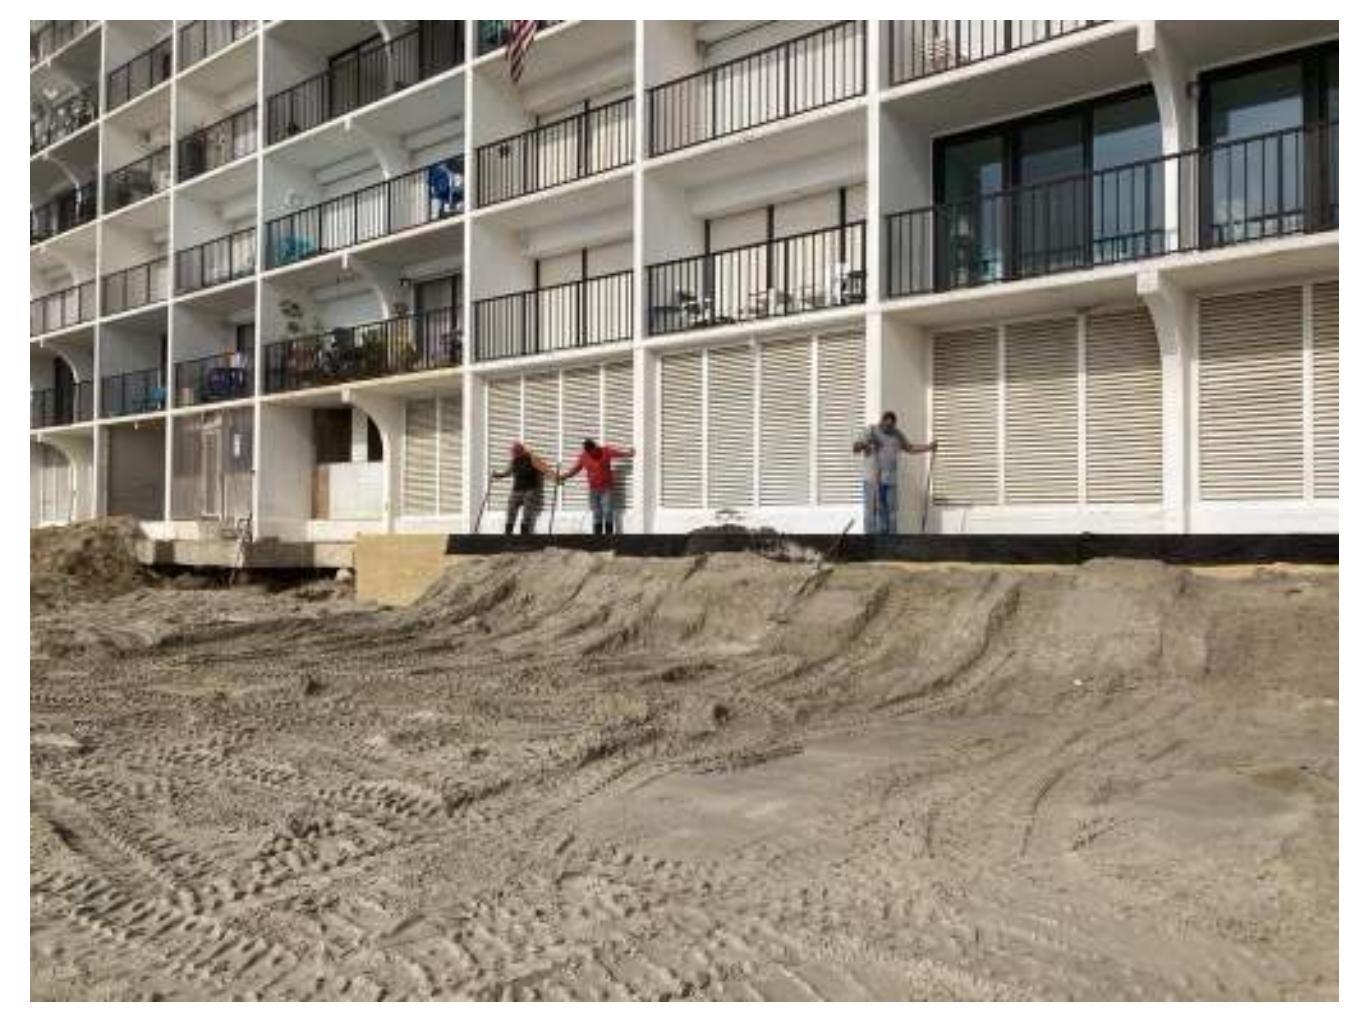
Formwork for the Backfill of Cement-Stabilized Sand @ Riviera I, Riviera I Shown in Background (Typical at the Three Condominiums)

The areas were cleared of debris from Hurricanes Ike, Harvey, Laura, and Delta. Other debris had accumulated from 2020 winter storms.

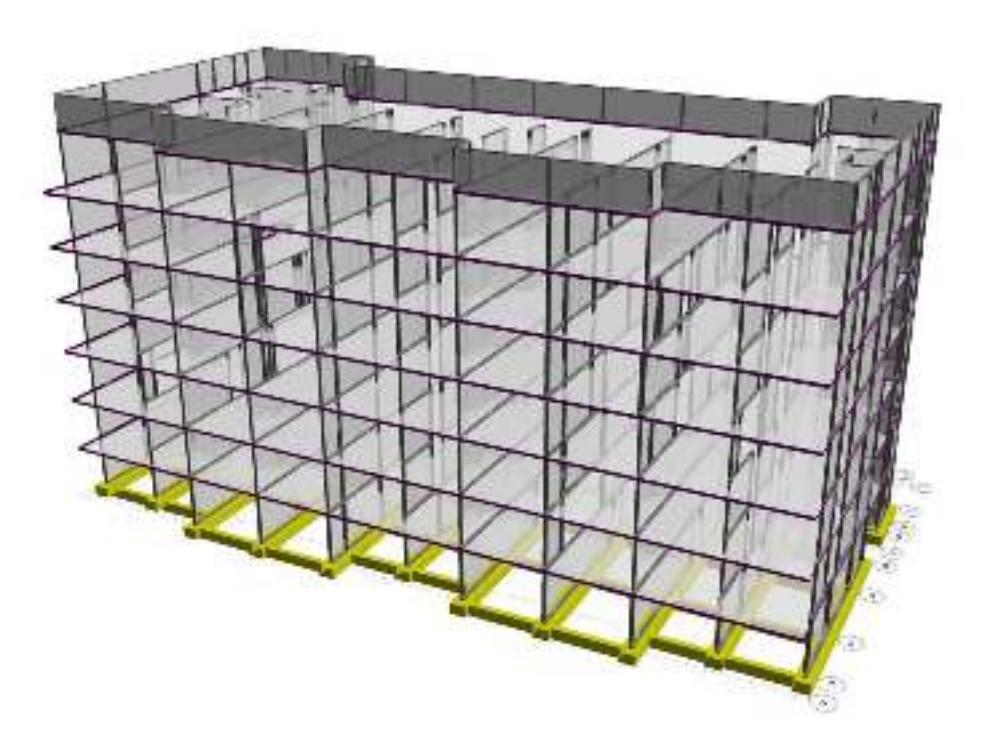
View of Riviera II from its Building SW Corner (Floors removed for clarity)

To perform the analysis of the Riviera II condominium, a model for the windloading analysis was built in Bentley Software's RAM Structural Systems.

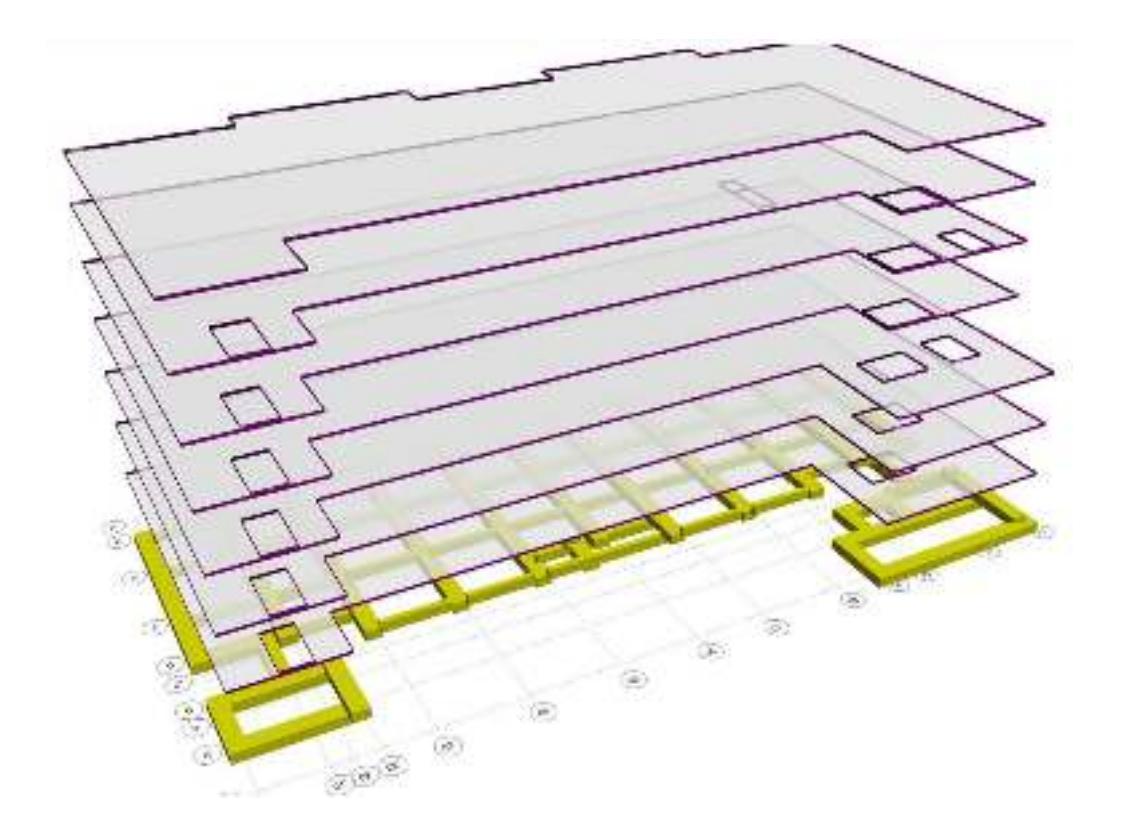
View of Riviera II from its Building SE Corner

To perform the analysis of the Riviera II condominium, a model for the windloading analysis was built in Bentley Software's RAM Structural Systems.

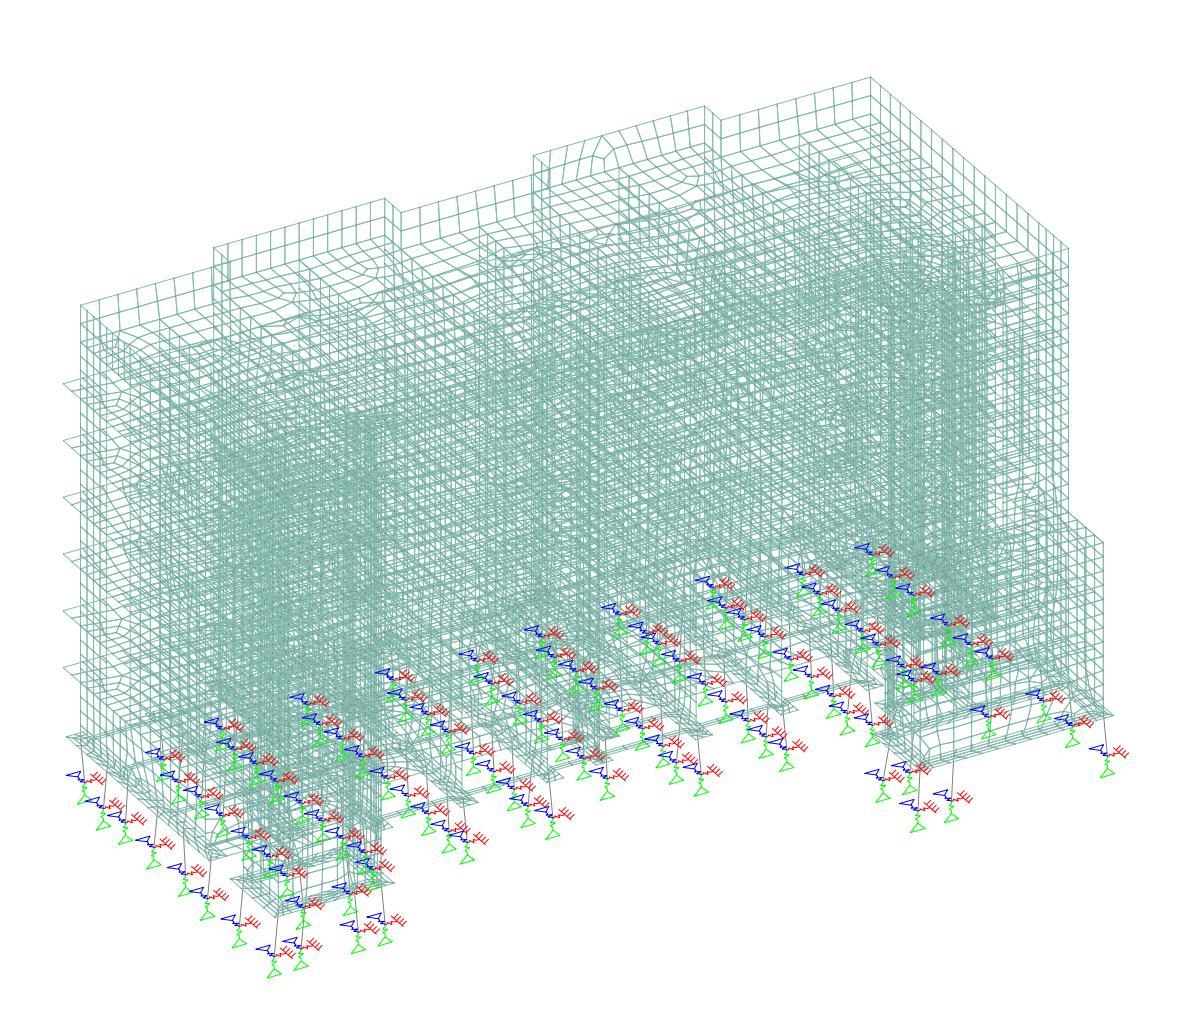
STAAD.Pro Model of Riviera II from its Building NE Corner

- RAM Structural Systems was converted via Bentley iTwins converter into a STAAD.Pro model.
- Linearized flexible foundation was added with pile stubs and piles springs.
- Pile springs were linearized via Tangential method from the P-Y and T-Z curves for the 16-inch piles.
- Quasi-static wave pressures from the 25-yr MRI storm and the 100-yr MRI storm were modeled at lateral pressure loads in the X direction (long'l)
- Quasi-static wave pressures from the said storms were modeled as applied points parallel to the shear walls, based upon the breakaway pressures for the non-loading bearings walls at the Ground Floor and the First Floor.

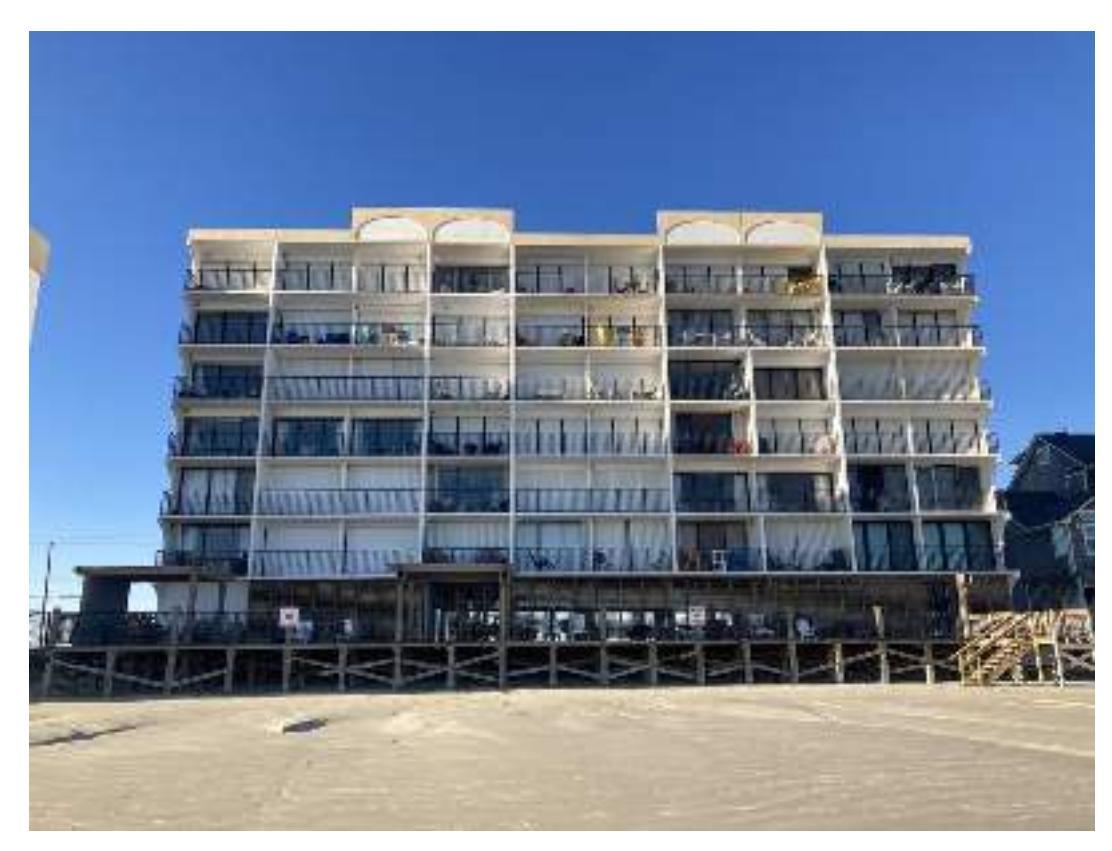
West Beach Grand condominium looking north at the seaward-facing side

- After completing Riviera II condominium analyses, West Beach Grand condominium is next.
- Whereas Riviera II had a complete set of drawings, albeit with water damage from flooding associated with Hurricane Ike, West Beach Grand structural drawings were lost.
- With existing Architectural drawings, WBG structural drawings were recreated as "IFC" drawings.
- Post-recreating the drawings, the dimensions were checked against the existing building.
- GPR was used to locate and identify pile caps and the piles.
- GPR was used to locate and to identify cover, layers of rebar, and rebar sizes.

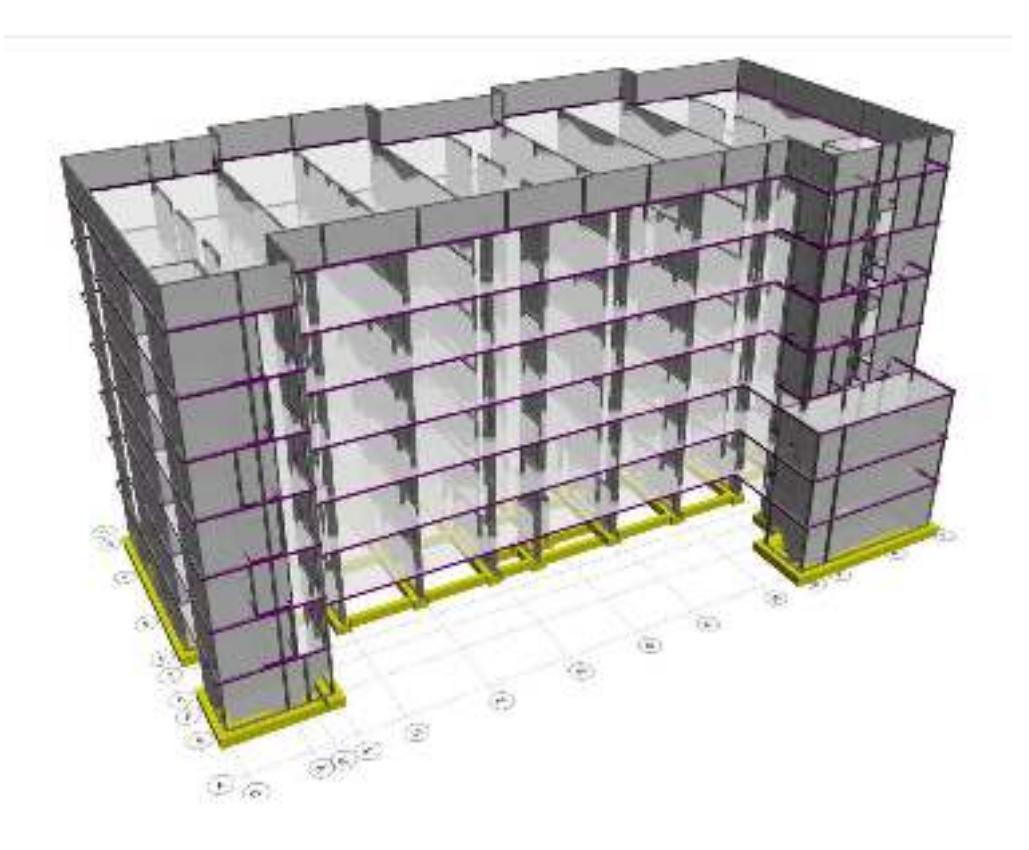
West Beach Grand condominium looking north at the seaward-facing side

- After completing Riviera II condominium analyses, West Beach Grand condominium is next.
- Whereas Riviera II had a complete set of drawings, albeit with water damage from flooding associated with Hurricane Ike, West Beach Grand structural drawings were lost.
- With existing Architectural drawings, WBG structural drawings were recreated as "IFC" drawings.
- Post-recreating the drawings, the dimensions were checked against the existing building.
- GPR was used to locate and identify pile caps and the piles.
- GPR was used to locate and to identify cover, layers of rebar, and rebar sizes.

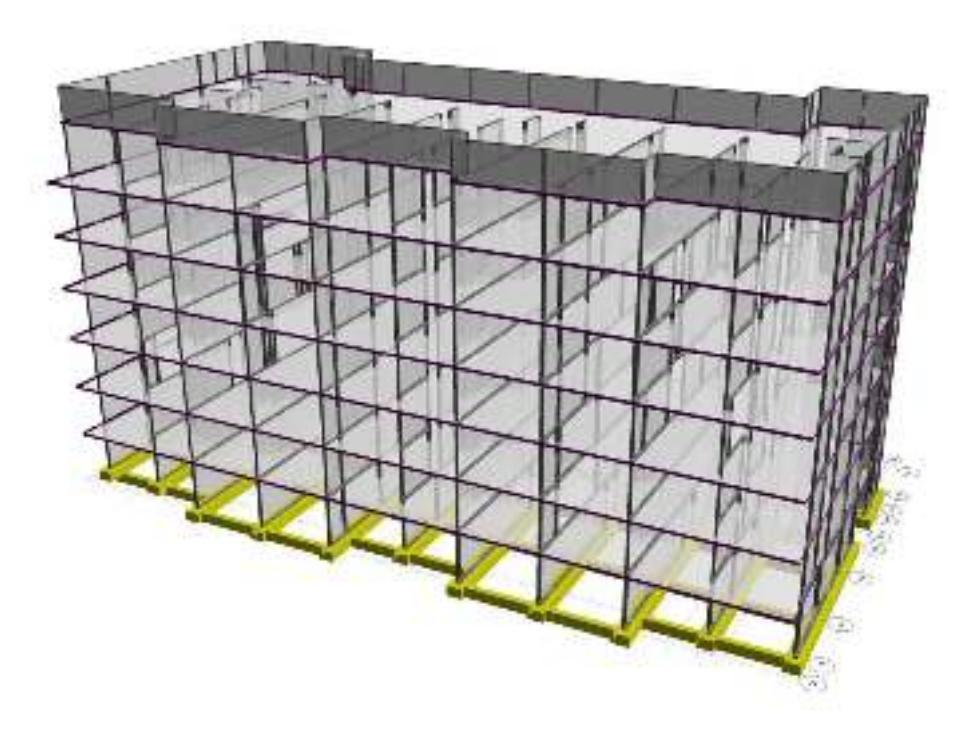
West Beach Grand condominium looking north at the seaward-facing side

- After completing Riviera II condominium analyses, West Beach Grand condominium is next.
- Whereas Riviera II had a complete set of drawings, albeit with water damage from flooding associated with Hurricane Ike, West Beach Grand structural drawings were lost.
- With existing Architectural drawings, WBG structural drawings were recreated as "IFC" drawings.
- Post-recreating the drawings, the dimensions were checked against the existing building.
- GPR was used to locate and identify pile caps and the piles.
- GPR was used to locate and to identify cover, layers of rebar, and rebar sizes.

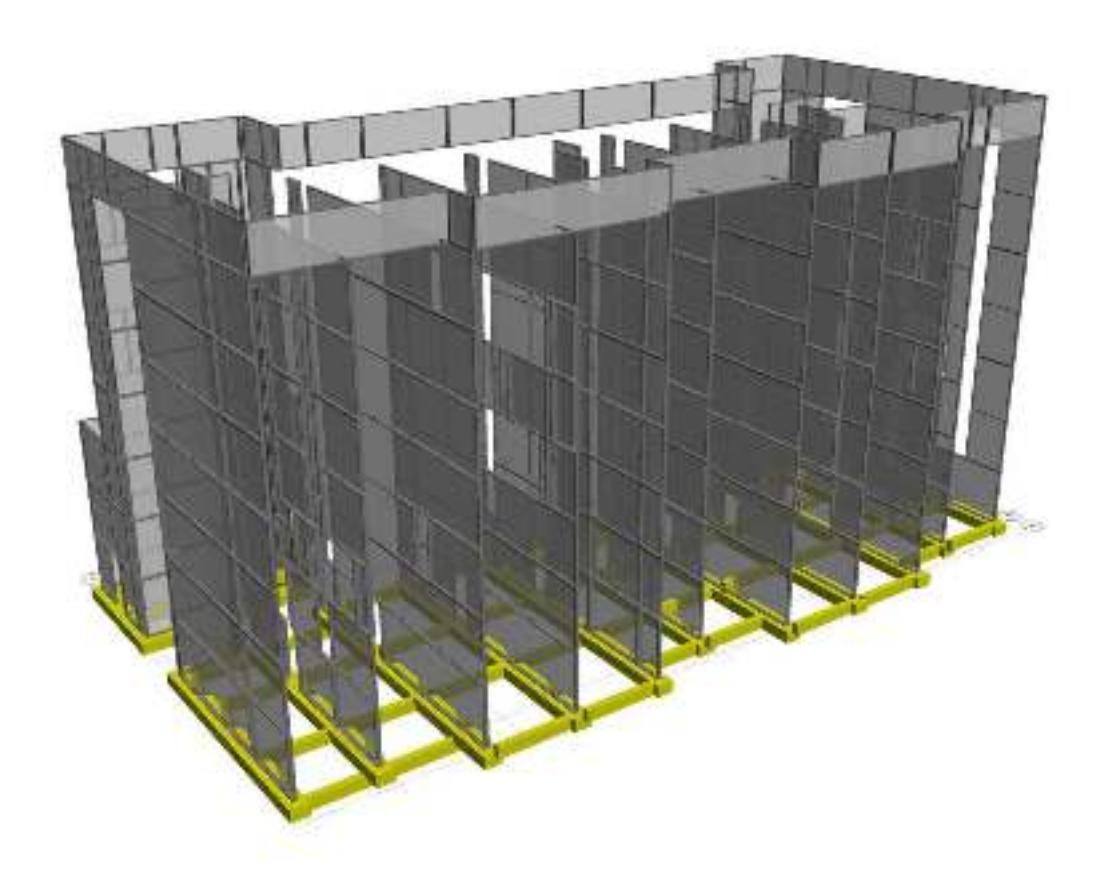
West Beach Grand condominium looking northeast at the seaward-facing side

- After completing Riviera II condominium analyses, West Beach Grand condominium is next.
- Whereas Riviera II had a complete set of drawings, albeit with water damage from flooding associated with Hurricane Ike, West Beach Grand structural drawings were lost.
- With existing Architectural drawings, WBG structural drawings were recreated as "IFC" drawings.
- Post-recreating the drawings, the dimensions were checked against the existing building.
- GPR was used to locate and identify pile caps and the piles.
- GPR was used to locate and to identify cover, layers of rebar, and rebar sizes.
