Foundation Performance Association

Imad F Abdullah AIA

June 14, 2017

A. Case Study 1: Structural Roof Collapse of 100,000 sq ft former “Kmart” due to Hurricane Ike, Analysis of parameters that contributed to collapse, Aftermath Structural Repair Options Considered, Remedies implemented

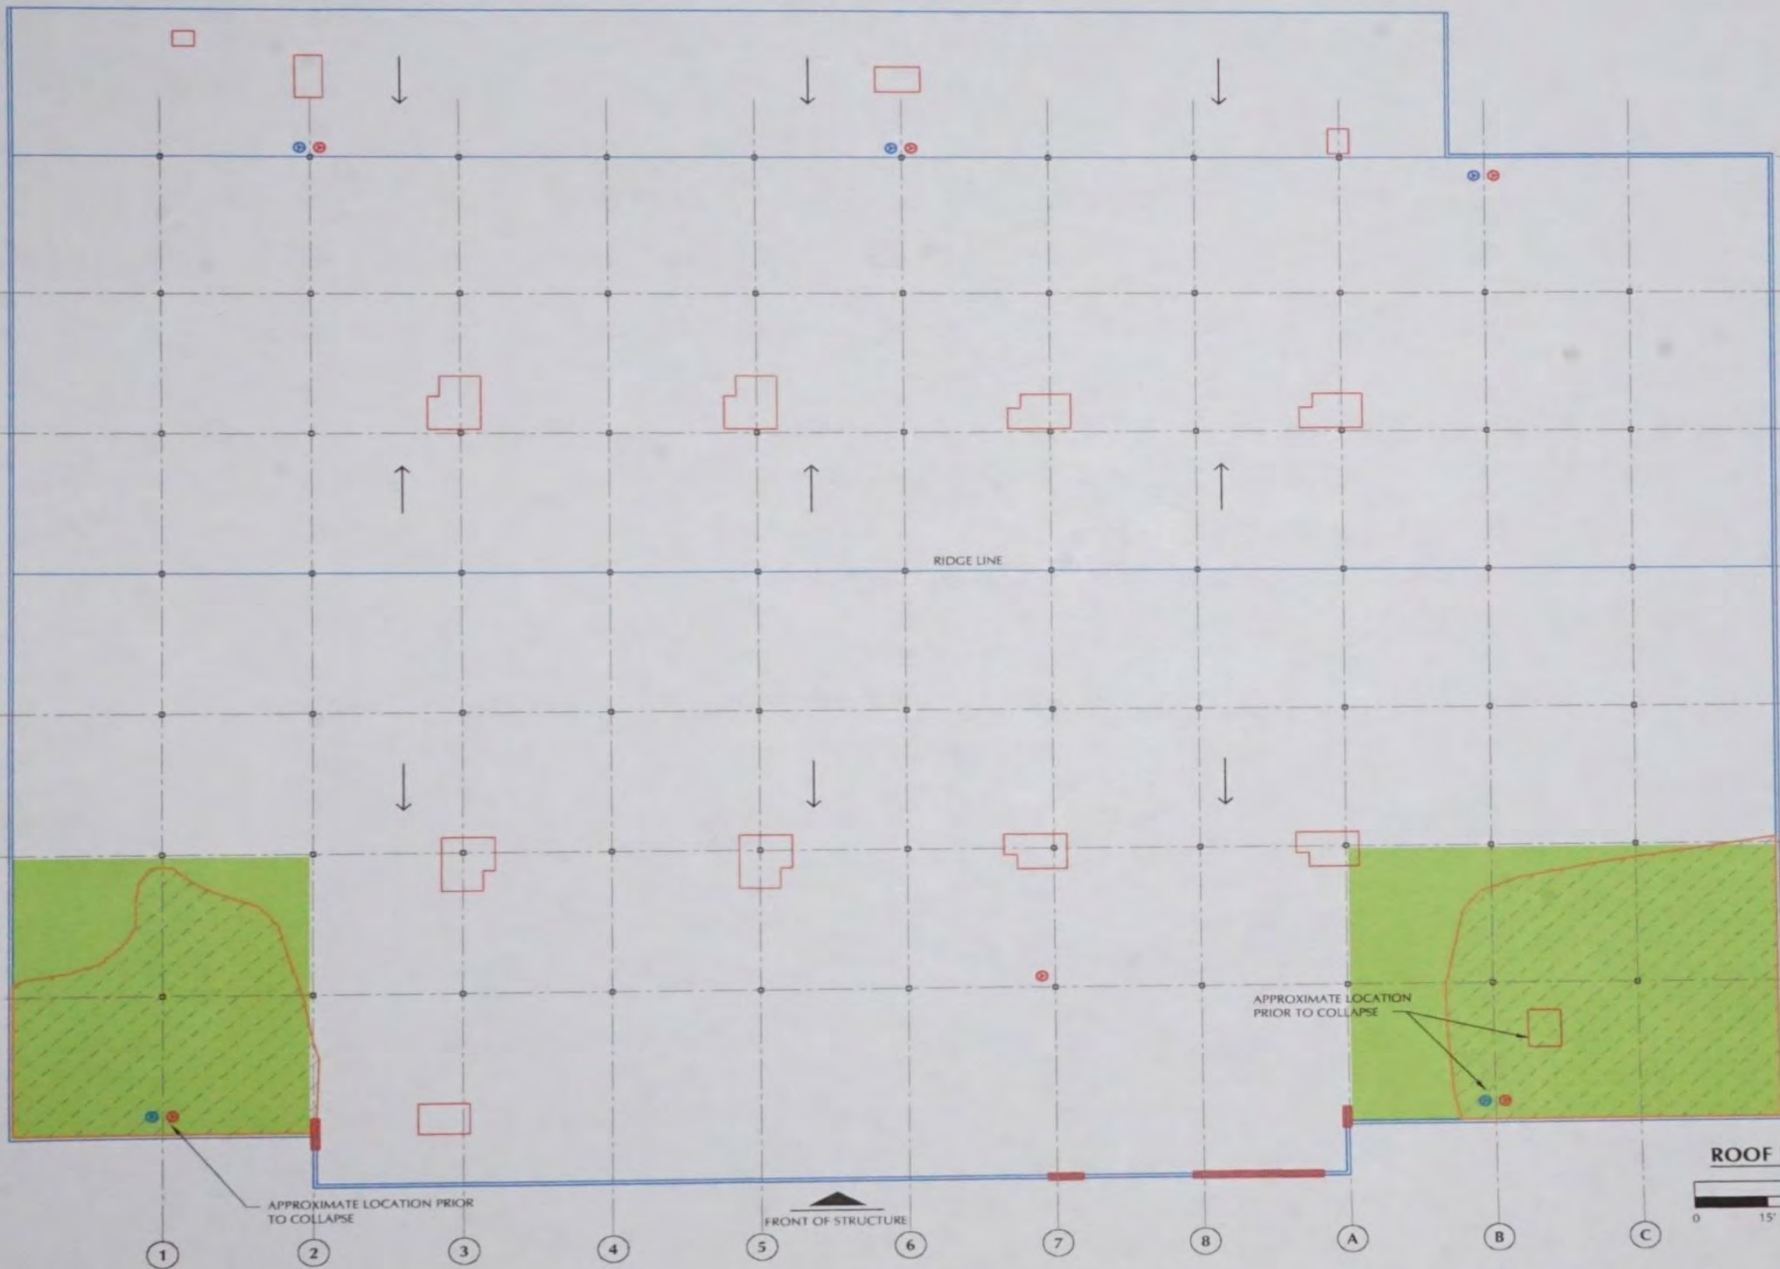
SHEET NUMBER: RE-1

ROOF DISTRESS SURVEY

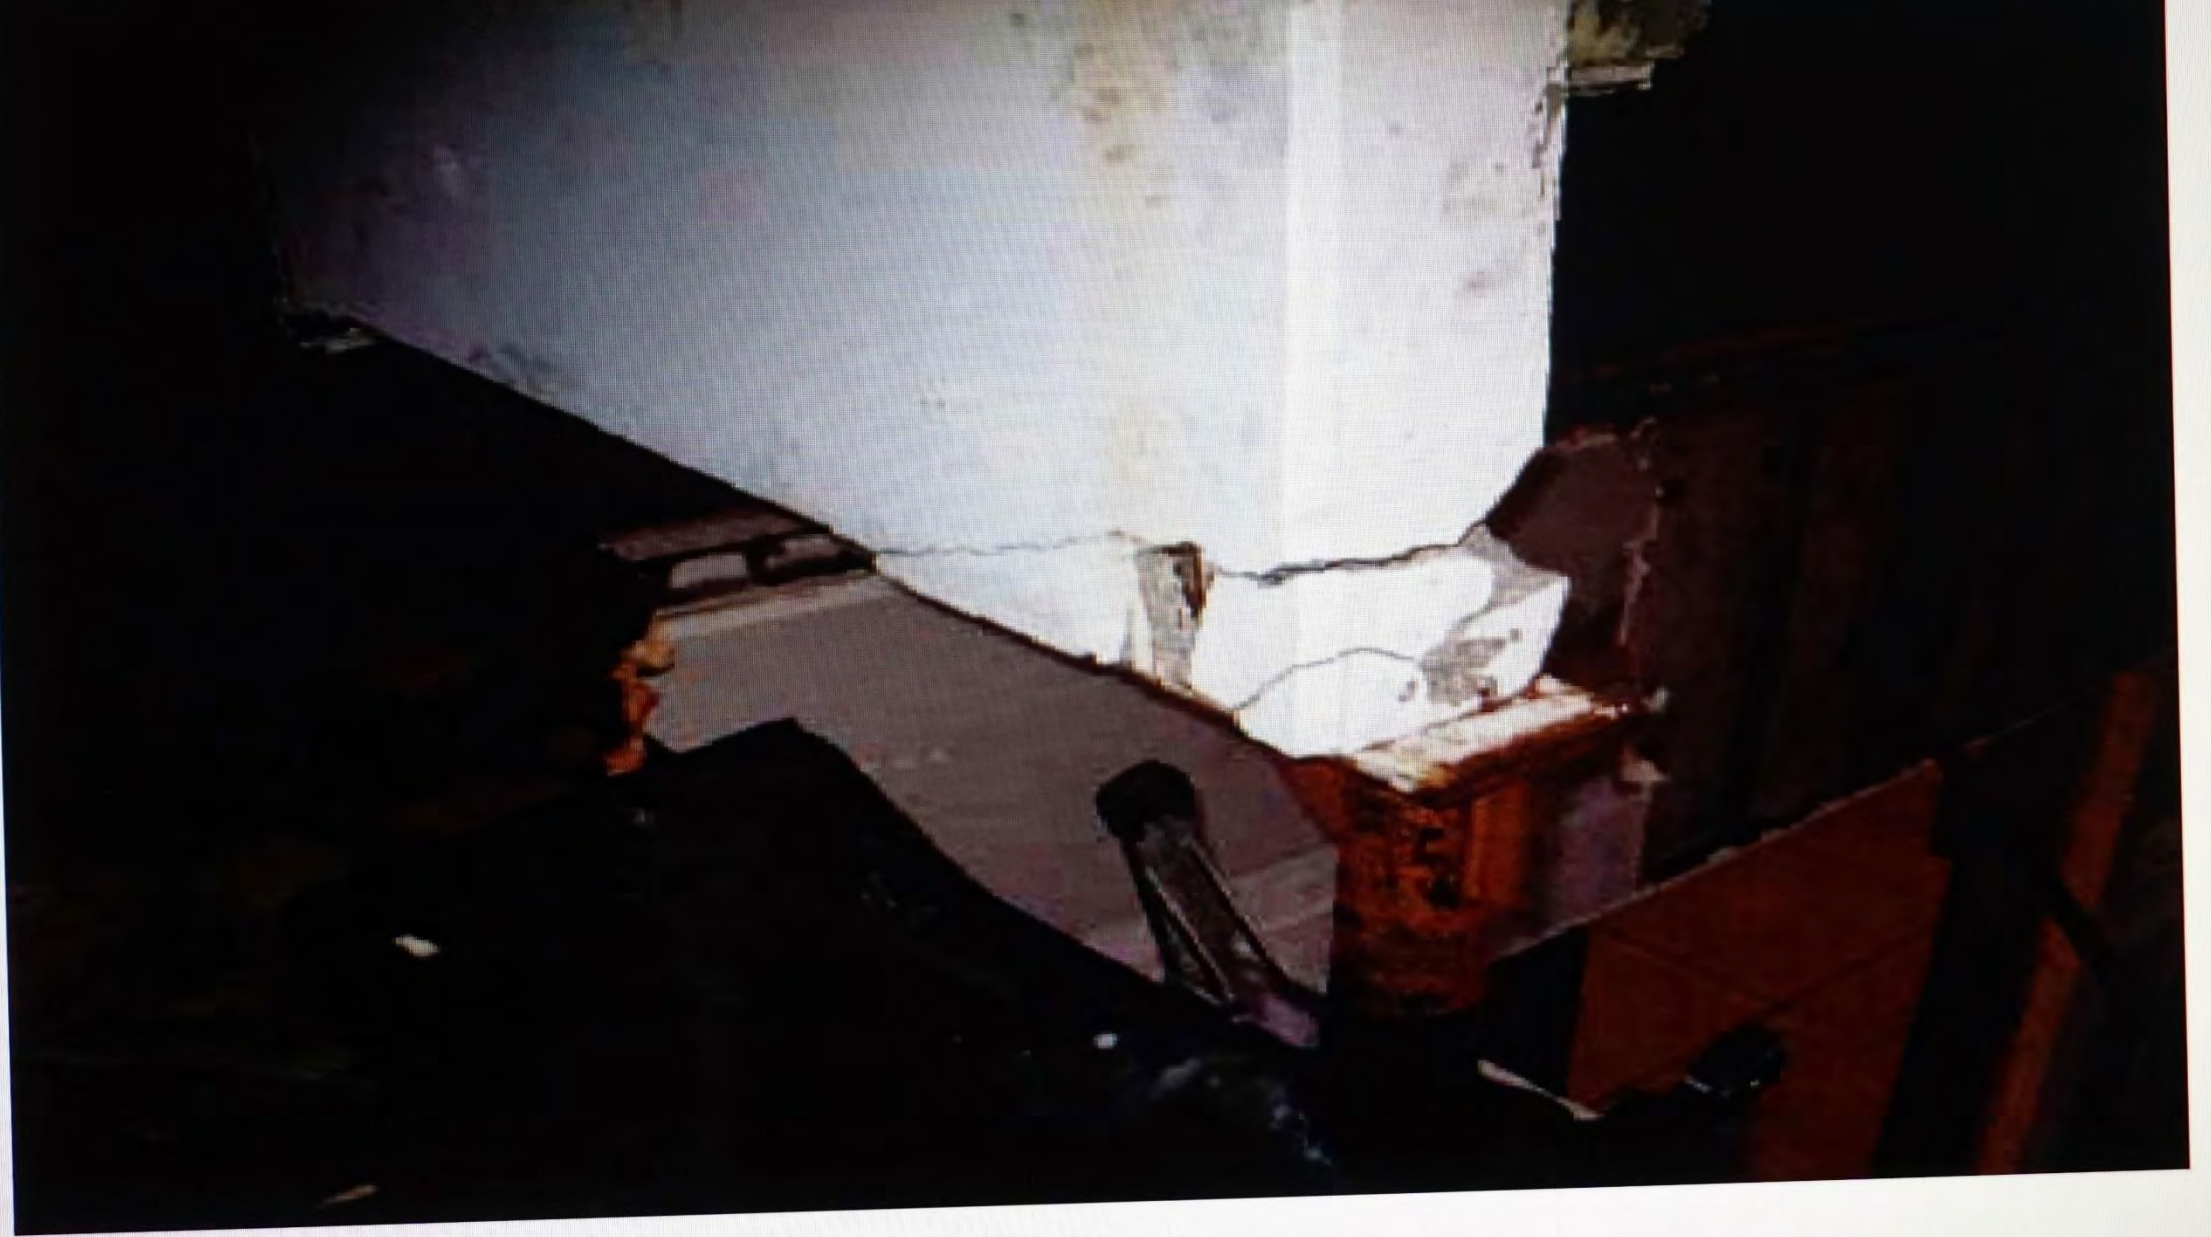
- REASONS FOR COLLAPSE
- VERY LARGE BUILDING
- SLOPE FRONT TO REAR OR SIDE WOULD ADD 2 TO 3' OF HEIGHT
- BUILDING SLOPED FROM MIDDLE TO FRONT AND TO REAR
- ALL ROOF DRAINS ARE INTERNAL
- ROOF DRAINS OF 5" MAY HAVE BEEN SIZED RIGHT BUT DID NOT ACCOUNT FOR PLASTIC BAGS AND DEBRIS
- NO SCUPPERS

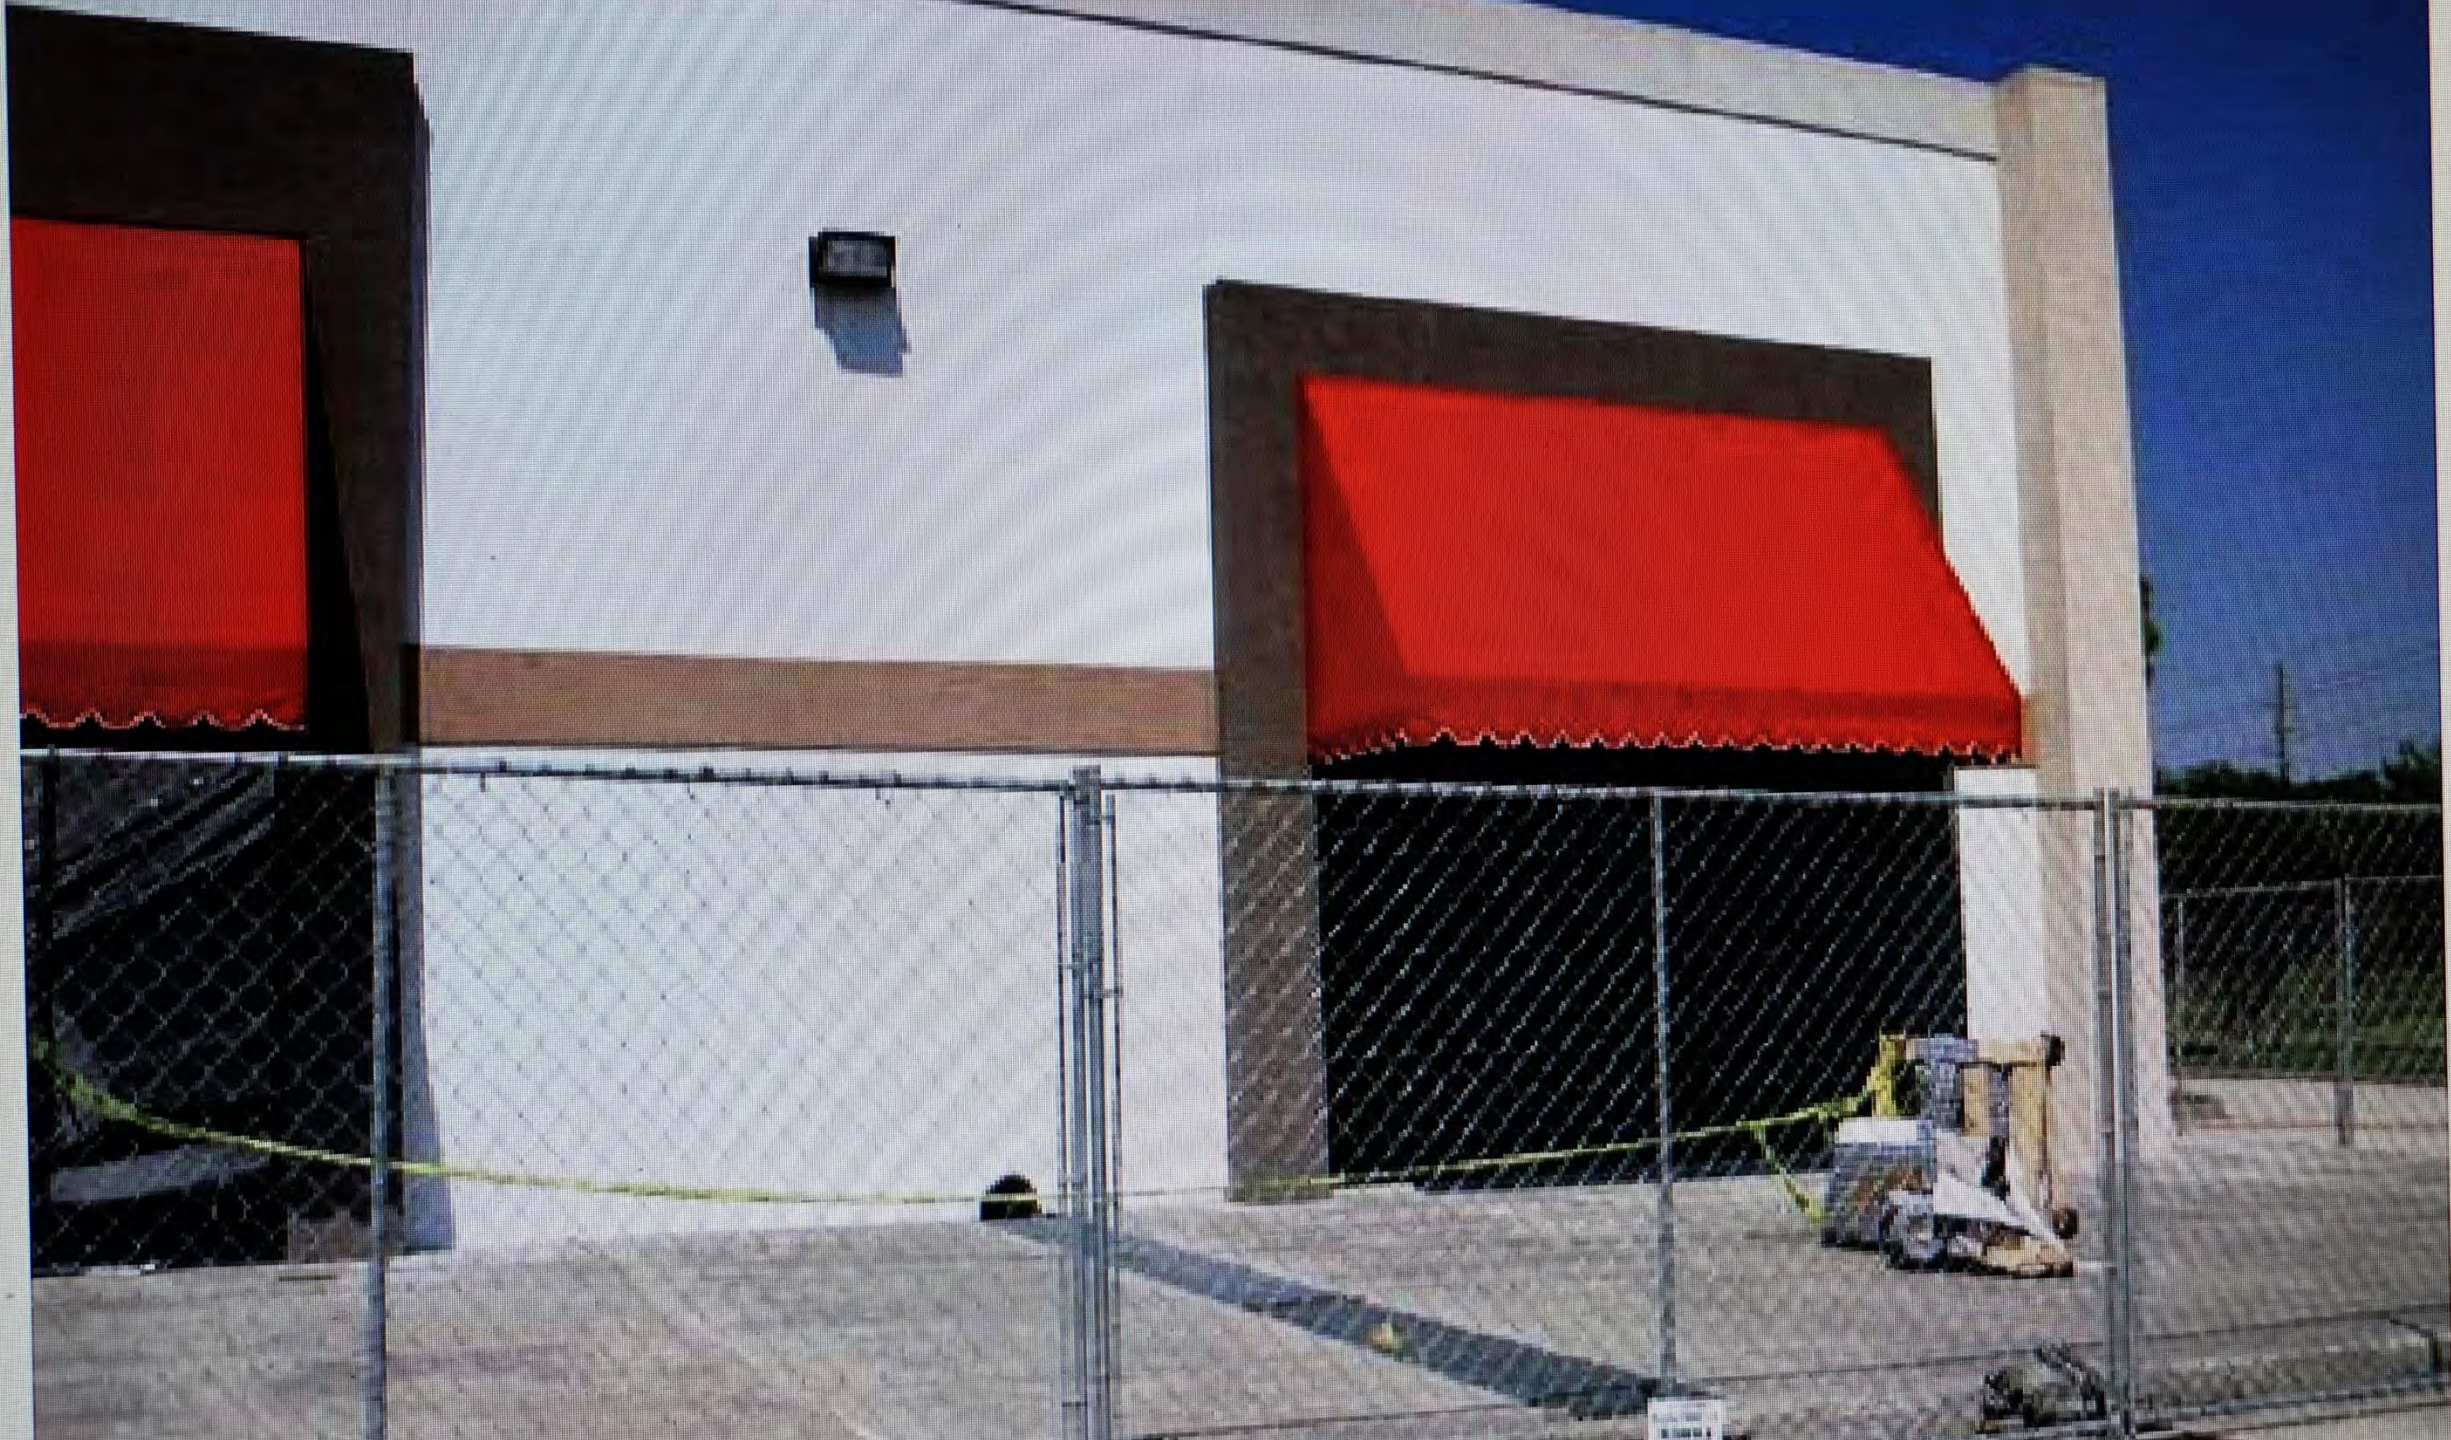
never were observed and the minor lateral displacement of the south wall panels at Grid 1 would indicate that the existing wall panels could be repaired and realigned. Collapsed joists, joist girders and interior columns have already been removed from the site. Additionally, certain remaining columns, joists and joist girders at the perimeter of the temporarily shored areas were damaged, deformed or distorted by the collapse events. The repair or replacement of these damaged components, along with the replacement of collapsed members previously cleared from the site, is related to Hurricane Ike.

At the remaining areas of the structure (away from the collapse areas), there were no signs of displacement, movement or distress to the existing structural members or connections that would indicate that the impact of the collapse or the wind contacting the remaining structural members weakened or diminished the structural integrity of the remaining structure. The primary load condition that caused the roof to fail at the two south corners of the building was an excessive live load due to ponding water on the roof related to an ineffective roof drainage system. This type of failure mechanism (i.e. gravity overload) typically does not affect the entire building. Additionally, there are no signs that once the collapse occurred and opened up the API building, that wind within the interior was severe enough to create lateral pressures strong enough to damage the remainder of the API structure. We evaluated the connections closely at numerous areas away from the collapse and found no distress or, more specifically, distress that could be correlated to Hurricane Ike.

It is NAE's professional opinion that the collapsed areas can be repaired to their pre-loss condition. There are no signs that the remainder of the building, outside the areas of the collapse, sustained any distress. In our experience of evaluating partial roof collapses, it is reasonable and typical to repair the collapse areas so that they are designed and
