Foundation Performance Association

Imad F Abdullah AIA

June 14, 2017

A. Case Study 1: Structural Roof Collapse of 100,000 sq ft former “Kmart” due to Hurricane Ike, Analysis of parameters that contributed to collapse, Aftermath Structural Repair Options Considered, Remedies implemented

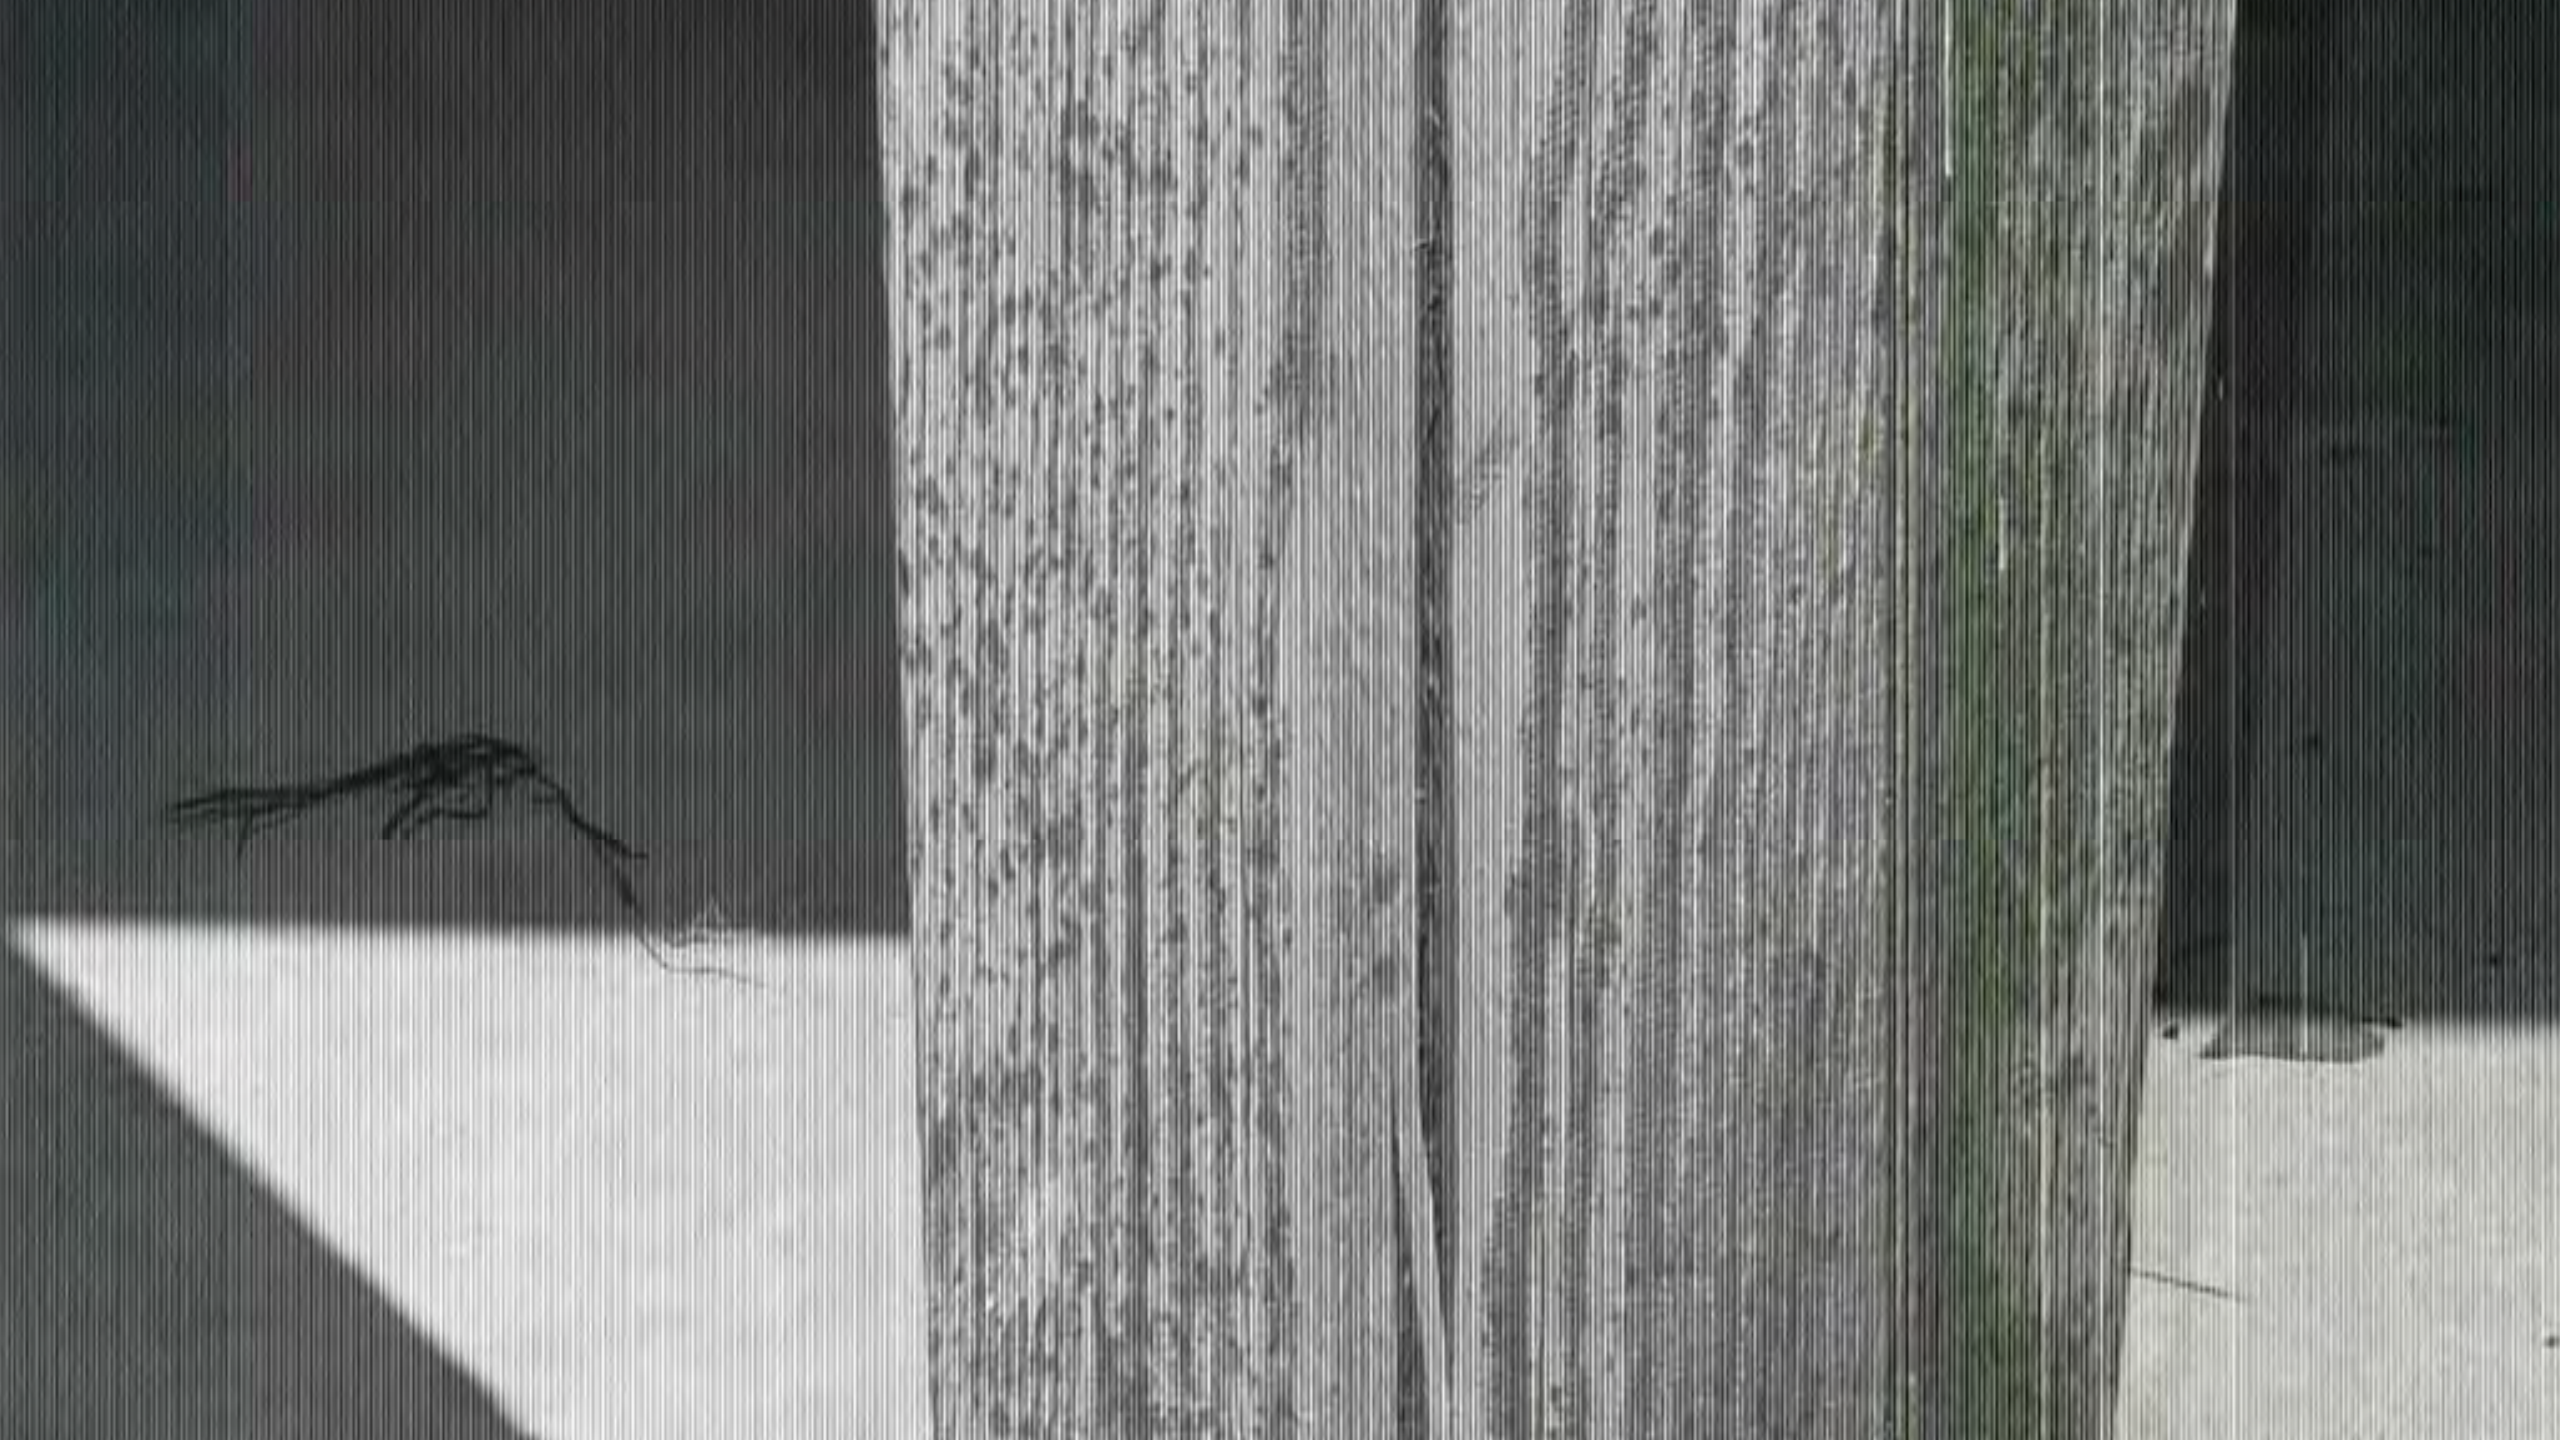
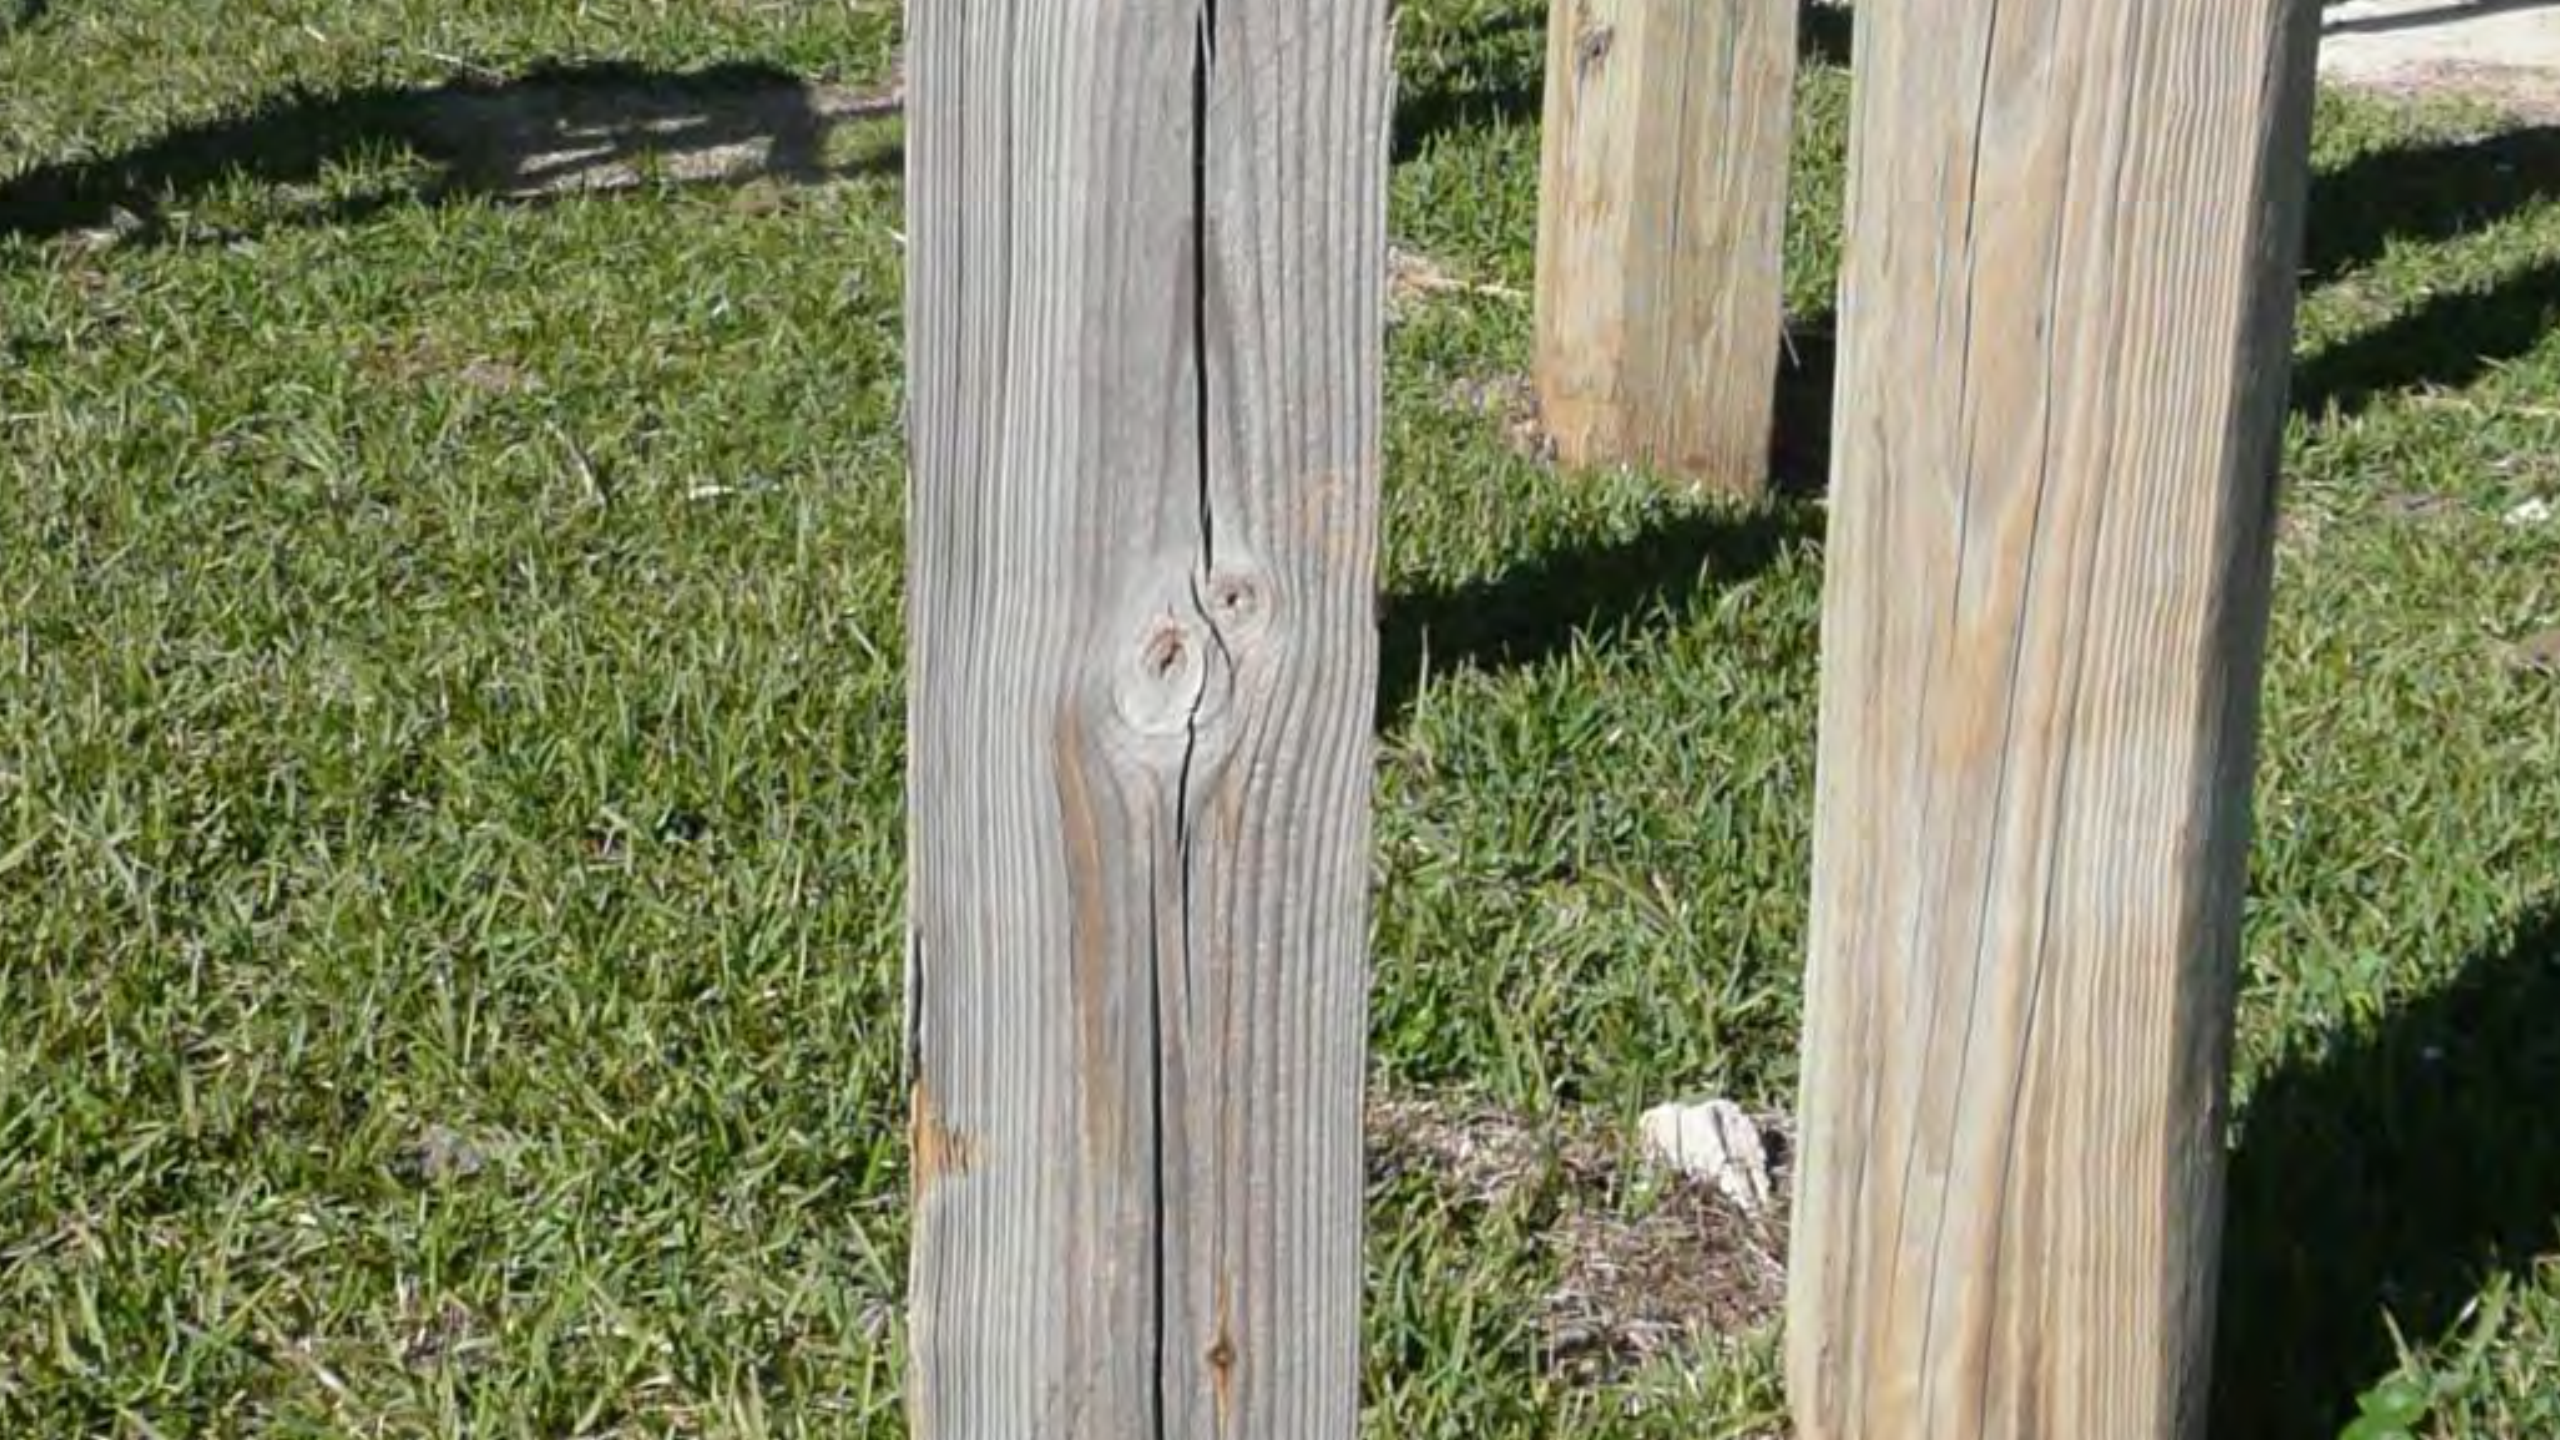
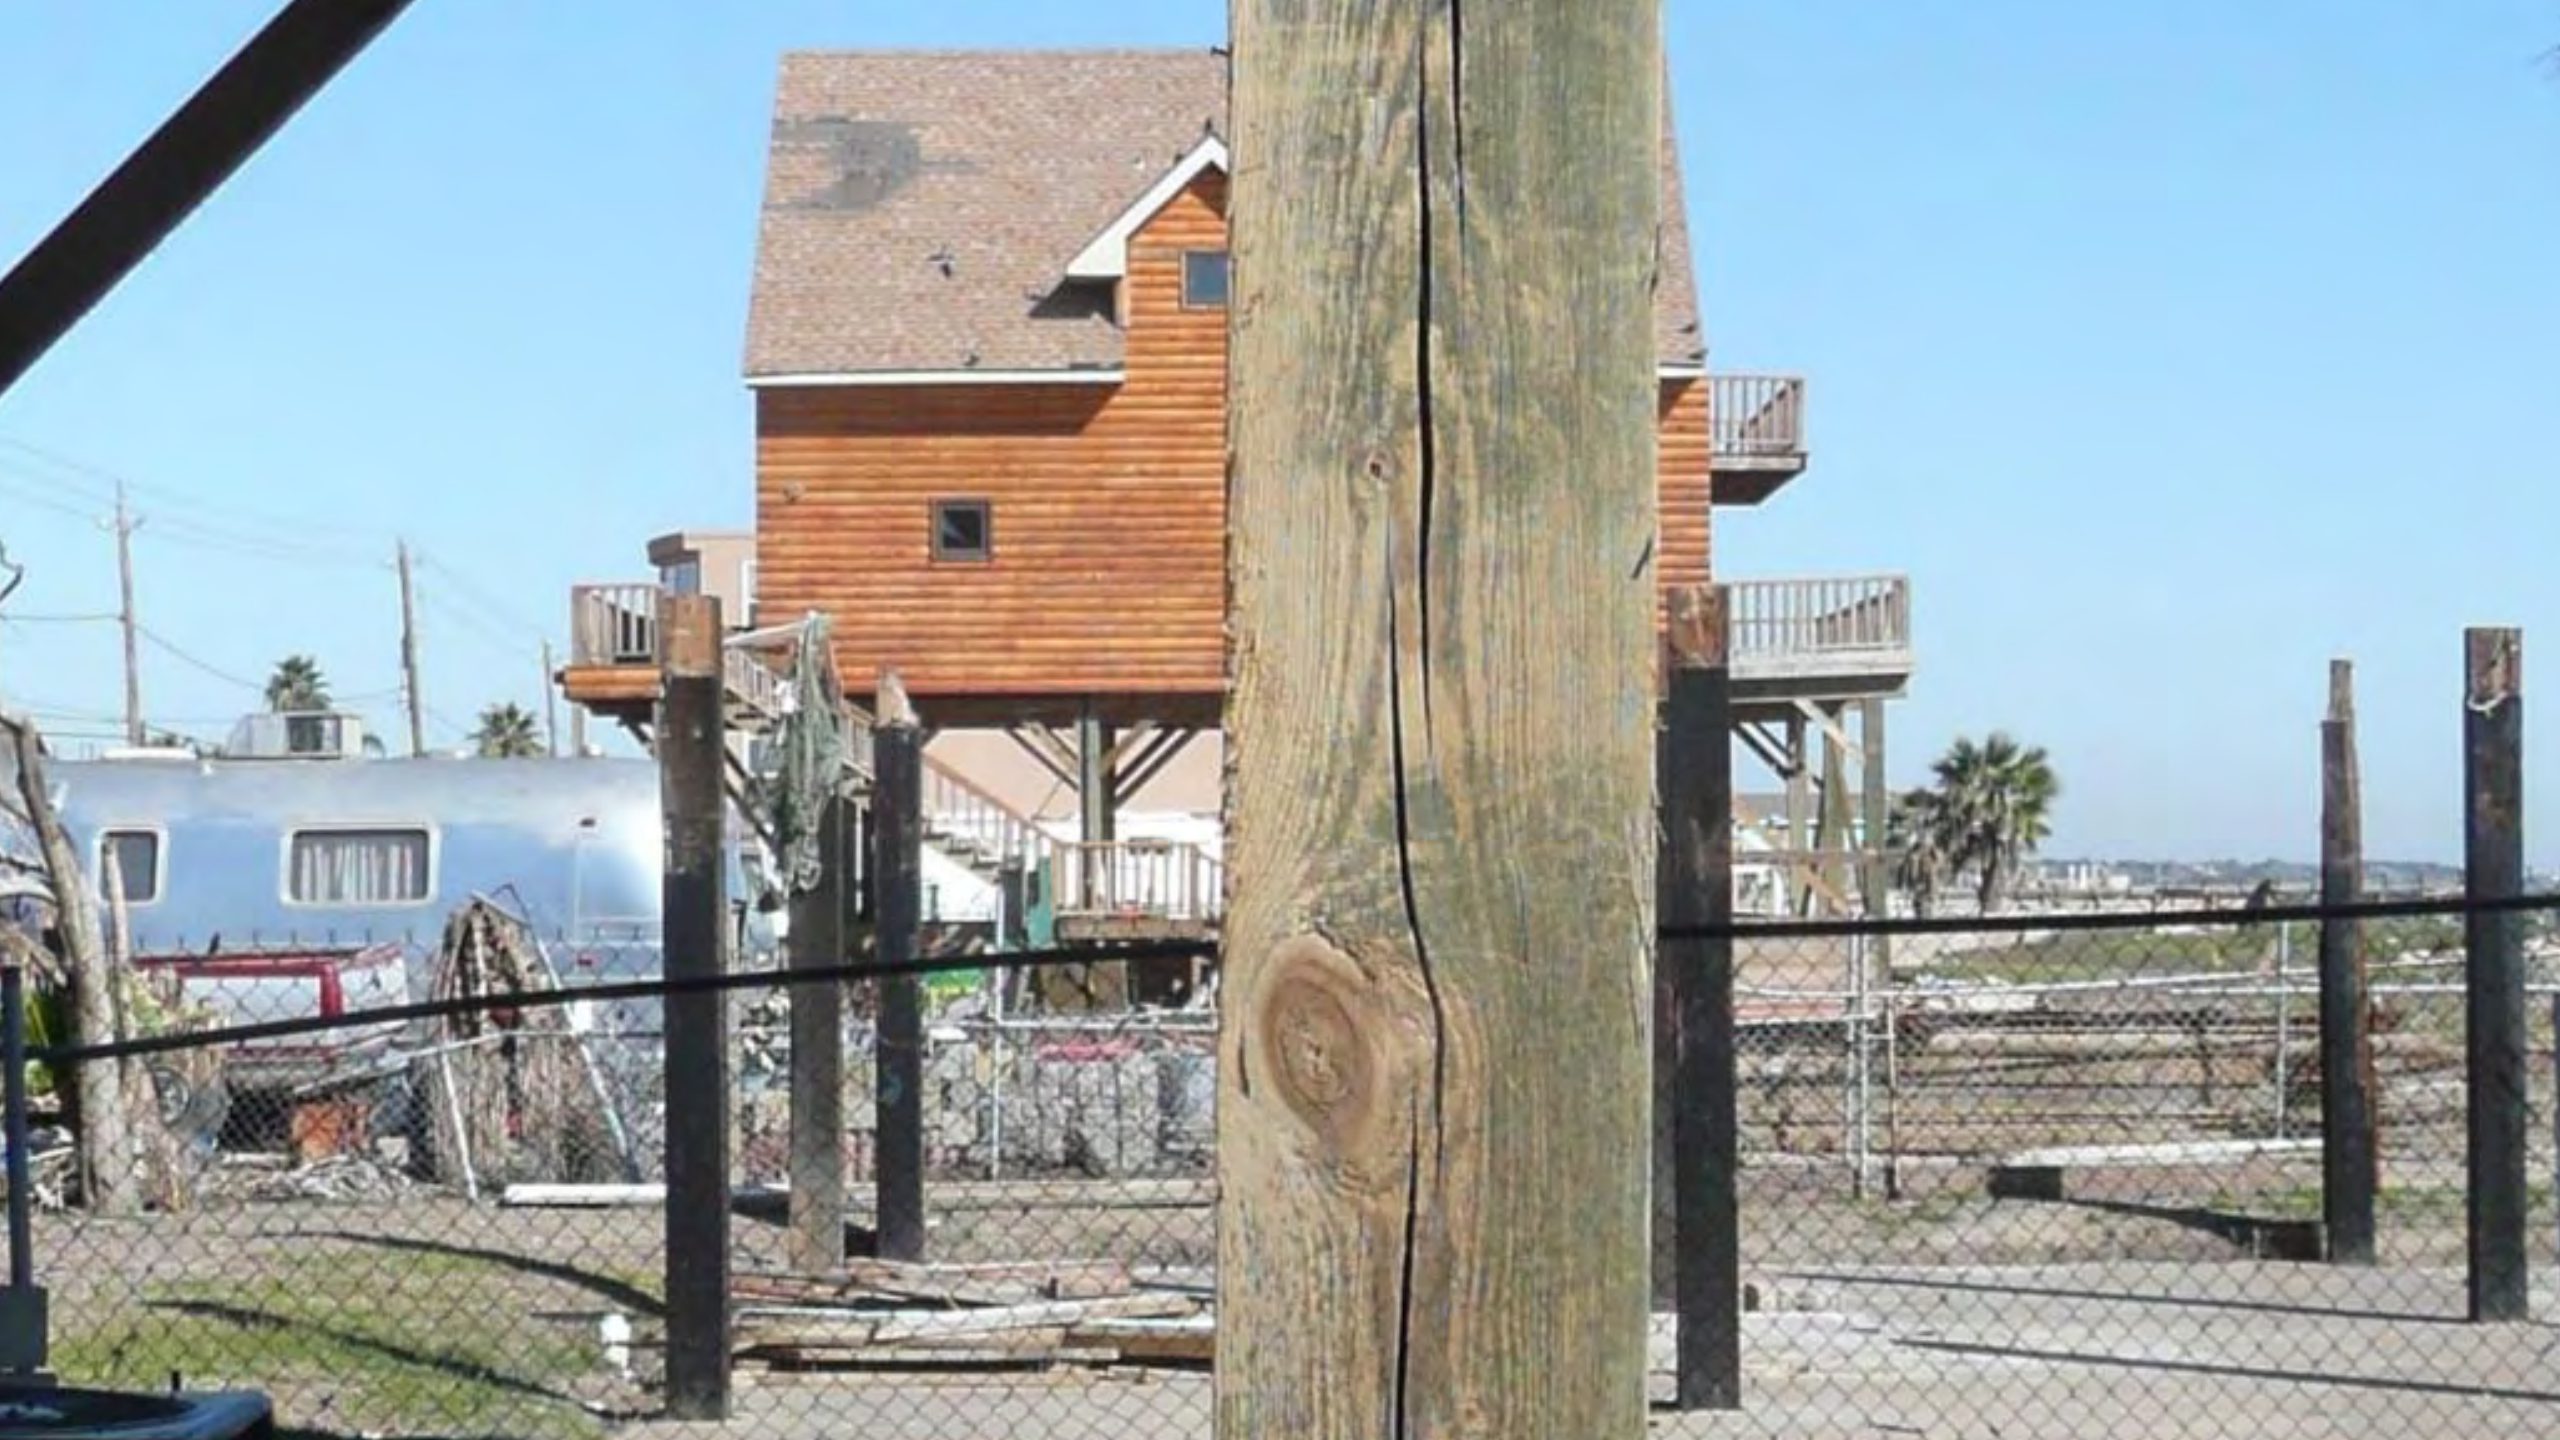
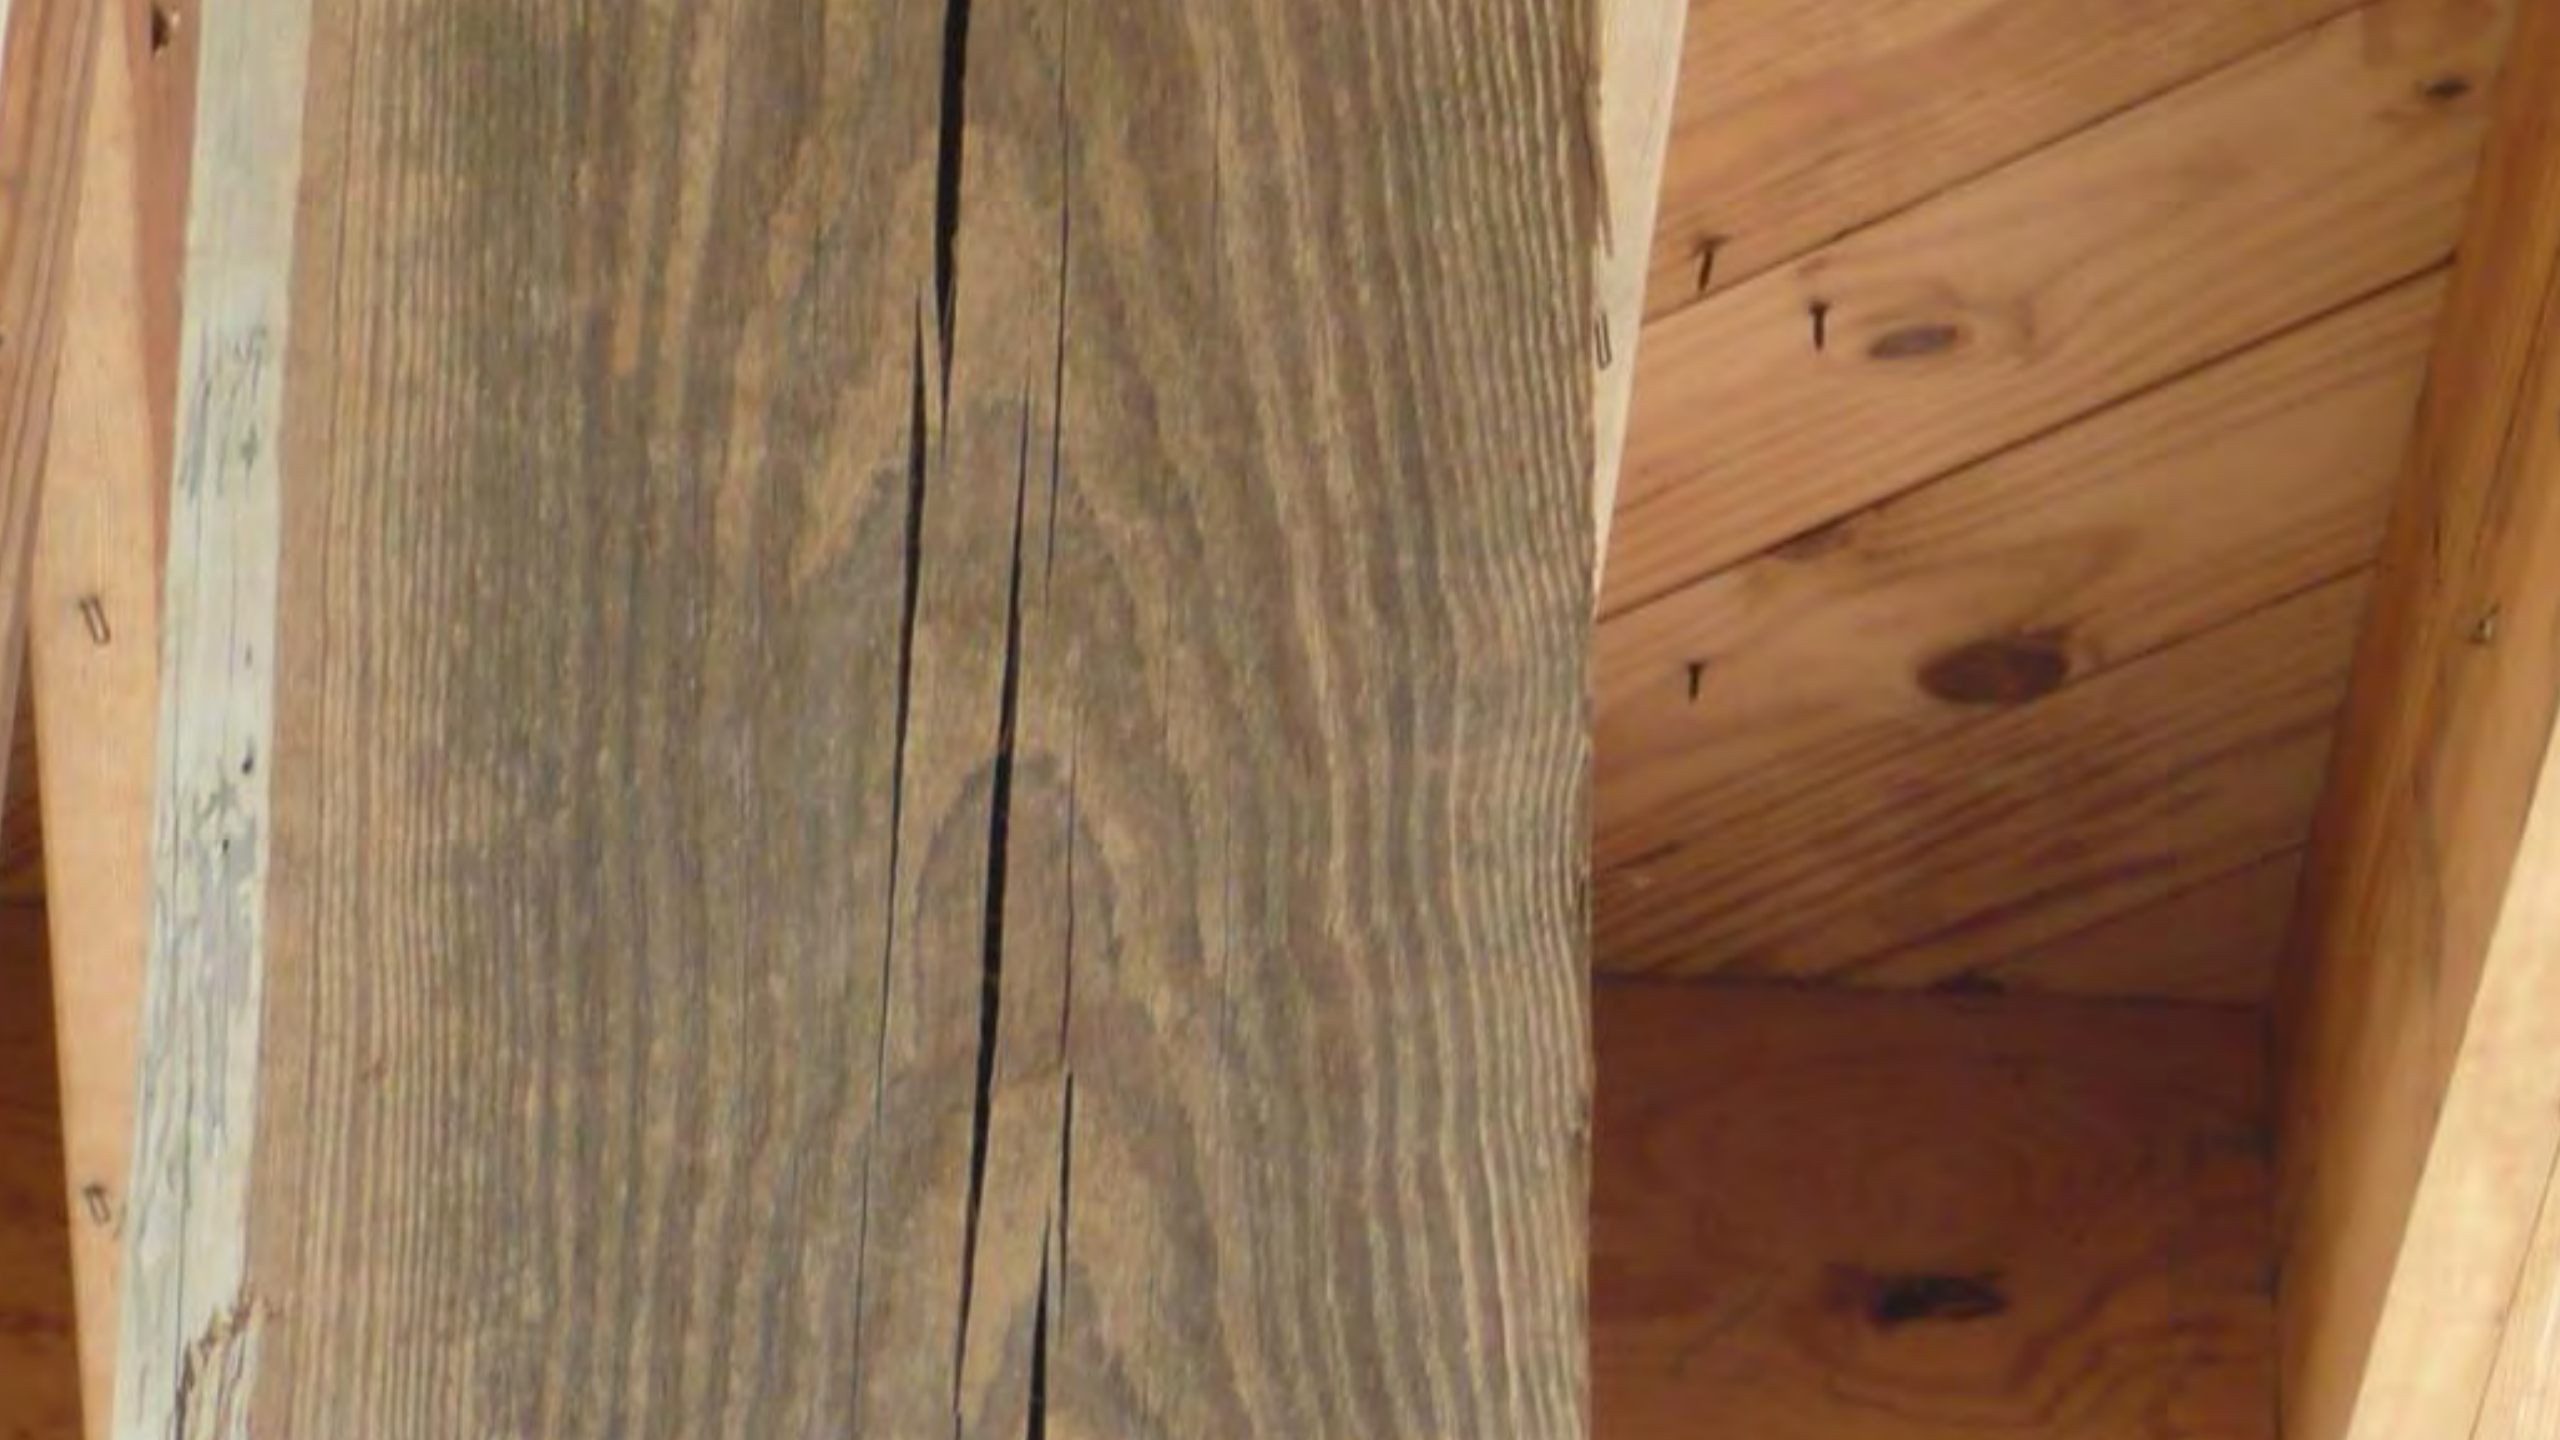
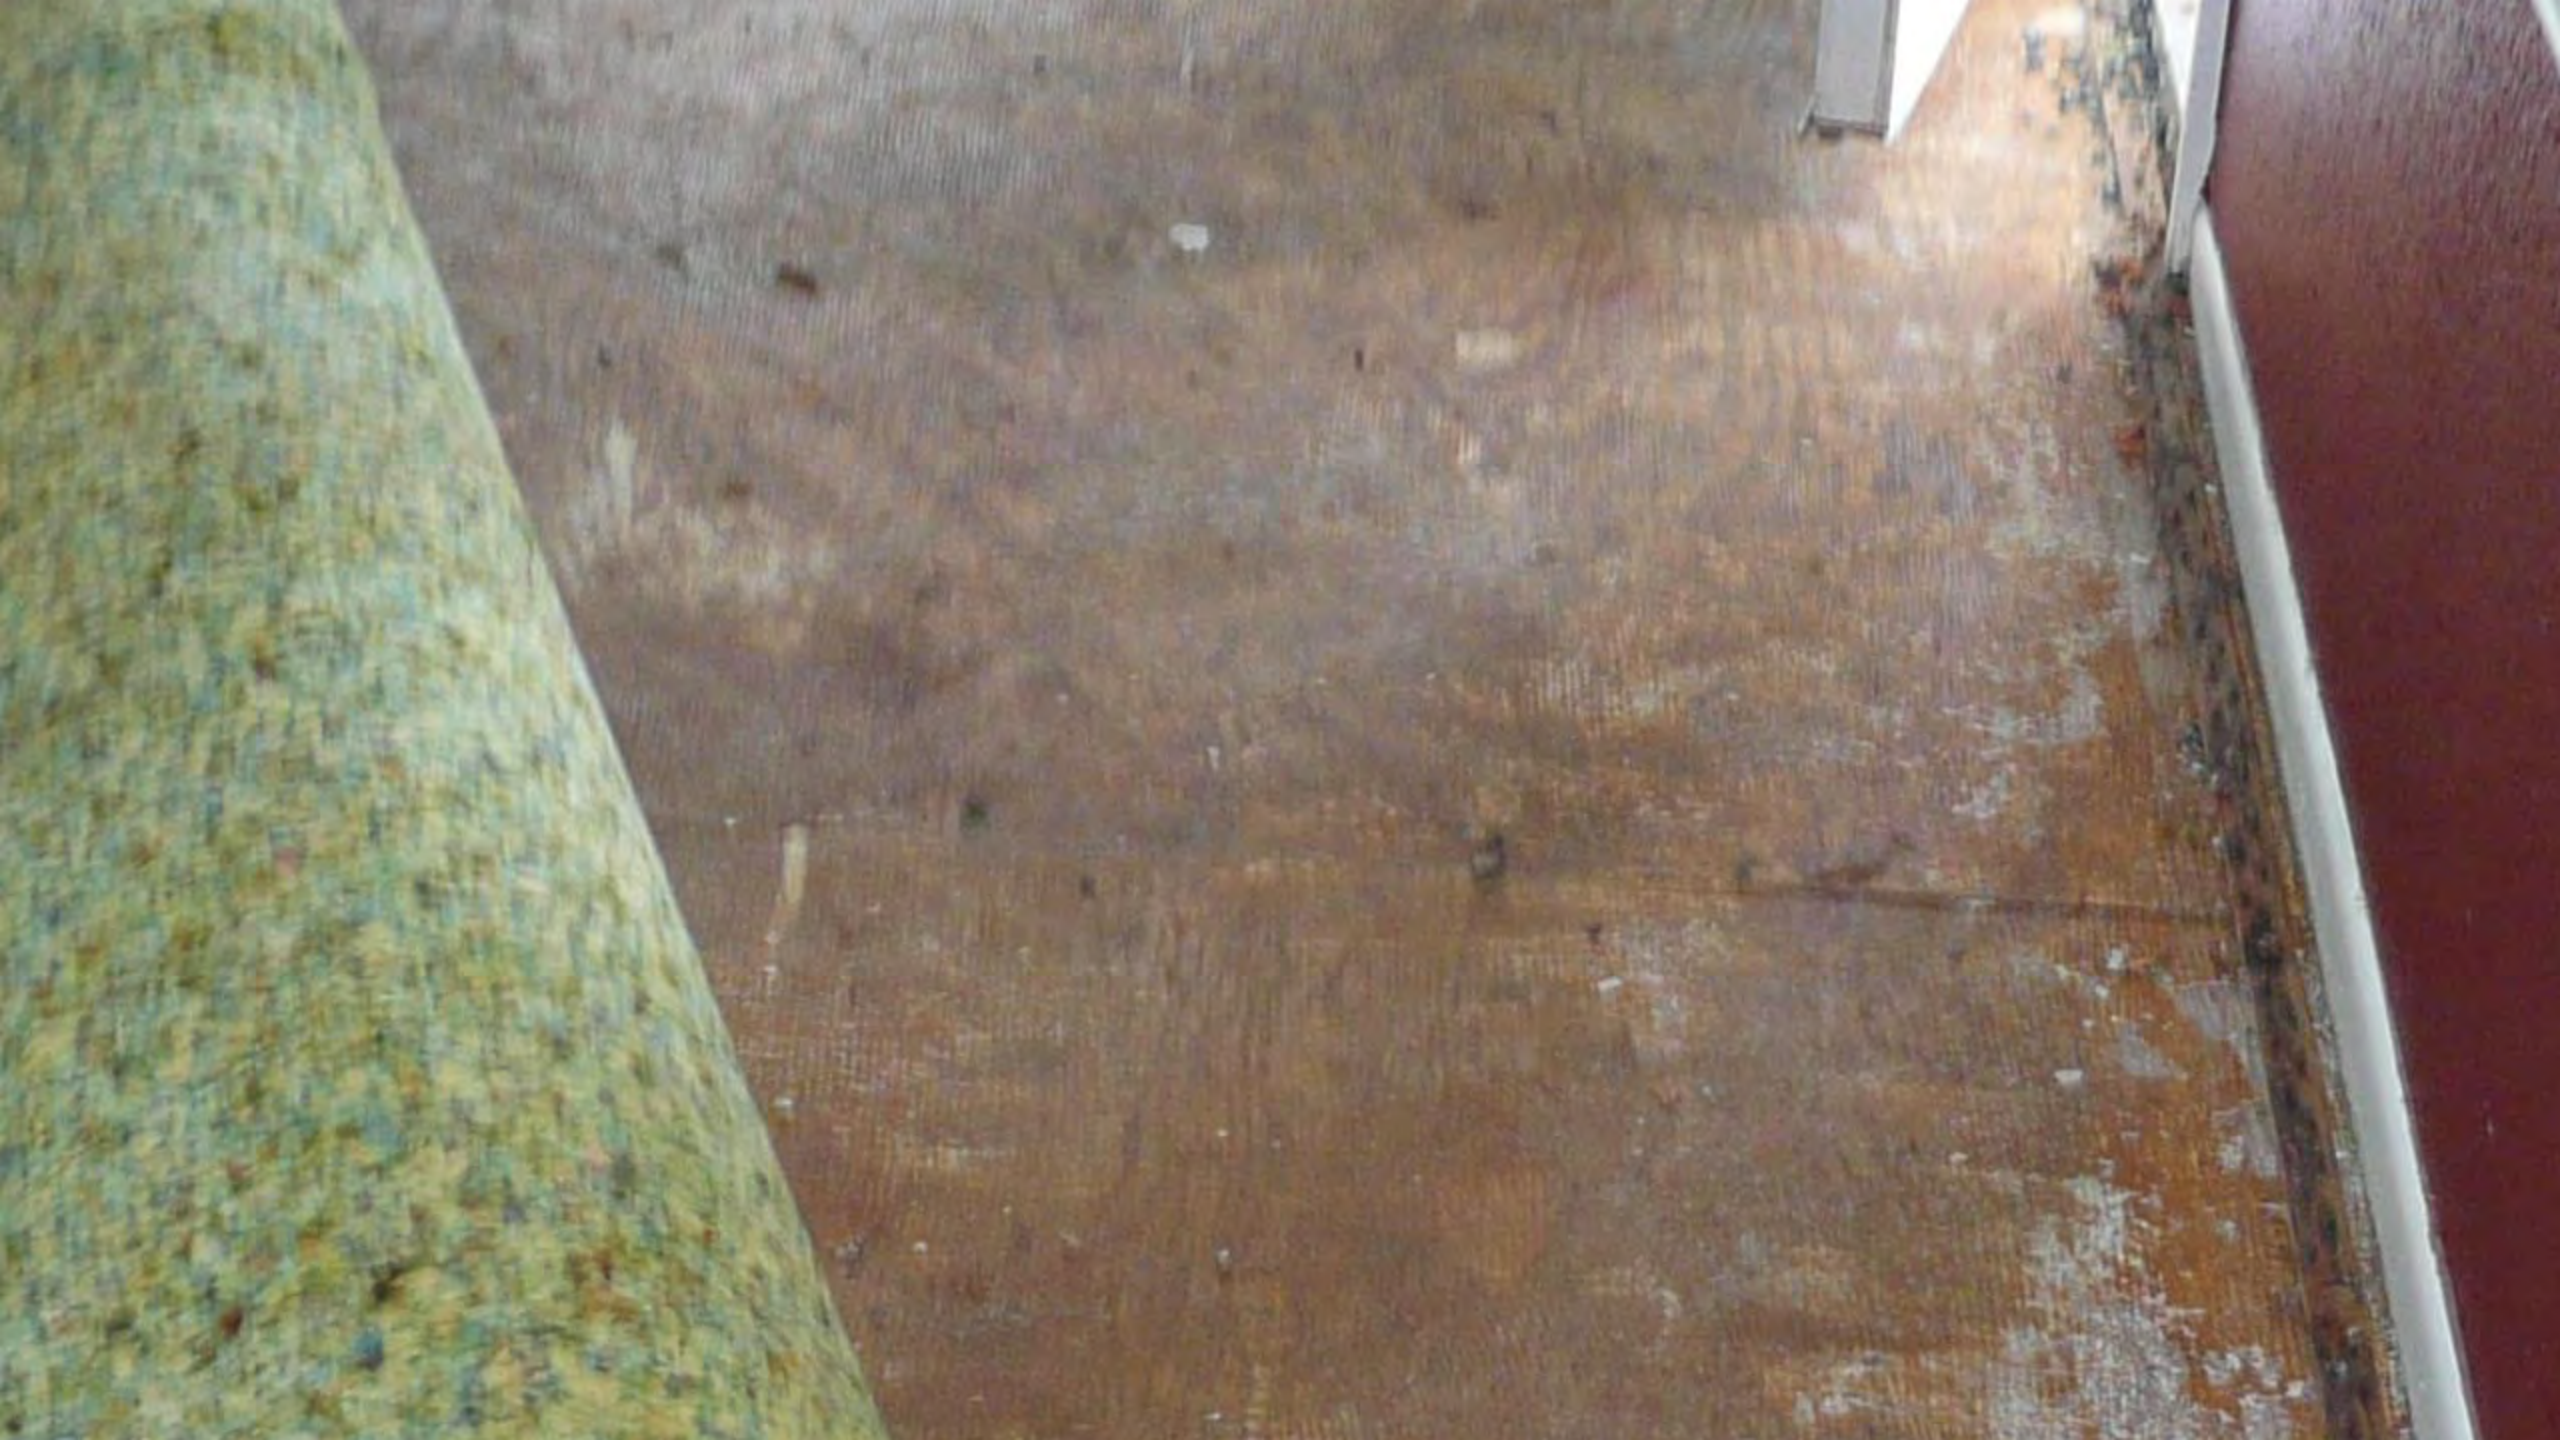
ISSUES OF CONCERN

STRUCTURAL INTEGRITY OF COLUMNS WITH TORQUE
CRACKS, FUTURE LIABILITY AS A SELLER

DID PLYWOOD FLOORING DECK LOSE MOMENT VALUE
SINCE IT WAS NOT MARINE PLYWOOD?

WOOD COLUMNS WERE SIZE 10X10 WHEREAS ONLY 6X6
AT BALCONY

WERE 6X6 UNDERSIZED SINCE IKE TORE UP BALCONY
AND THE WHOLE FRONT ON THE LAKE?

ELEVATION WAS 15' AT FLOOR LEVEL AND
13' TO BOTTOM OF LOWEST STRUCTURAL MEMBER

SETTLED WITH INSURANCE AFTER 3 YEARS, REMOVED EXISTING
STRUCTURE
