Foundation Performance Association

Imad F Abdullah AIA

June 14, 2017

A. Case Study 1: Structural Roof Collapse of 100,000 sq ft former “Kmart” due to Hurricane Ike, Analysis of parameters that contributed to collapse, Aftermath Structural Repair Options Considered, Remedies implemented

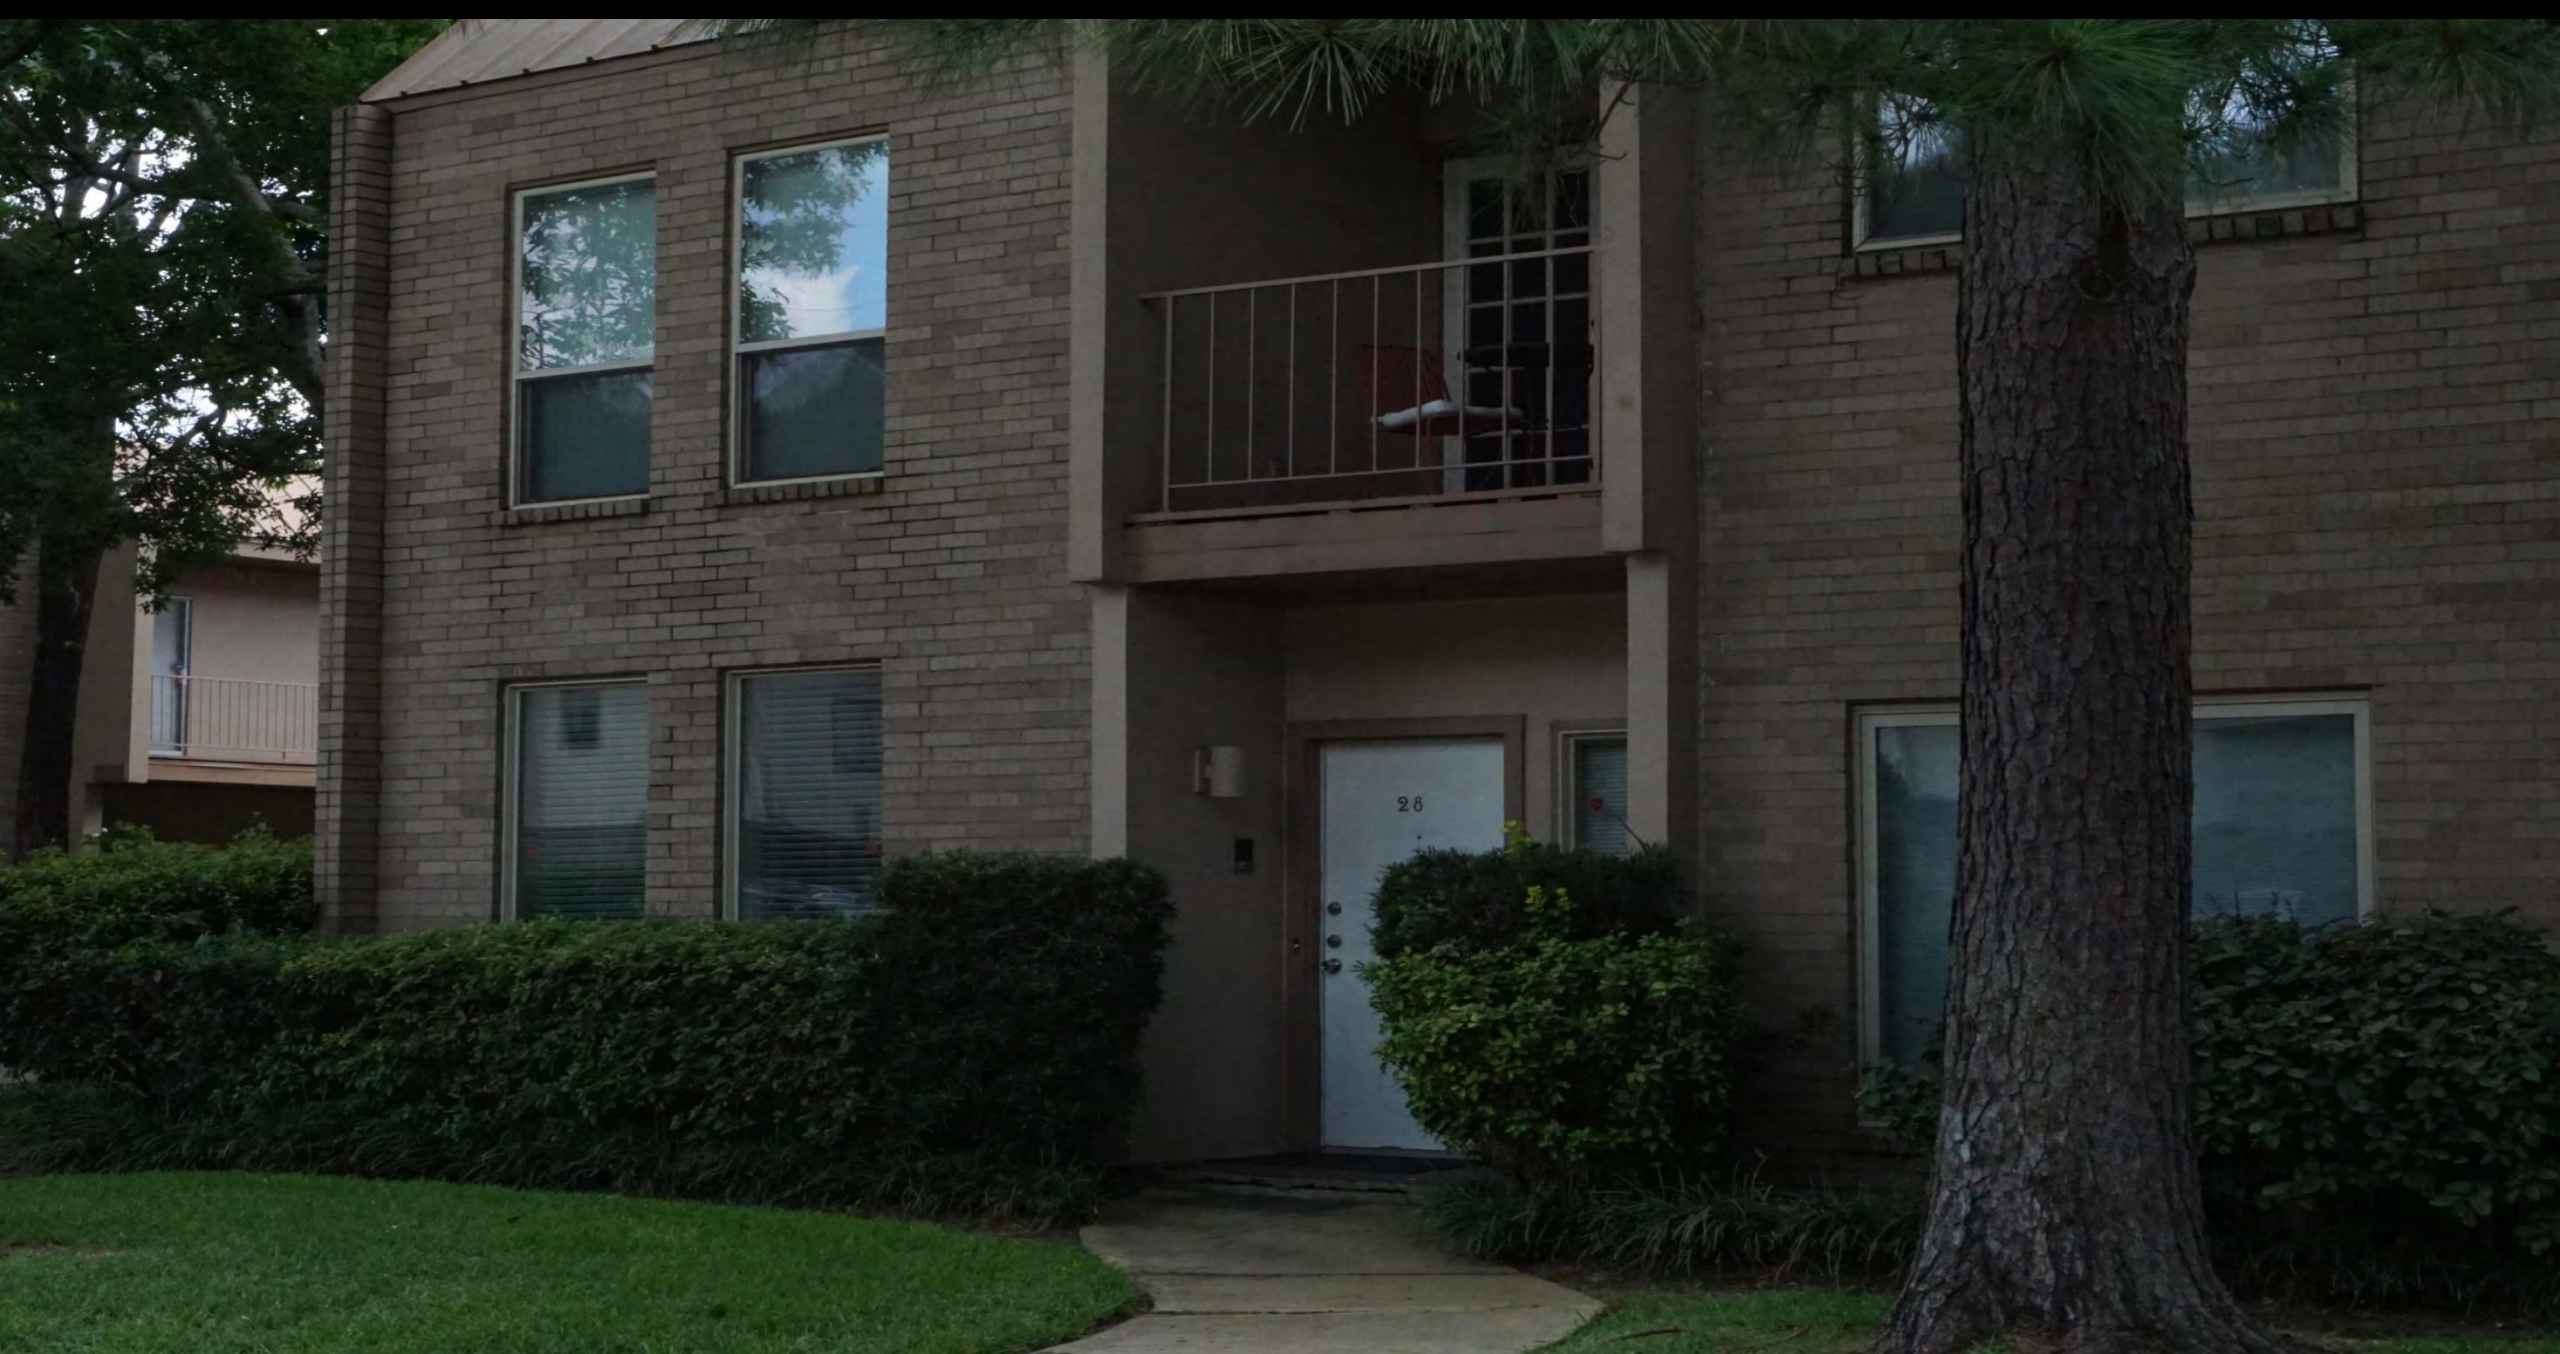
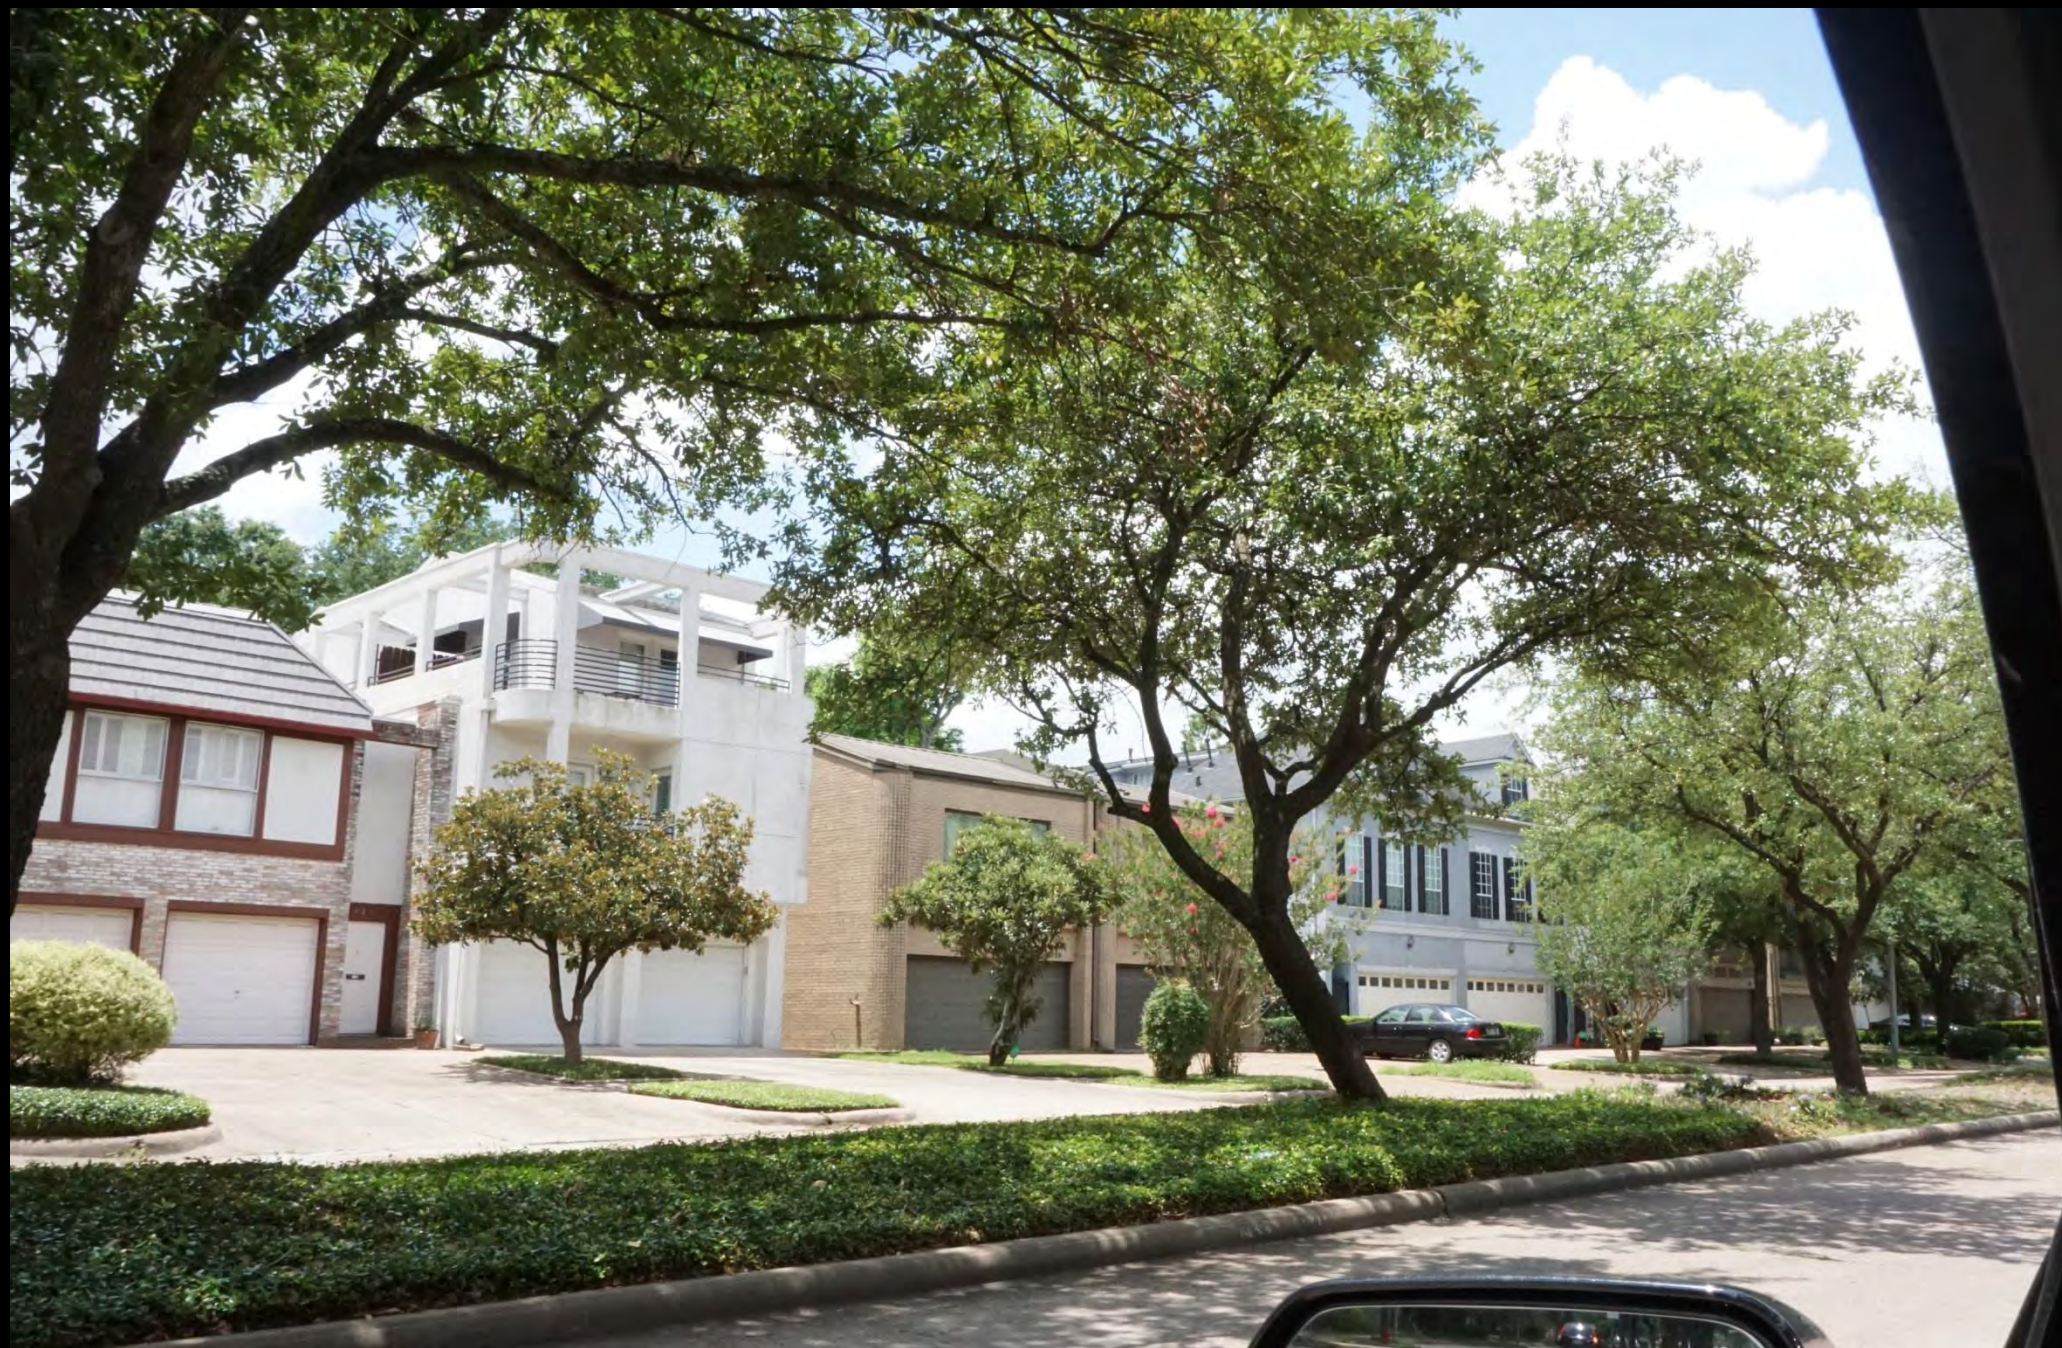
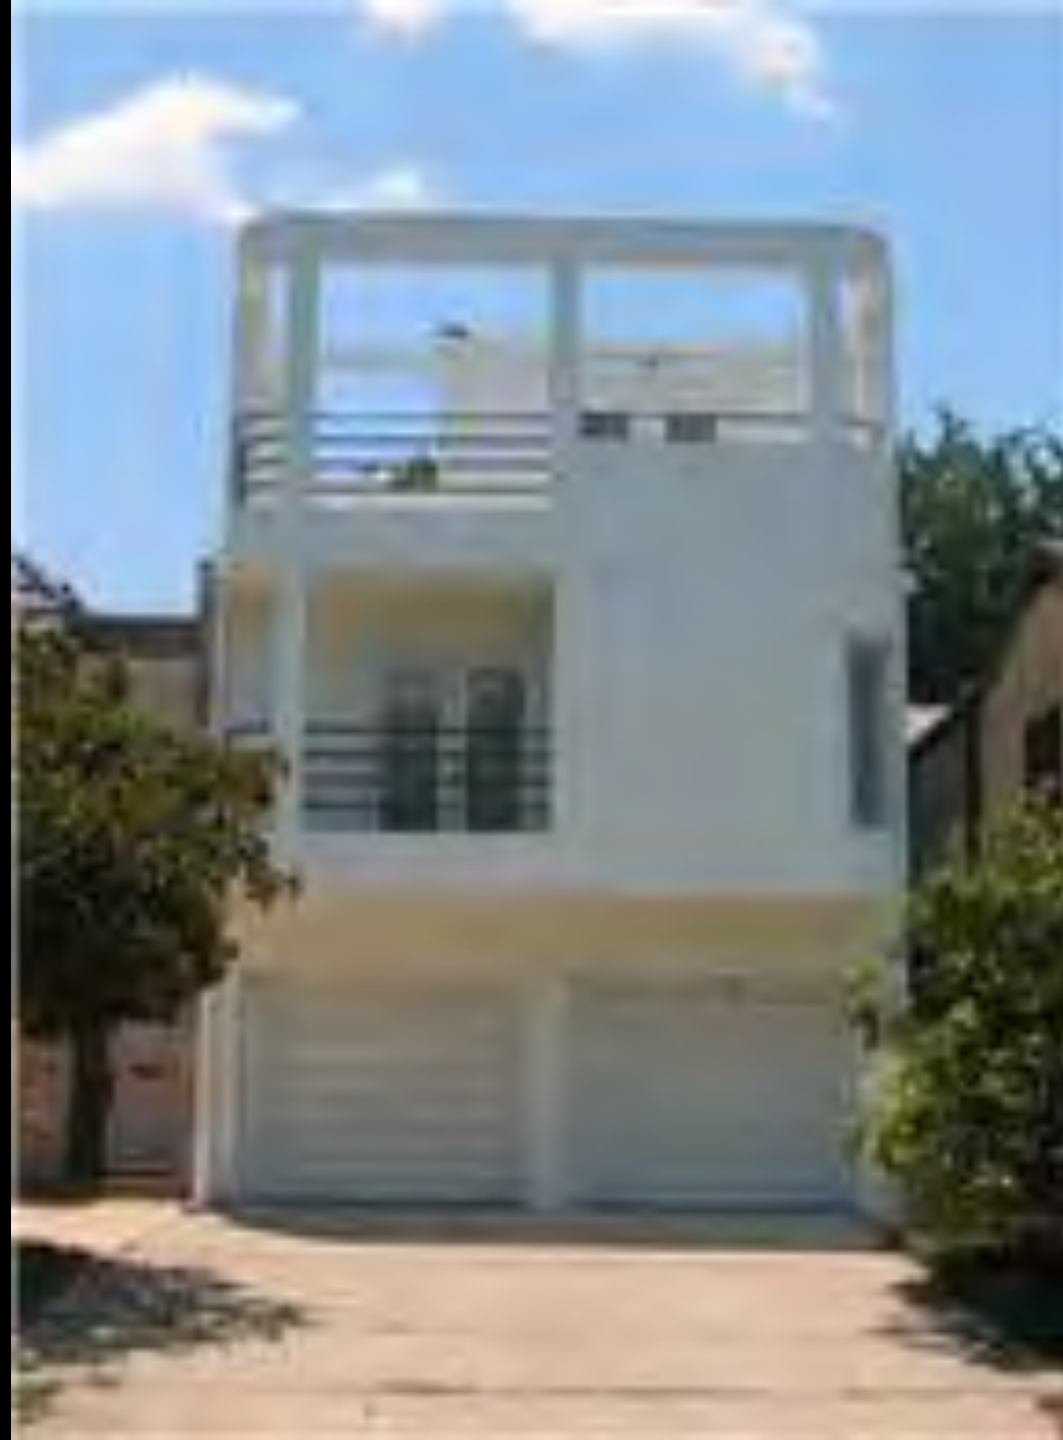
Augusta Square, 1300 Augusta Drive

- Post Tension Slab
- First Cable from slab edge went through 8" concrete element creating vertical brick column
- When tension pressure was applied on cable, the 8" ledge exploded
- Expensive remediation

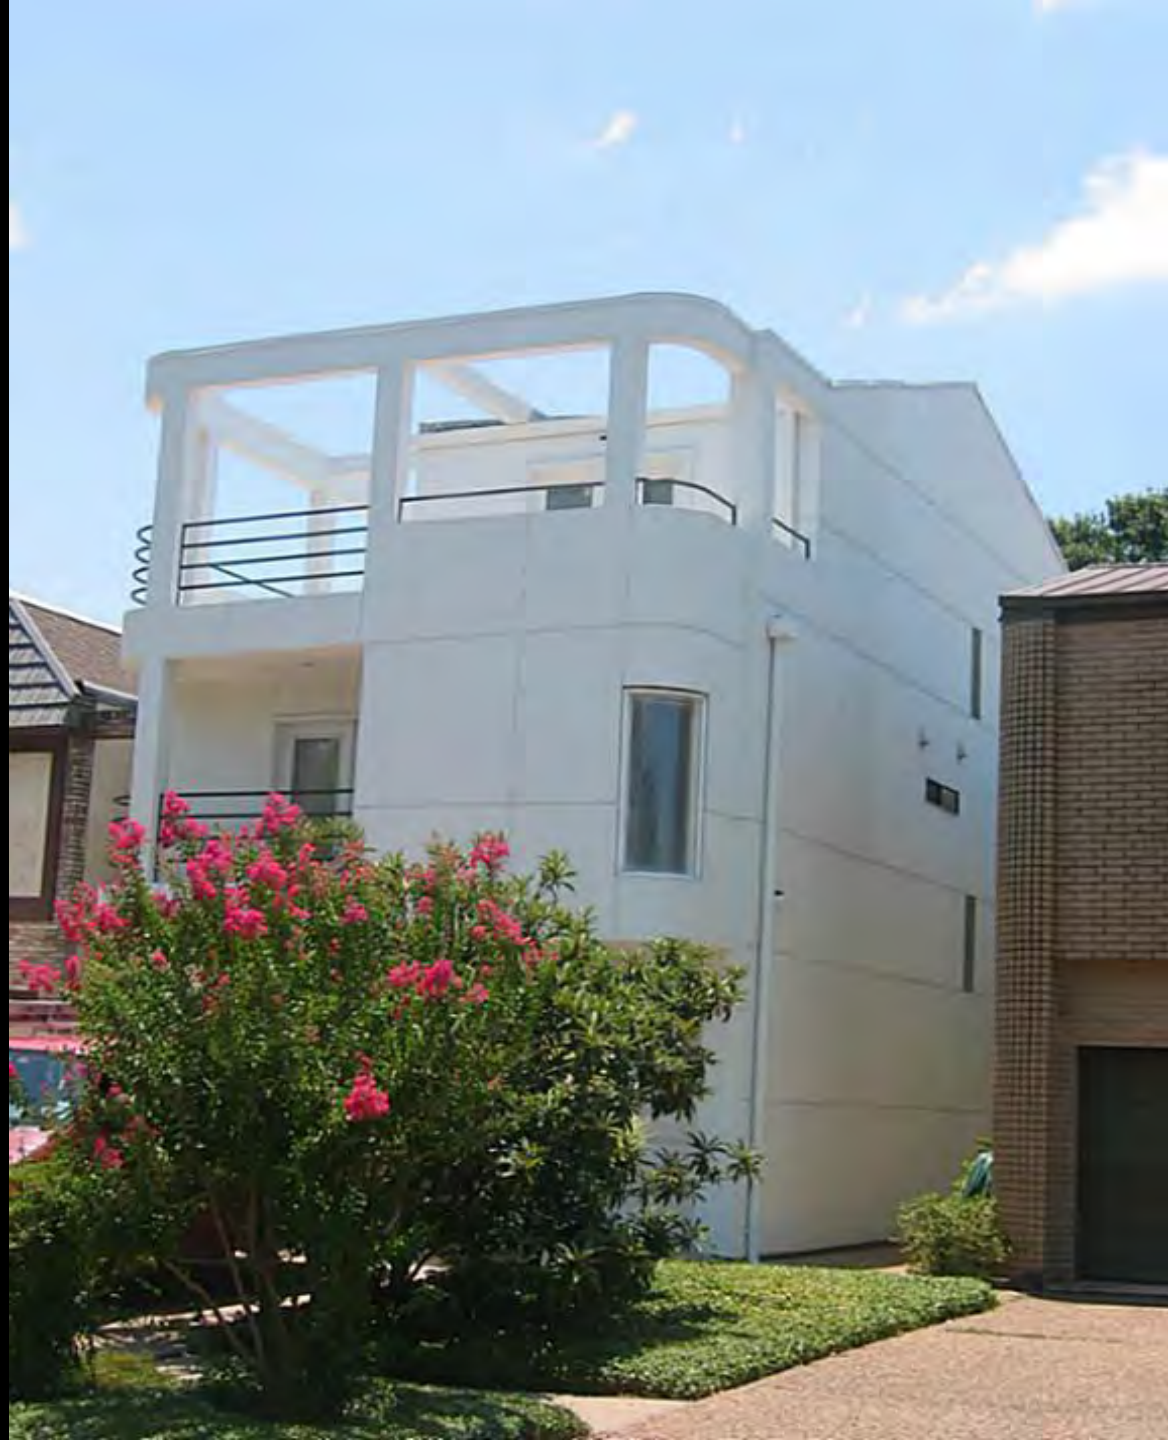
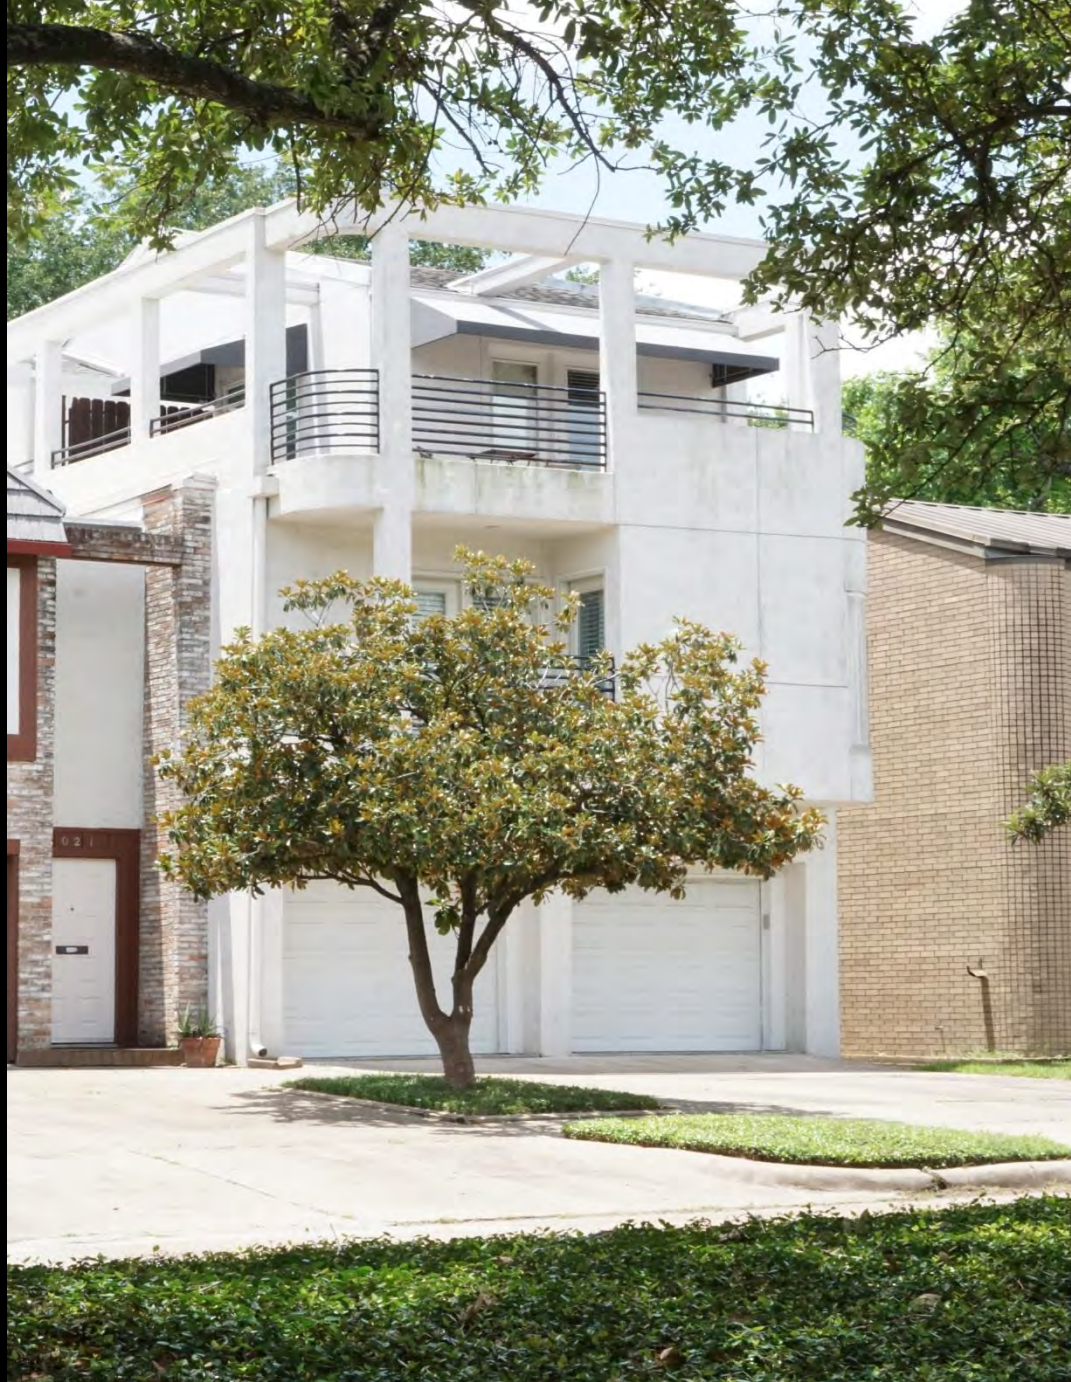
3023 Bissonnet

- Three story, garage in front, entrance from side due to a 6' fire access easement
- While in Framing stage, framer calls says: "it shakes"
- The moment for lateral stability at the garage frame was not factored in the design
- The solution was a flitch beam with ½ inch steel plate, staggered bolts at 8" through 3- 2x12's around the frame, and similar small beams at 45 degrees at the corner and posts tied together

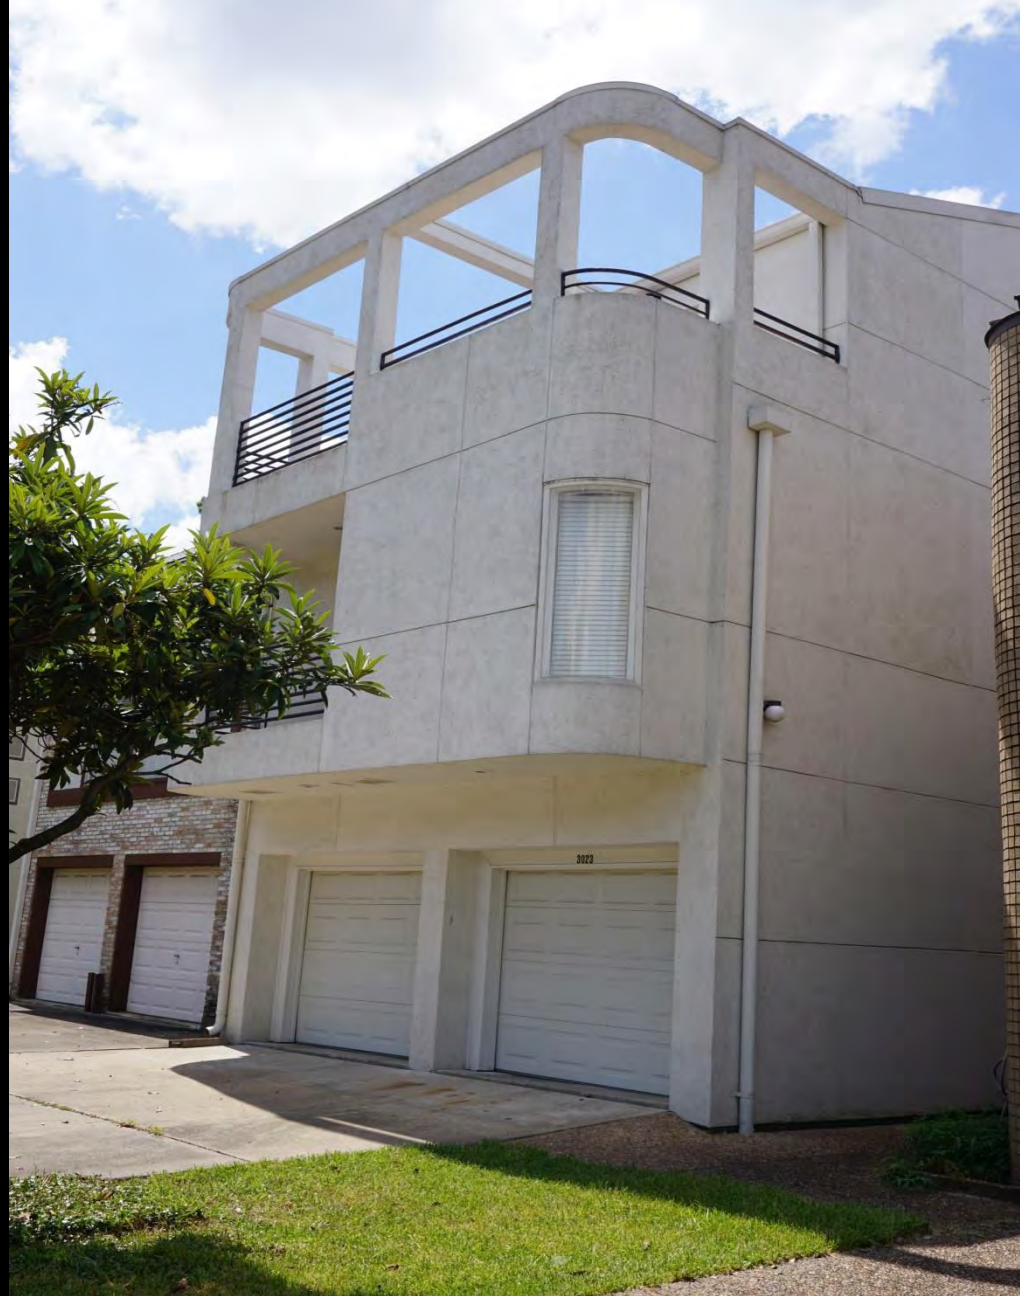
- Wind between buildings when a 3 story is next to two-story causes water to go up the wall and under the metal caps. Use 4" minimum metal cap, insert backer rod and seal
- Book-End walls: parapets cause roof shingles to buckle with heat. Water penetrates between flashing and shingles
- If there is no overhang, water running into gutter will roll back up and enter the building

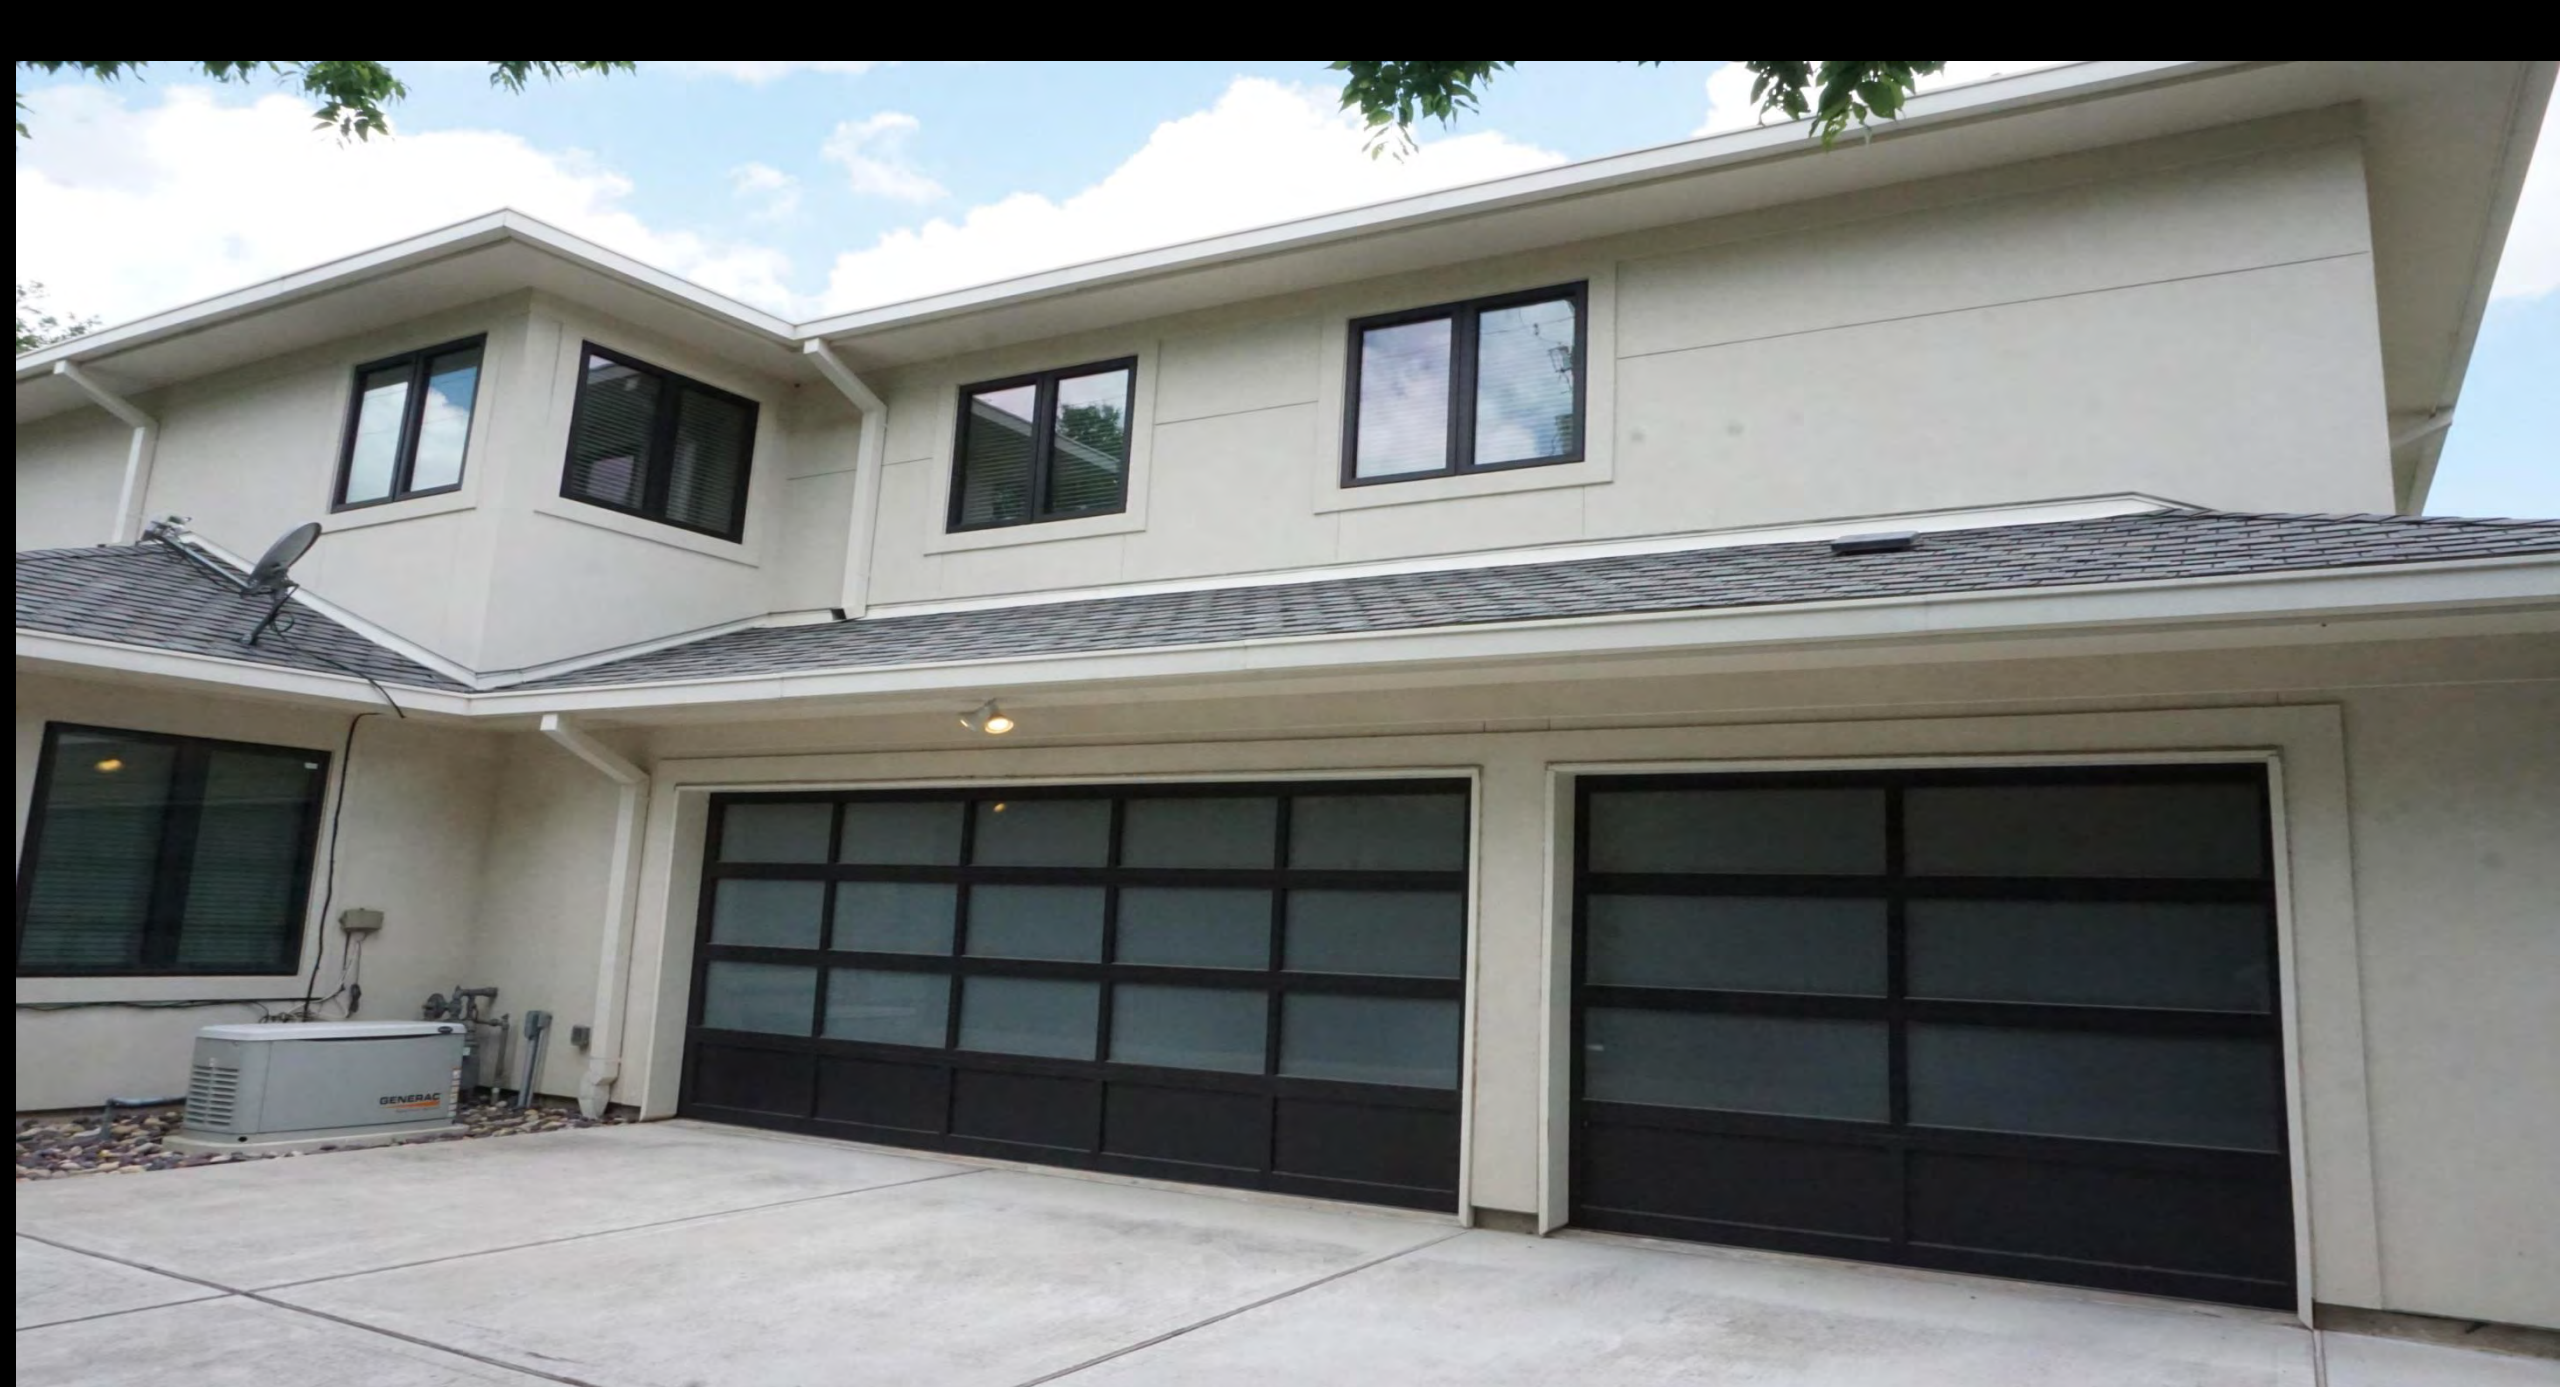
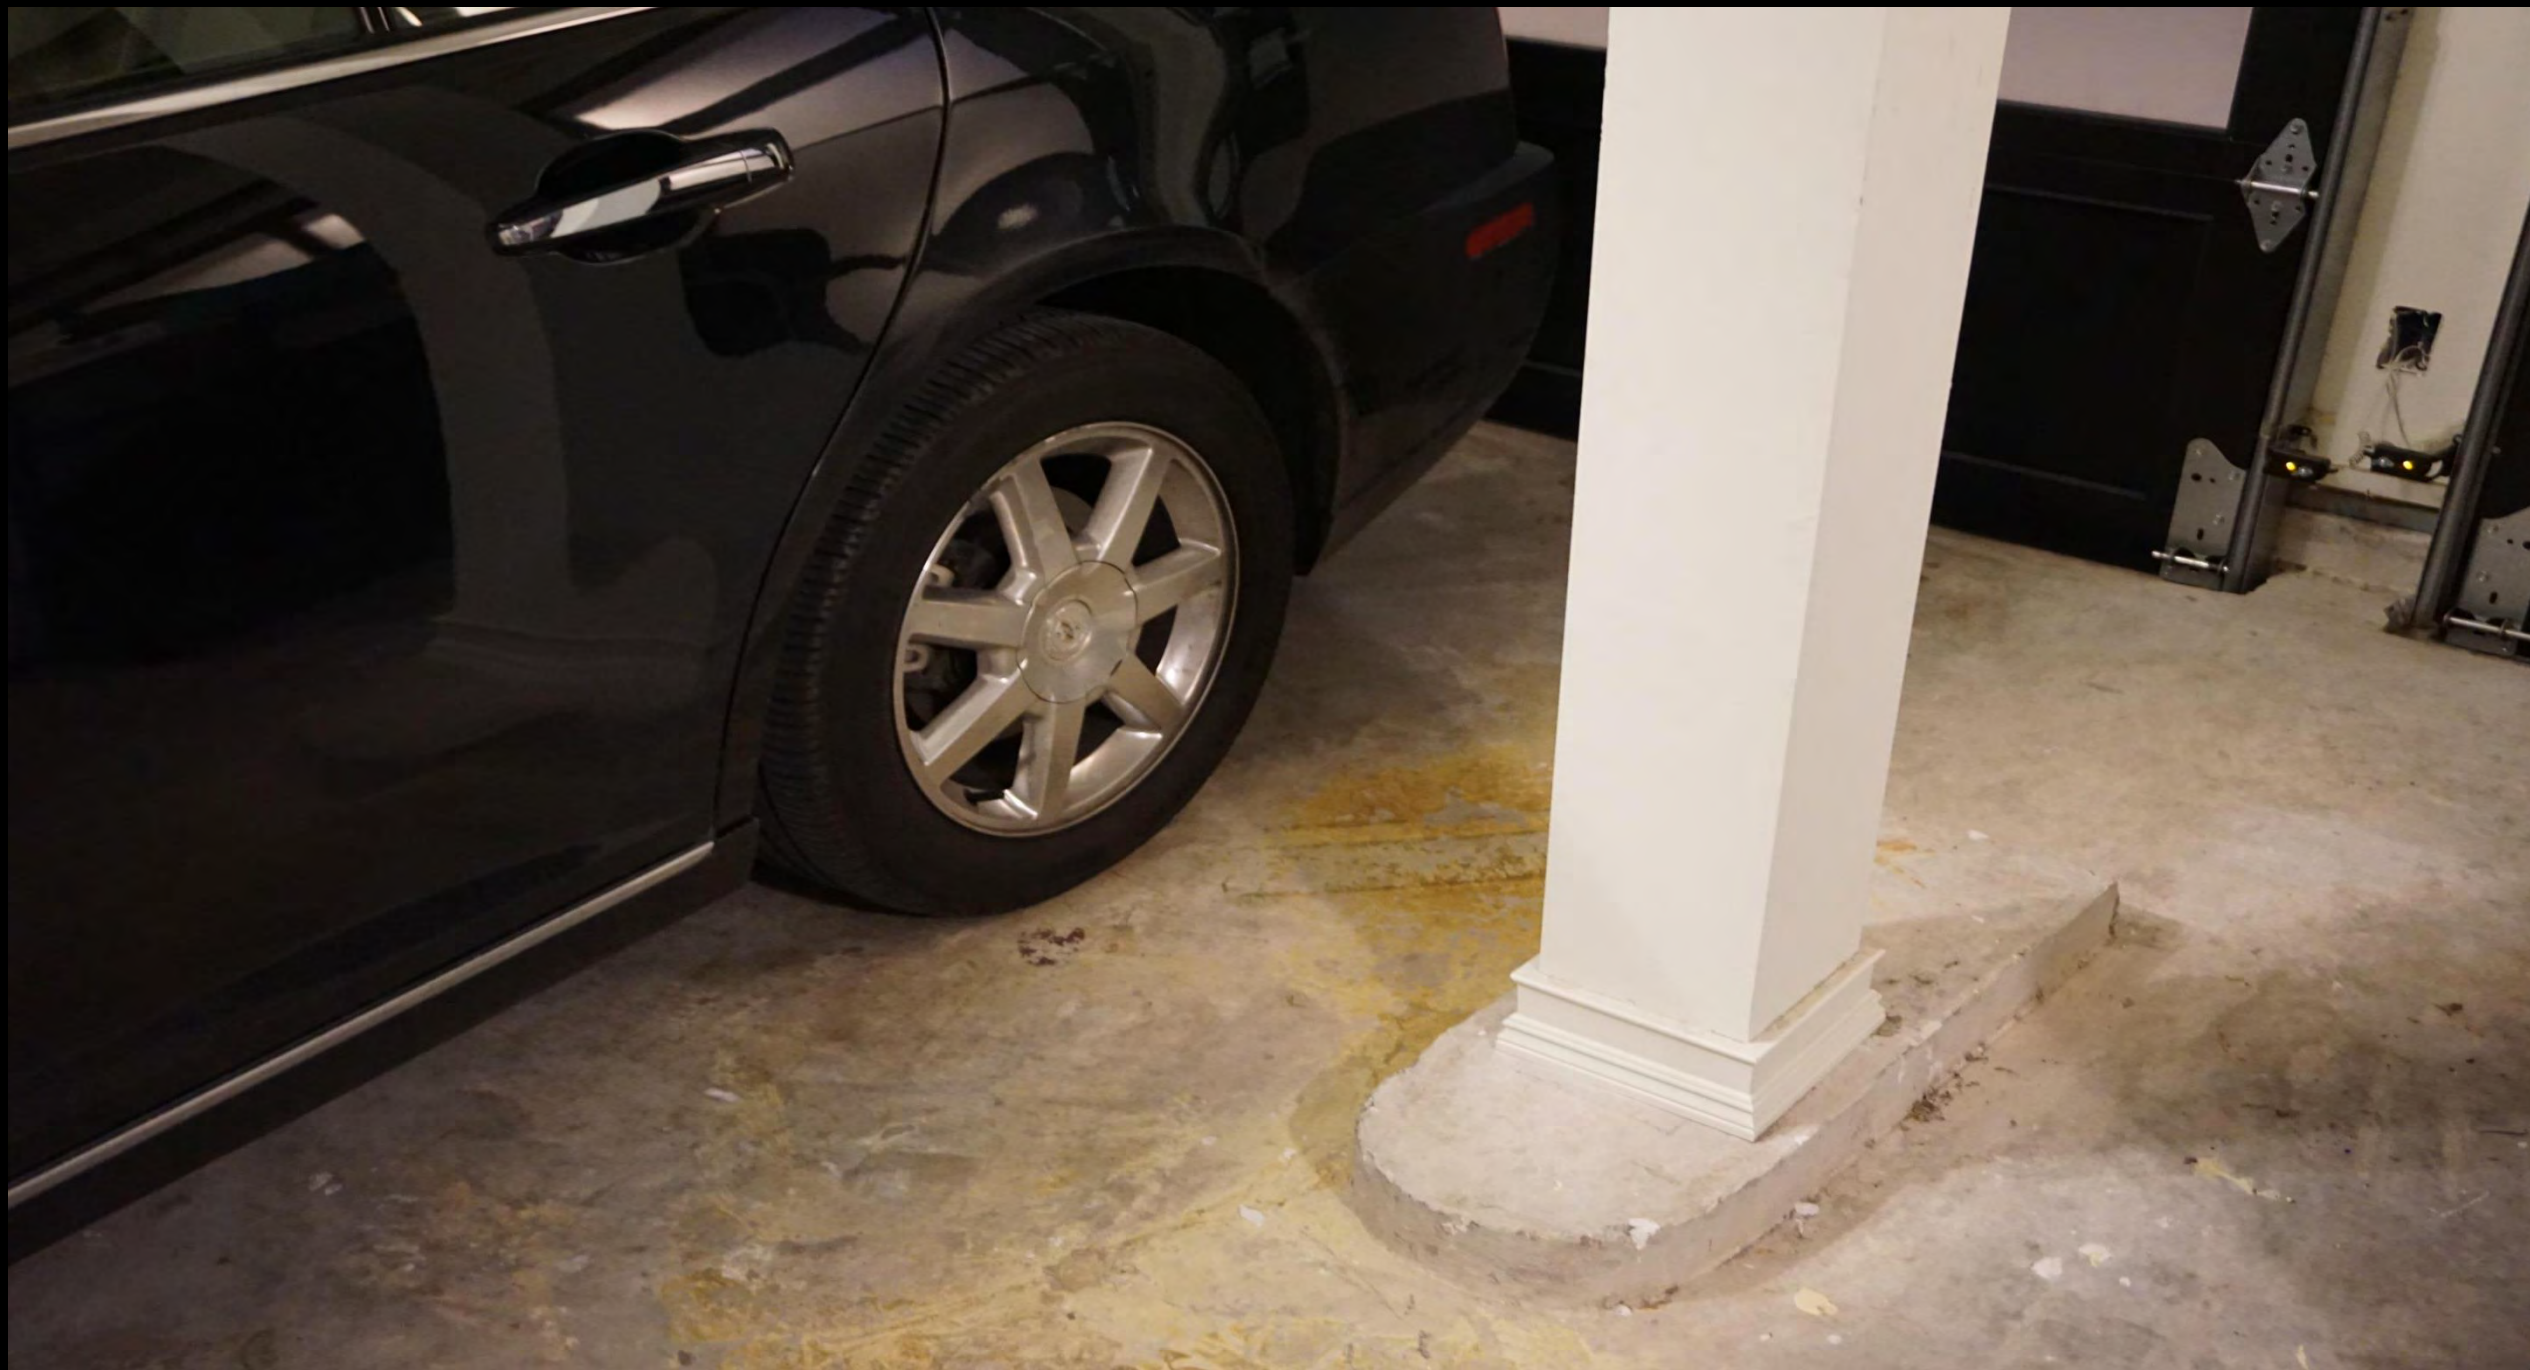
- Maximizing space over 25' bldg. setback line: floor cantilevered 4' to add living space. Had to use 2x12's cantilevered out and going back twice as long inside garage to cross beam
- Intermediate column to cut the span. On raised concrete curb. Pour perimeter walk to cut water penetration
