Foundation Performance Association

Imad F Abdullah AIA

June 14, 2017

A. Case Study 1: Structural Roof Collapse of 100,000 sq ft former “Kmart” due to Hurricane Ike, Analysis of parameters that contributed to collapse, Aftermath Structural Repair Options Considered, Remedies implemented

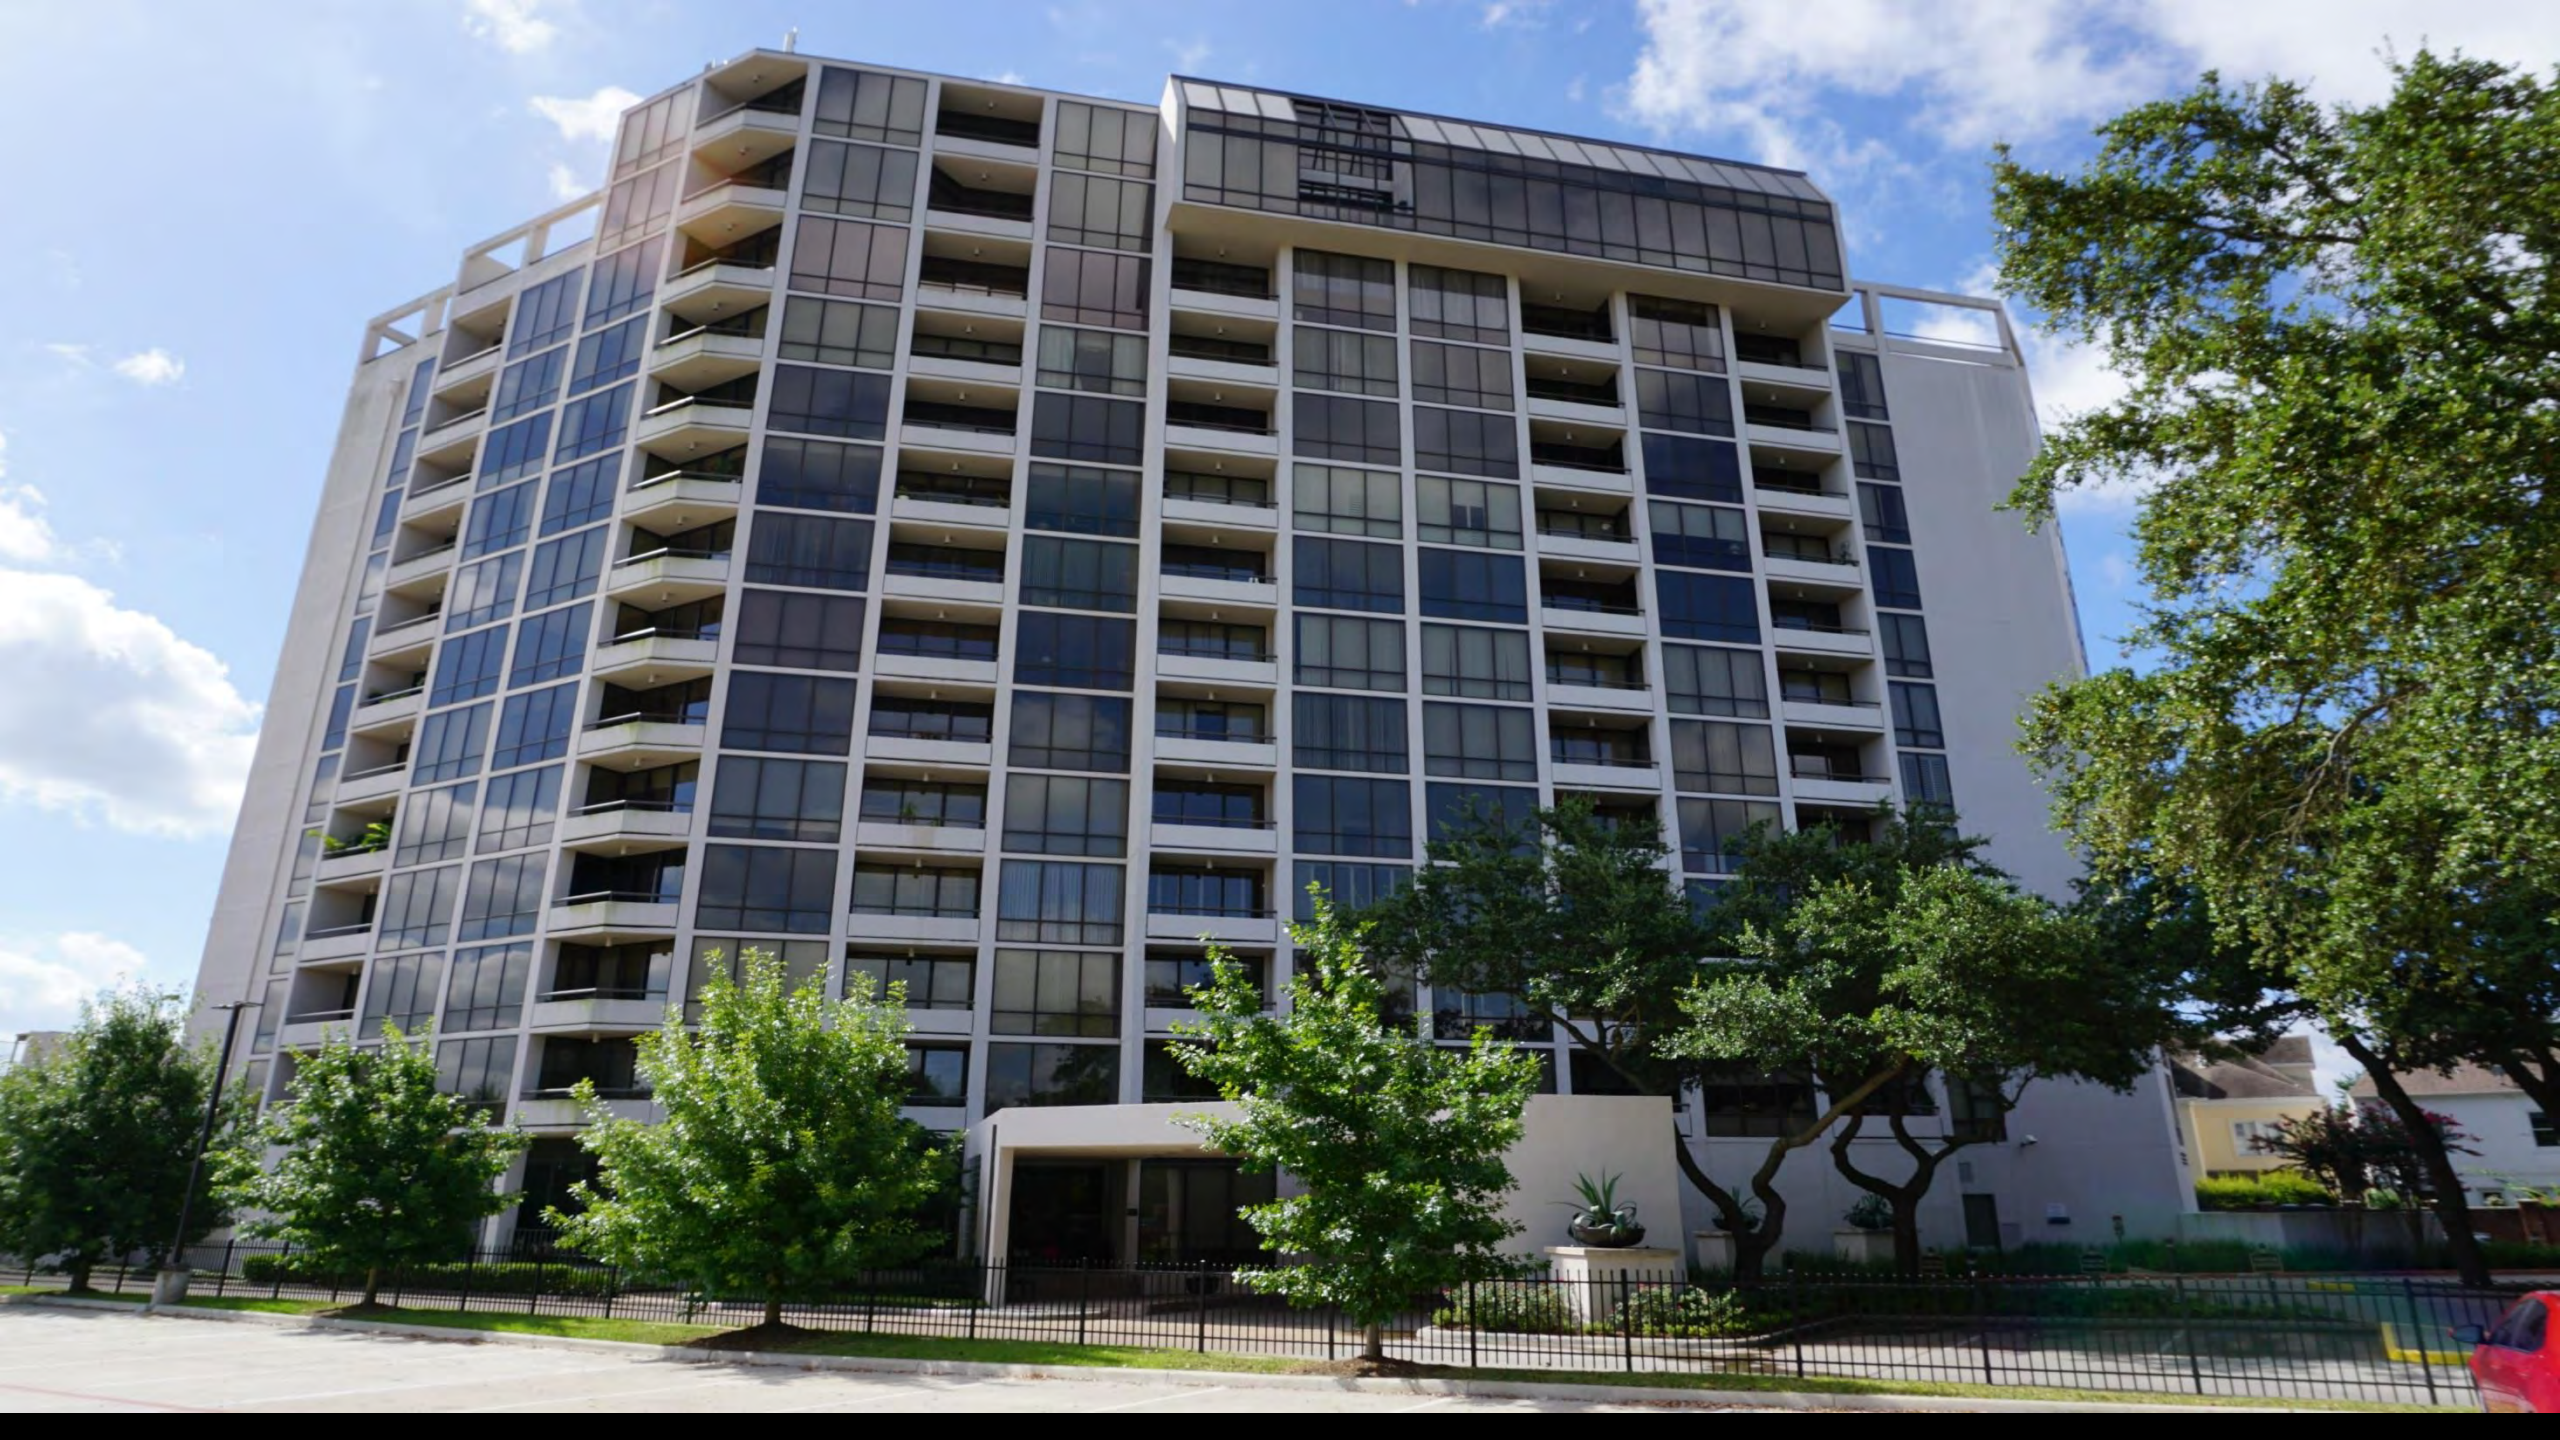
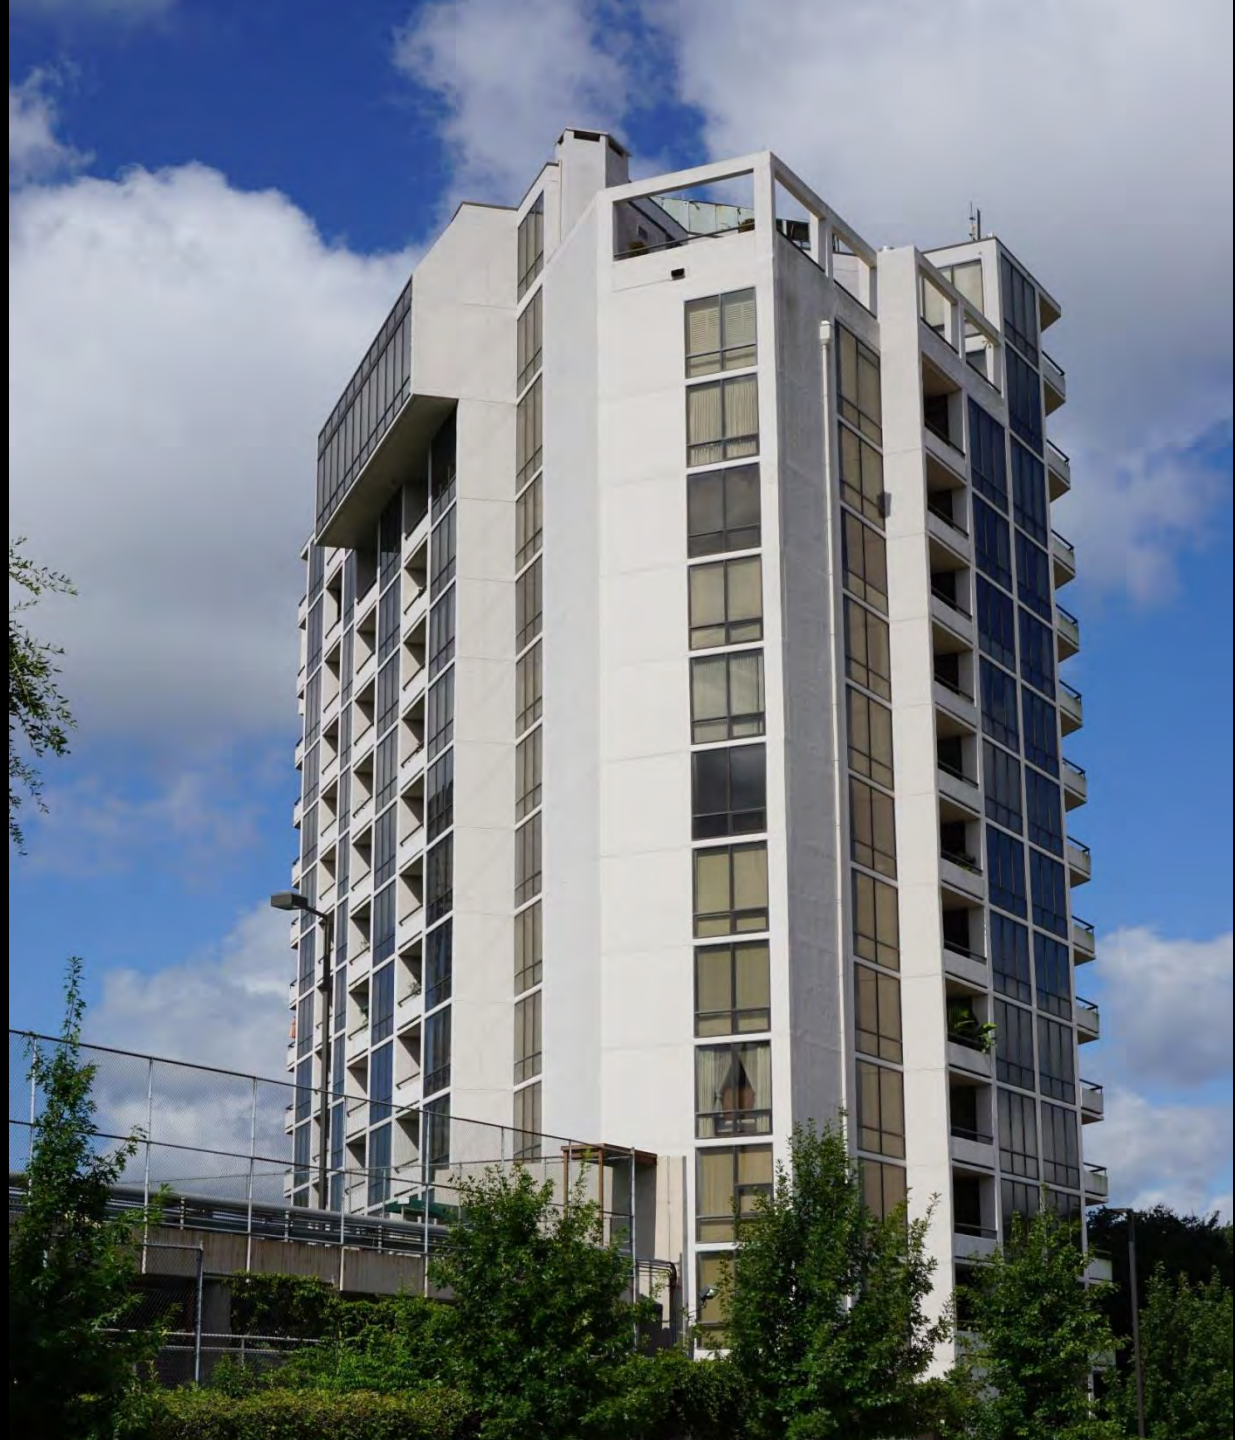
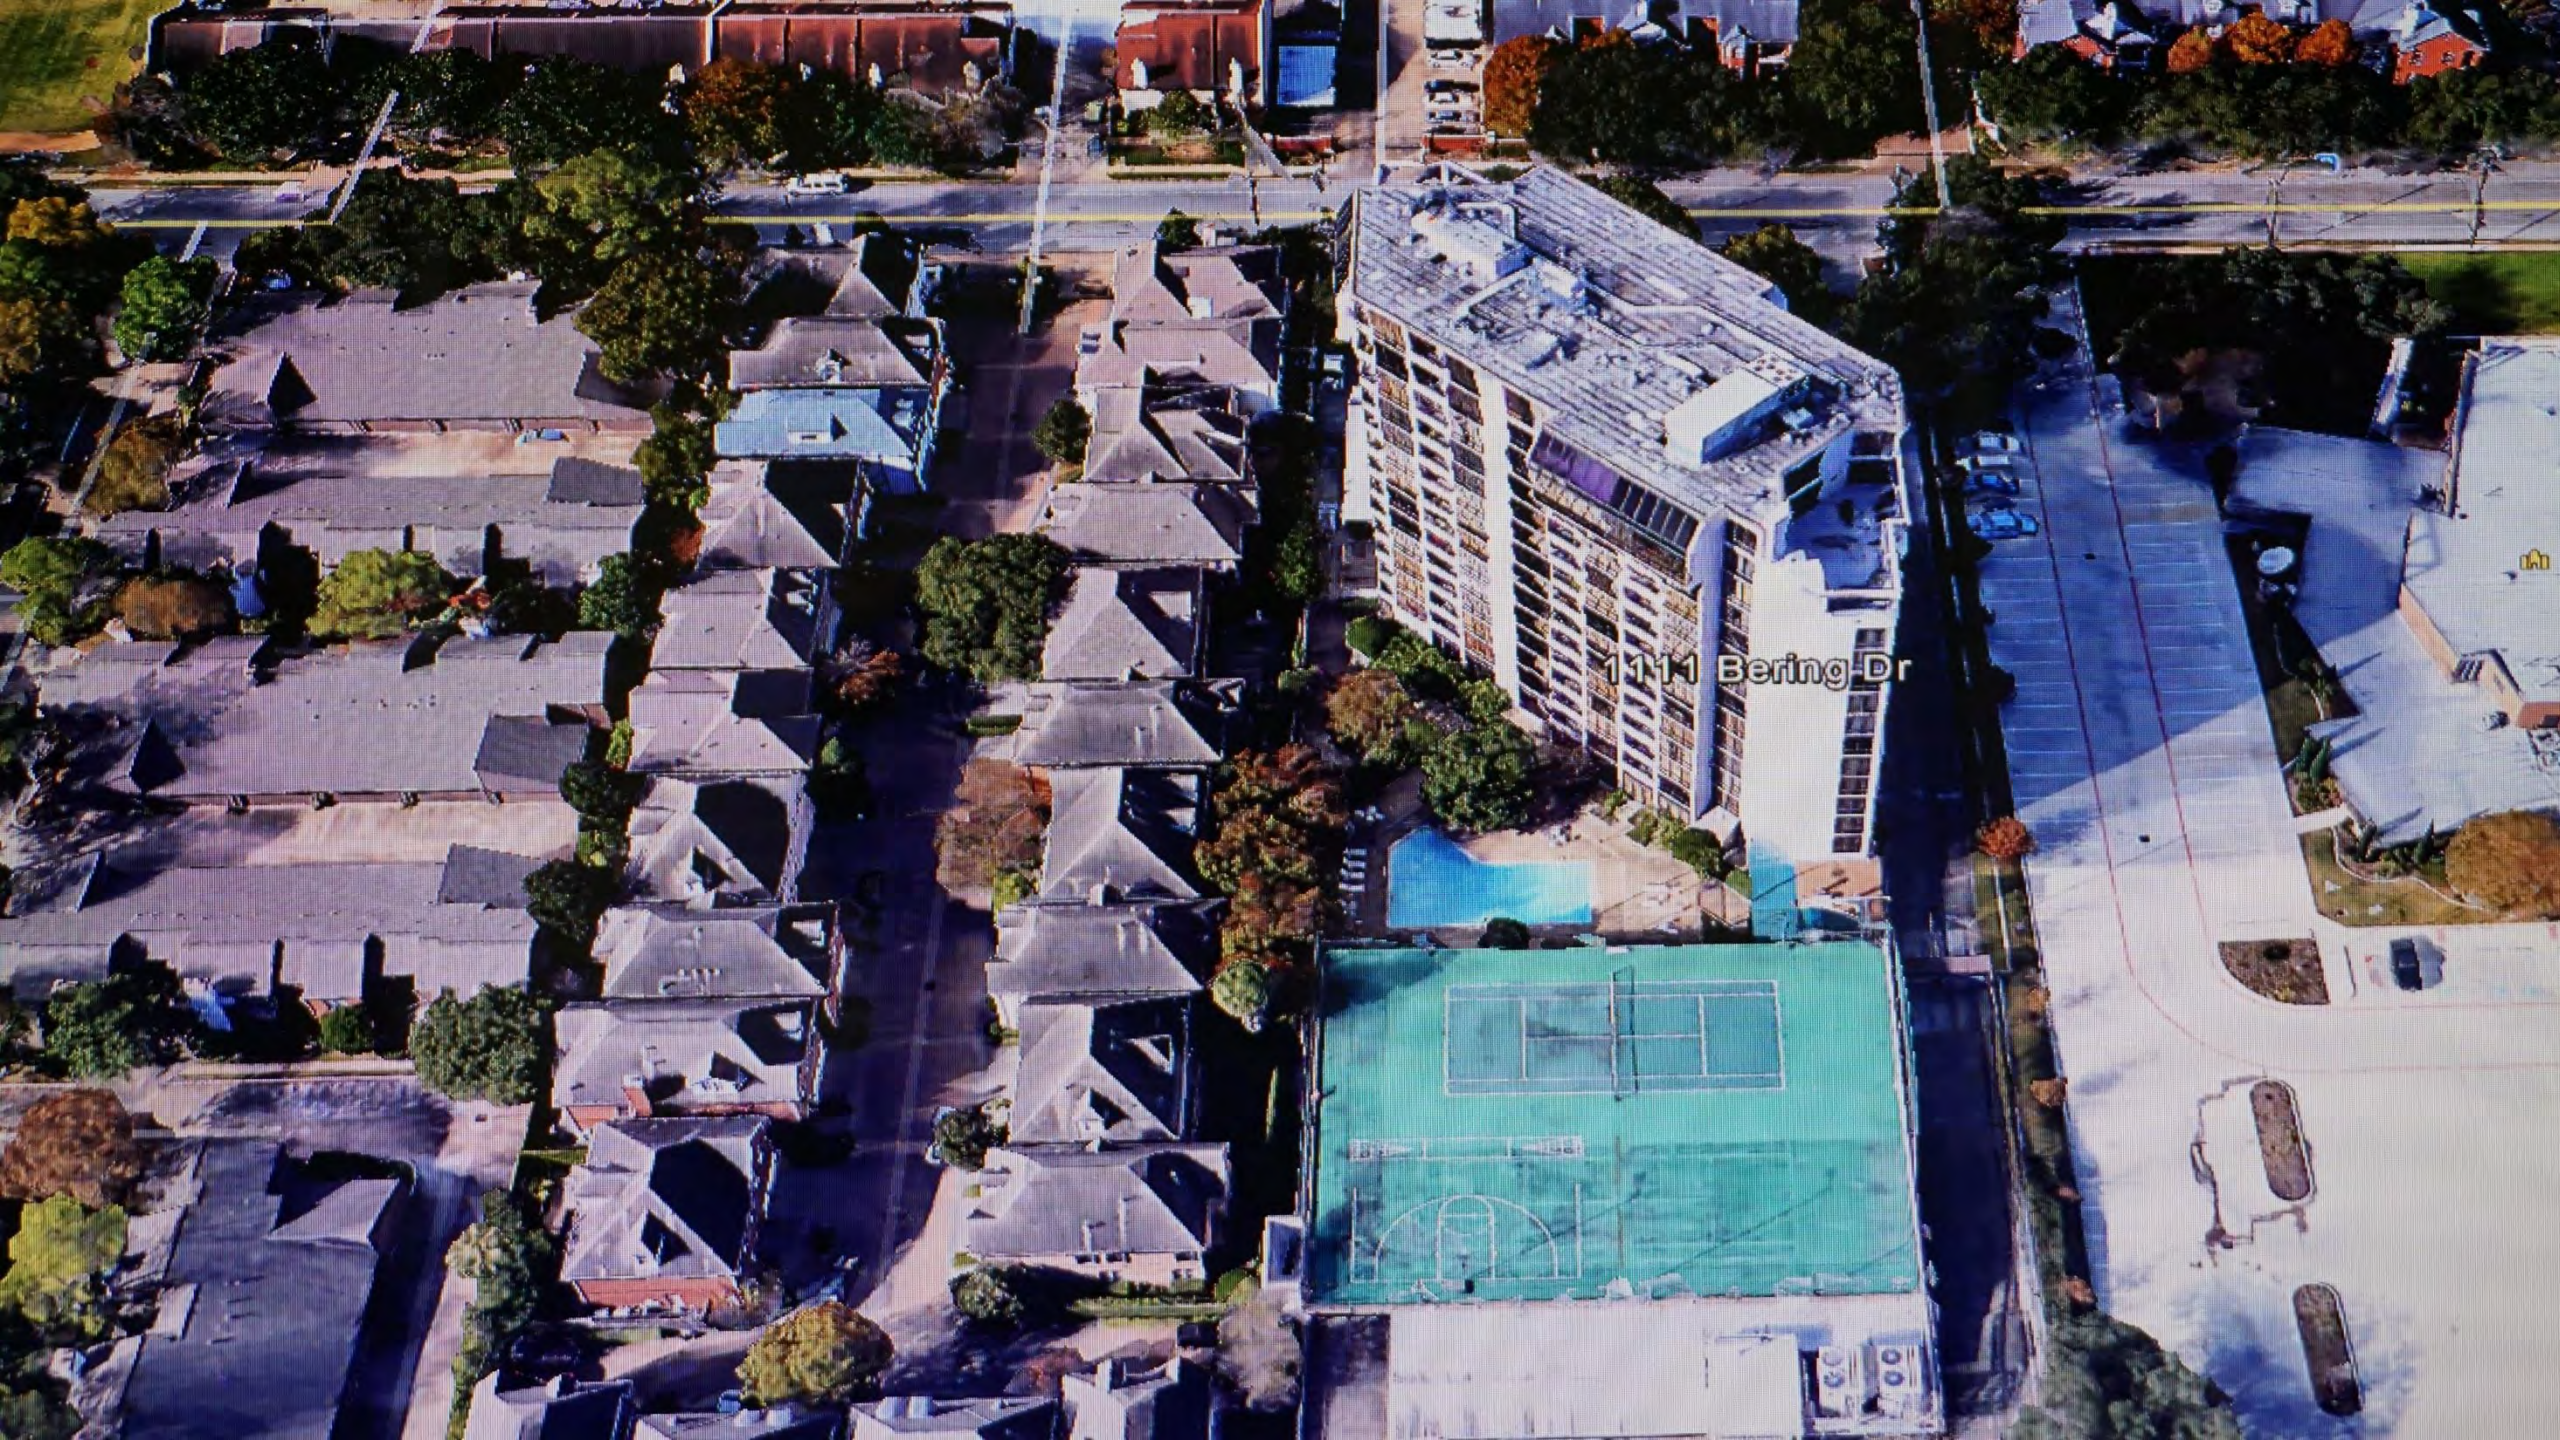
St Clair Tower, 1111 Bering Drive

- Raise concrete ceiling of unit below 2', build pool ledge 2' above deck to get close to 4' depth.
- What this entailed is raising the whole 12th floor 2 ' all around the building and the associated cost
- Had heavy perimeter beams under pool
- Kept pool over one unit below, ceiling lowered to 8' - 9", had extensive insulation,
- Aluminum Pool was brought by helicopter in two sections, assembled on job

- Concern about Movement, leaks
- Had owner sign release to Architect
- As expected, substantial leaks occurred over the years
- Penthouse was foreclosed, pool was removed by Bank
