Subsurface Void Detection for the Foundation Performance Association

Causes of subsurface voids

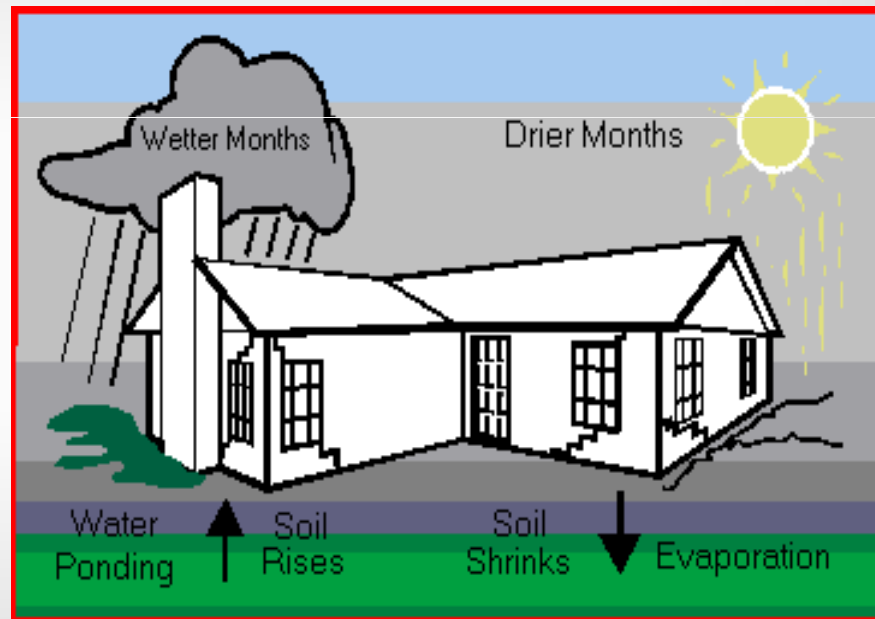
- Expansive soils

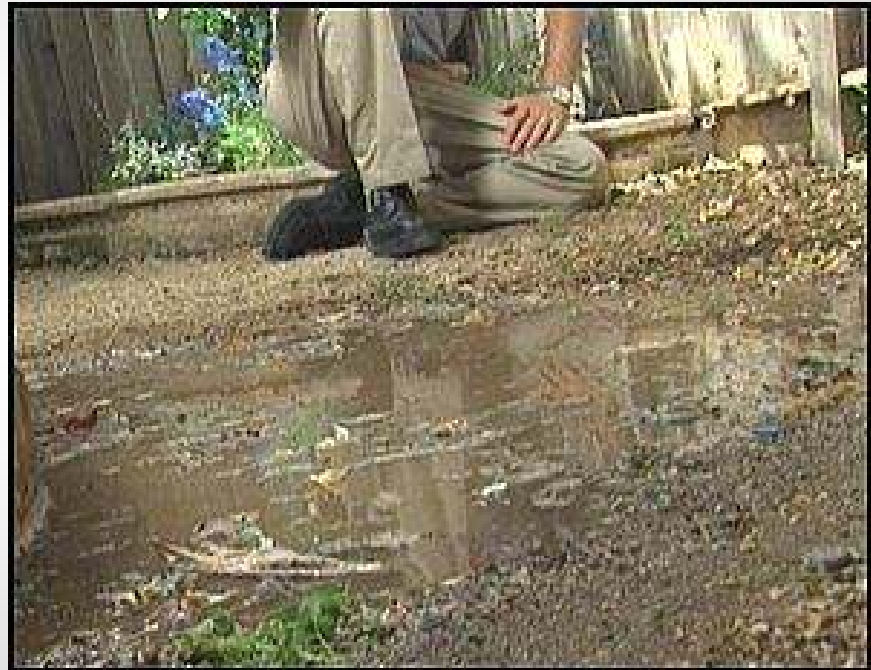
- Poor drainage

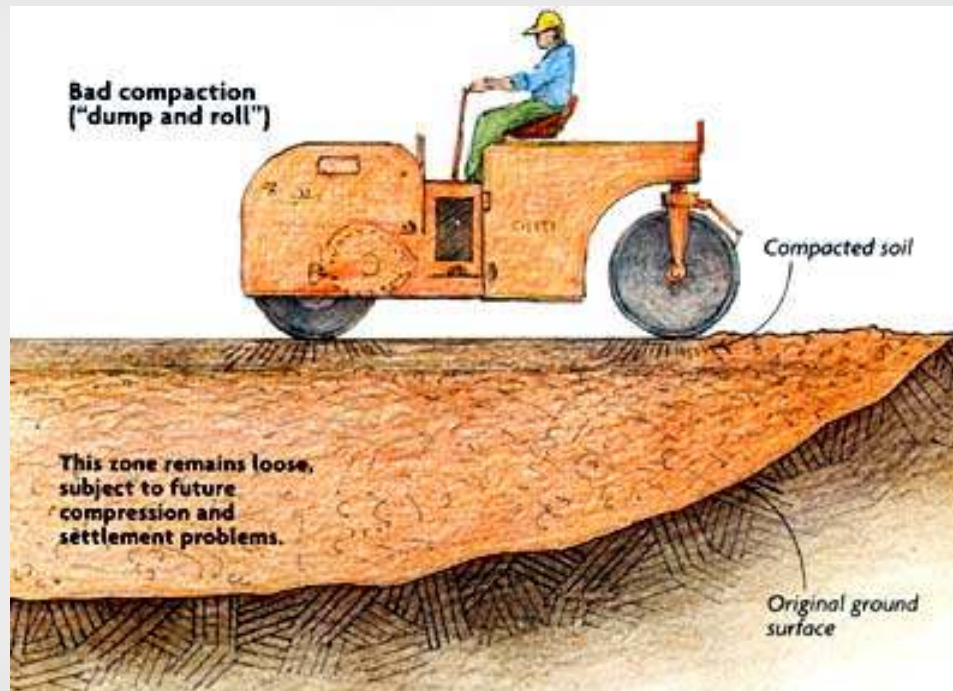
- Poor compaction of soil - wrong way

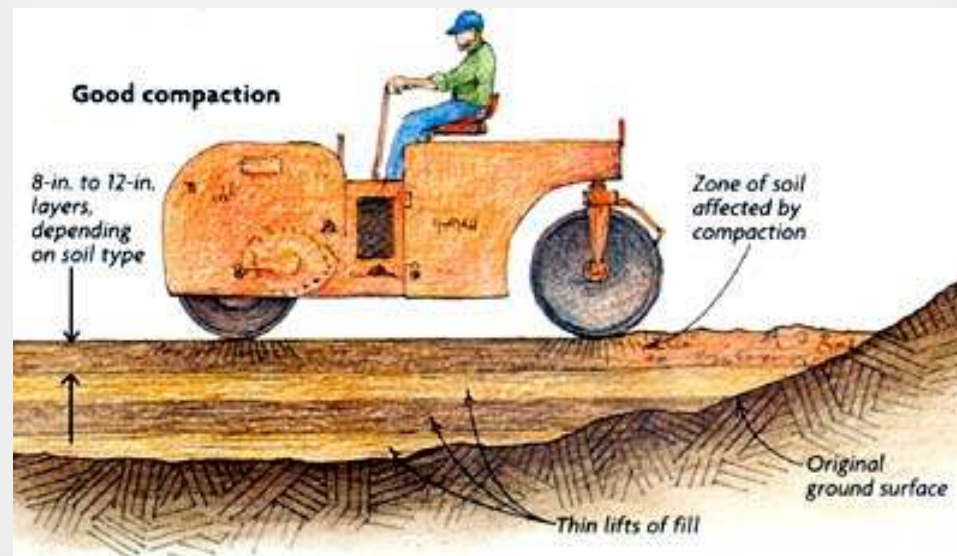
- Poor compaction of soil – right way

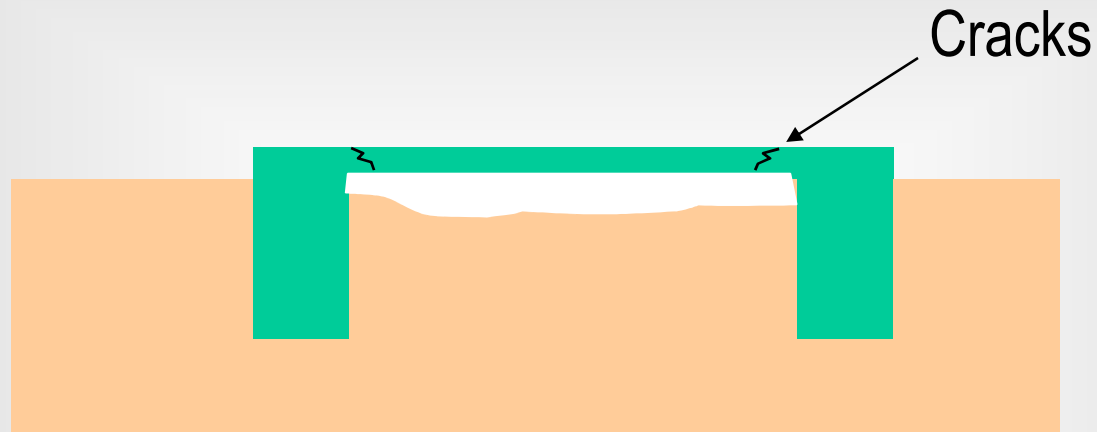
- Poor compaction of soil - effect

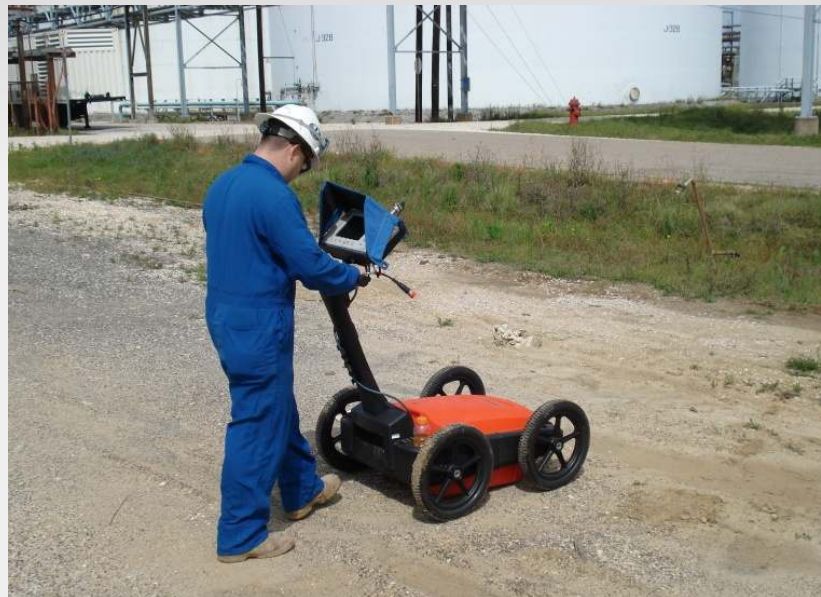
- Ground Penetrating Radar (GPR)

- Early usage: Austria 1929, Military 1950's
- 1st commercial system developed in the early 1970's for use in Geotechnical applications
- Advanced 3D Software developed in the late 1990's
- Uses Electromagnetic Wave Propagation to measure changes in electrical and magnetic properties
- Allows Non-Intrusive look into or through low-conductivity materials
- Used in Geophysical, Structural, Civil, and other industries

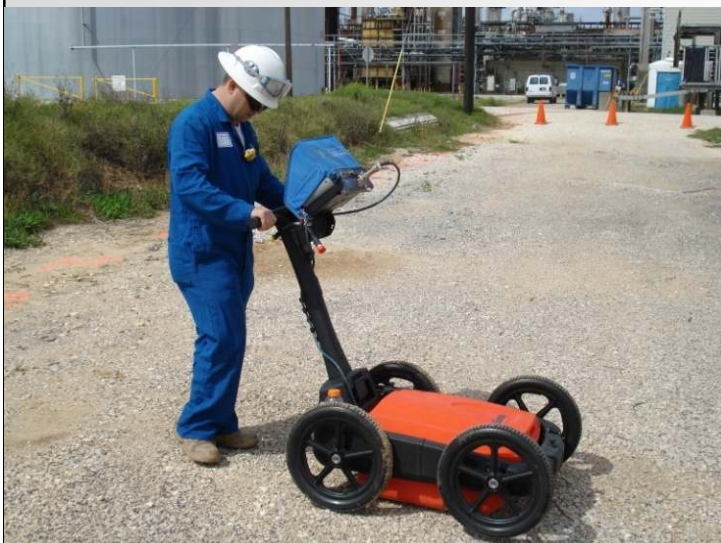
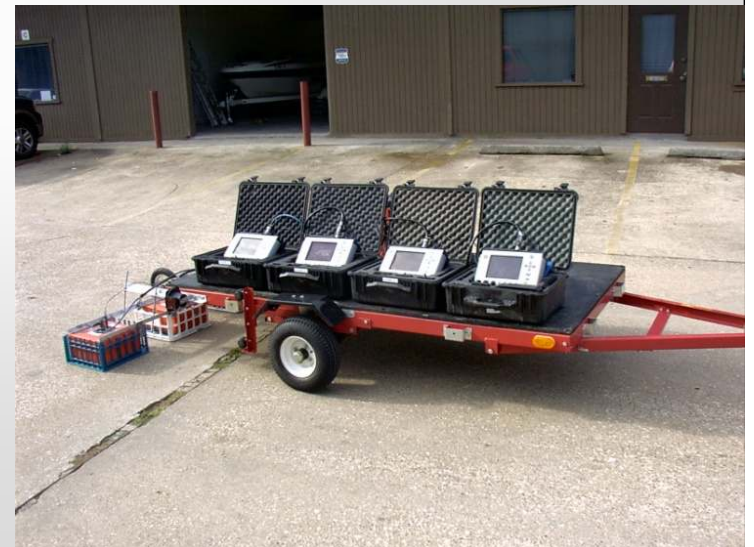
Forms of GPR

- Single and two-channel systems are most commonly used for foundations, bridges, buildings, short road sections
- Multi-channel and phased array systems are used for high speed long sections of highways

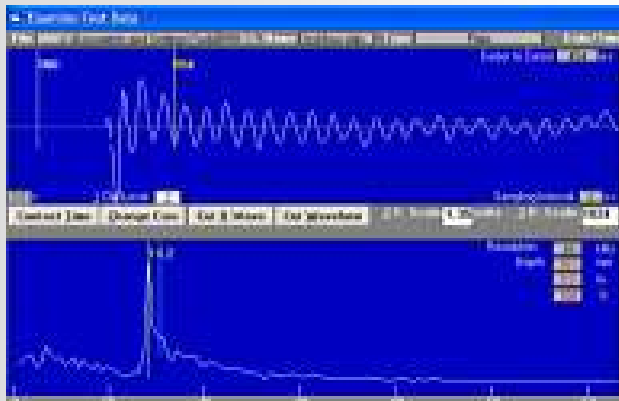
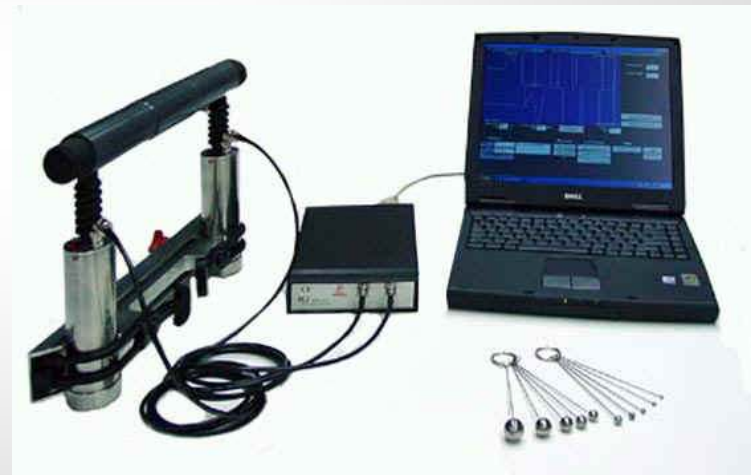
- Impact-Echo

- Stress (sound) waves that propagate through concrete and masonry are reflected by internal flaws and external surfaces
- Primarily used to determine defects in concrete structures. It can also locate voids in the subgrade directly beneath slabs and pavements.
- Accurate method, but slower than GPR for voids surveys

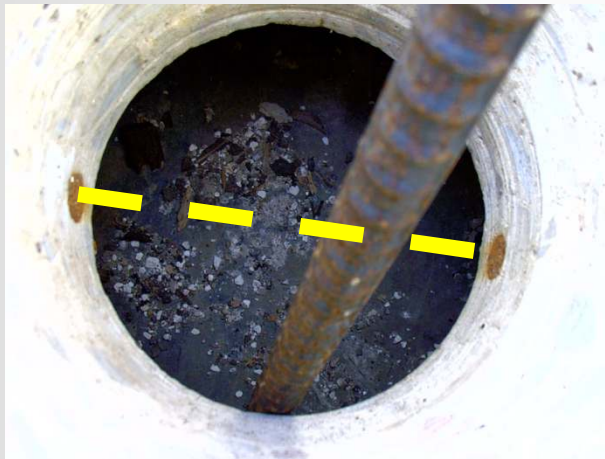
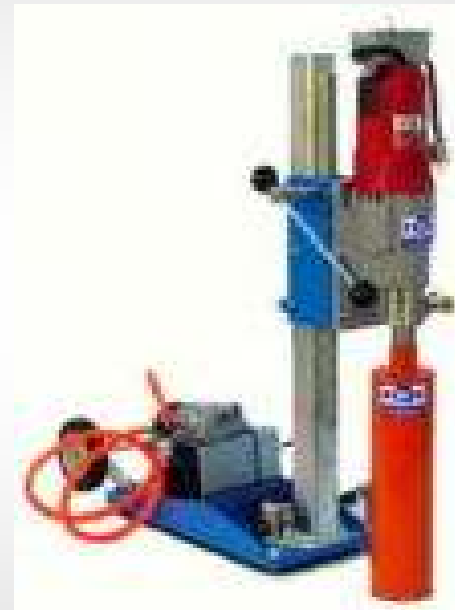
- Core Drilling – effective to verify a suspect location but would require many holes in order to “Survey” an area for voids.
- Will not give a true indication of the void size in sq. ft.
- Destructive – effects aesthetics, carpet, flooring, cuts PT cables, rebar & utilities

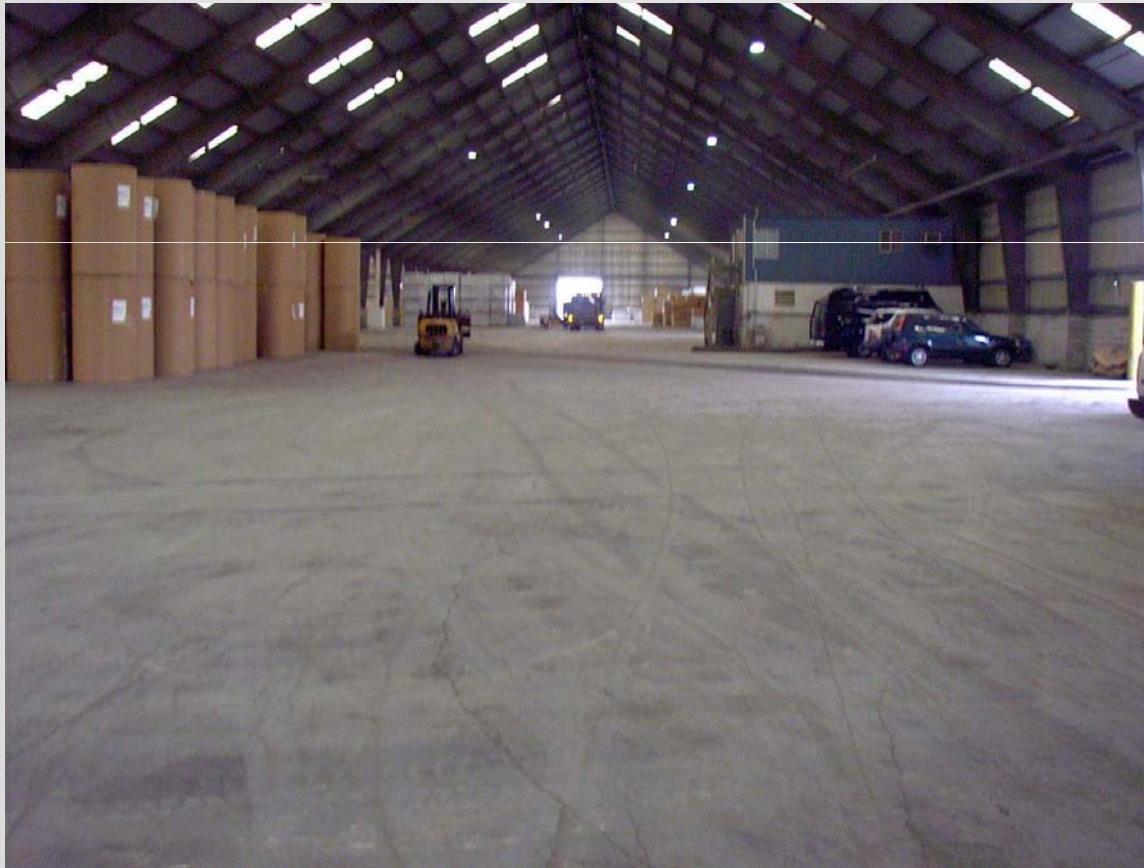
Warehouse floor

- Heavy trucks cracking the slab
- Proof of concept void detection and sizing
- NDE technologies:
 - GPR
 - Laser Elevation survey

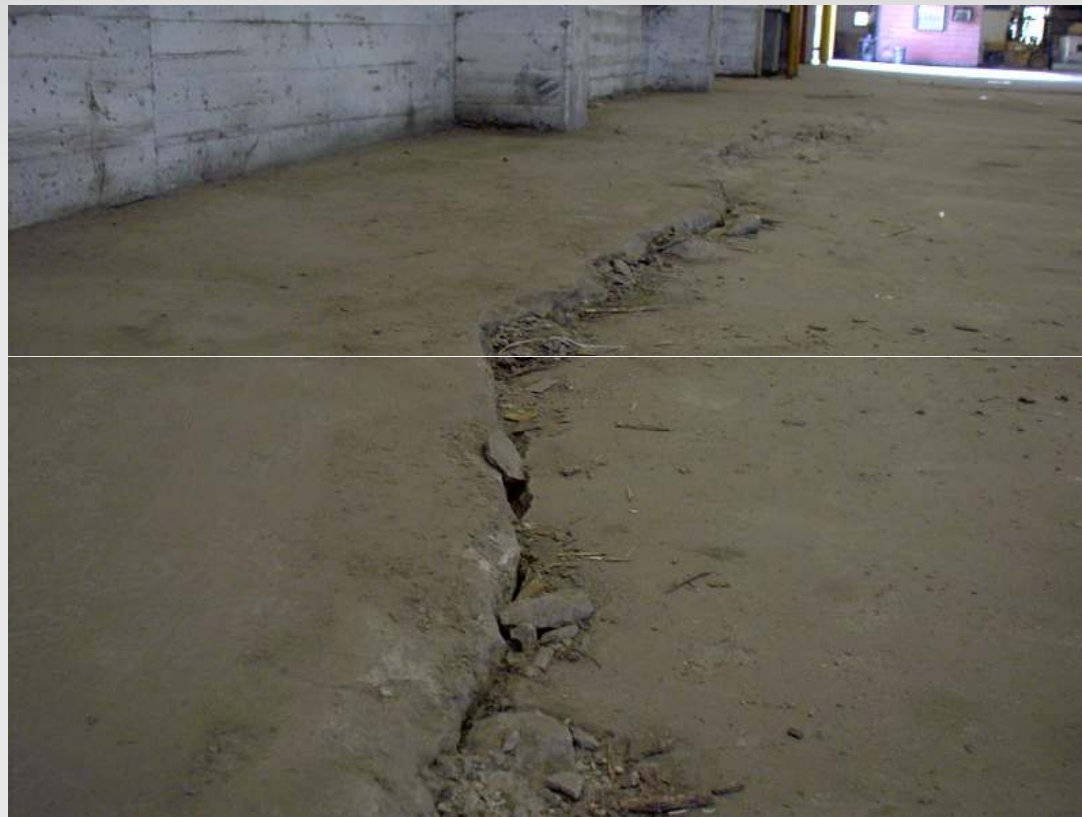
Slab failure near exterior grade
beam due a large void.

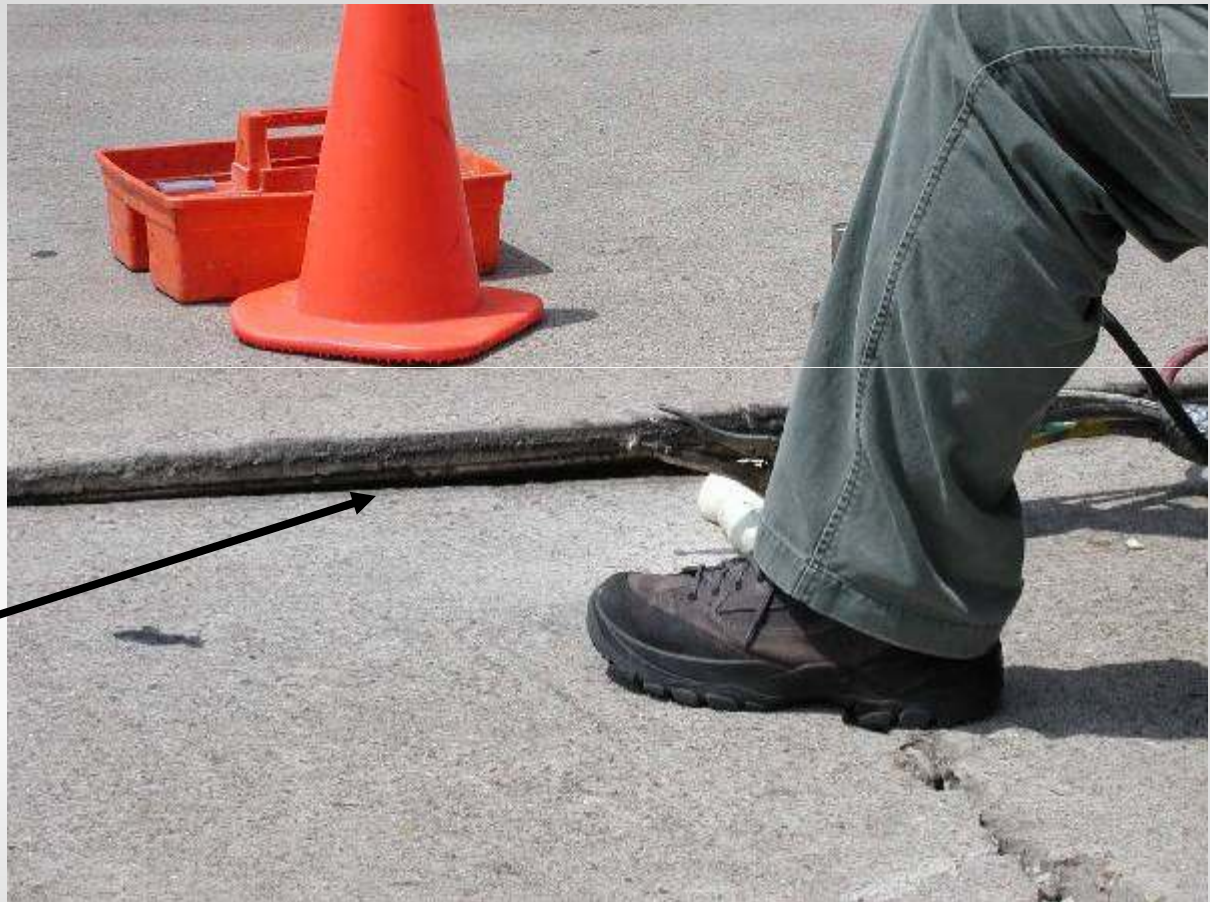
Visible settlement

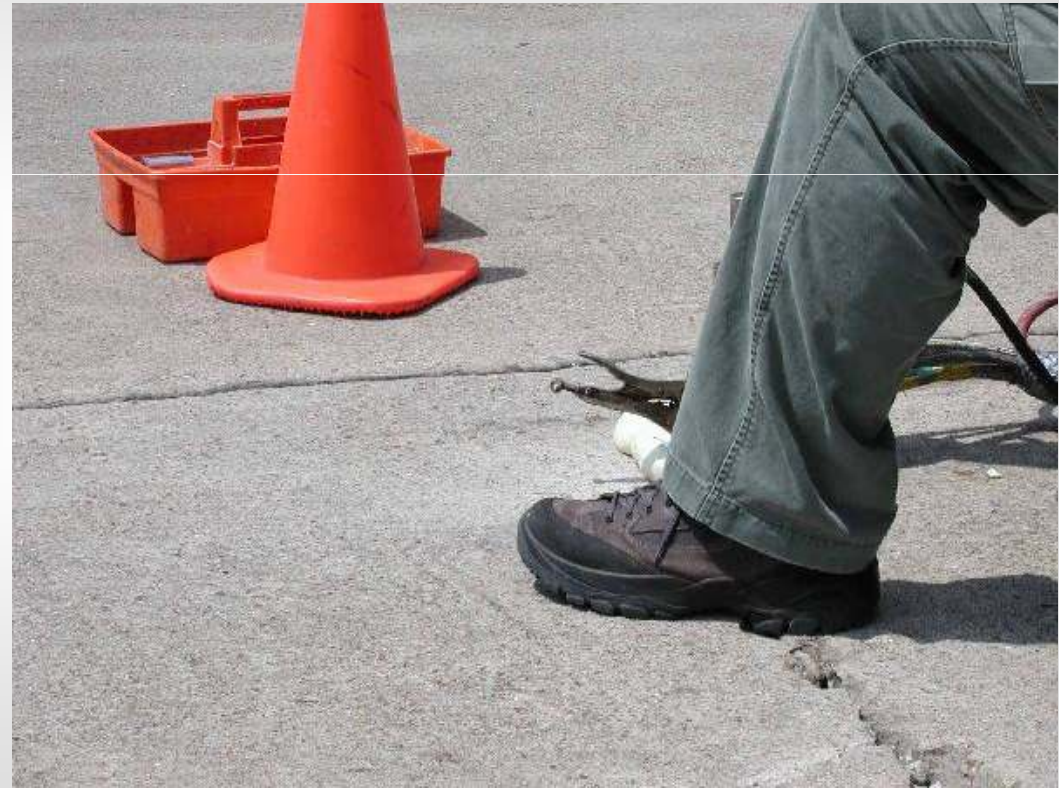
After lifting the slab

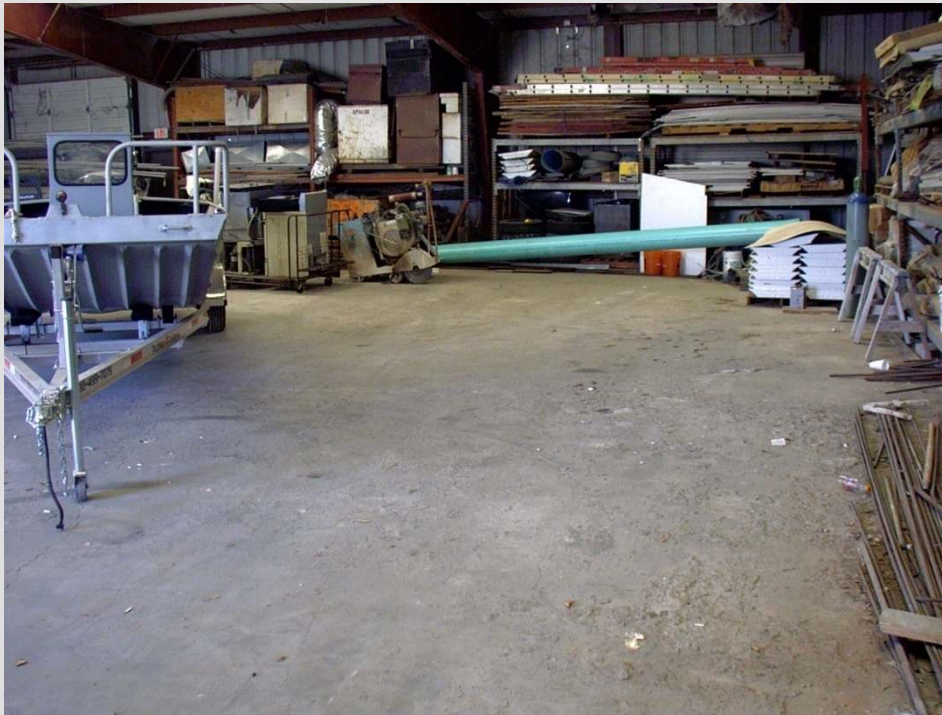
Client observed settlement in the offices and warehouse floor. The visible settlement was about 1-2".

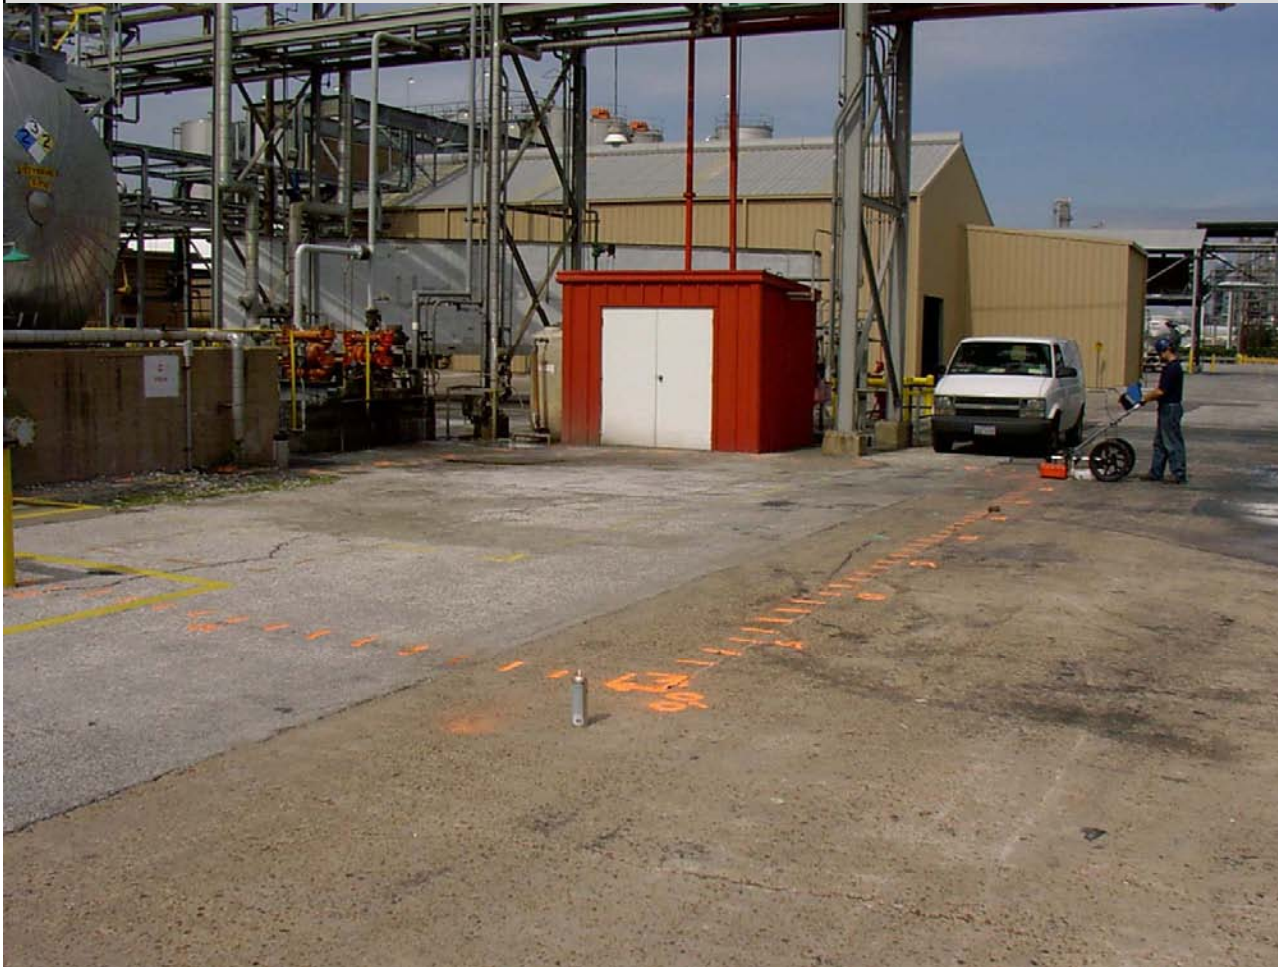
The orange paint outline shows the area to be examined.

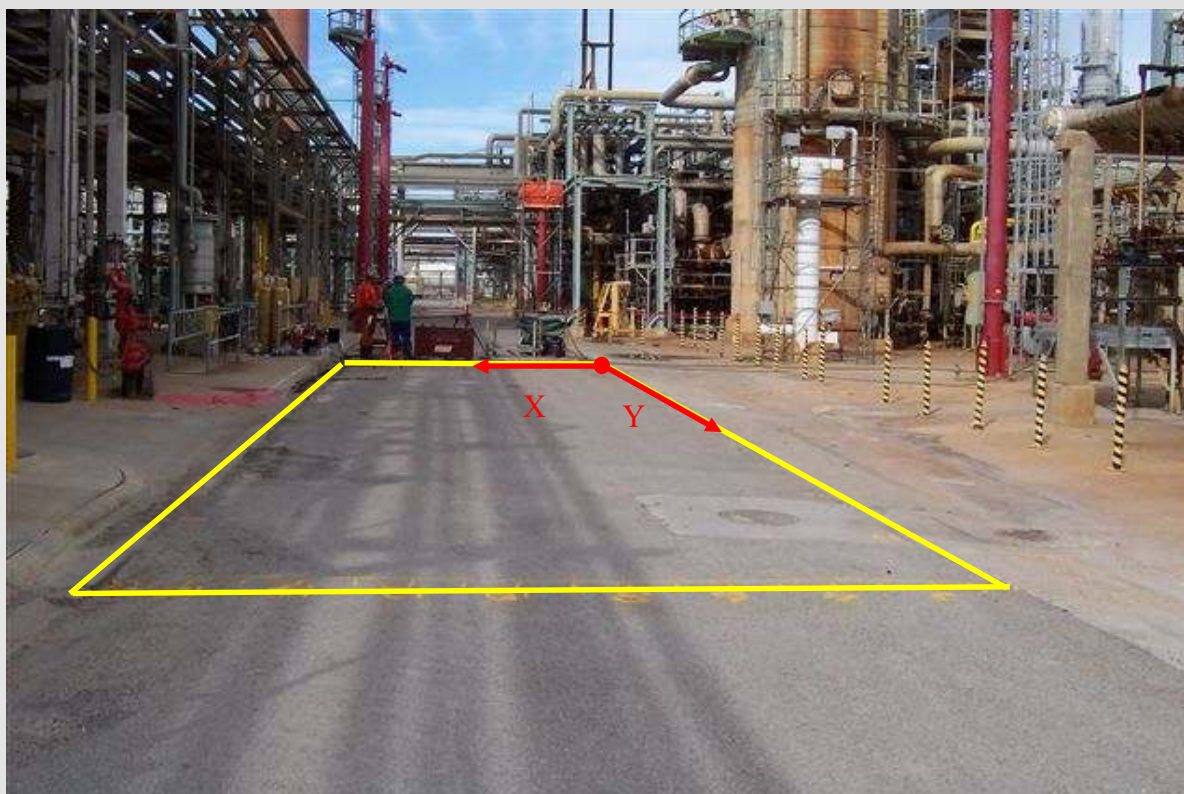
The area to be examined is outlined above.

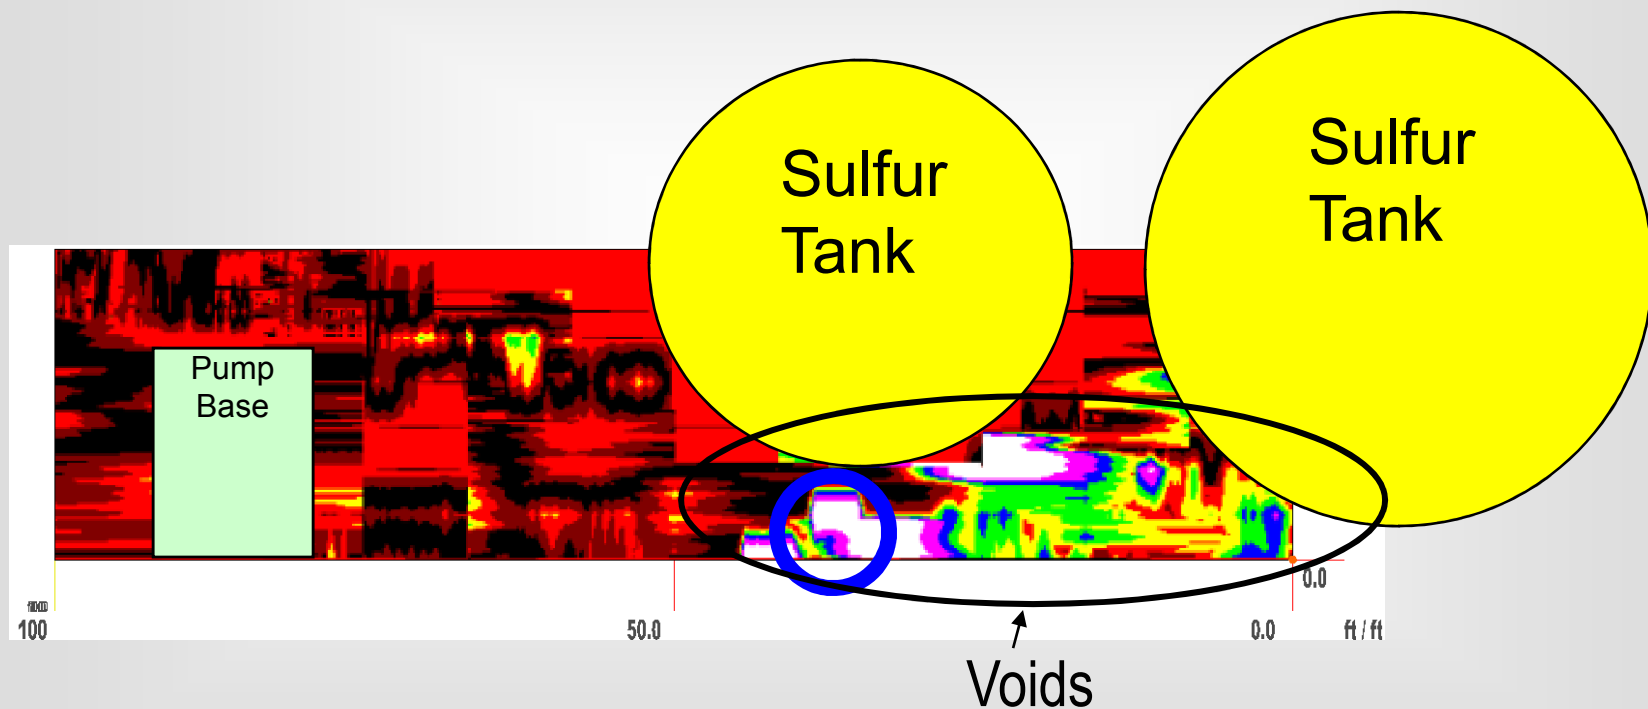
The outline below shows the intermittent void area detected beneath the pavement. Erosion of soil from a nearby leaking acid cooling tower was the cause.

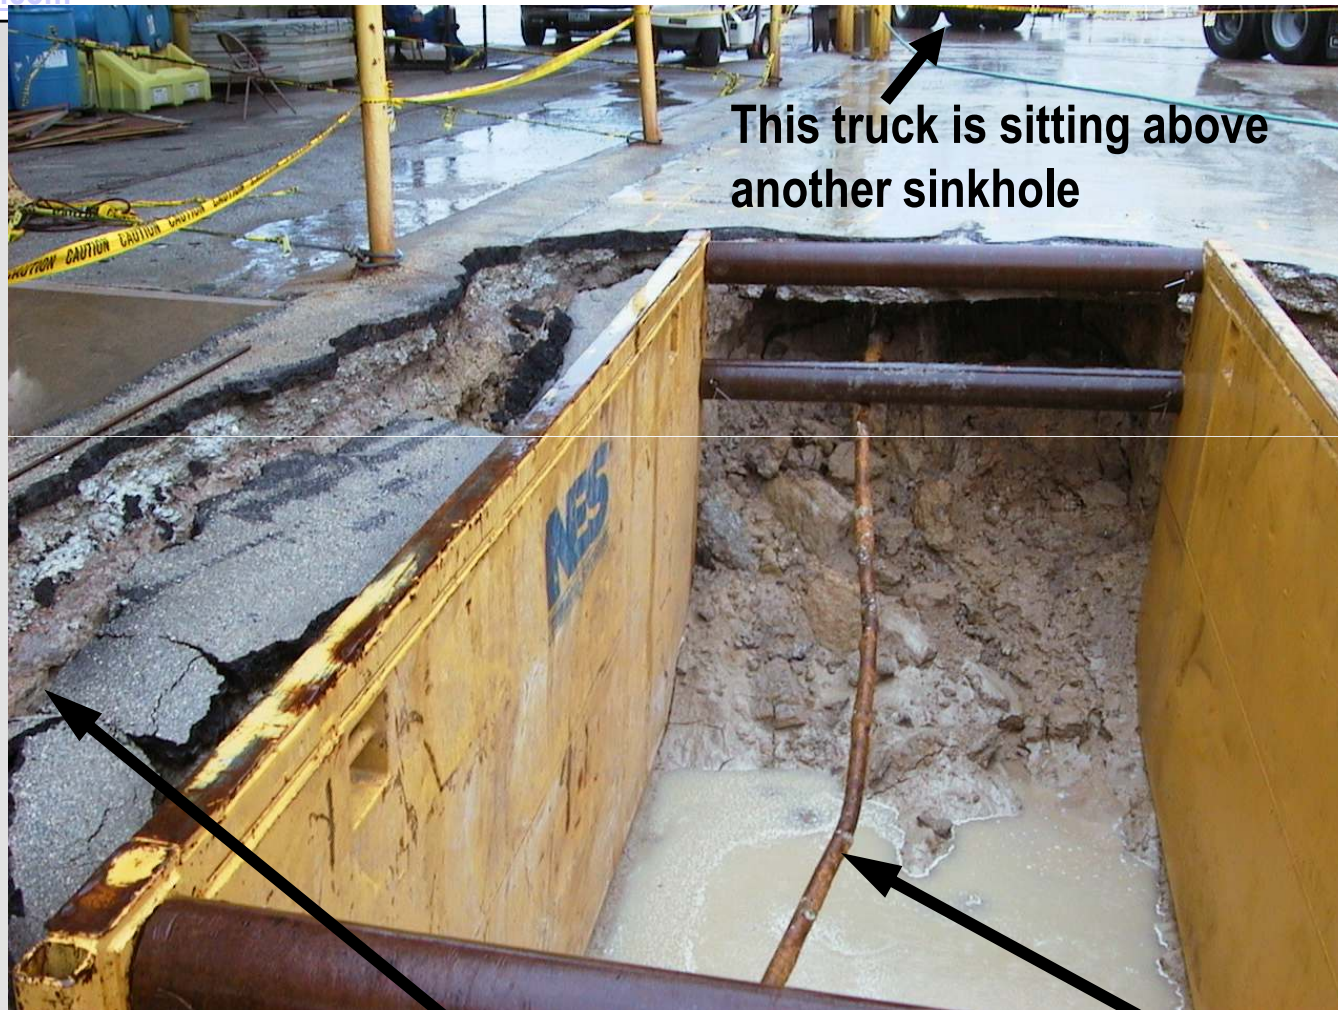
This truck is sitting above another sinkhole

6" Clay Water Pipe

2" Gas Pipe

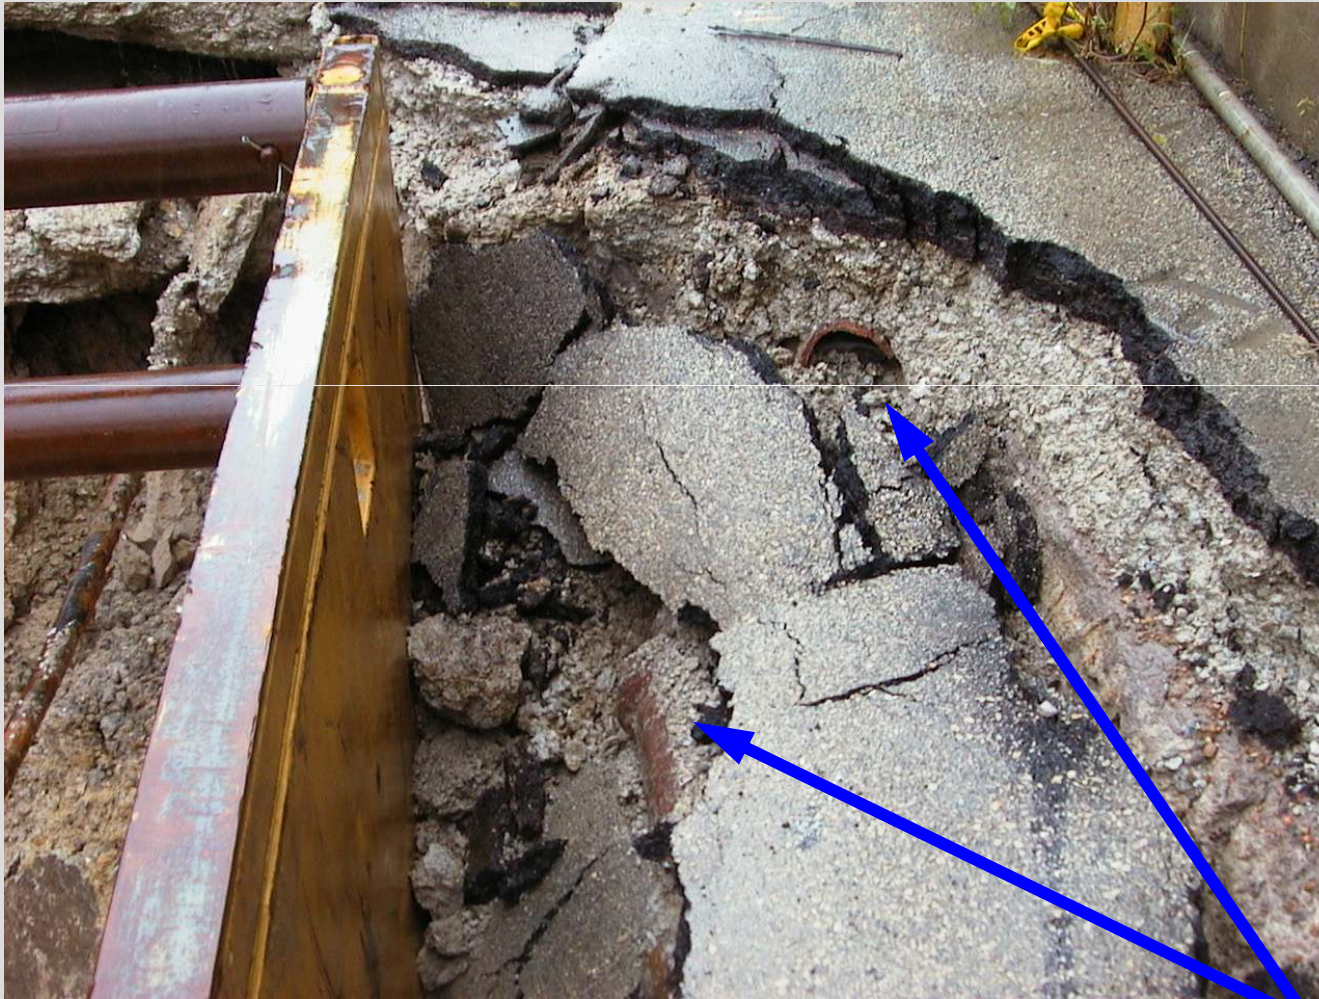
6" Clay Pipe

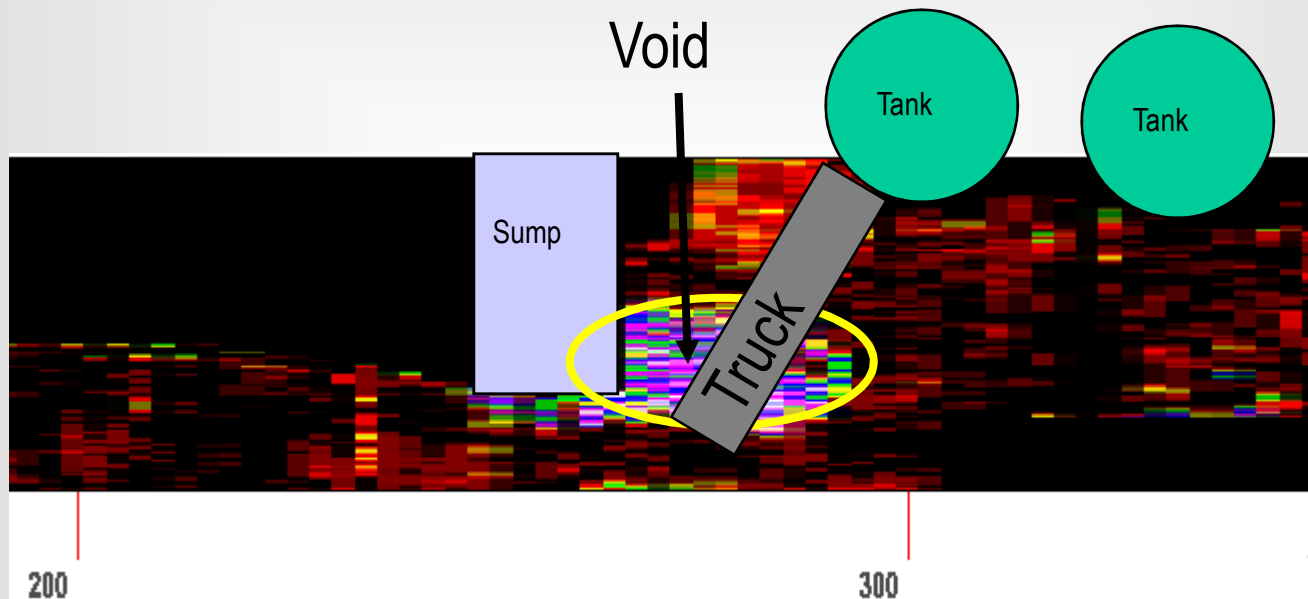
The truck that was shown two slides before is outlined below. Another large void was detected where the truck was parked.
