GUIDELINES FOR EVALUATING FOUNDATION PERFORMANCE BY MONITORING

Document no: FPA-SC-12

Developed by: FPA Structural Committee

Presented by: Nicole Wylie, E.I.T., Forensic Engineers Inc.

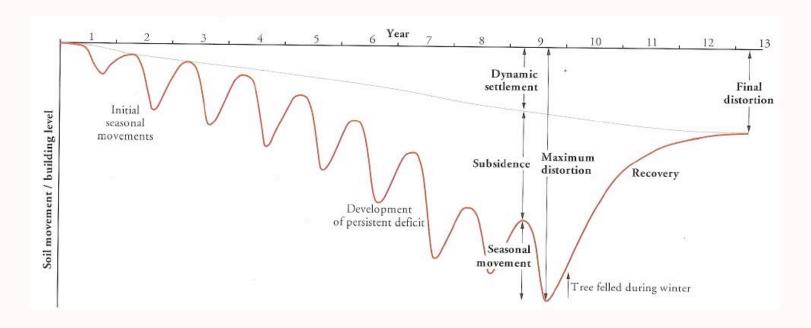
TREES AND SHRINKAGE

Plot from "Tree Root Damage To Buildings," Vol. 1, by P.G. Biddle ISBN 0953308618

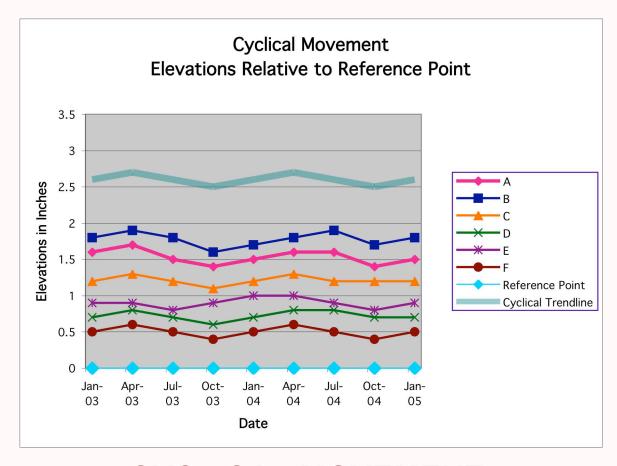
GRAPH OF PLOT POINTS VS. TIME:

CYCLICAL MOVEMENT

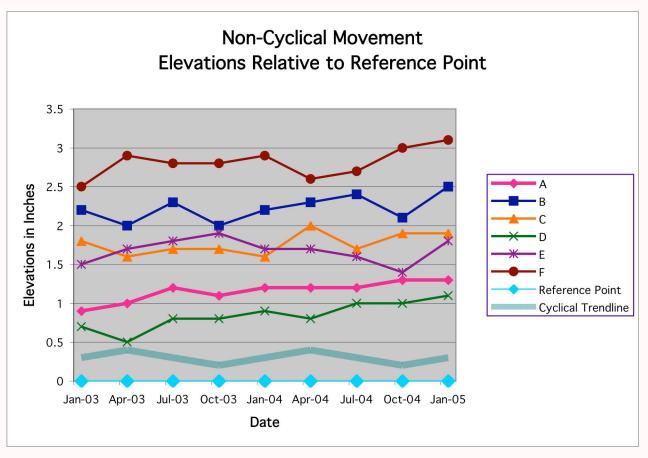
GRAPH OF PLOT POINTS VS. TIME:

NON-CYCLICAL MOVEMENT

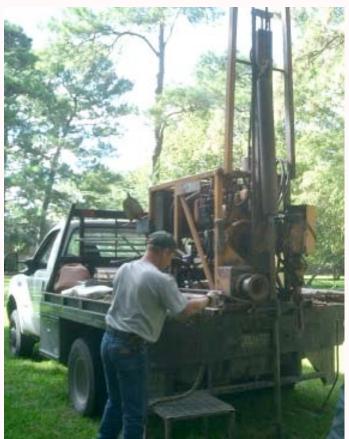
Portable Drill Rig

Truck Mounted Drill Rig

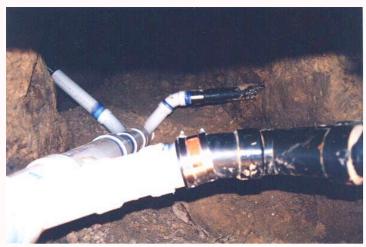
Tunneling under slab for leak repair

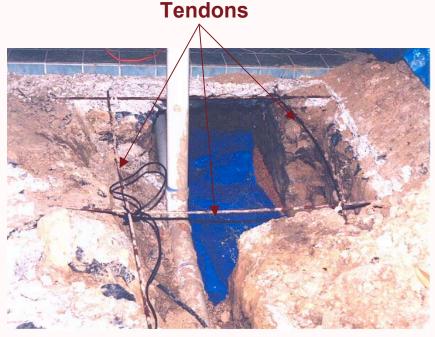
Slab break-out for leak repair

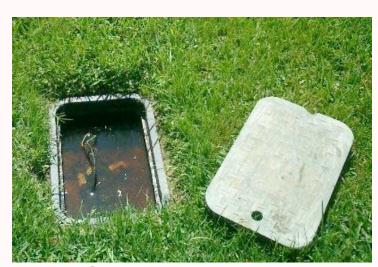
Submerged water meter

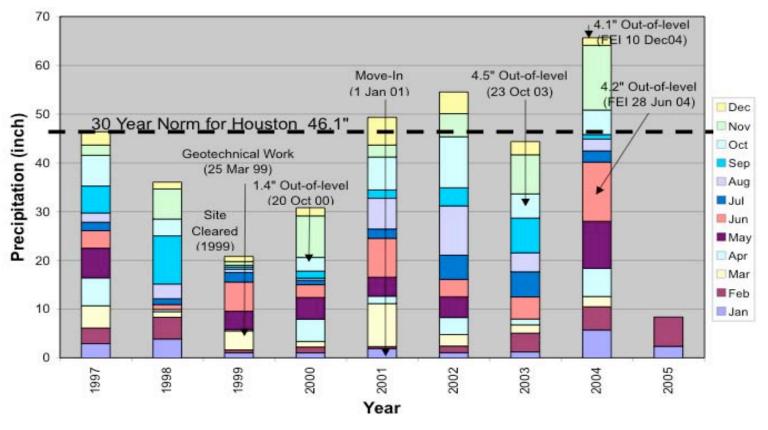
Average Precipitation at Gauge 470 (Brays Bayou at Belle Park Dr.) and Gauge 2270 (Buffalo Bayou at West Belt)

Monthly Rainfall Plot

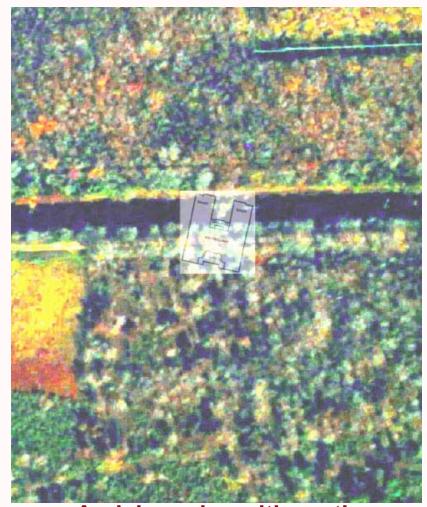
Aerial overlay with north end of house over canal

FEI used aerial photo overlays to find that house was sited across a canal, a road and mature trees.

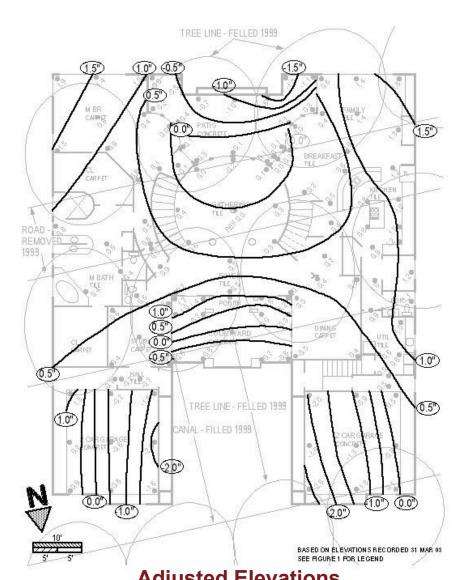
FEI Elevation survey shows Maximum Differential Elevation of 2.6"

Contours follow an east-west direction following the rows of felled trees along the canal and road.

Adjusted Elevations 31 Mar 03

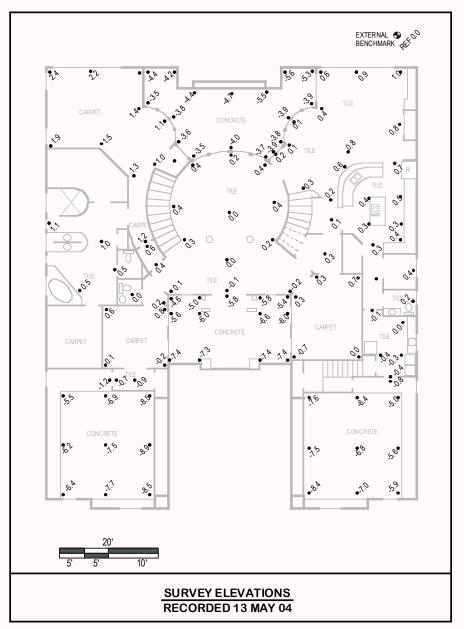
Example Survey Elevation Plan at right.

Full Elevation survey conducted every 12 months (figure at right). Note benchmark in backyard.

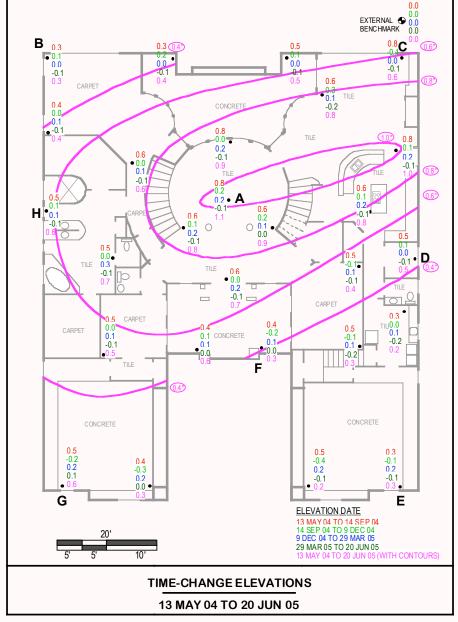
Time-change Elevations calculated as noted in the figure's legend.

Comparing the contours for the Time-change Elevation Plots showed the high point moving to the right over time.

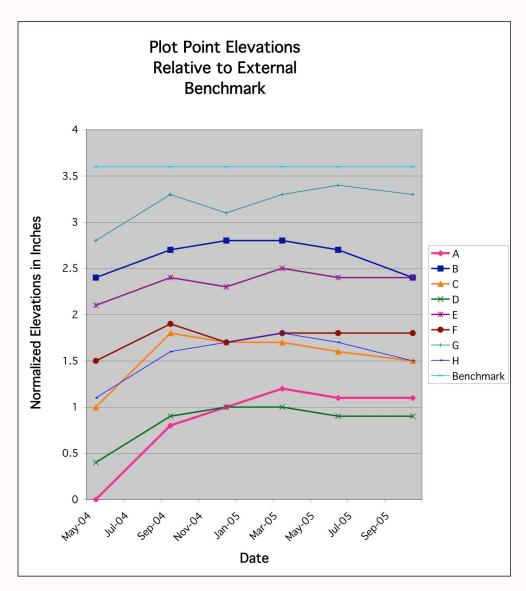
May 04 - Oct 05 Plot Point Elevations:

General upward trend with some cyclical movement.

Although A, D, E and F remained level Jul-Oct 05, the weather was extremely dry and a "normal" foundation would have moved

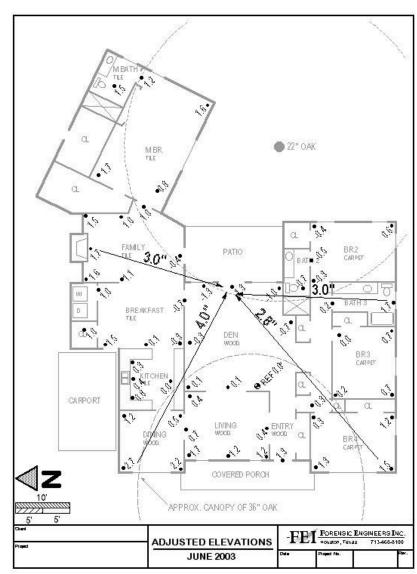
Forensic Engineers Inc's Adjusted Elevation Survey showed 4.0" out-of-level in June 2003, low at Den/Patio.

Adjusted Elevations Recorded June 2003

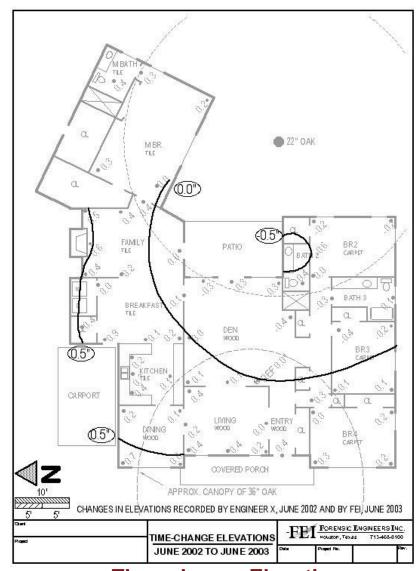
Comparing FEI's June 2003 survey to a June 2002 survey showed the Patio/Den/Bedroom 2 area had dropped relative to the rest of the residence, and overall change of 1.5" in one year.

Time-change Elevations
June 2002 to June 2003

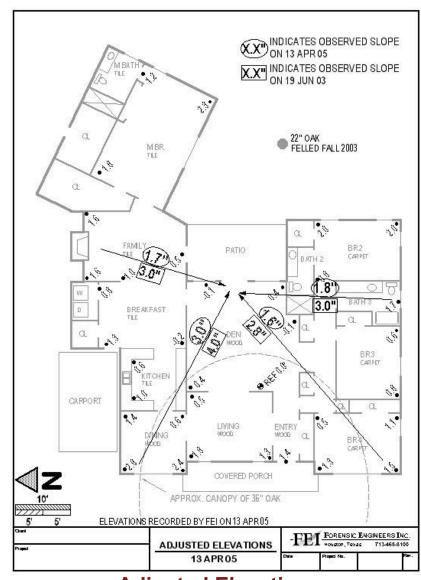
Remarkable change - Patio/Den/Bedroom 2 area lifted significantly after felling the tree 18 months prior.

Adjusted Elevations Recorded 14 Apr 05

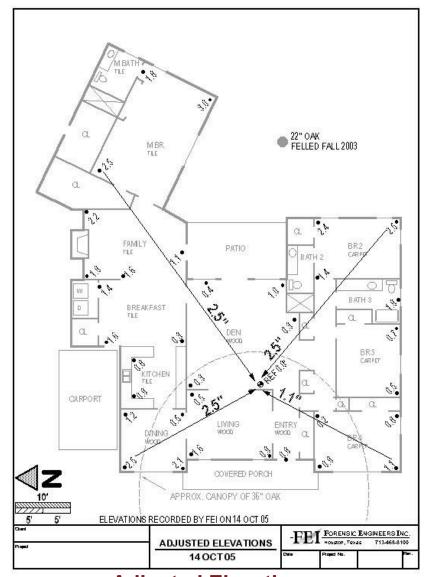
14 Oct 05 Adjusted Elevation Survey showed 3.0" out-of-level; Compare to 4.0" prior to felling oak tree.

Low point moved from Den/Patio interface to Den/Living Room interface, ~20'.

Adjusted Elevations Recorded 14 Oct 05

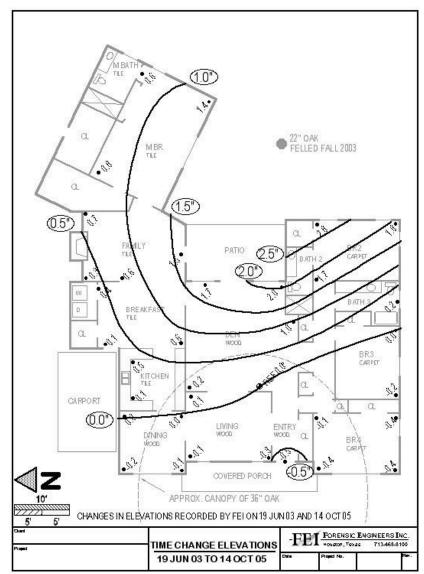
Contours on Time-change Elevation Survey tell the story.

Time-change Elevations
19 Jun 03 to 14 Oct 05
