TECHNICAL PROGRAM

Case Studies: Structural Collapse and Aftermath Considerations for Steel Structures, Concrete Tilt-up and Wood. Solving Construction Issues and Protecting against Lawsuits

PRESENTATION SUMMARY

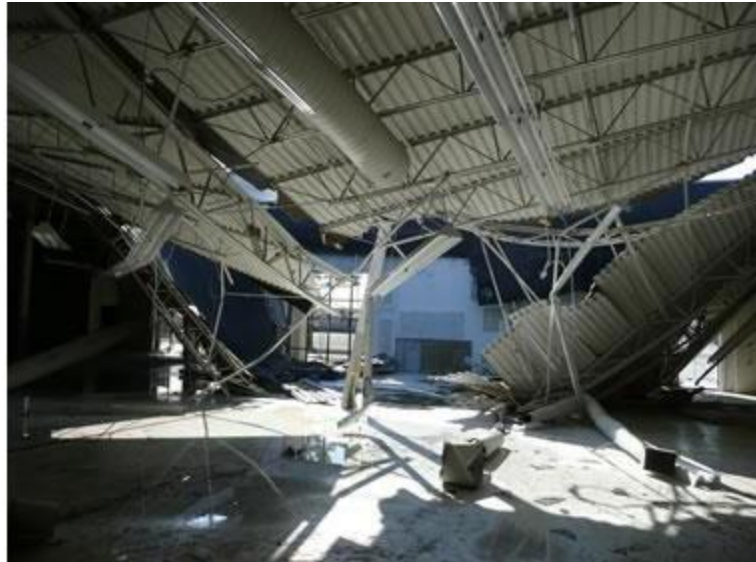
A. Case Study 1: Structural Roof Collapse of 100,000 square foot former "Kmart" due to Hurricane Ike

This was a very large tilt wall and steel one story building that appeared to have a number of issues that contributed to the collapse. All roof drains were internal to the structure. No scuppers were installed to handle emergency overflow or ponding. The roof drains were clogged with debris suggesting lack of maintenance although the debris could have been caused by short term windblown items deposited during the storm. The designed slope of the roof was not efficient and may have led to ponding during extreme rainfall events. The roof collapse was limited to several areas of the building. The difficulty was in assessing the ancillary damage to other parts of the building. The consultants were concerned that force of the collapse may have affected the integrity of the structure and connections in areas away from the local damage. The owner's position was to patch the local damage and sell the building. The consultants were justifiably concerned with long term liability for repairs and issues after the sale. Testing of all connections was very expensive. It was decided to simply remediate all connections as the lesser cost.
