## **MAY 2008 MEETING**

## **Coatings and Sealers for Protecting Concrete Facilities**

**Speaker:** Dr. C. Vipulanandan, Ph.D., P.E., Chairman and Professor of Civil Engineering and director of CIGMAT and THC-IT at the <u>University of Houston</u>, Tel. No. 713-743-4278

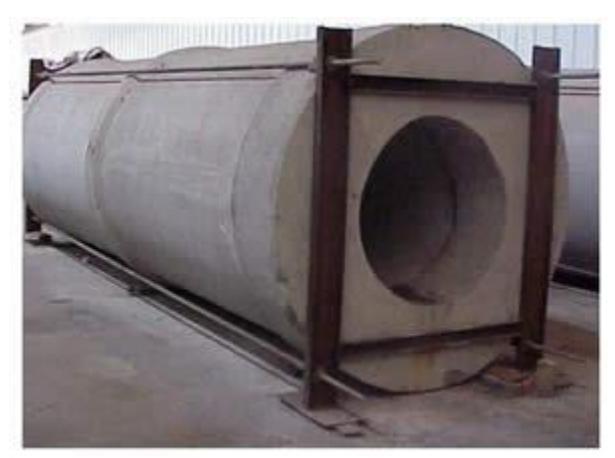
<sup>(</sup>a) Hydrostatic Test Facility

Dr. Vipu and the U of H lab conducted a study evaluating the applicability of either coating or sealing the pipes for concrete maintenance versus pipe restoration or replacement. He utilized pipe-in-pipe pressure testing in the lab by applying products to the inside of the smaller inside pipe and monitored how the products protected the pipes when vapors penetrated the inner pipe walls.

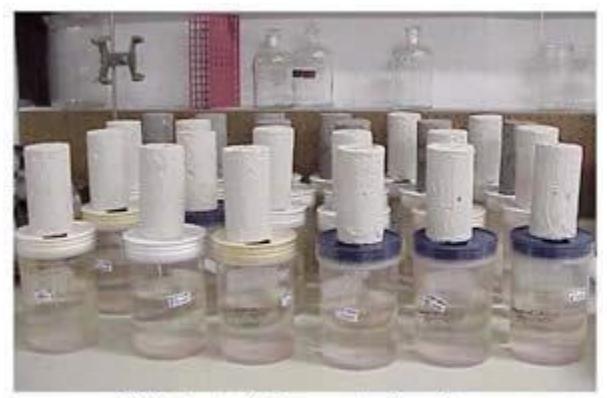
(b) Coated Concrete Specimens

Dr. Vipu described tests conducted with coatings and/or sealers being added to inner surfaces of waste lift stations. There they were conducting in-situ product bonding and water vapor emission tests. Additional product testing included using concrete cylinders with 'holiday' pinholes drilled into the coatings, then coating and/or sealing them and partially immersing them in assorted chemicals simulating environmental conditions. The cylinders were periodically removed, tested, and then returned to their test conditions for future bonding tests. He discovered the coating decay in lift stations closely matched simulation tests he conducted in the lab.
