WALKER
RESTORATION CONSULTANTS

**ASR and DEF in Concrete Structures
“It’s not as Bad as it Seems”**

**Al Bustamante, P.E.
September 13, 2017**

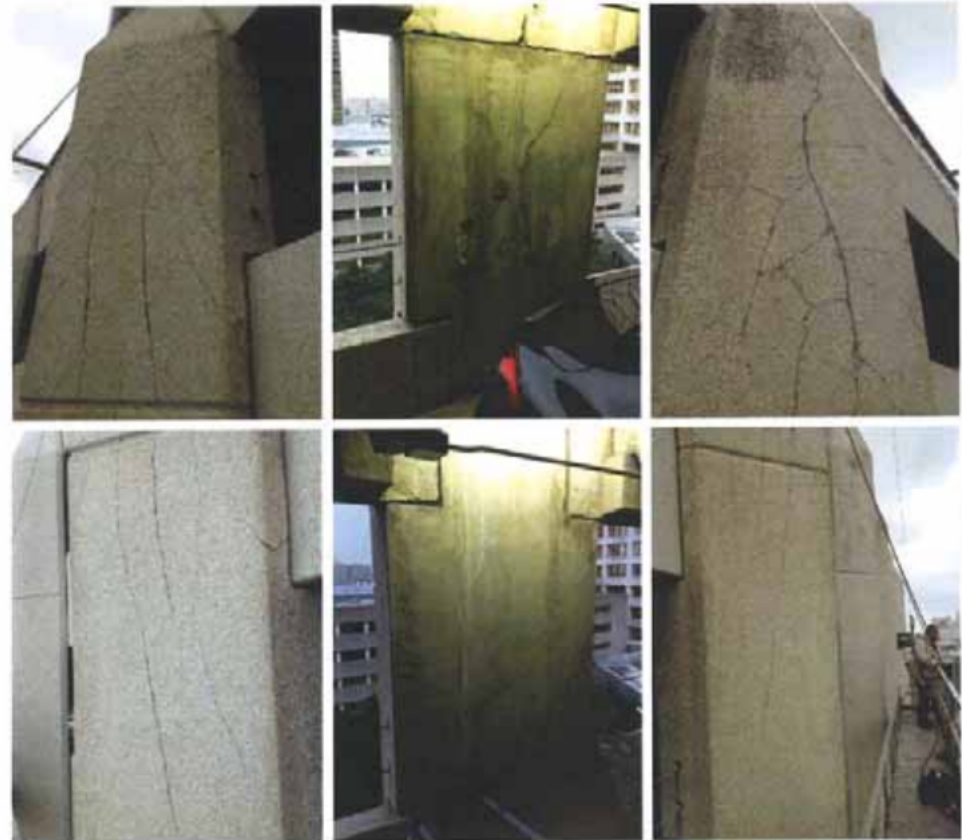
1 DETAIL
SCALE: 3/8" = 1'-0"

COLUMN KEY PLAN	LEGEND
B	— = COLUMN CRACK
C A	▨ = PORTION OF COLUMN NOT VISIBLE

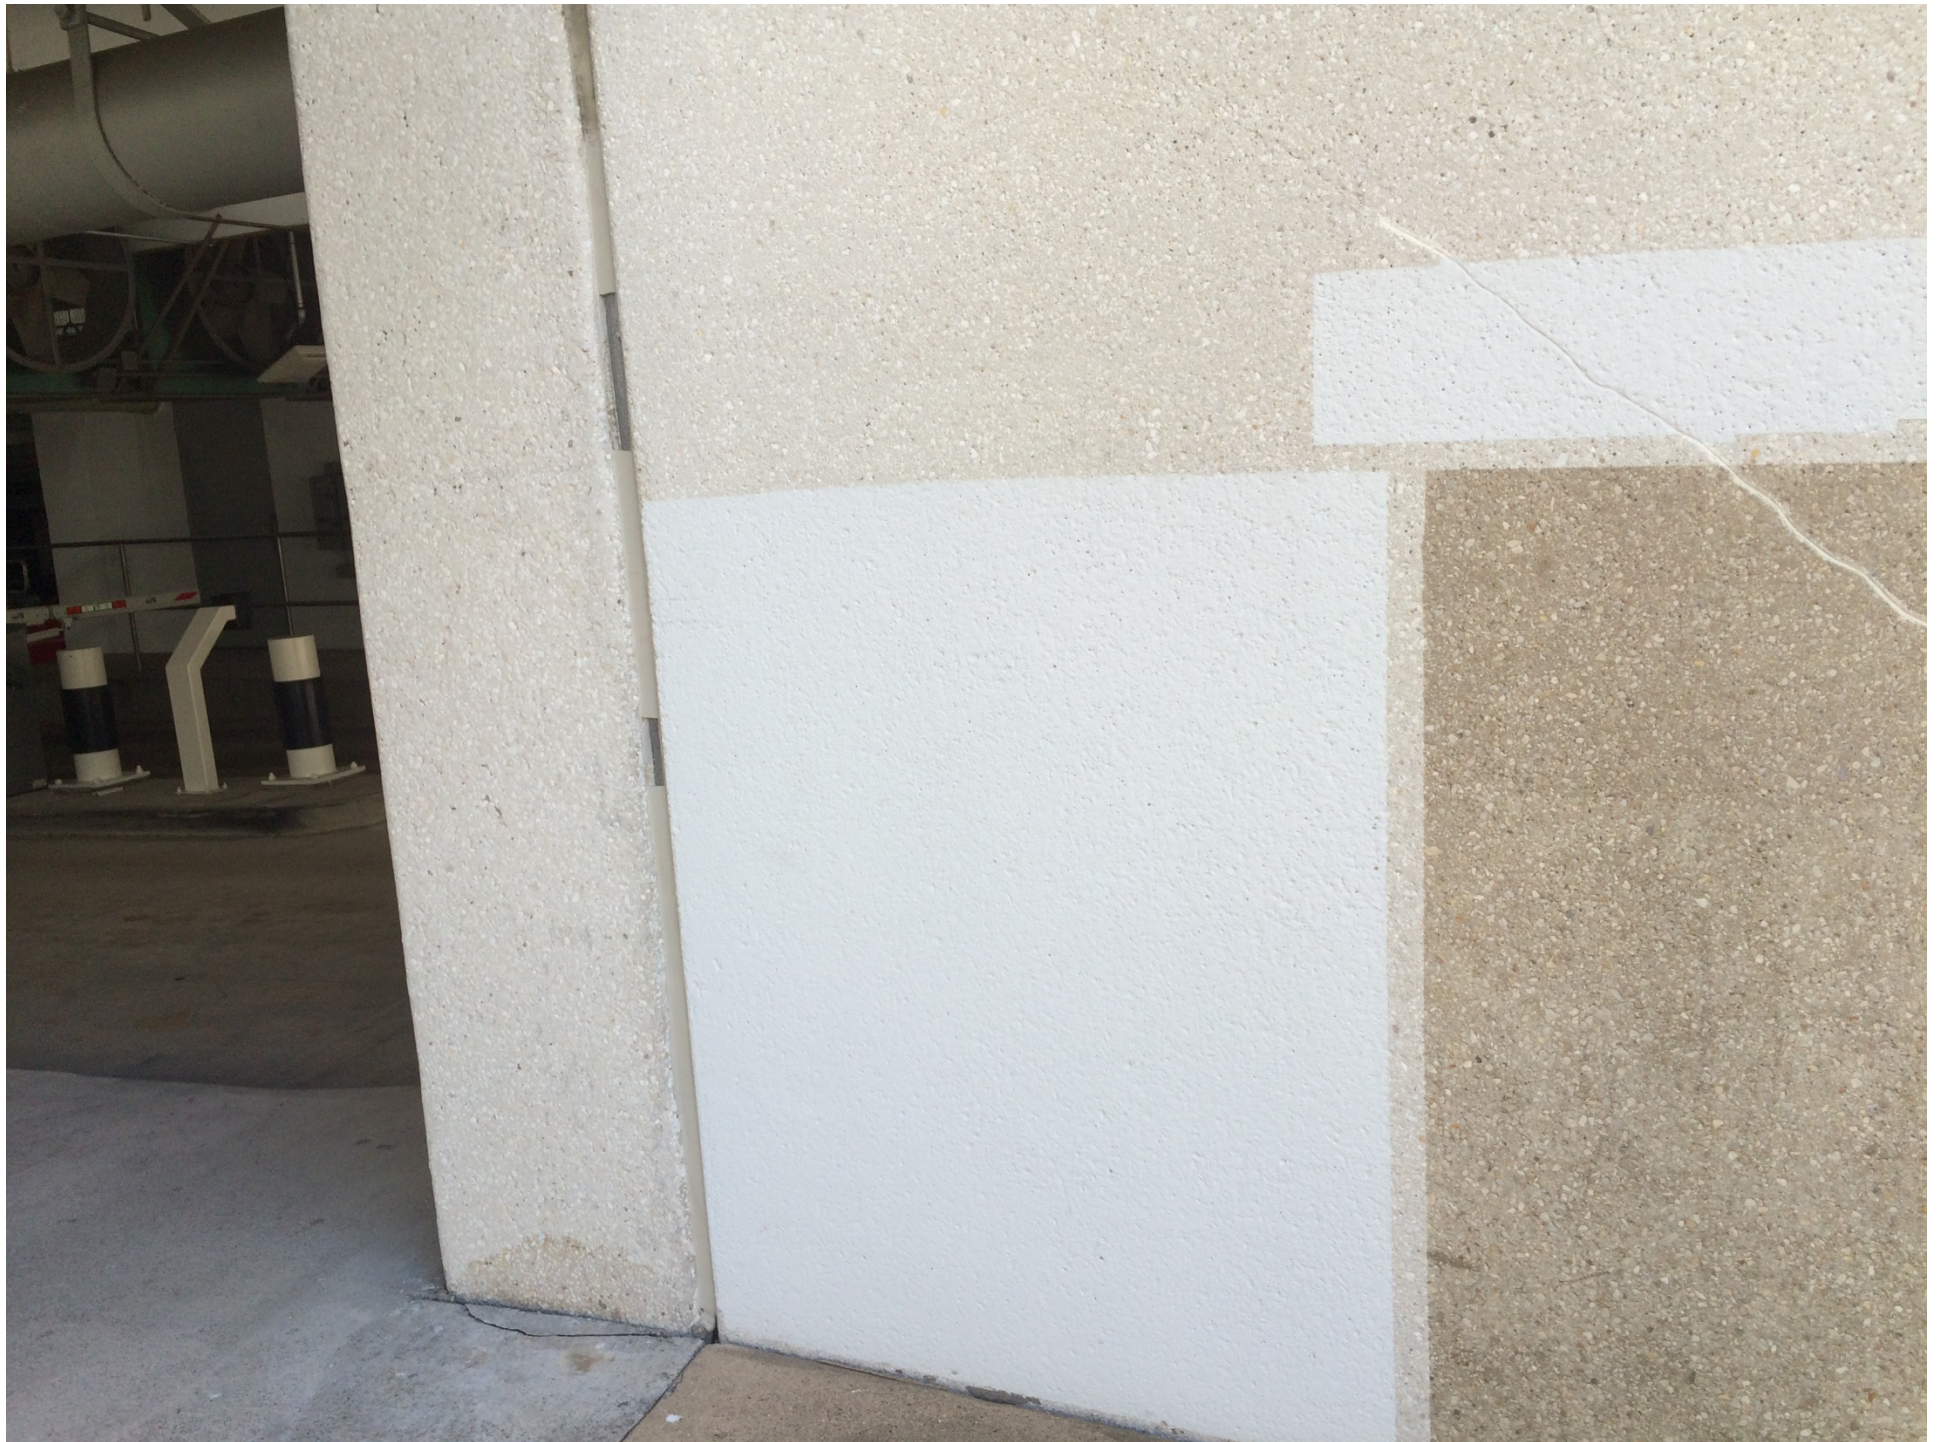
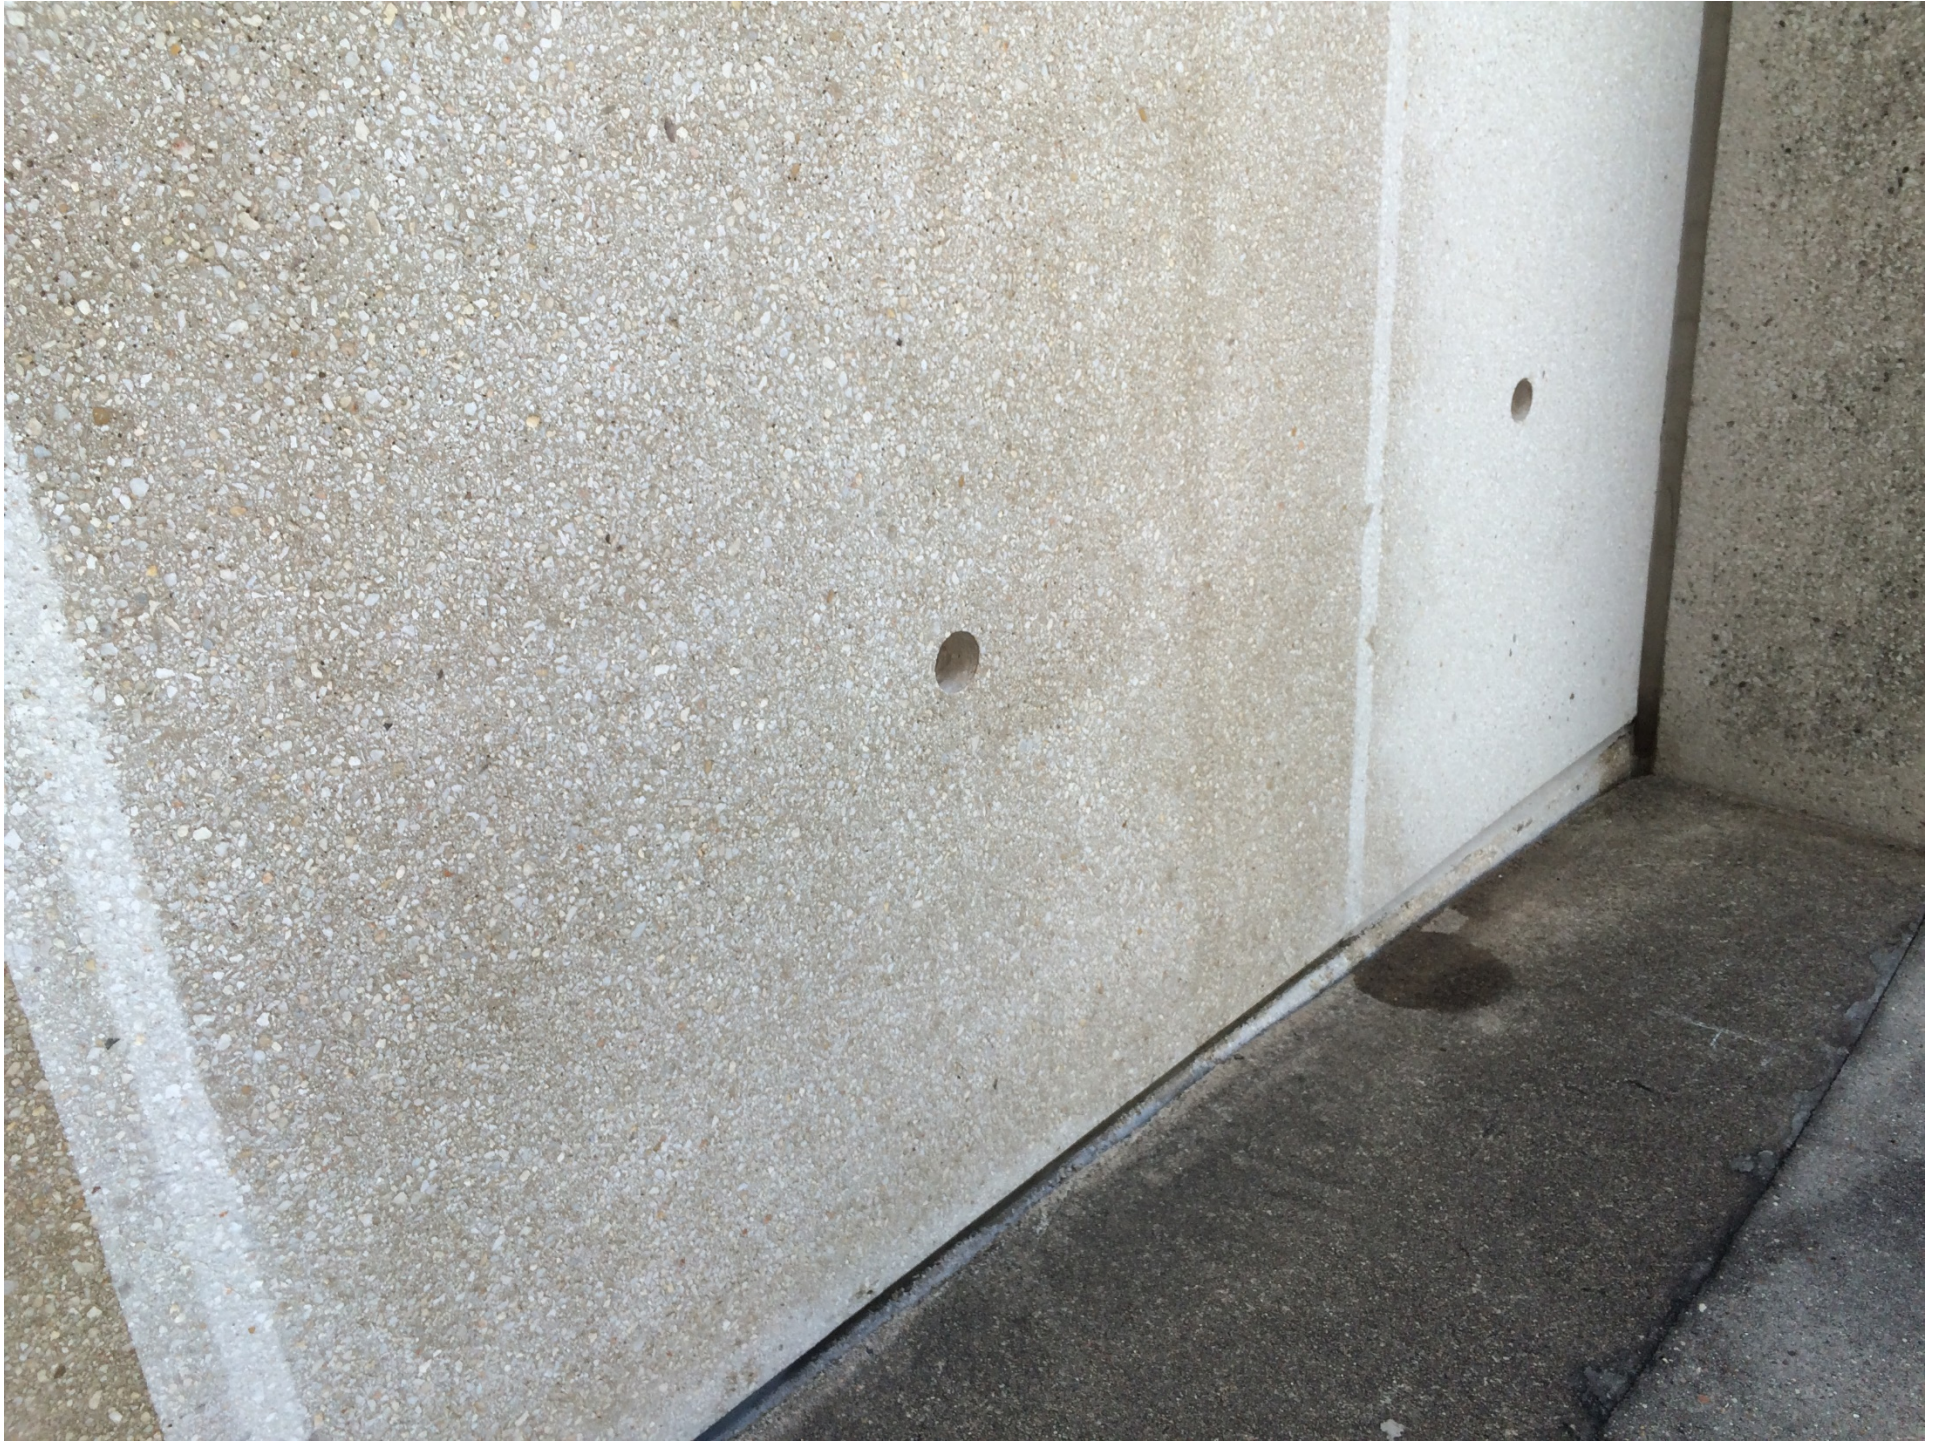
Repairs

CRACKS DO NOT HAVE A
STRUCTURAL SIGNIFICANCE

- Clean and prepare concrete surface: Water-assisted blasting.
- Water repellant: Silane 100% solids
- Seal cracks and joints: Flexible sealant
- Flexible surface coating: Elastomeric
- Periodic surveys: Annual

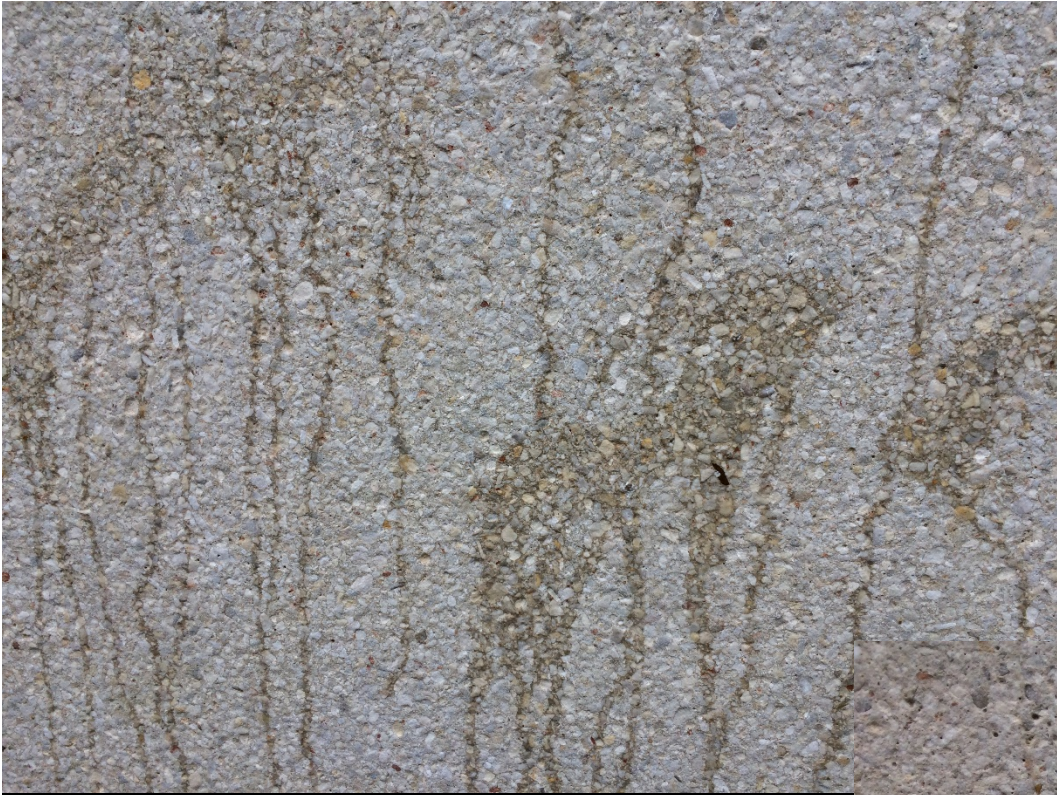
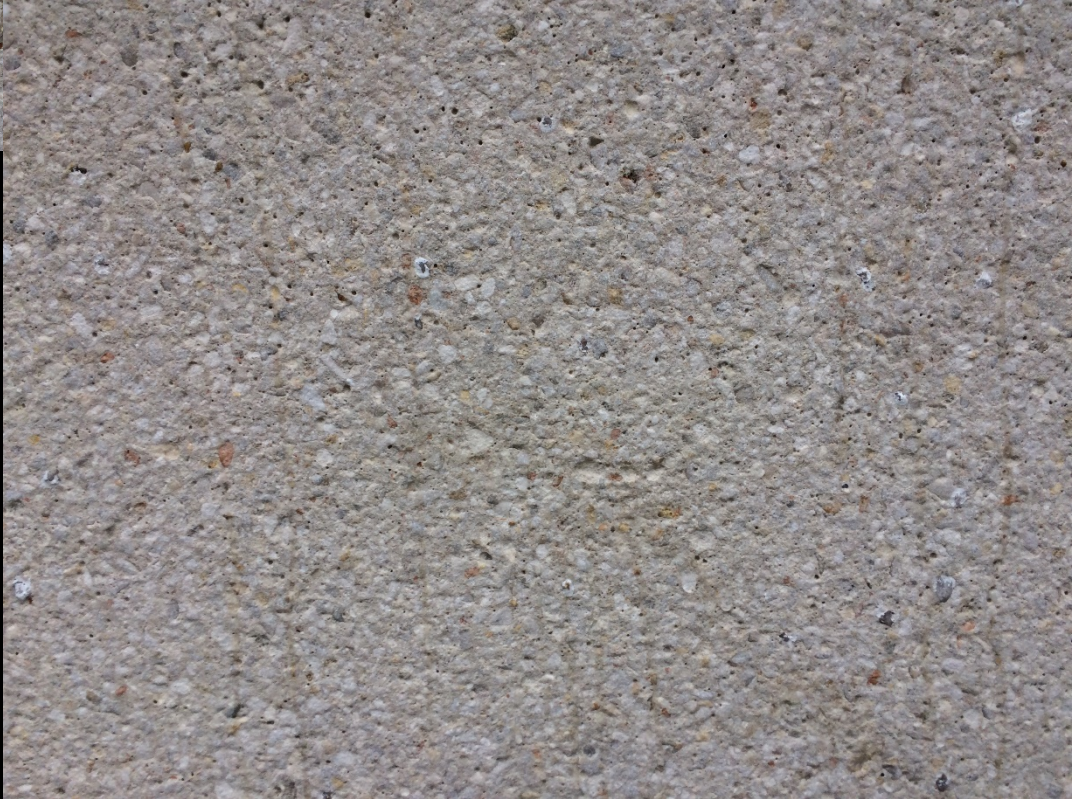
DO NOT
ROUTE
CRACKS

TWO COATS OF PAINT
